# Active-layer detachments following the summer 2004 forest fires near Dawson City, Yukon

Lipovsky, P.S., Coates, J., Lewkowicz, A.G. and Trochim, E., 2006. Active-layer detachments following the summer 2004 forest fires near Dawson City, Yukon. *In: Yukon Exploration and Geology 2005*, D.S. Emond, G.D. Bradshaw, L.L. Lewis and L.H. Weston (eds.), Yukon Geological Survey, p. 175-194.

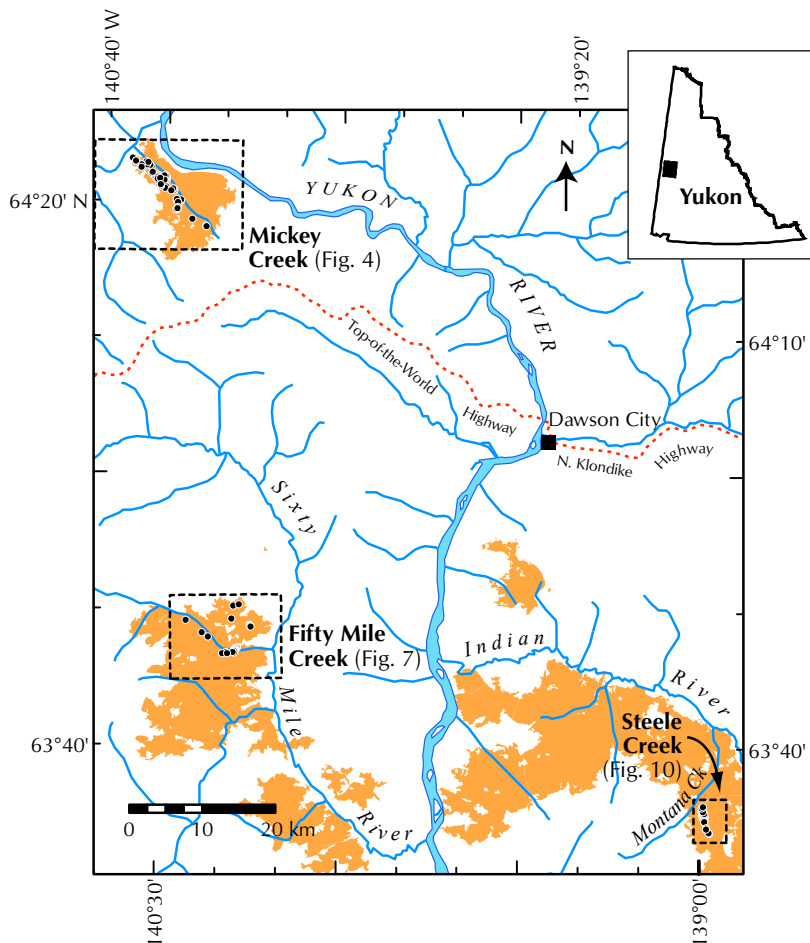
**Figure 1.** Index map of Dawson area, displaying the locations of Mickey Creek, Fifty Mile Creek and Steele Creek watersheds. Dots represent locations of active-layer detachments. Shaded areas represent those regions burned by forest fires in 2004. Inset map shows location of study area within Yukon.

Extensive forest fires burned in the Dawson City area from late-June to mid-September, 2004 (Fig. 1). Numerous active-layer detachment failures subsequently developed in the burnt areas during the summers of 2004 and 2005. Investigations in three watersheds near Dawson City revealed that more than 70 detachments occurred on slopes and tributaries adjacent to a 10-km-reach of Mickey Creek, 40 detachments on slopes adjacent to a 4-km reach of Steele Creek, and a further 28 detachments in the lower 12 km of the Fifty Mile Creek watershed.

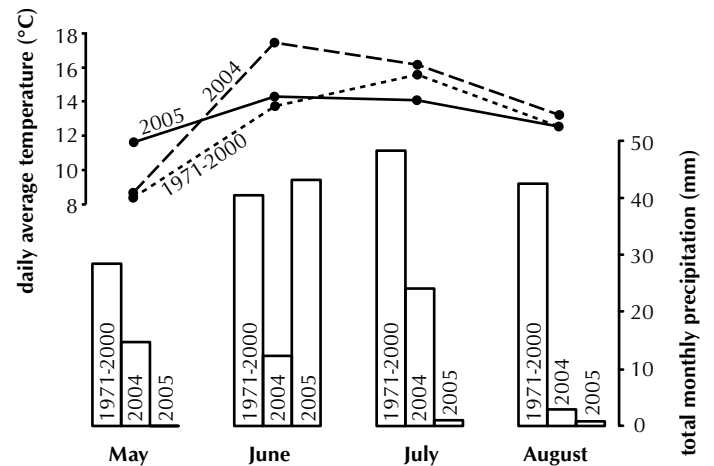
**Figure 3.** 2004 and 2005 daily average temperature and total monthly precipitation for the months of May to August, compared to 1971–2000 climate normals. (Data from Environment Canada Dawson weather station,  $64^{\circ}3'\text{N}$ ,  $139^{\circ}7'\text{W}$ , elevation 370 m.)

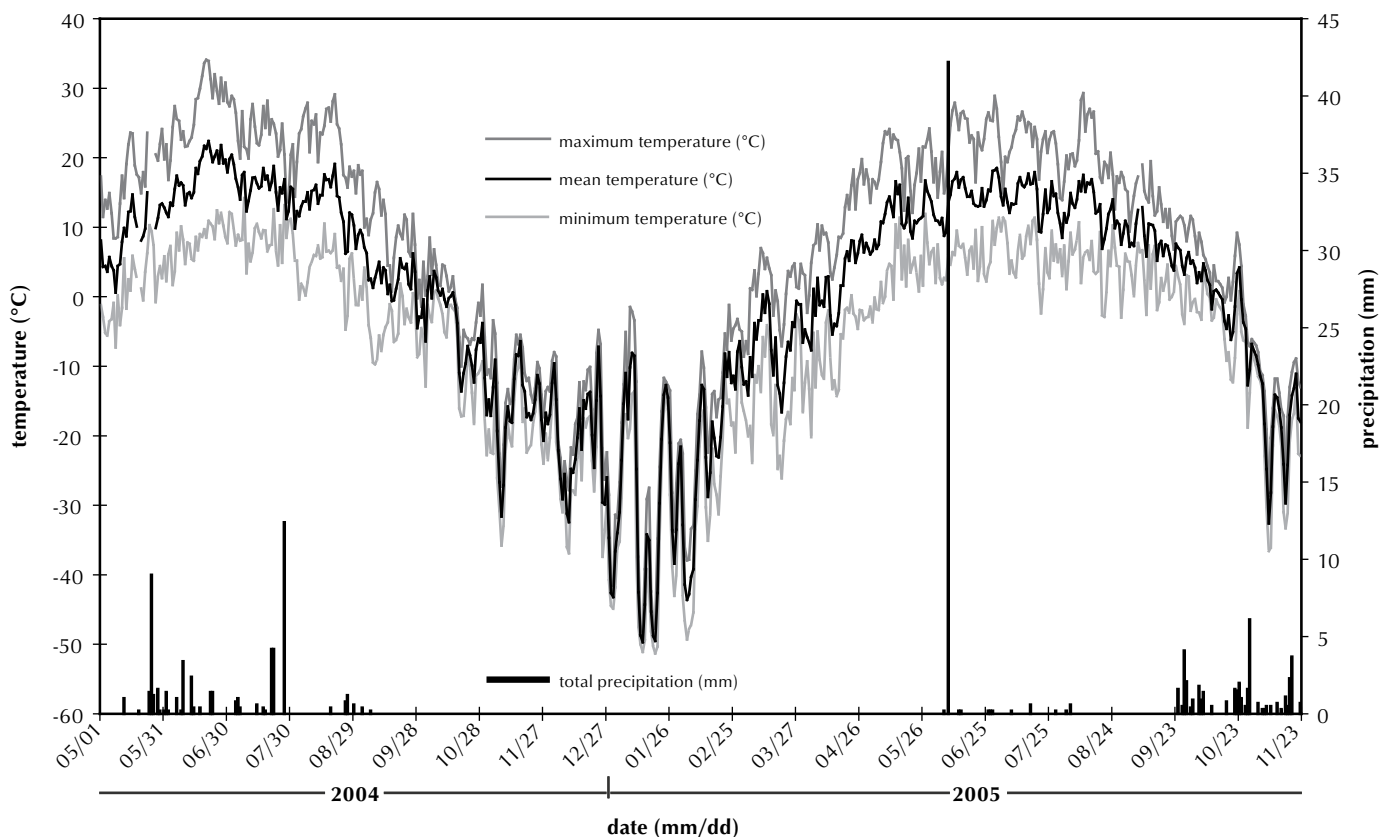
**Figure 2.** Daily temperatures (mean, maximum and minimum) and total daily precipitation at Dawson weather station ( $64^{\circ}3'\text{N}$ ,  $139^{\circ}7'\text{W}$ , elevation 370 m; data from Environment Canada).

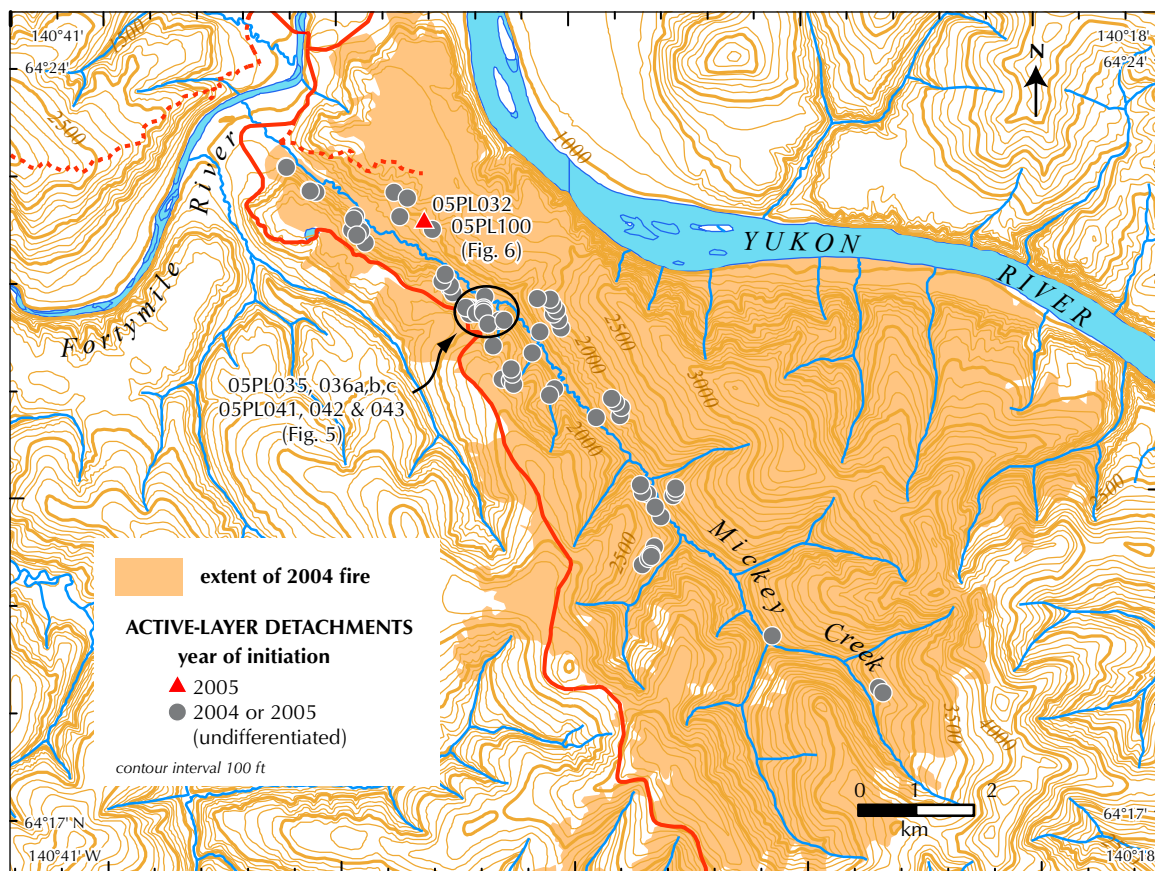
**Figure 4.** Location map displaying the extent of burned areas, as well as locations of active-layer detachments surveyed in Mickey Creek watershed.

On July 20, 2005, seventy-four slope failures were located in the watershed by hovering above each detachment with a helicopter and recording GPS waypoints. Fifteen of the detachments were visited on the ground on July 13, 20 and 21 (Figure 4).

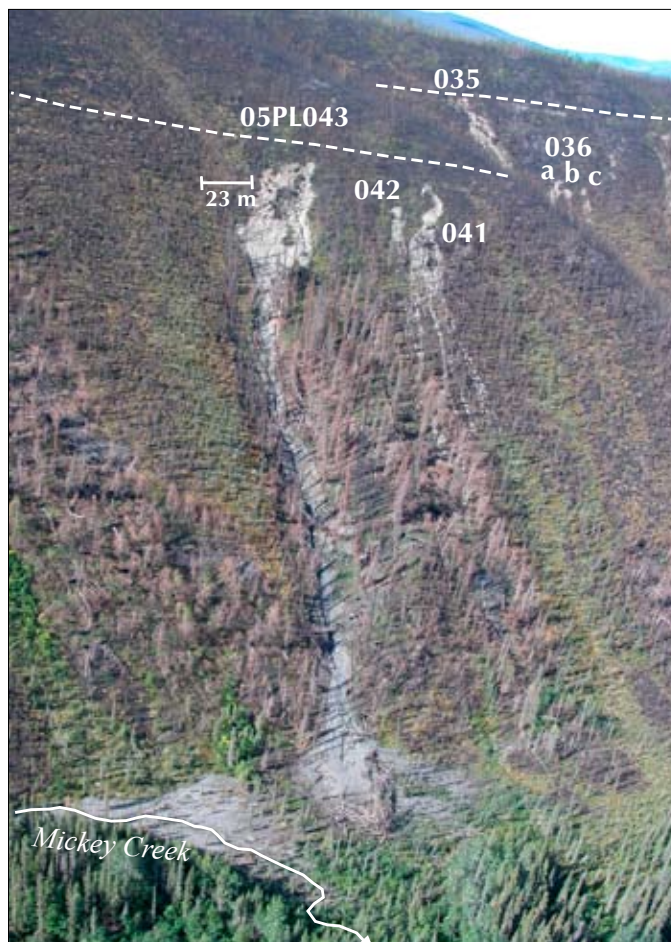
**Figure 5.** Oblique aerial photograph of numerous failures originating along the scarp of a Pre-Reid glaciofluvial terrace (see dotted lines) on upper, northeast-facing slopes. View is to the southwest. Numbers represent active-layer detachments surveyed near Mickey Creek.

Seventeen of the surveyed detachments initiated at, or near the edge of, a narrow (~20-m-wide) Pre-Reid distal glaciofluvial terrace. The terrace is located on the upper, moderately steep, northeast-facing slopes in the lower portion of the watershed. The failures exposed light-coloured gravel which contrasted well with the burned surface and readily defined the existence of the terrace, which was otherwise difficult to detect (Fig. 5).

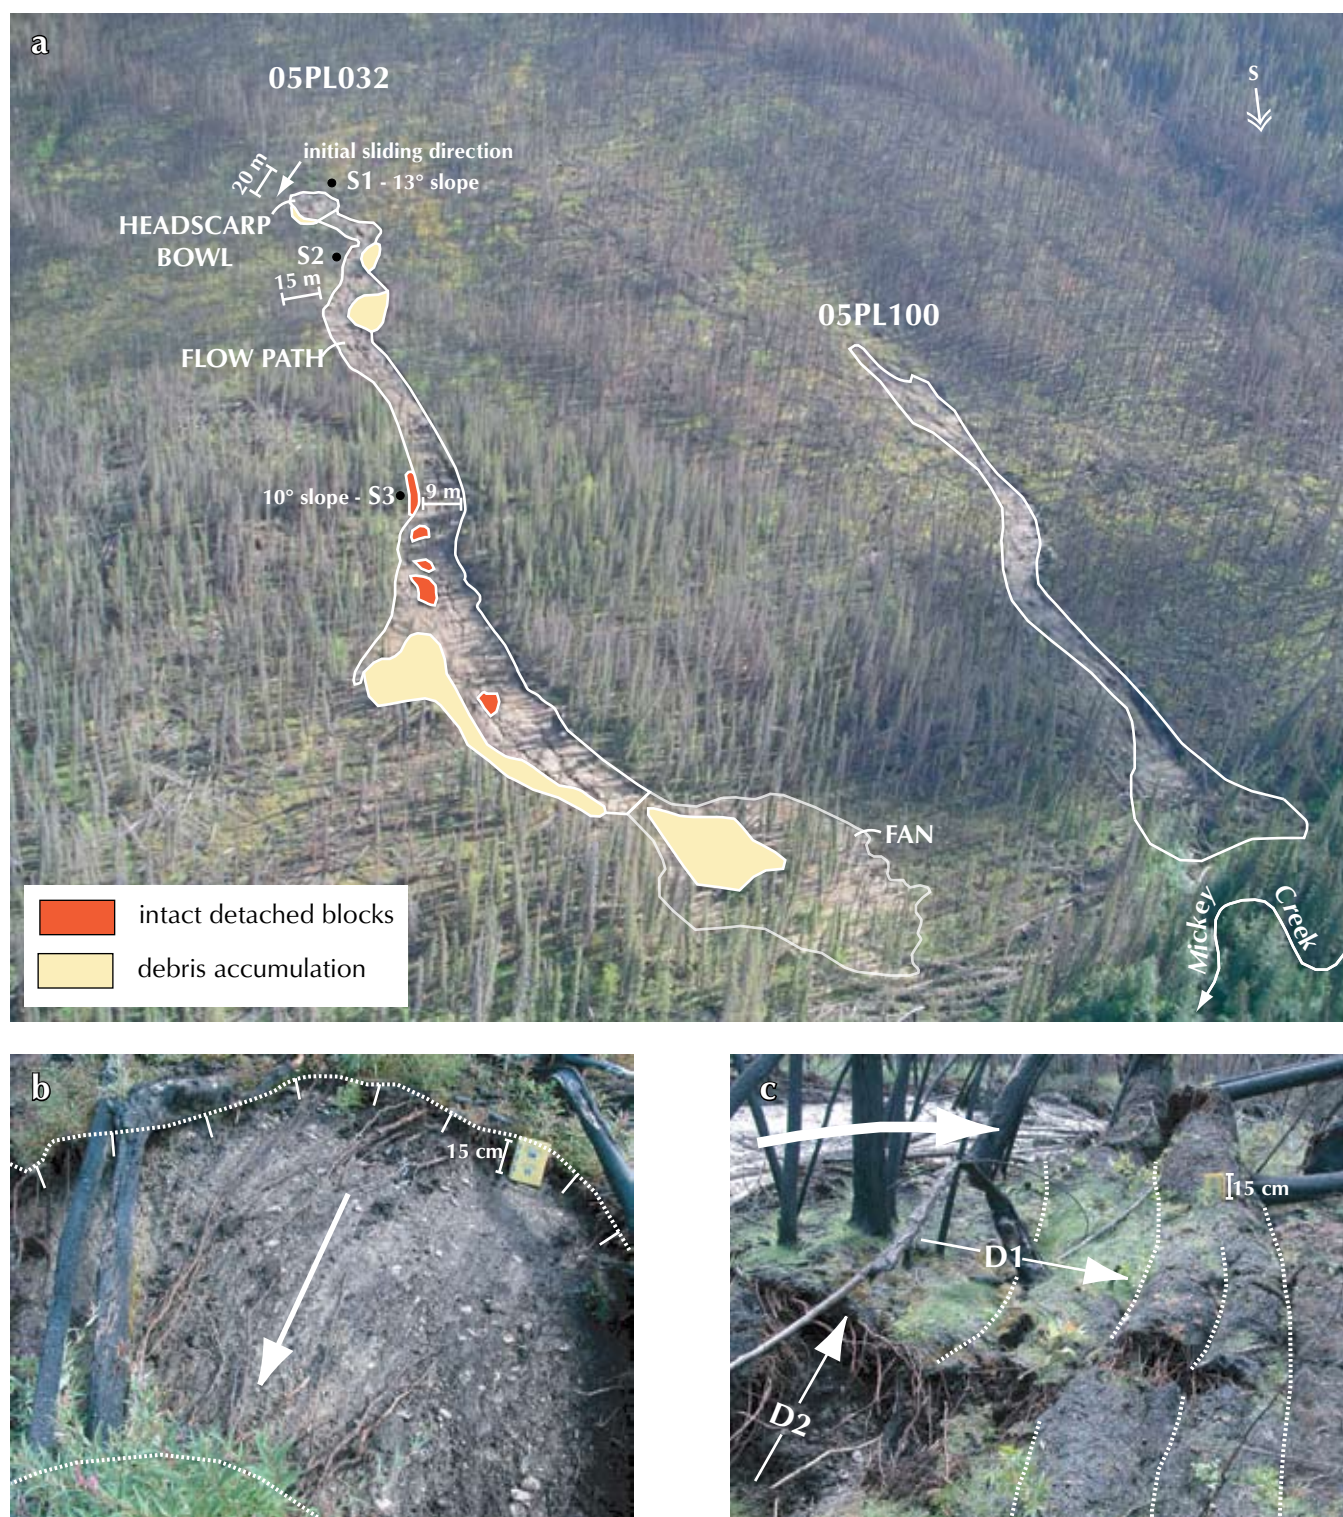
**Figure 6.** (a) Oblique aerial view of two detachments (05PL032 and 05PL100) that occurred on a gentle south- to southwest-facing slope. The larger failure is over 200 m long and initiated only a few days prior to these photos being taken on July 20, 2005. (b) Detachment of organic mat exposed in tension cracks above the headscarp (location S1 in Figure 6a). Roots are stretched in the direction of sliding. (c) Deformed organic mat (location S3 in Figure 6a), marginal to flow path (heavy arrow). The mat was initially compressed (direction D1) to form folded compression ridges (small dotted lines). It was then torn away from the surrounding mat (direction D2).

A fresh detachment (05PL032) was observed on July 20, with material still actively flowing (Fig. 6). The detachment was not visible in photographs taken 7 days earlier and it is likely that the detachment occurred within a day or two of the field visit. The failure began with a small slide in a 20-m-wide headscarp bowl, on a southwest-facing, gentle (13°), lower slope. The initial sliding depth was between 10 cm and 50 cm, just below the bulk of the root mat. The organic mat had collapsed along the edge of the headscarp, indicating that it had greater strength than the underlying soil. Probing revealed a frost table at 104 cm beneath a fresh sliding plane, and 88-99 cm behind the headscarp. Above the headscarp, water was ponded around many tree wells. Roots were outstretched in the direction of extension (Fig. 6b) and fresh sliding plane surfaces were exposed between tension cracks above the headscarp, and along the flow path margins where intact blocks of forest floor had been torn away (Fig. 6c).

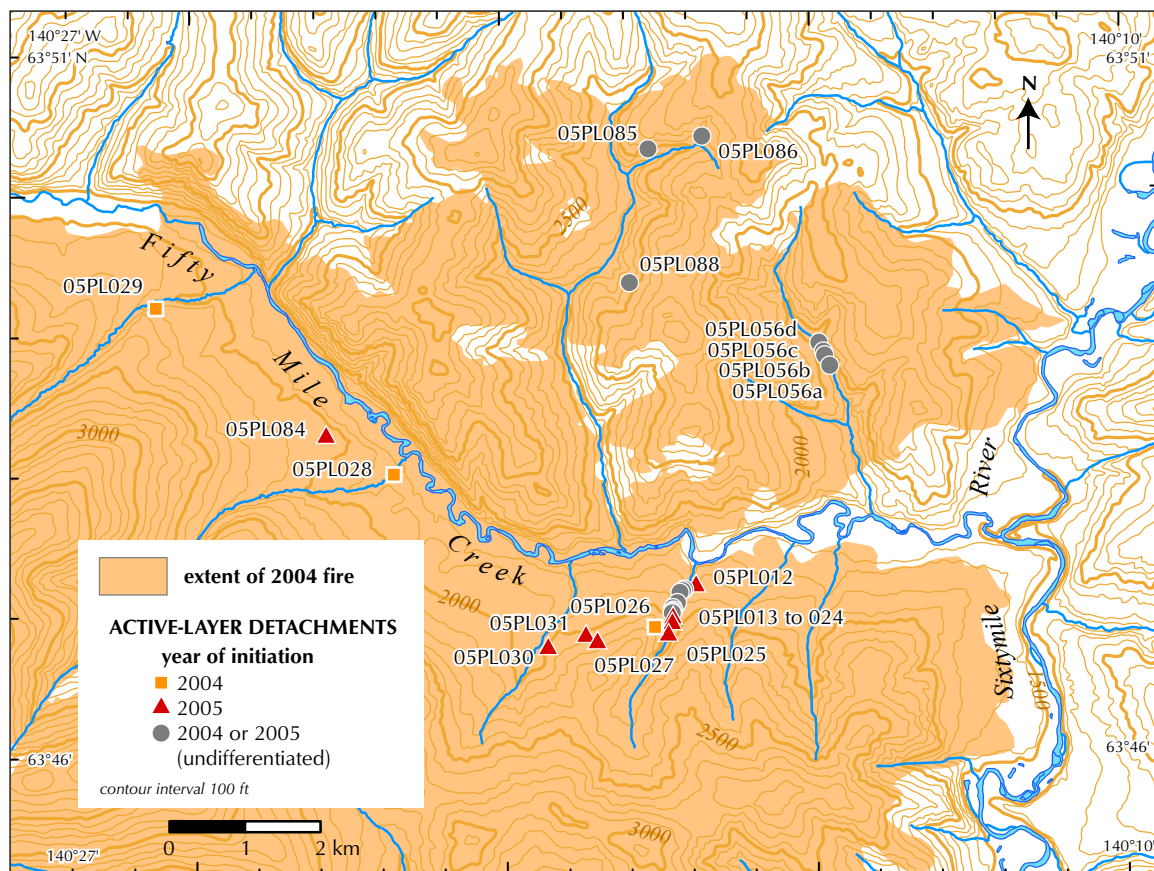
**Figure 7.** Location map displaying the extent of burned areas, as well as locations of active-layer detachments surveyed in the lower part of the Fifty Mile Creek watershed.

The lower half of the watershed was burned in the 2004 fires (Fig. 7). Fires were detected by MODIS satellite instruments in the watershed between June 25 and July 13, 2004 (USDA Forest Service, 2005). The fires started on the upper slopes, south of Fifty Mile Creek, about a third of the way up the valley. They burned most extensively near the subsequent detachments on June 29 and 30. Between July 1 and 11, only scattered hotspots were detected. On July 12, the entire lower portion of the watershed burnt extensively both north and south of the creek.

Twenty-eight slope failures were located in the watershed using GPS waypoints recorded while hovering above each detachment with a helicopter; this data was gathered on July 16 and 19, 2005 (Fig. 7). Twenty of the failures were

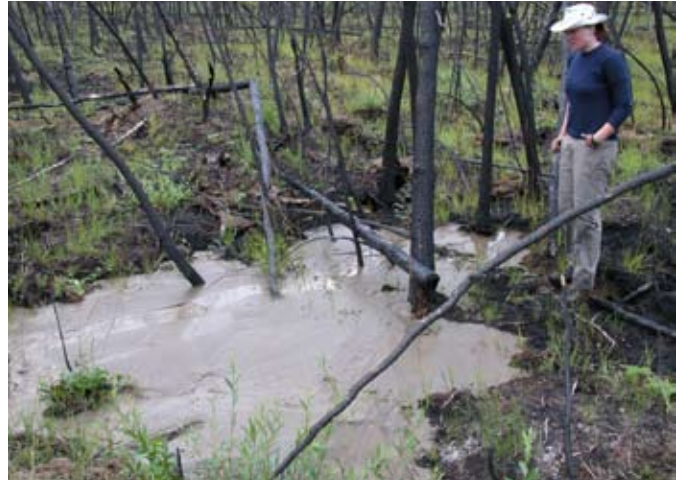
**Figure 9.** Surface sediment plume created by artesian groundwater flow. These commonly occurred on saturated slopes and near the initiation zones of recent failures.

Sediment-laden artesian springs (sediment plumes) were noted in proximity to many initiation zones (Fig. 9), indicating extremely high pore water pressures. Frost probing in mid July located the frost table between 44 cm

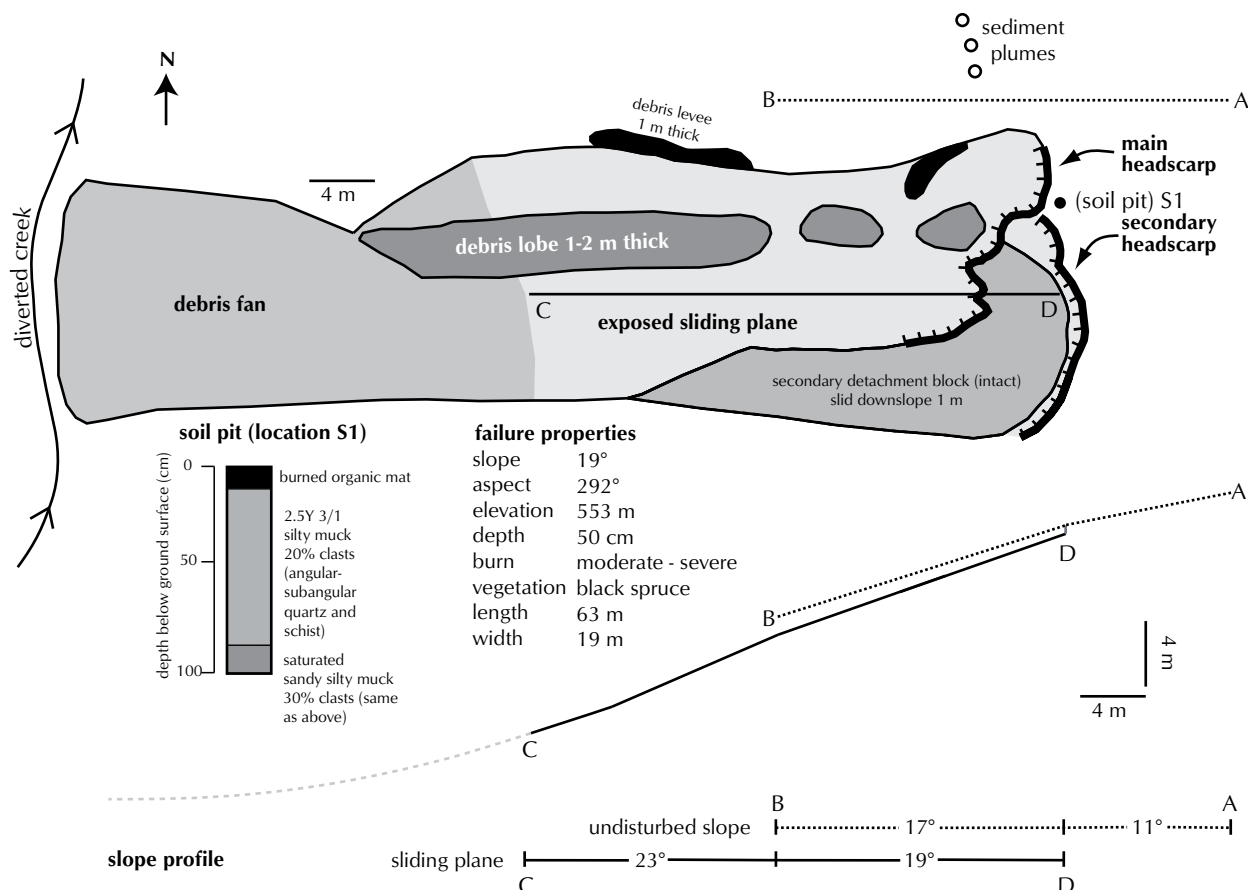
**Figure 8.** Morphology and slope profile of typical elongate detachment (05PL012) in Fifty Mile Creek watershed; drawn to scale.

Active-layer detachments occurred mainly along the upper portions of convex tributary valley slopes in the Fifty Mile Creek watershed. The morphology of a typical elongate-shaped detachment is shown in Figure 8. Slope angles in the initiation zones ranged between  $11^\circ$  and  $25^\circ$ . Failures occurred on all aspects, but were most common on north- and east-facing slopes. The highest density of failures occurred along one tributary valley, where 15 detachments have occurred within 1 km (05PL012 to 05PL027). Failures were very shallow, ranging between 15 cm and 50 cm. They were generally up to 60 m long and up to 25 m wide, although a few failures traveled several hundred metres downslope. Surficial materials in the initiation zones of the failures consisted of brown, silt-rich (up to 37-60% silt) colluvium, with 20-50% angular to sub-angular schistose clasts.

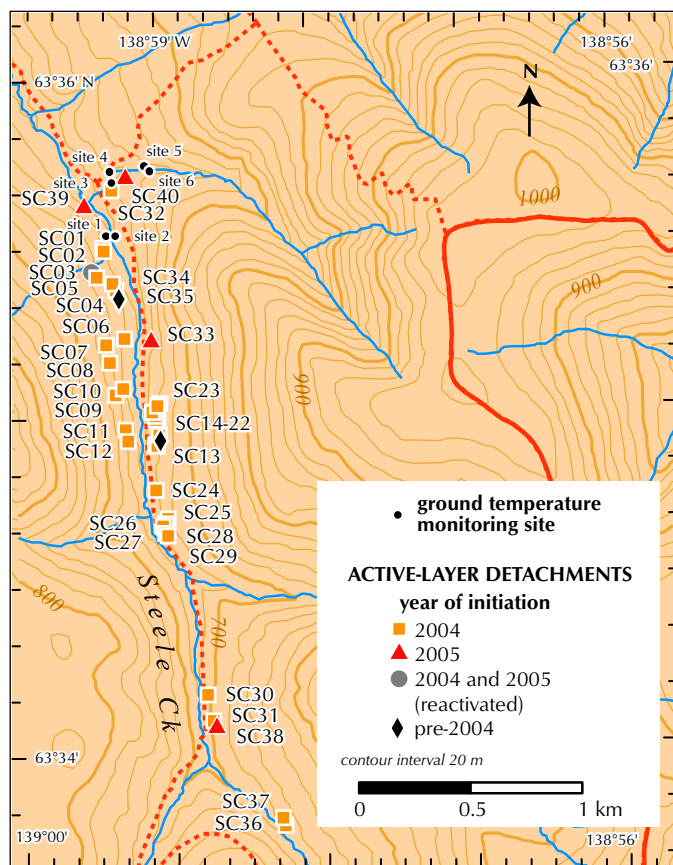
**Figure 10.** Map displaying burned area and locations of active-layer detachments surveyed in Steele Creek watershed. The entire area was burned during the summer of 2004.

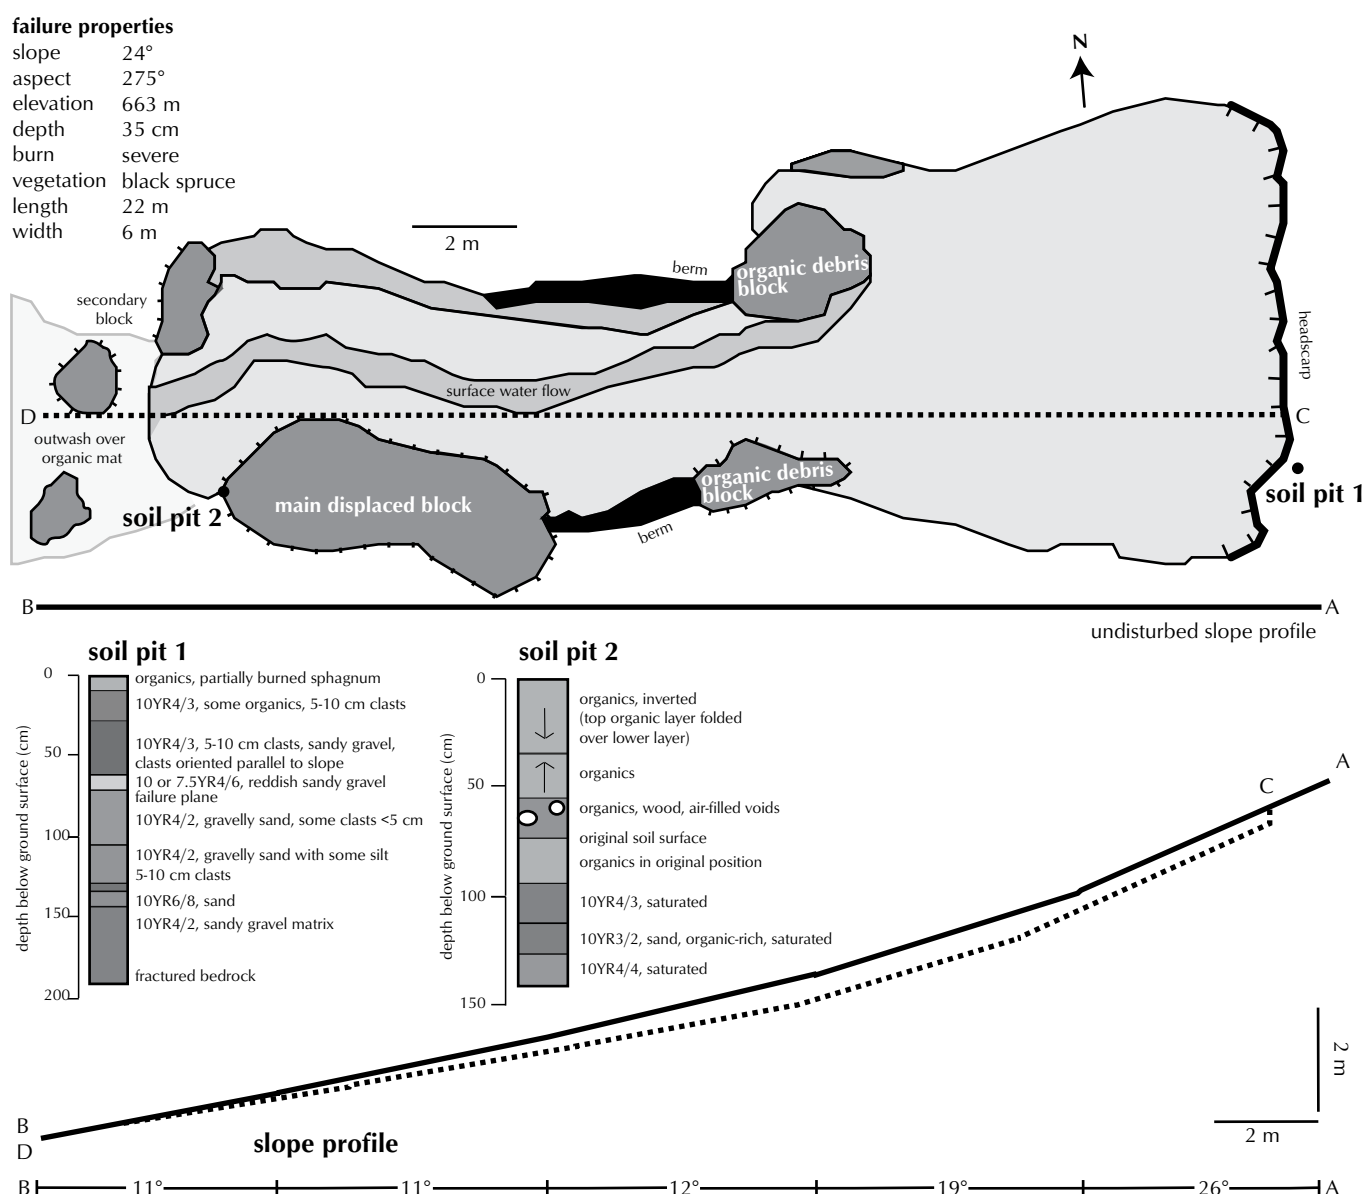
**Figure 11.** Morphology and slope profile of typical elongate detachment (SC13) in Steele Creek watershed; drawn to scale.

Representative detachment failures from both years were mapped in detail, and soil pits were excavated in order to examine soil stratigraphy (Fig. 11). Probing was conducted

Active-layer detachments were 50–80 cm in depth, ranged in length from tens to hundreds of metres, and were 1 m to 20 m wide. The morphology and slope profile of a typical elongate detachment failure (SC013) is shown in Figure 11. Several of the failures deposited sediment and debris directly into Steele Creek (Fig. 14). One detachment failure partially blocked the creek, creating a small pond upstream.

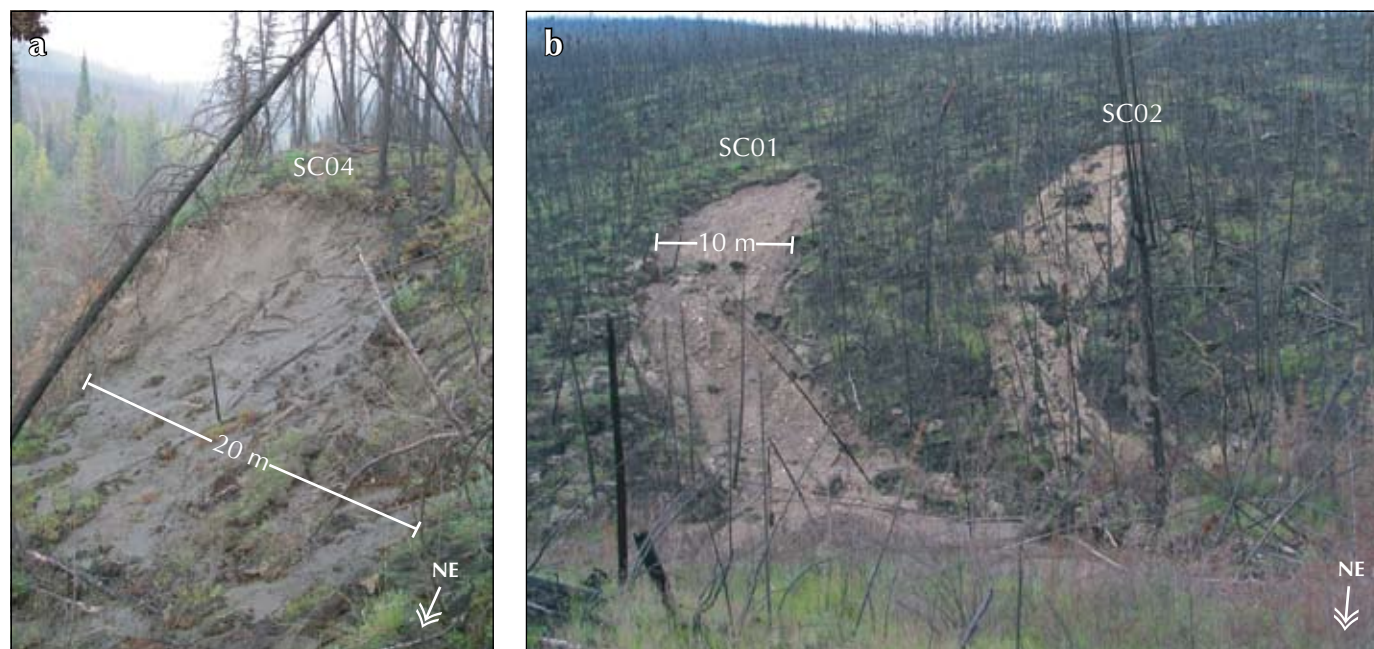
**Figure 12.** Typical bell-shaped (a) and elongate (b) detachment failures on northeast-facing slopes in the Steele Creek watershed.

Both bell-shaped and elongated detachment failures (Lewkowicz and Harris, 2005b) were present (Fig. 12). They developed on hillslopes with a variety of aspects. All failures occurred on slopes underlain by permafrost; no detachments were observed on south-facing slopes that were permafrost-free. Most failures initiated on slopes of  $19\text{--}24^{\circ}$ , often proximal to a convex break in slope (Fig. 13).

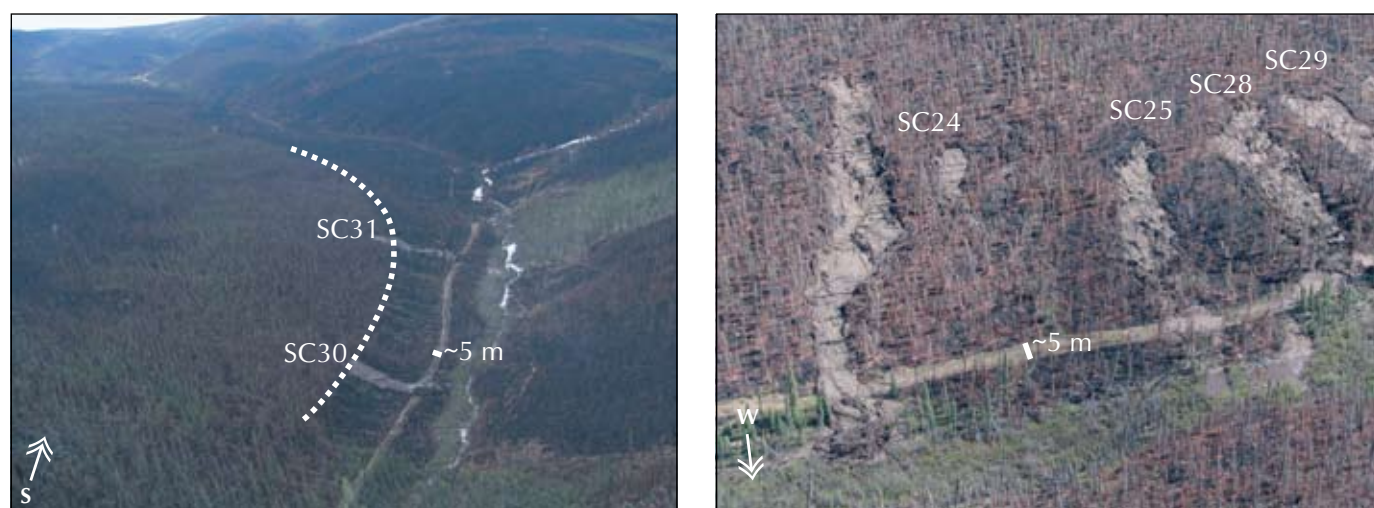
**Figure 13.** Oblique aerial photograph of active-layer detachments in Steele Creek, which initiated from a prominent convex break in slope (shown by dotted line).

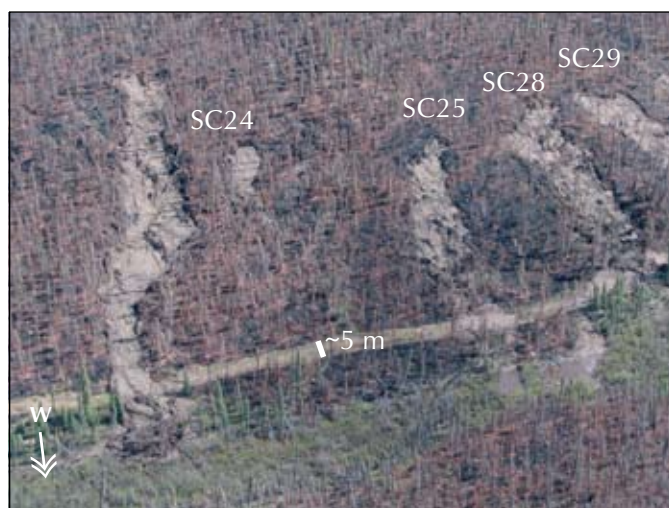
**Figure 14.** Oblique aerial photograph of multiple active-layer detachments on a west-facing slope. The failures crossed local access trails and deposited material directly into Steele Creek.

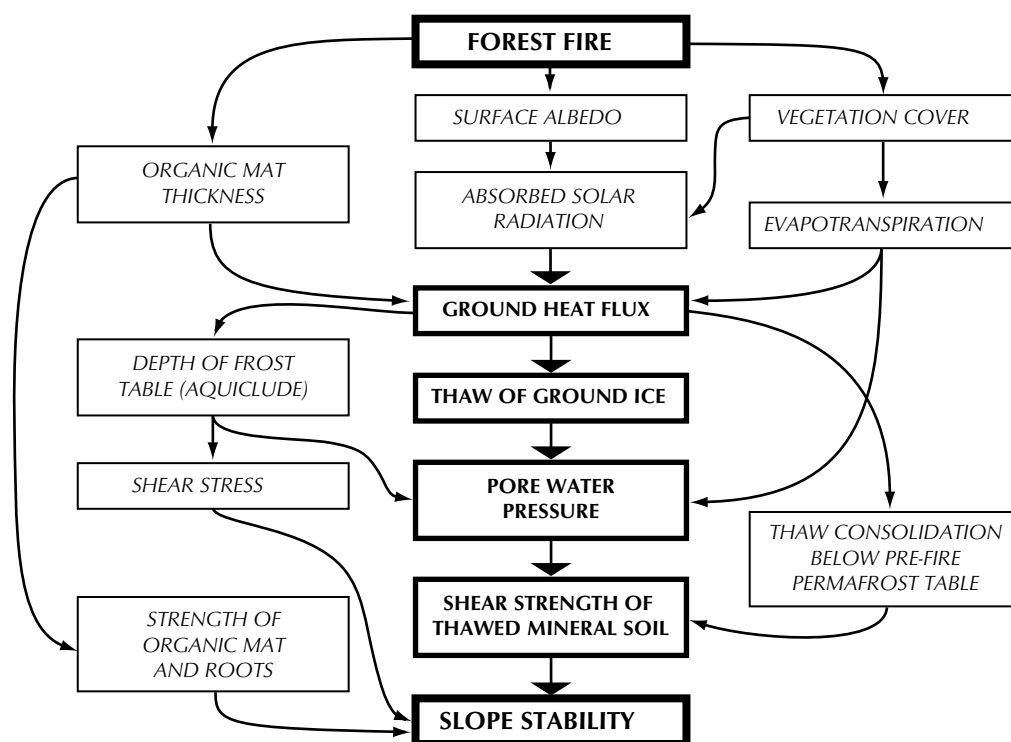
**Figure 15.** Conceptual framework for the impacts of forest fire on the stability of slopes underlain by permafrost. Note: for clarity, factors that are unaffected by fire (e.g., topography, precipitation) are not shown.

Forest fires impact numerous aspects of the thermal, hydrological and geotechnical conditions of slopes underlain by permafrost. A conceptual framework for these direct and indirect factors is shown in Figure 15. The relative significance of each of these controls on overall slope stability is difficult to assess, and merits future study.

Although not shown in Figure 15, which focuses only on changes following forest fire, topography and precipitation are also very important factors for slope

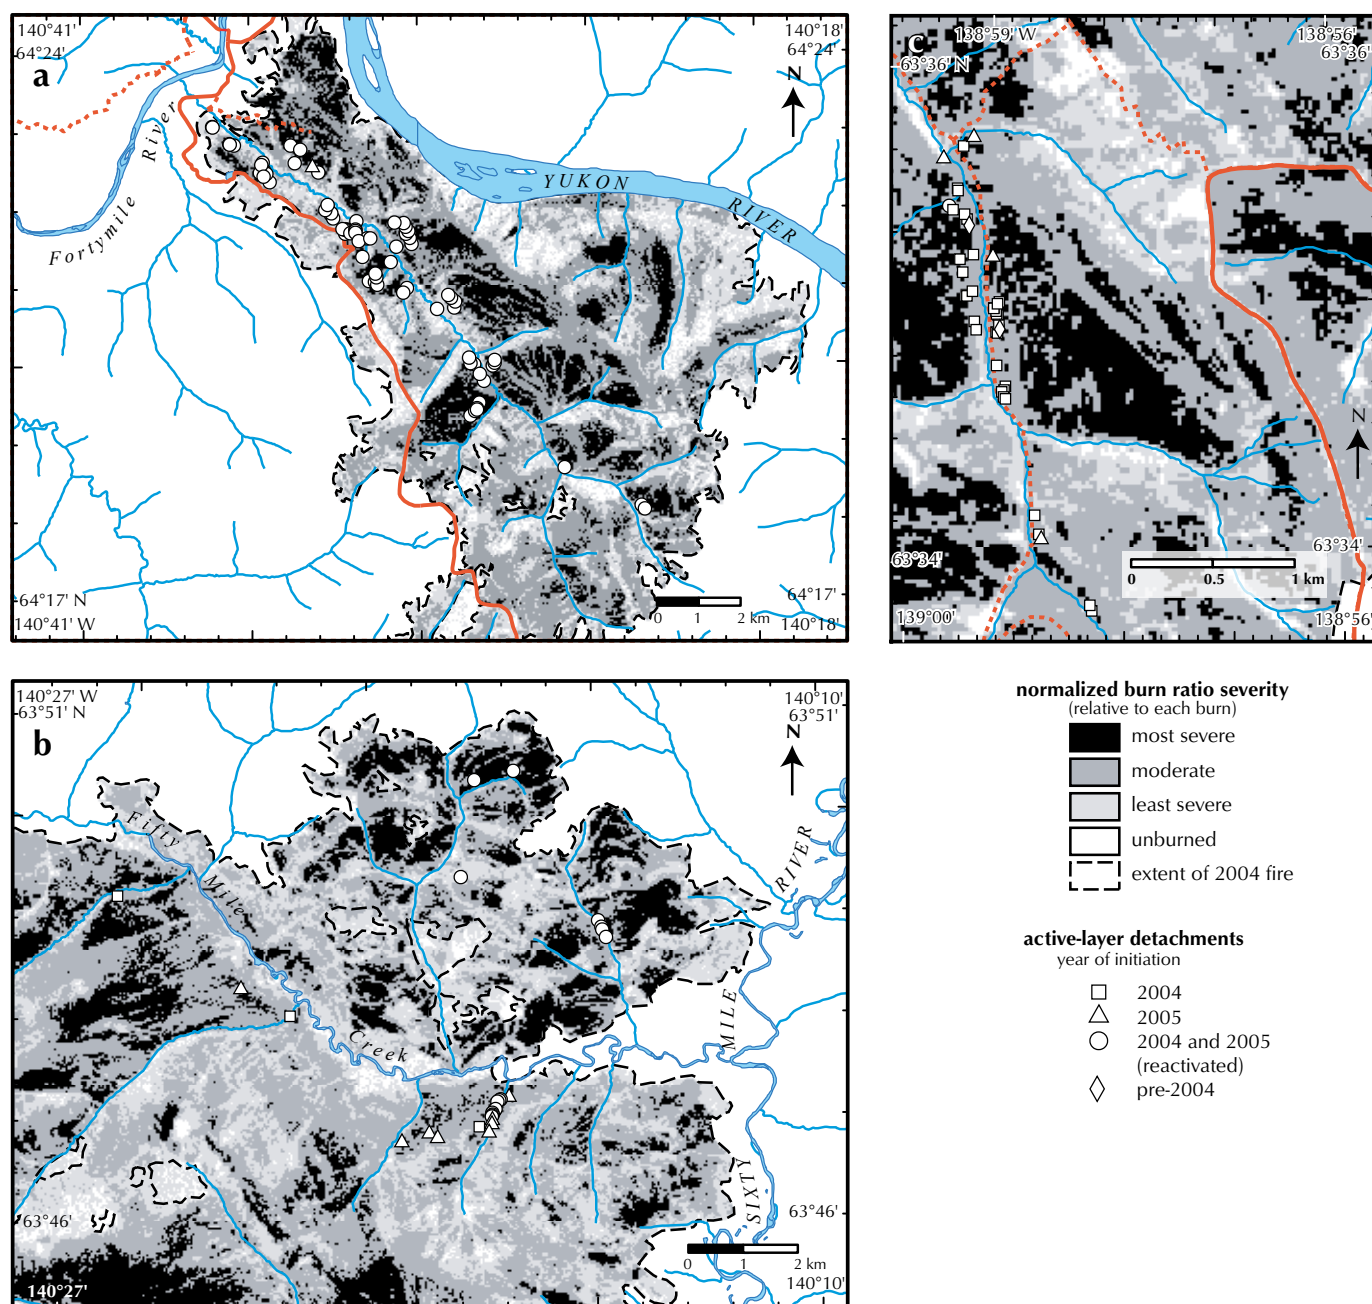
**Figure 17.** Example of relative burn severity evaluation performed in the (a) Mickey Creek, (b) Fifty Mile Creek and (c) Steele Creek watersheds. Differenced Normalized Burn Ratio (DNBR) analysis is based on differences in ground cover reflected in Landsat 7 TM Bands 4 and 7 (30 m resolution) before (September, 2001) and after (September, 2004) the forest fire. White outlined shapes represent active-layer detachments as shown on Figures 4, 7 and 10.

The relative severity of the 2004 fires within the three watersheds was examined using 30-m resolution Landsat 7 Thematic Mapper (TM) satellite imagery taken at approximately the same time of year before and after the forest fires. TM Band 4 (near infrared) is sensitive to live vegetation, while Band 7 (middle infrared) is sensitive to ash, char and mineral soil. A Normalized Burn Ratio (NBR) was calculated ( $NBR = (Band\ 4 - Band\ 7) / (Band\ 4 + Band\ 7)$ ) for all pixels in the pre-fire scene (September 2001) and the post-fire scene (September 2004). The difference in the pre-fire NBR and the post-fire NBR is referred to as the Differenced Normalized Burn Ratio (DNBR), which has been shown by field testing to be a reliable indicator of burn severity (Cocke *et al.*, 2005). Preliminary analyses of the data (Fig. 17) suggest that detachment failures in all three watersheds occurred in areas where the relative burn severity (with respect to each watershed) was moderate to severe. This indicates that significant burning promotes detachment failures in the watersheds. Not all significantly burned slopes fail, however, since numerous other factors (as described above) affect their stability.
