Ongoing displacement monitoring at the Dawson City landslide (Dawson map area NTS 116B/3)

Brideau, M.-A., Stead, D., Roots, C., and Lipovsky, 2012. Ongoing displacement monitoring at the Dawson City landslide (Dawson map area NTS 116B/3). *In: Yukon Exploration and Geology 2011*, K.E. MacFarlane and P.J. Sack (eds.), Yukon Geological Survey, p. 17-26.

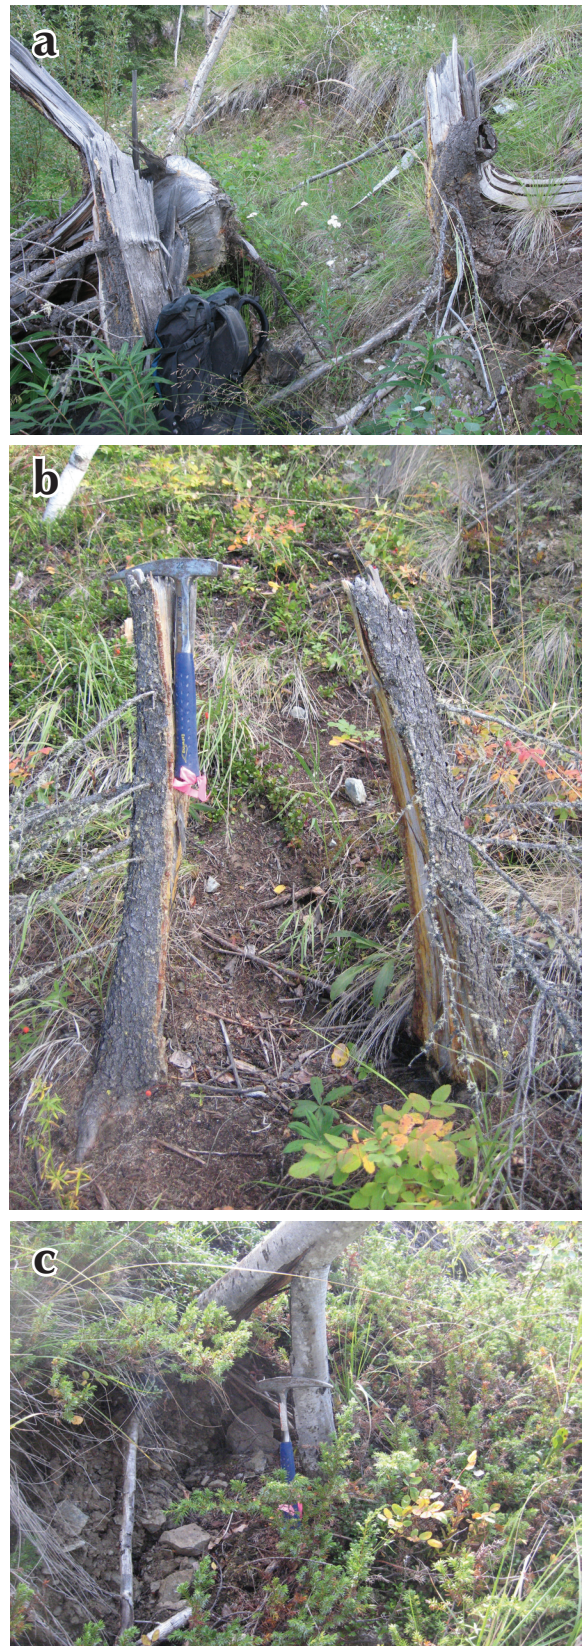
Figure 2. Split trees along the main tension crack located upslope from the current headscarp. See Figure 1 for the location.

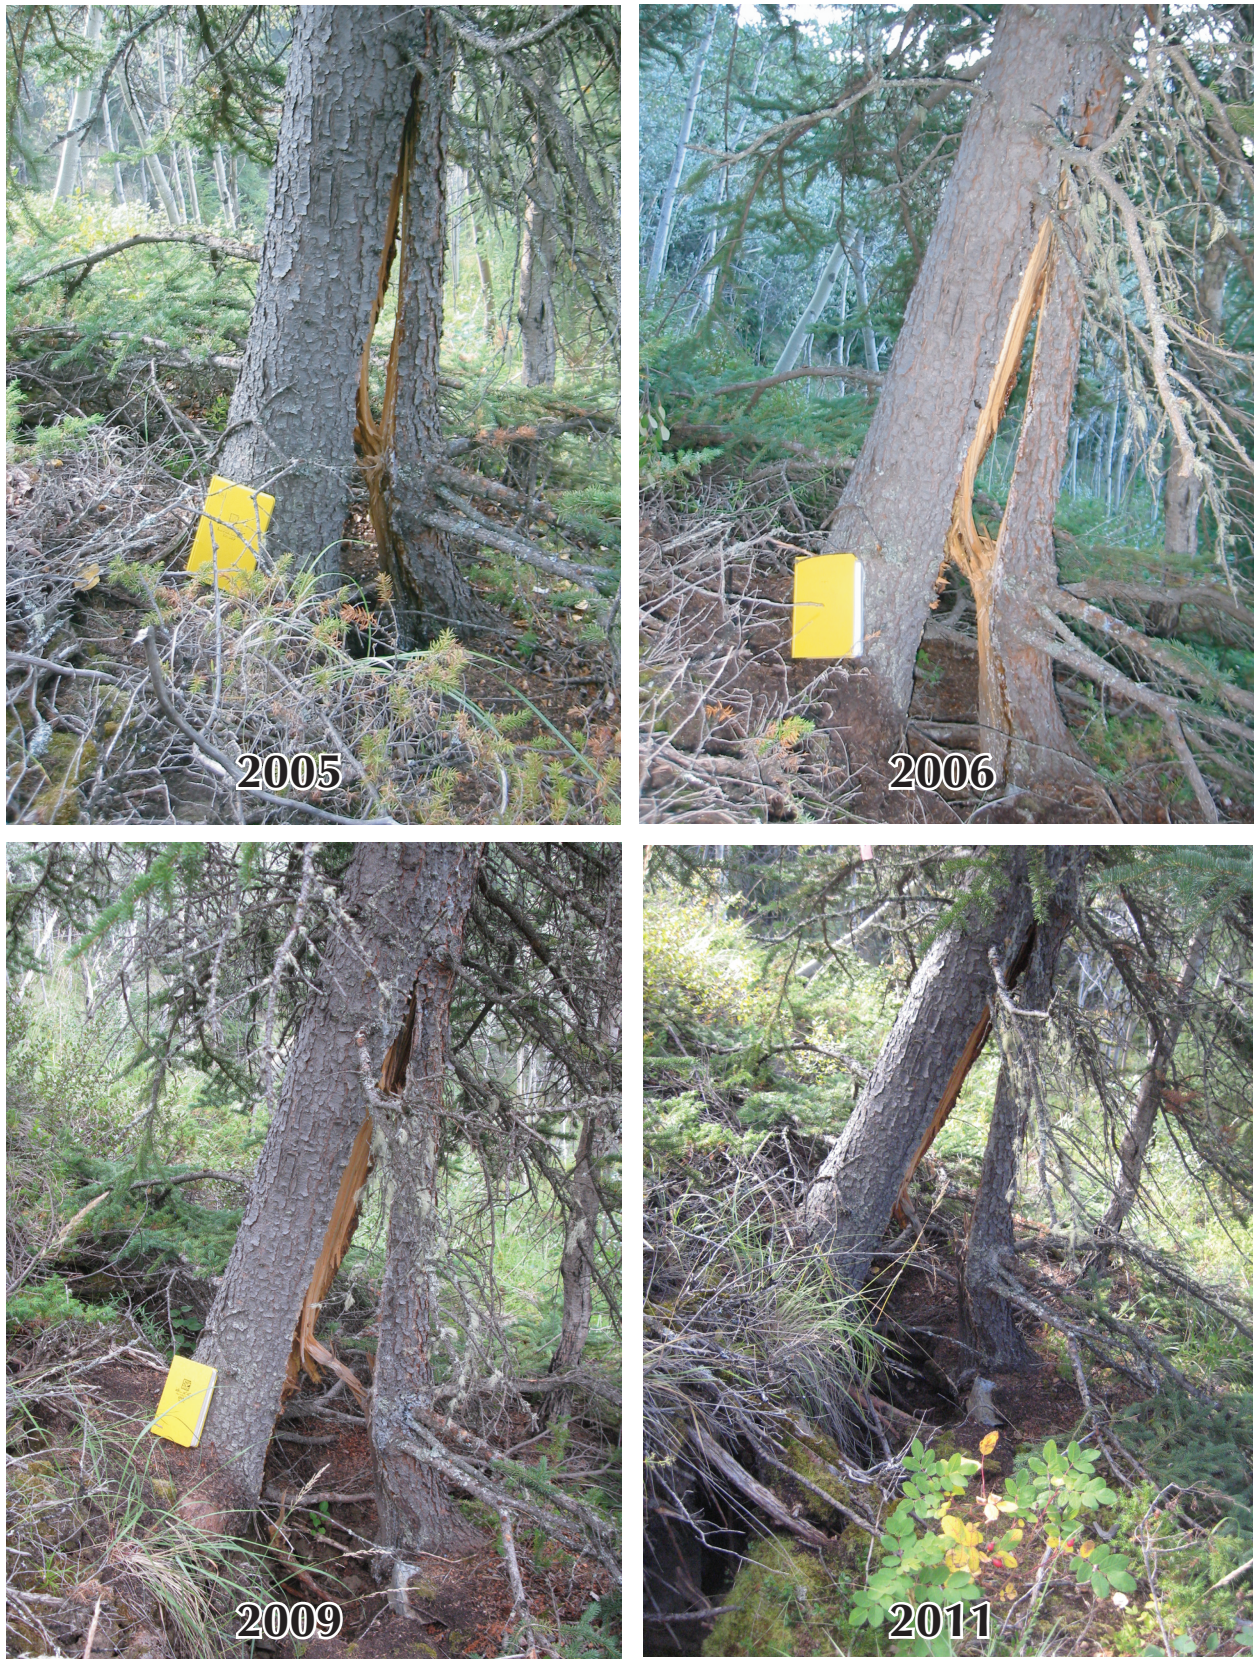
Figure 3. Expanding split tree located along tension crack upslope from current headscarp. See Figure 1 for location. UTM 7 NAD 83 coordinates 0577496E, 7106020N.

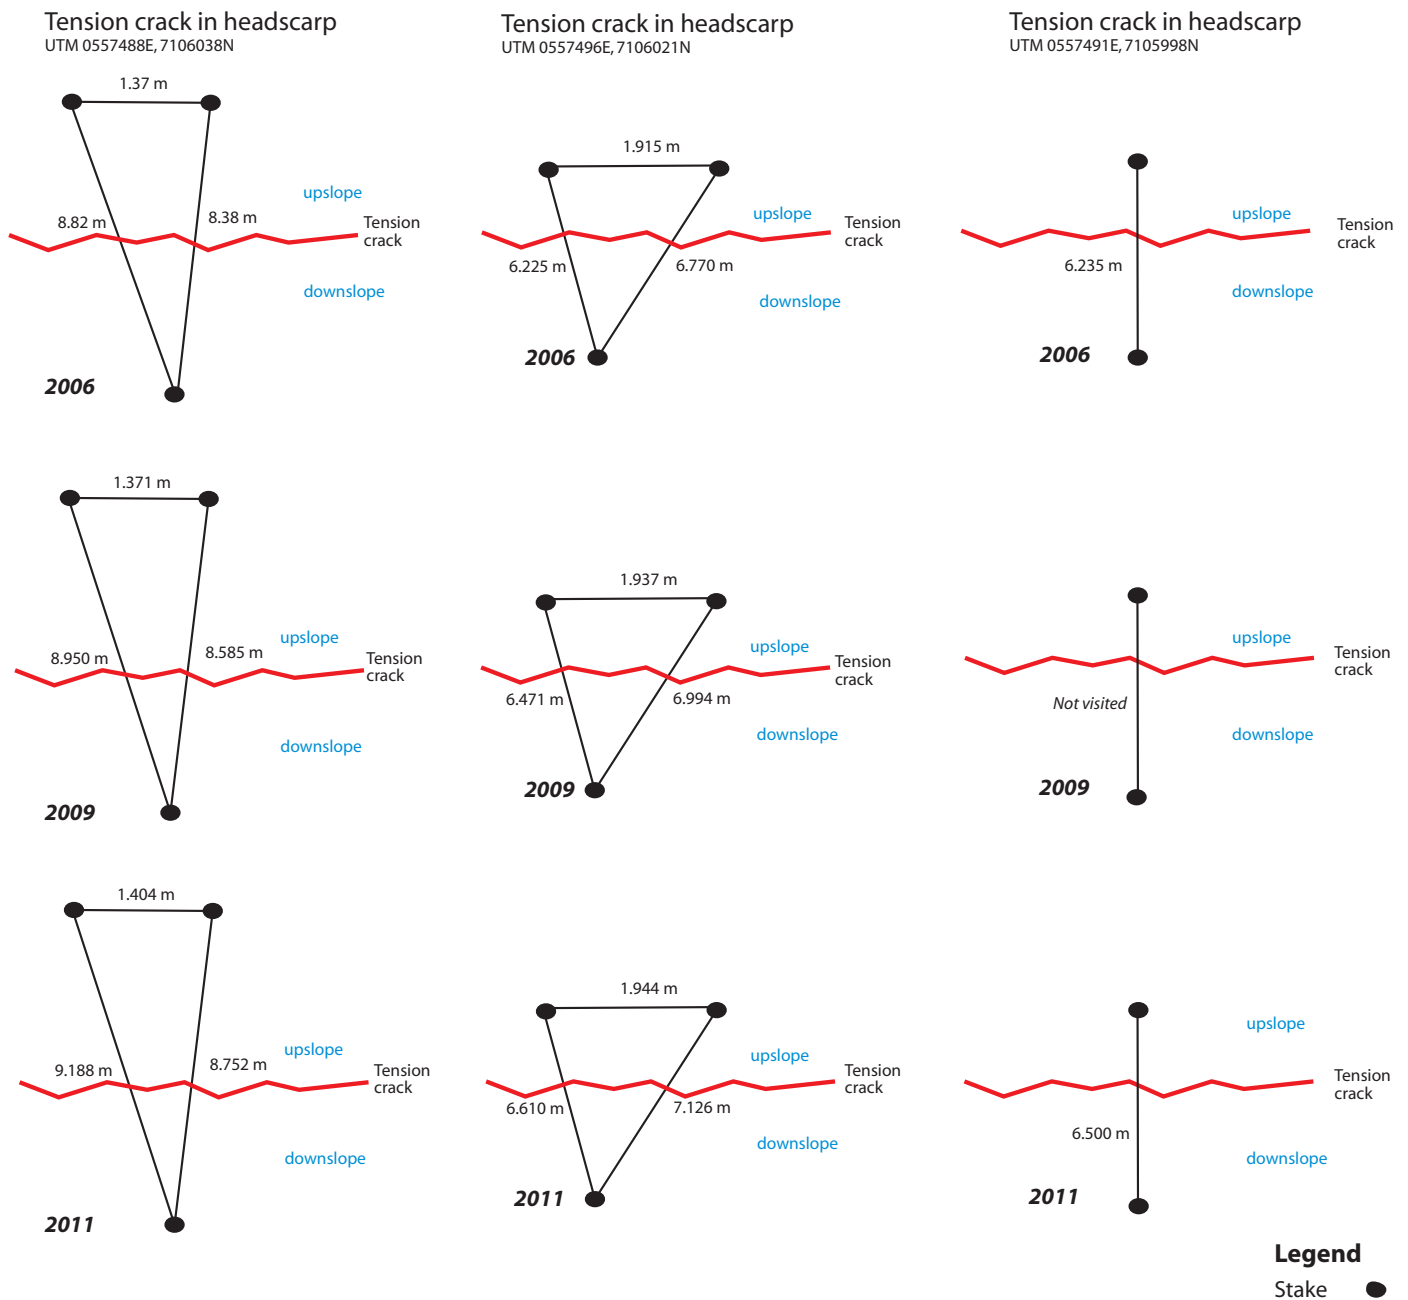
Figure 4. Periodic measurement of displacement in arrays across tension cracks at the upslope edge of the unstable block (measurement at 3 sites). Jagged red line is approximate locus of tension crack.

Geomorphic evidence of ongoing movement (disturbed soil and vegetation) was identified by Brideau *et al.*, (2007a,b) along a tension crack approximately 200 m in length and upslope from the current headscarp (Fig. 1). Between this crack and the headscarp is an unstable rock mass. Assuming a length of 200 m, a width of 50 m, and a depth between 1 and 5 m, the volume of the unstable mass is between 10 000 and 50 000 m³. It should be emphasized that the range in volume represents a first order approximation and further work is needed to refine the estimate. A number of trees located along this feature have had their trunks split (Fig. 2). One tree was photographed on four occasions between 2005 and 2011 and provides a time-series illustration of the movement along the tension crack over that period (Fig. 3). Several wooden and metal stakes were installed in 2006 to quantify the deformation rate. The displacement data presented in Figure 4 demonstrate that downslope movements of 4.3 to 11.9 cm/yr have occurred along a 40 m section of the tension crack.

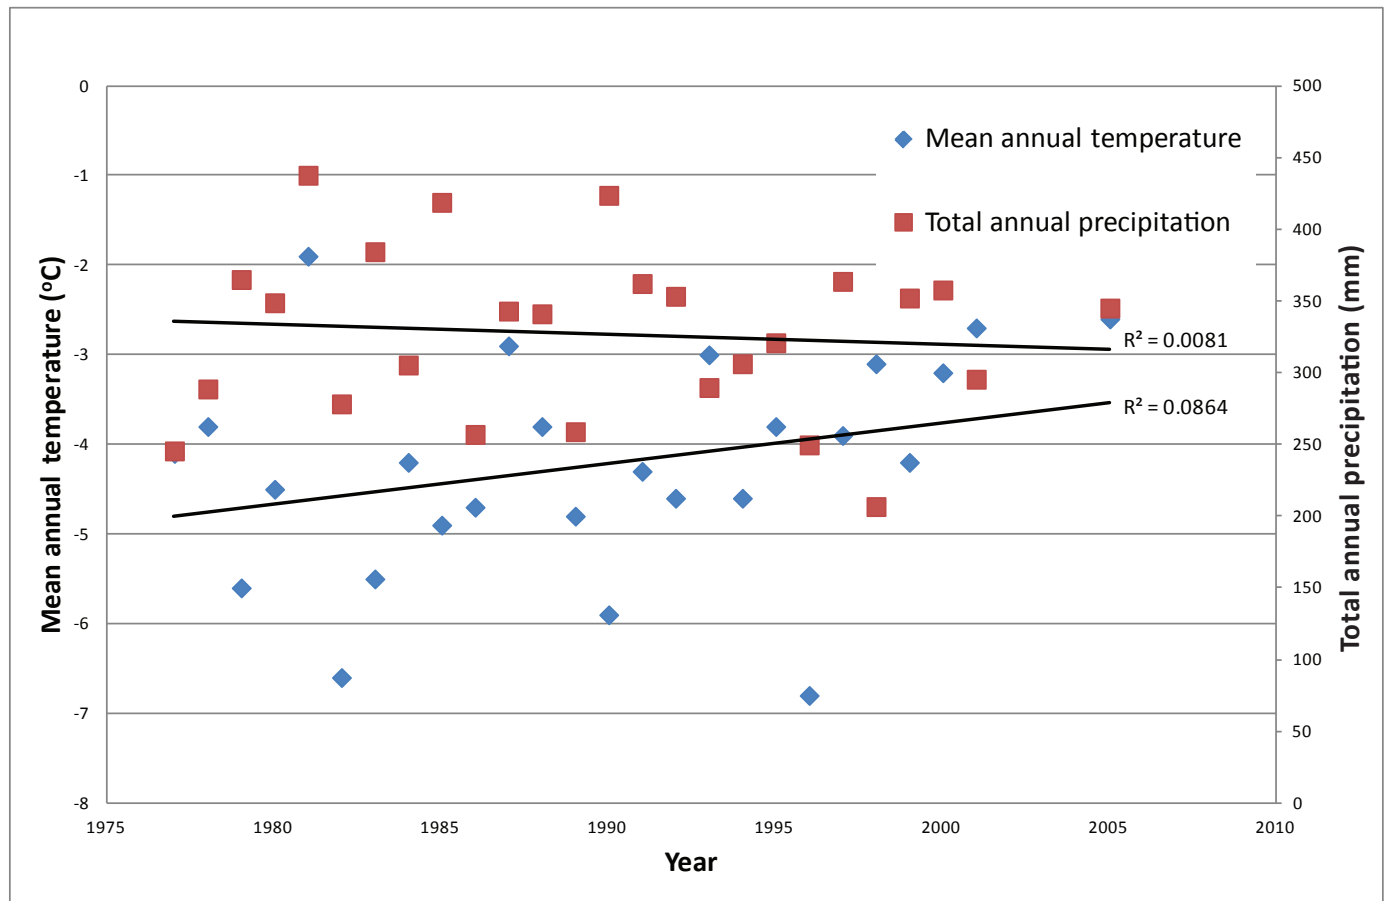
Figure 7. Mean annual temperature and total annual precipitation at the Dawson City weather station (data from Environment Canada, 2011).

The average annual mean temperature between 1978 and 2007 appears to have increased $>1^{\circ}\text{C}$ for Dawson City (Fig. 7). This increase in mean annual temperature could have contributed to the renewed activity on the Dawson City landslide. It should be noted that the total annual precipitation does not appear to have changed significantly over that same period of time (Fig. 7).
