The Sunnydale landslide, current understanding and research, Dawson (NTS 116B/3)

Bodtker, J., Cronmiller, D.C, Bond, J.D. and Shugar, D., 2023. The Sunnydale landslide, current understanding and research, Dawson (NTS 116B/3). In: Yukon Exploration and Geology 2022, K.E. MacFarlane (ed.), Yukon Geological Survey, p. 19–33.

Abstract

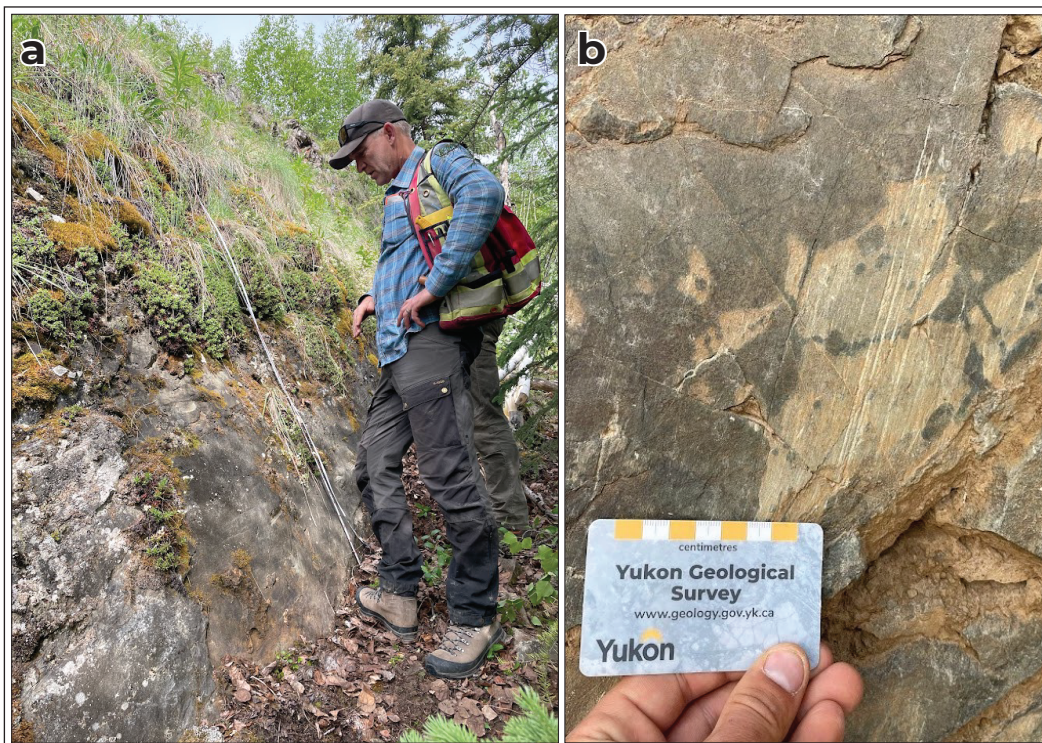
Figure 4. (a) The headscarp of the slide near TCMS station 3. Note the distinct change in vegetation at approximately waist height. (b) Slickenlines on the headscarp.

vegetation cover that increase with height (Fig. 4). Competent bedrock is best exposed at the southern margin of the slide at TCMS station 3 (Fig. 2). The headscarp here has a strike and dip of 300/75 and slickenlines covering the bottom ~1 m at a plunge and trend of 67/070 (Fig. 4). The bedrock forming the headscarp becomes increasingly, but non-linearly, weathered and vegetated first with lichen and then moss and grasses towards the top. These differences may indicate episodic movement on a timescale of thousands to tens of thousands of years. Rock samples taken from the headscarp are being analyzed for cosmogenic-nuclide measurement to determine the timing of surface exposure and to further elucidate a chronology of prehistoric movement.

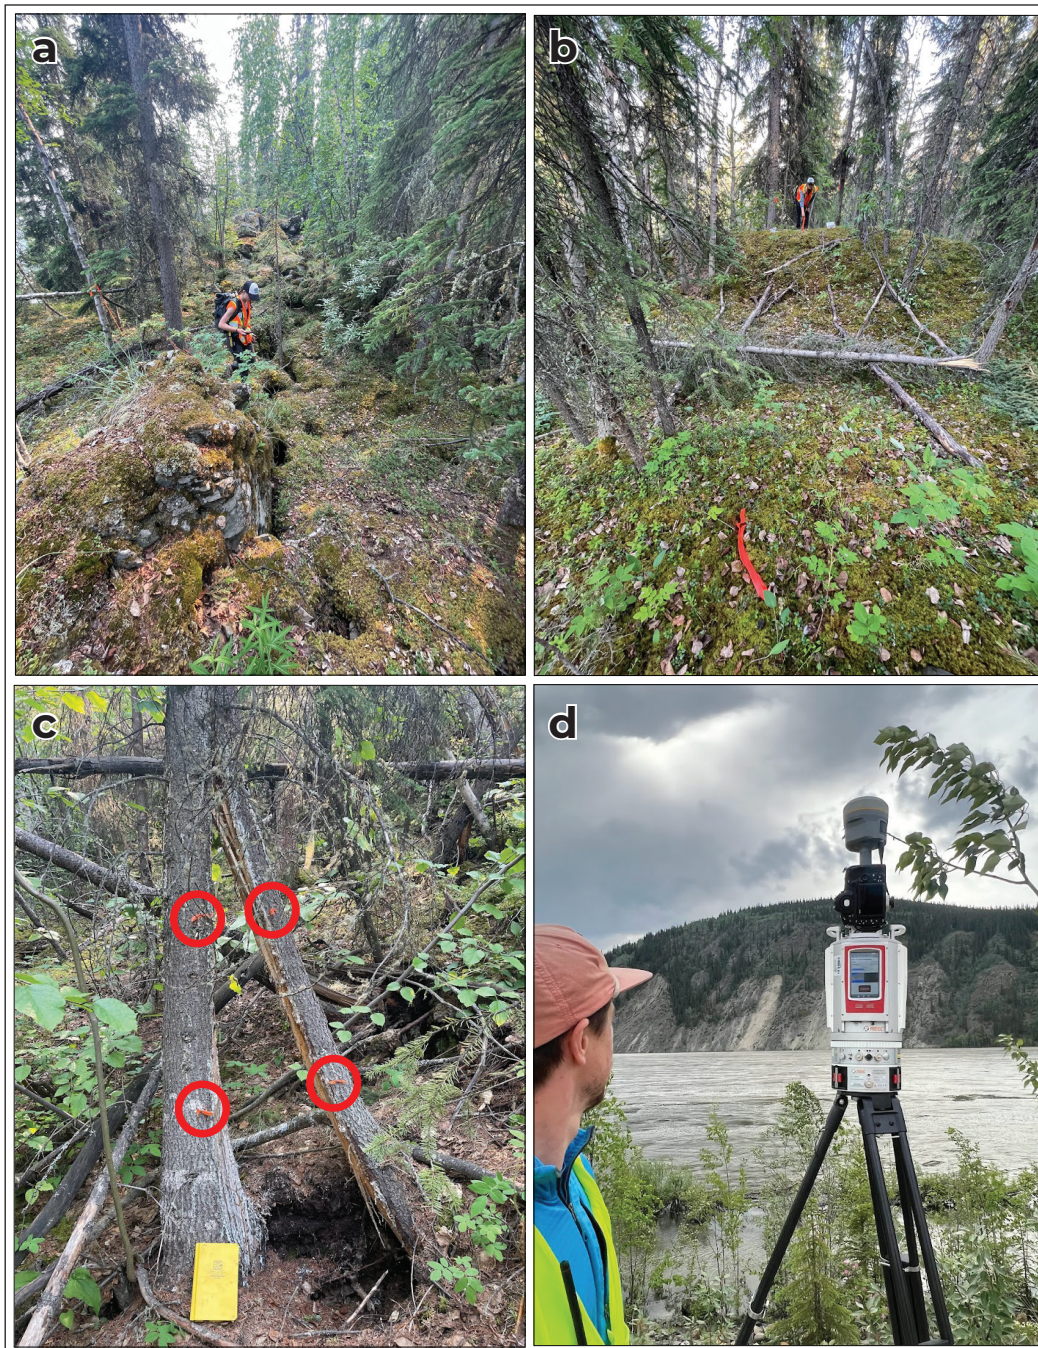
Figure 5. (a) Tension crack near TCMS station 2. Recent movement is shown by the gap between the rock and moss growth. (b) TCMS station 6. (c) Split tree near TCMS 8 with nail monitoring installed. This crack opened 2.2 cm and 3.3 cm between June and September 2022 at the upper and lower nail sets respectively. (d) Terrestrial lidar scanner with the Sunnydale slide in the background across the Yukon river, note the shallow landslide directly left of the scanner.

Many of the lineaments mapped on the upper half of the slide consist of sediment-filled grabens or tension cracks. Several of these features were investigated using soil trenches to document the stratigraphy of the sediments that have filled them (Fig. 5). Tephra from the northern lobe of the White River ash volcanic event found within these features date them to approximately 1625 years old (Reuther et al., 2020) providing a current

Three types of physical monitoring stations are currently in use on the landslide; GPS pin stations (DGPS; Table 1), tension crack monitoring stations (TCMS; Table 2), and nails in split trees (NT; Fig. 5; Table 2). The DGPS consist of a single rebar pin, these stations were installed on July 2 and 3, 2021 by Jeffrey Bond and Peter von Gaza. The TCMS consist of two rebar pins spanning a tension crack or scarp feature to assess rates of opening. TCMS 1 to 5 were established by Jeffrey Bond and Peter von Gaza coincidentally

with the DGPS stations while TCMS 6 to 9 were established by Jackson Bodtker and Holly Basiuk on June 24 and 30, 2022. The NT stations consist of trees that have been split due to differential ground motion below them (Fig. 5), and were installed by Jackson Bodtker and Holly Basiuk on June 30, 2022.

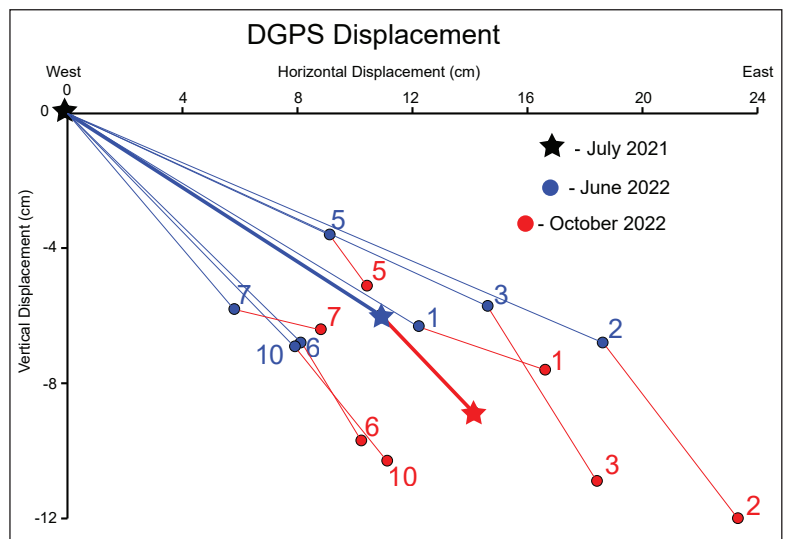
Figure 7. Vertical and horizontal displacement observed at DGPS stations. Positions from the original July 2021 measurements have been normalized to the origin. Stars indicate average values given time intervals.

Results from comparing repeat DGPS measurements show significant and potentially accelerating movement of 6 to 11 cm/year across the slide since installation (Figs. 7, 8 and 9; Table 1). TCMS measurements also indicate motion on the slide (Fig. 10).

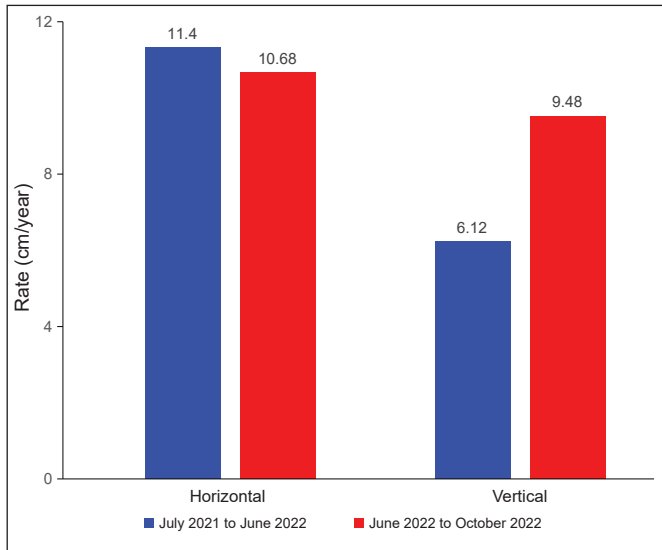
Figure 8. Average rate of change in the vertical and horizontal directions observed at DGPS stations from July 2021 to June 2022 and June 2022 to October 2022.

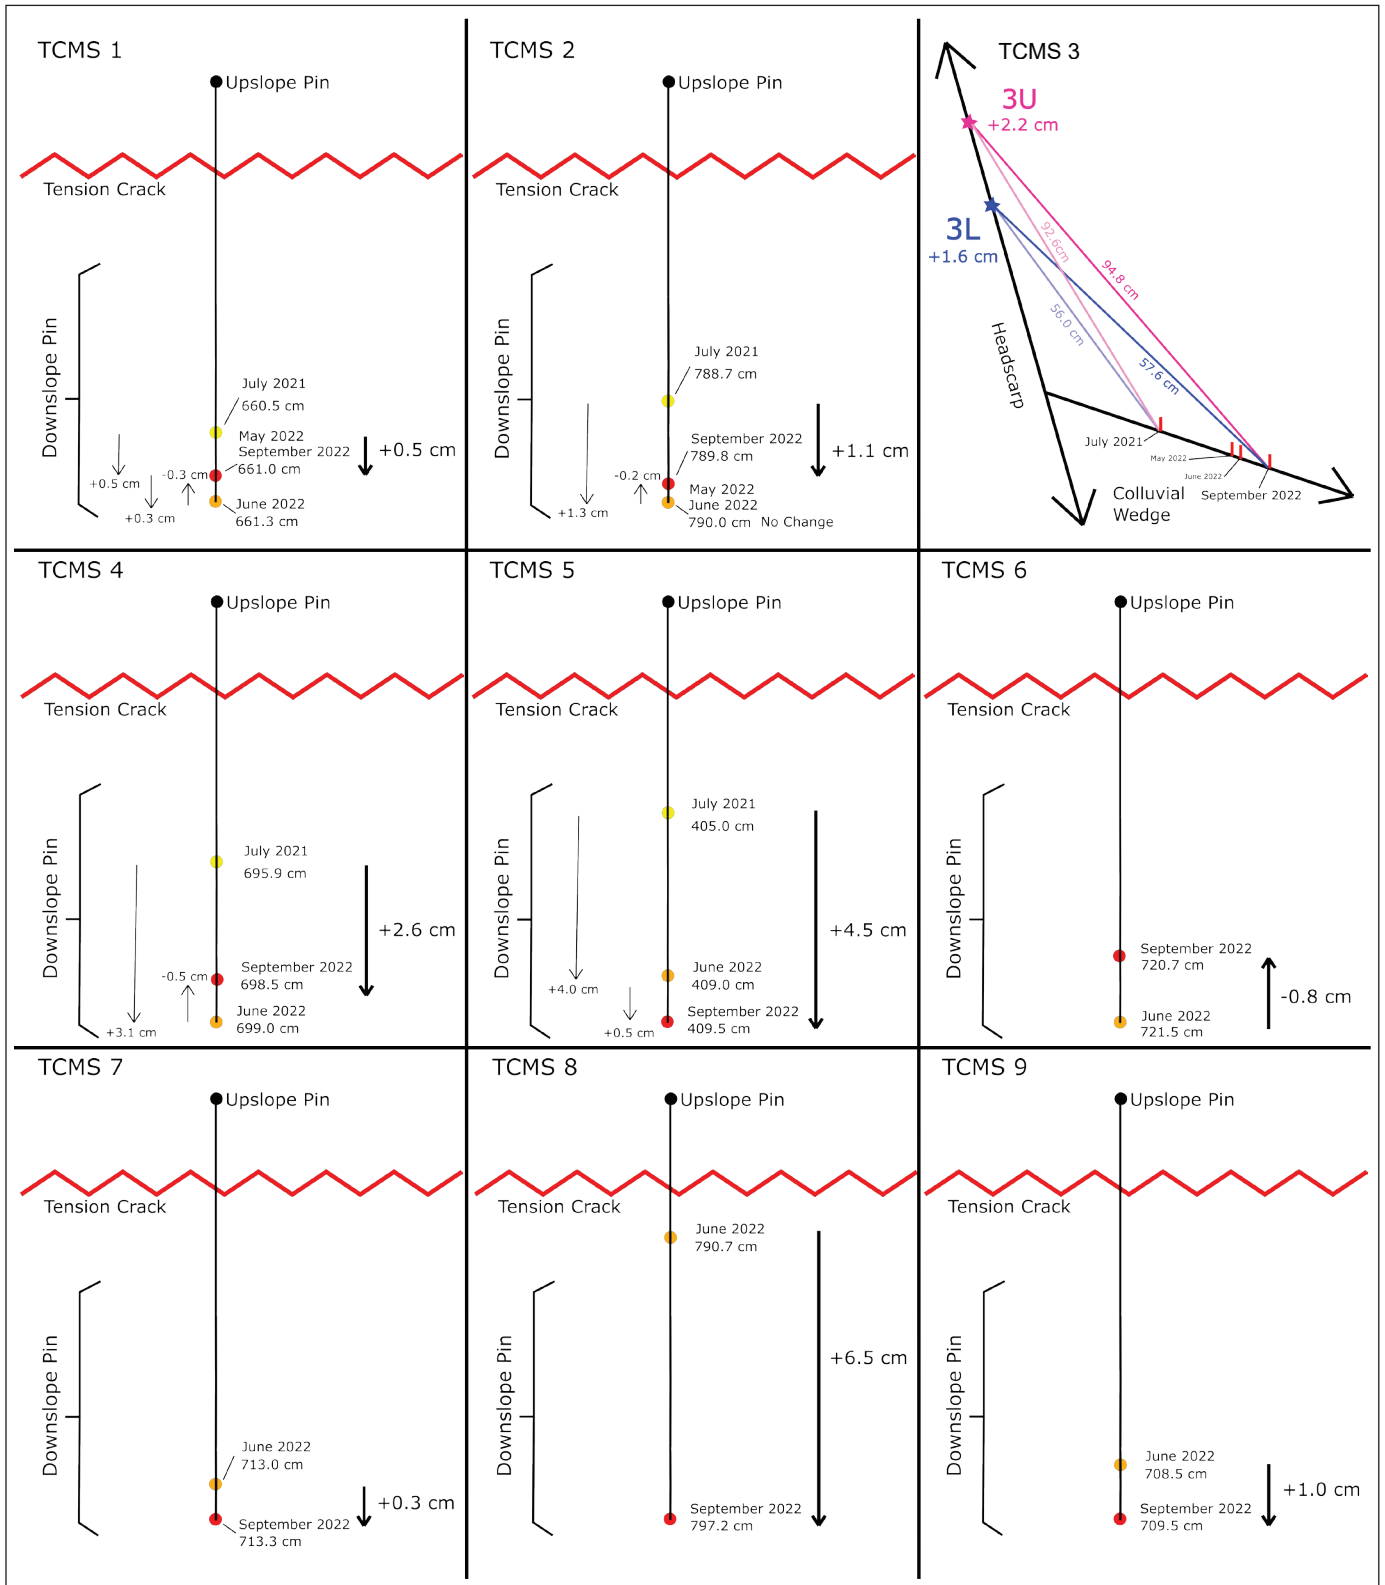
Figure 10. Periodic measurement of displacement across tension cracks and scarps. See figure 2 for station locations.

Displacements across TCMS 1 and 2 of less than 1 cm/year compared to 16.6 to 23.3 cm of eastward change seen at adjacent DPGS 1, 2 and 3 indicate that these tension cracks are not currently opening, and this area of the slide is likely moving as a larger semi-coherent block. TCMS 3, 4 and 5 are located along the margins of the slide and show 1 to 3 cm/year movement relative to areas with less or no current motion. TCMS 6 to 9 only have measurements across ~3 months from June to September 2022, yet TCMS 8 shows an alarming 6.5 cm of motion on the northern margin of the slide during this time. We assume up to 1 cm of error in these measurements due to approximately 0.5 cm of flex at each rebar pin.
