CLIMATE CHANGE VULNERABILITY ASSESSMENT DEMPSTER HIGHWAY, YT/NT

Government of Northwest Territories

MARCH 2015
ISSUED FOR USE
FILE: W14103156-01

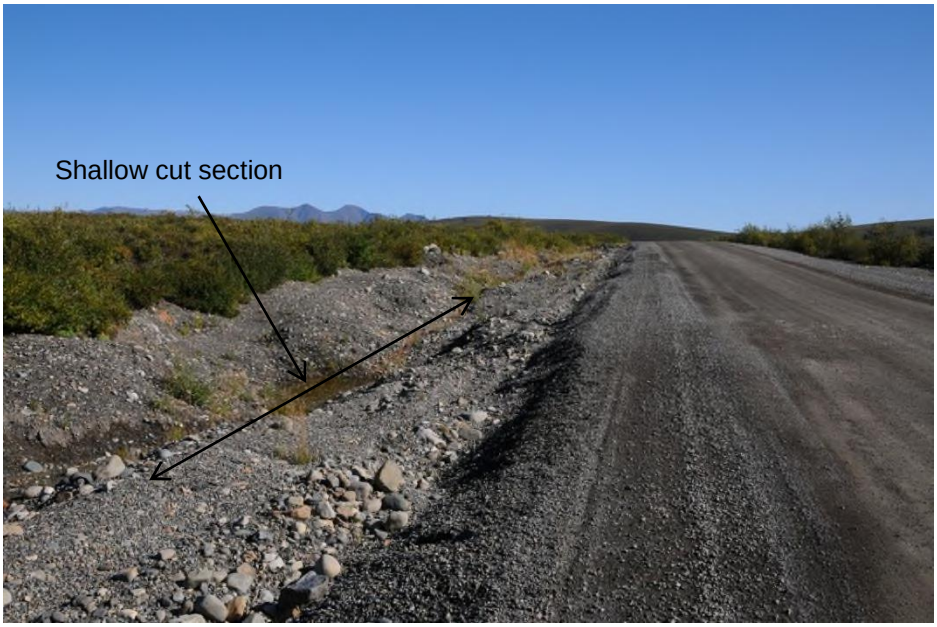
Erosion from the Blackstone River has affected the highway at about km 122, necessitating a realignment. The highway was moved away from the river, but reconstruction included a minor cut section that has created ongoing permafrost thaw-settlement issues and initiated progressive instability that requires regular maintenance.

Photo 5:
New alignment further away from Blackstone River, But the shallow cut section has created thaw settlement problems in the left shoulder, km 122 (August 27, 2013)
