GUICK-PLOT GEMCOM Services Inc.	DATE = 16-07-91 TIME = 22:32:44	CURRAGH RESOURCES INC. Faro Mine	Section = 198,050 Outline = Lithology NEW GEOLOGIC INTERPRETATION EAST WALL MONITOR LOCATIONS - PROJECTED ONTO THE CLOSEST REPRESENTATIVE SECTIONS.
HORIZONTAL SCALE = 1 : 600		VERTICAL SCALE = 1 : 600

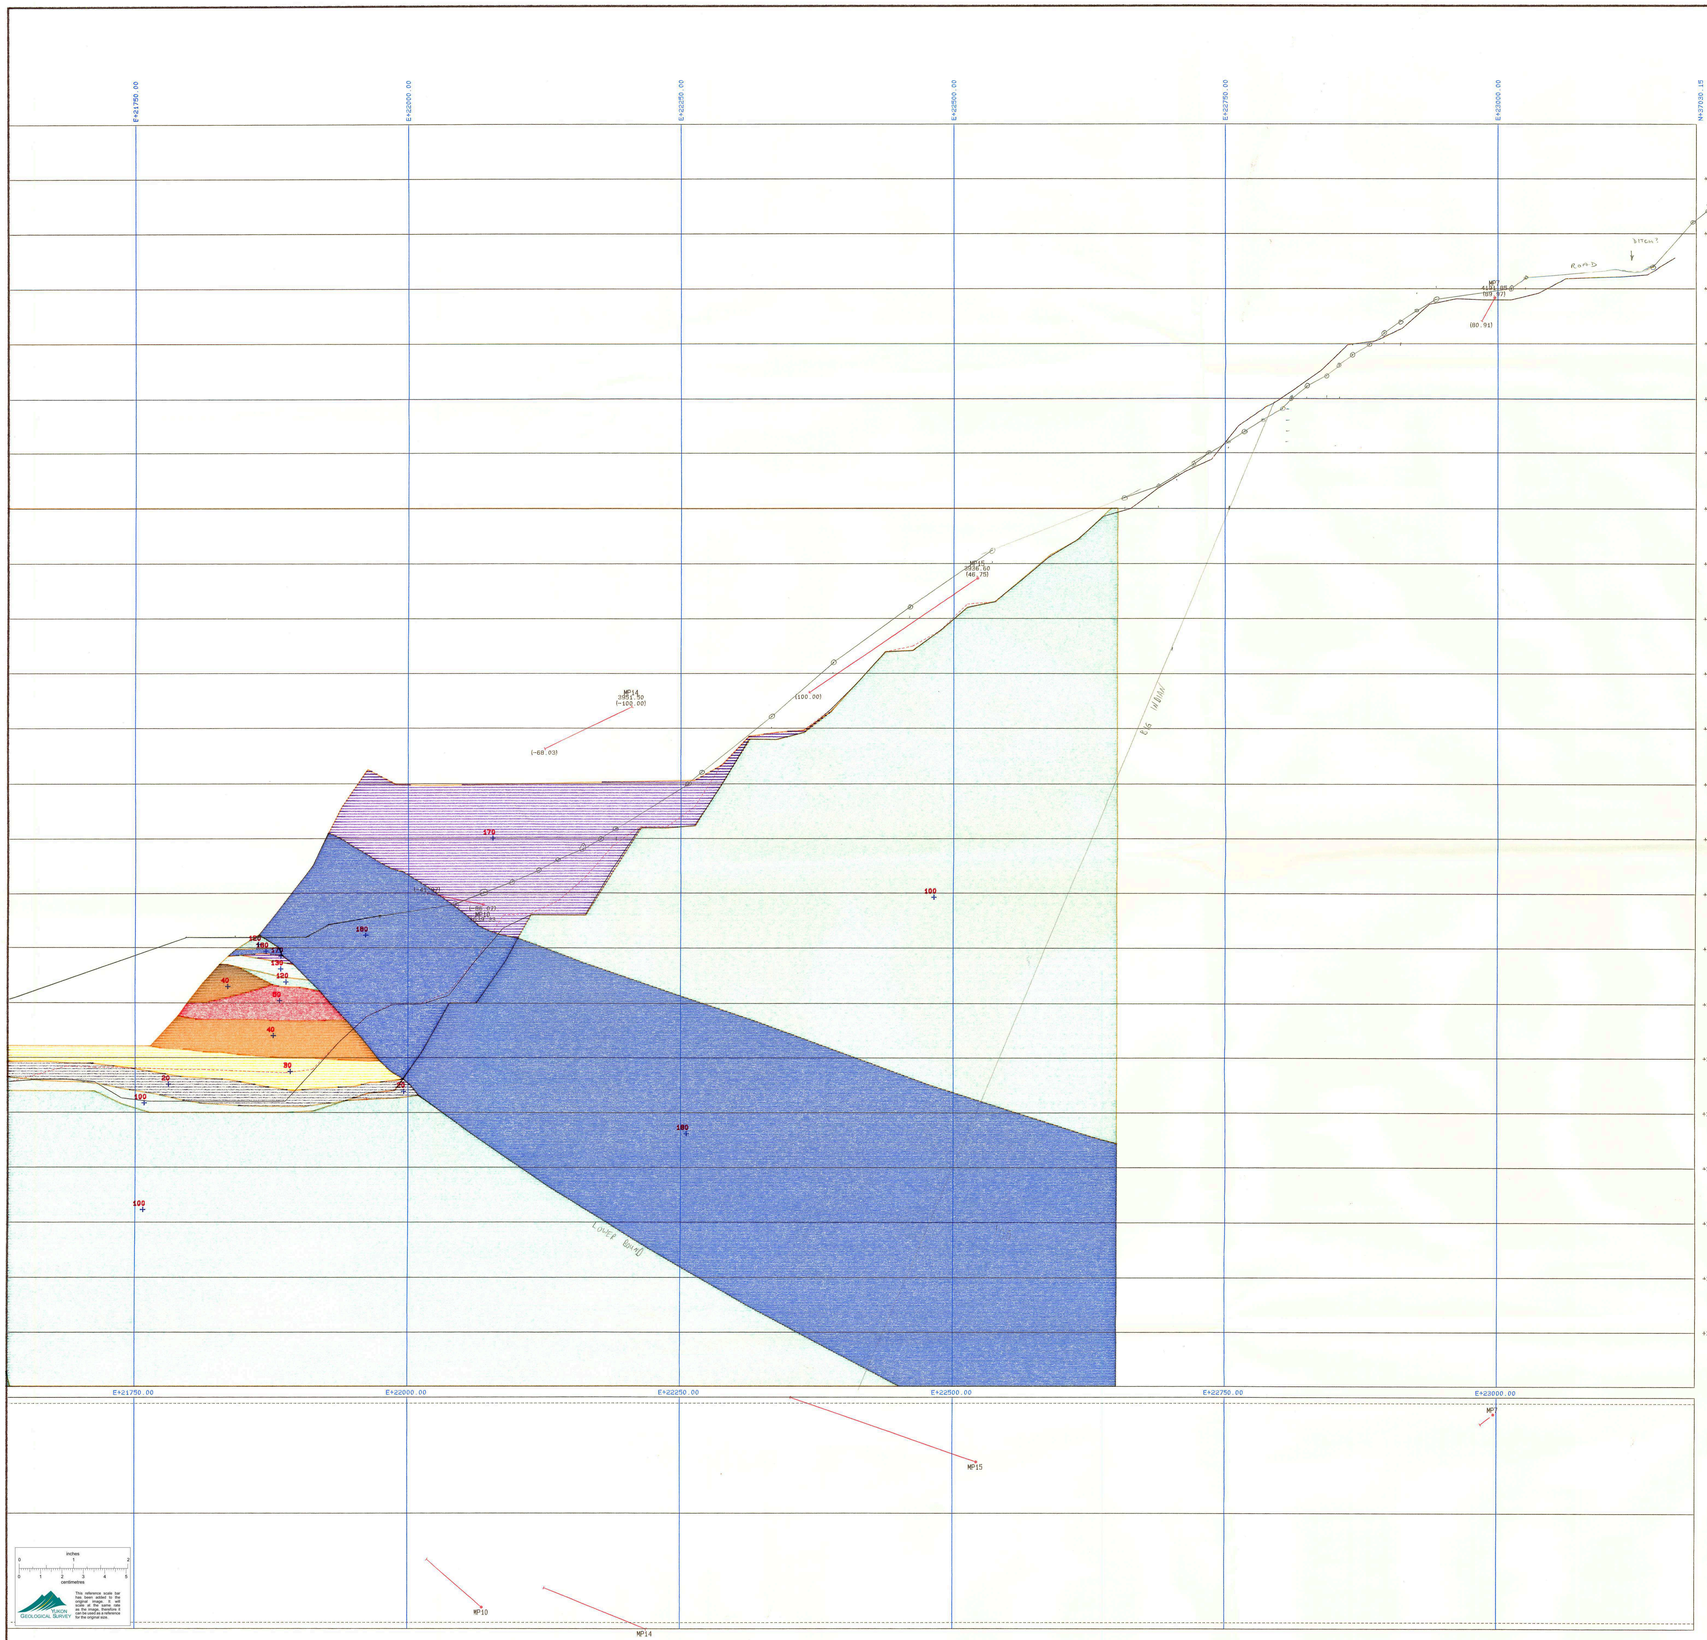
- June 1991 month end surface
- Modified FIV ultimate pit
- Monitoring prisms and movement direction
- Faults

Monitor Scale 1 in. = 50 m/day
