QUICK-PLOT GEMCOM Services Inc.	DATE = 18-07-91 TIME = 20:43:34	CURRAGH RESOURCES INC. Faro Mine
HORIZONTAL SCALE = 1 : 600	VERTICAL SCALE = 1 : 600

Section = 119_050 Outline = Lithology
NEW GEOLOGIC INTERPRETATION
EAST WALL MONITOR LOCATIONS - PROJECTED ONTO THE CLOSEST REPRESENATIVE SECTIONS.

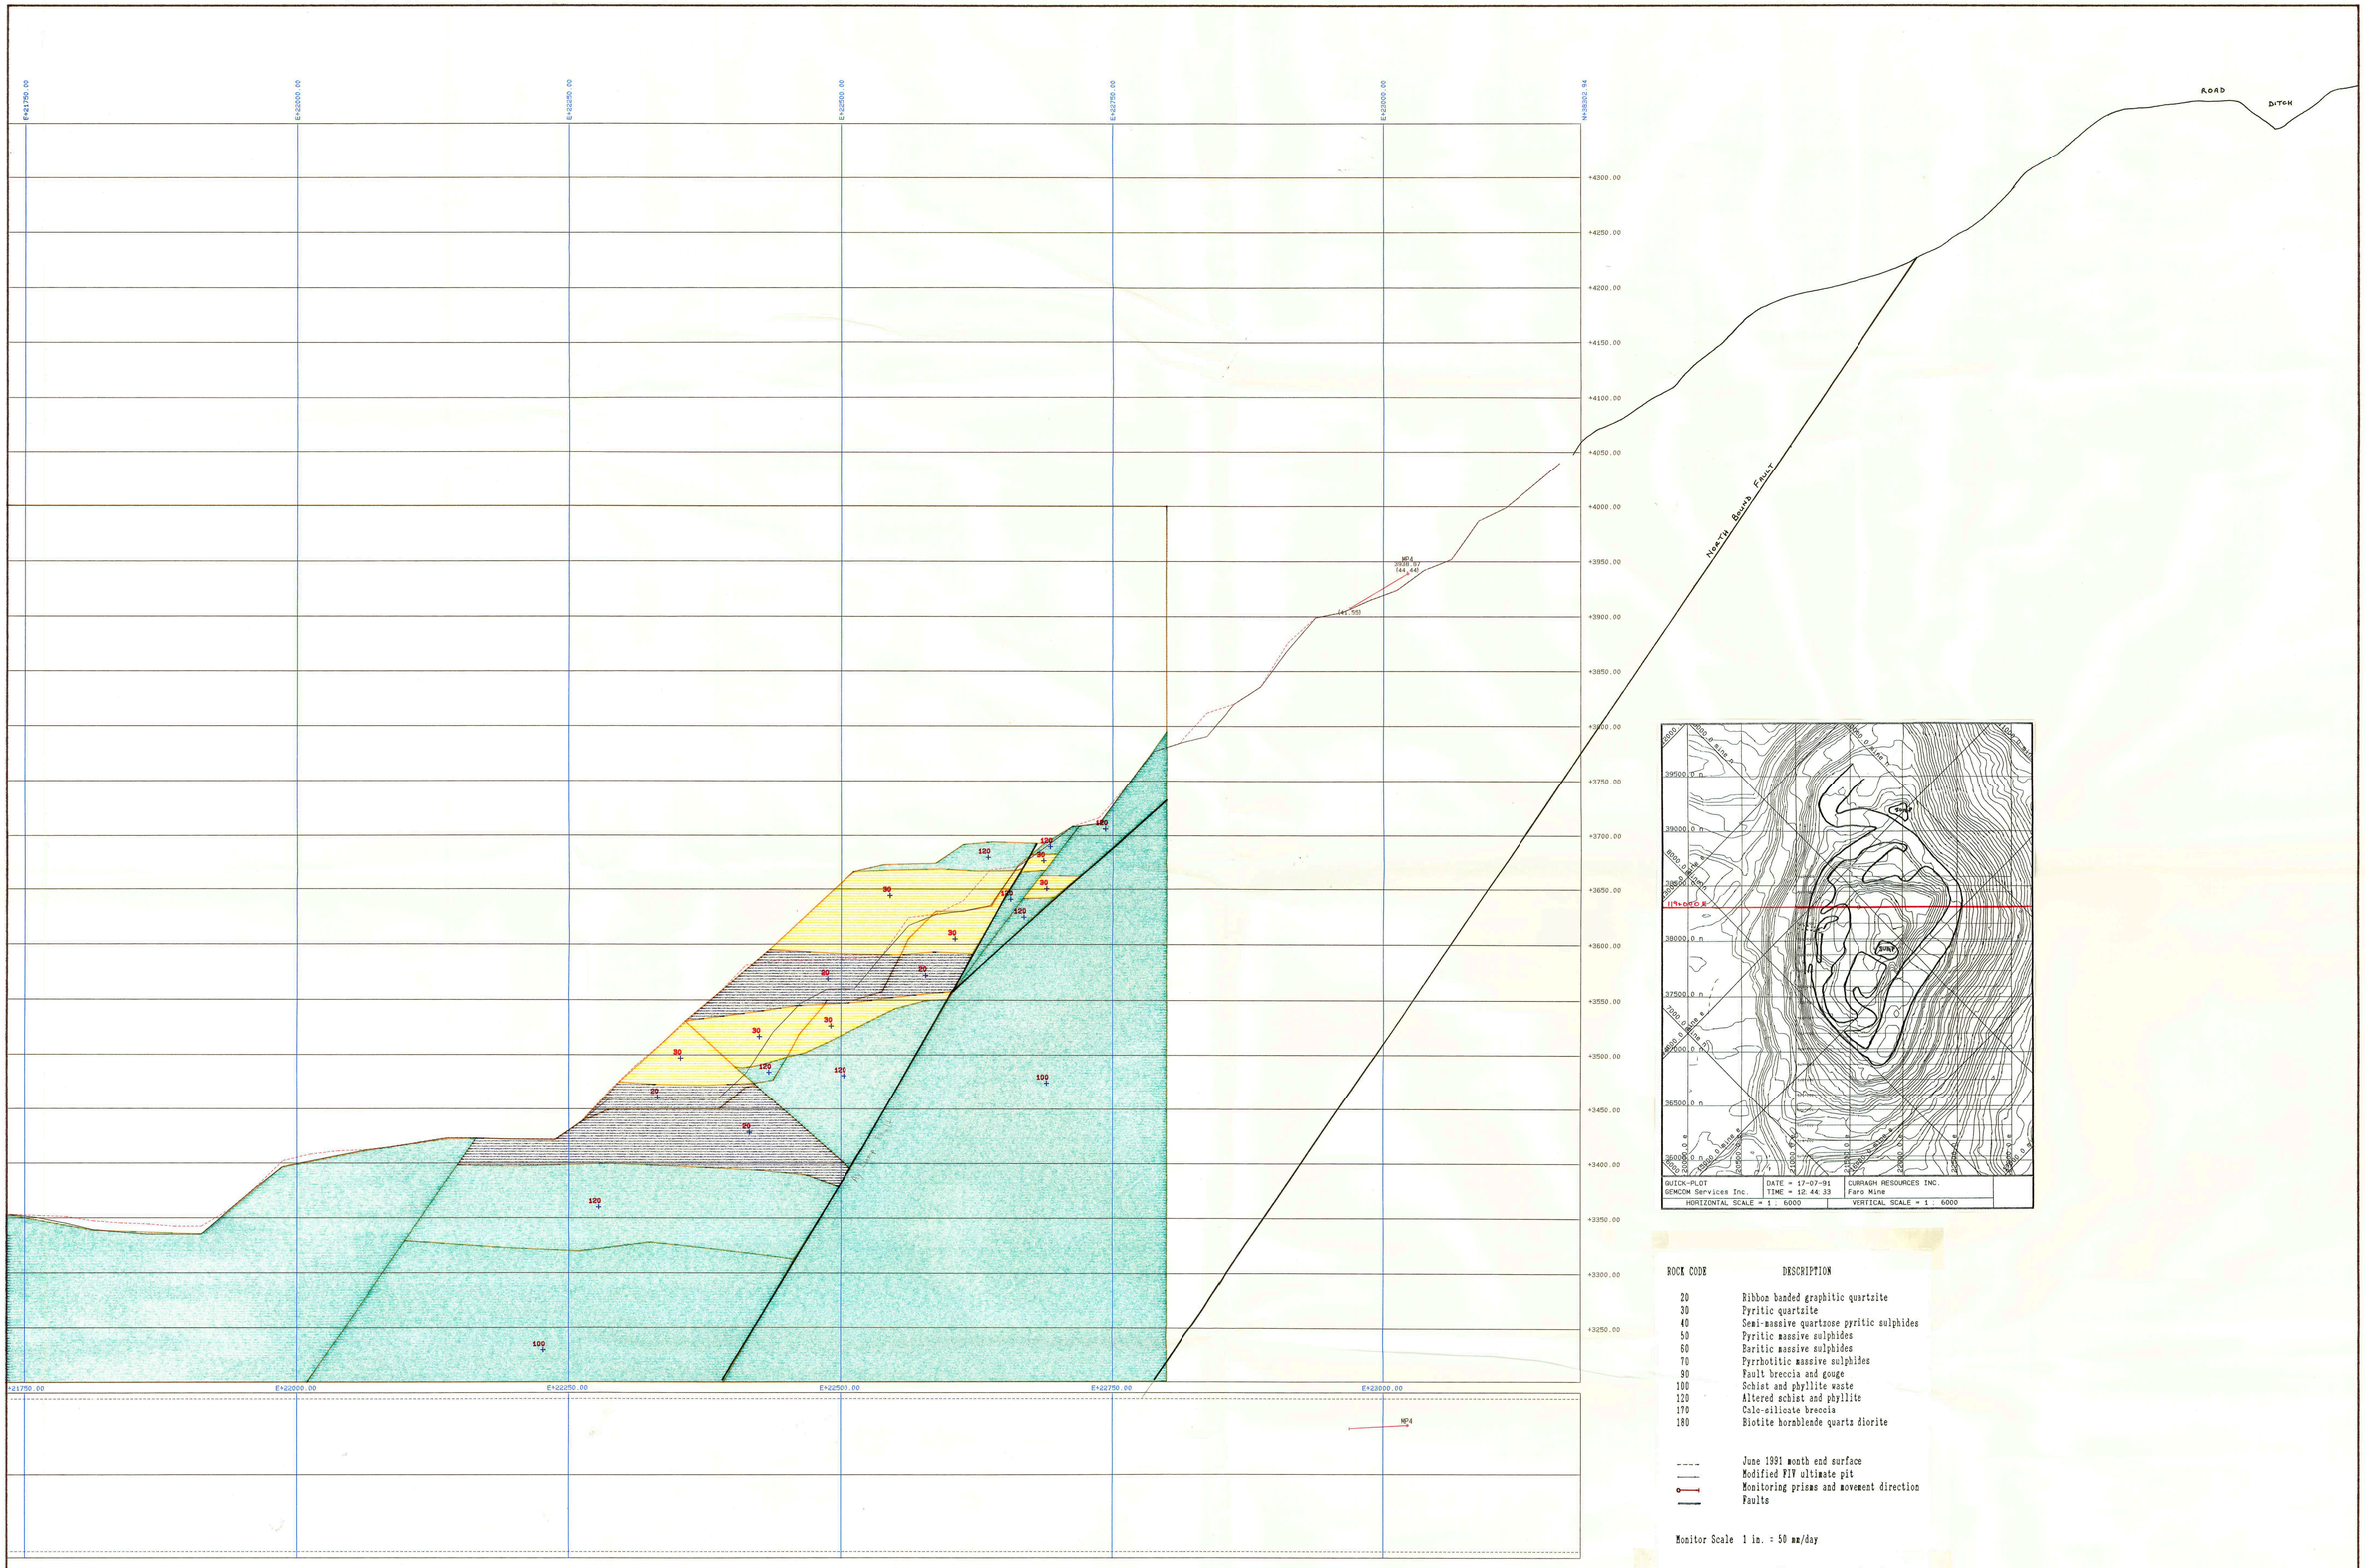
June 1991 month end surface
Modified FIV ultimate pit
Monitoring prisms and movement direction
Faults
