Geotechnical Evaluation Proposed North End Subdivision Dawson City, Yukon – 2016

Prepared For: Yukon Government – Energy, Mines and Resources

Date : September 18, 2016

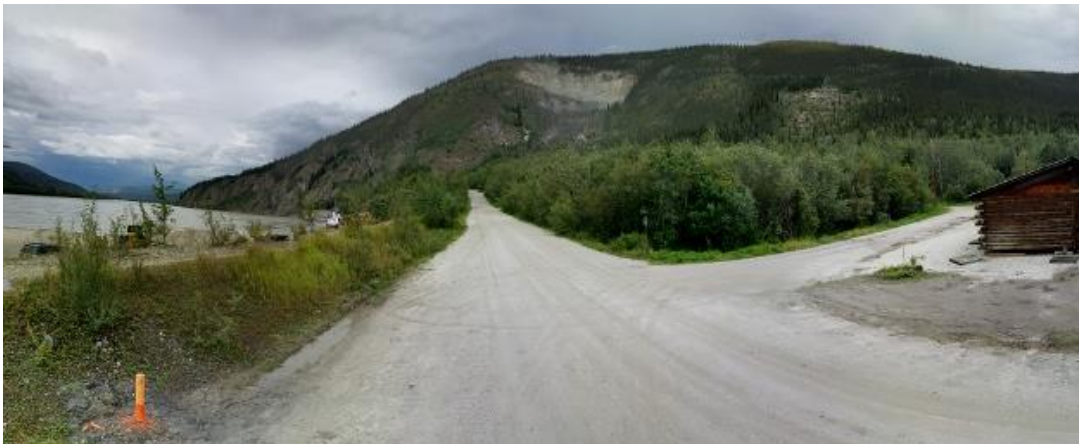
Panoramic view of study area from intersection of Front and Edward facing north-east. BH 3-16 well on lhs

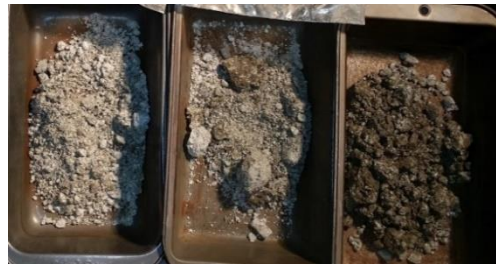
Sample No. 47, 48 & 49

Sample No. 49, which was retained from the base of BH 5-16, was classified as a silty sand with some gravel and may also be remnants of the original native deposits intermixed with the slide rubble from the 1st slide event.

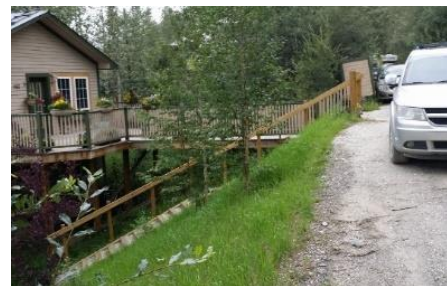
Residence access along 8th Avenue.

These lots will be suitable for residential lot development. The lots located on the east side of this area may be accessible from Judge Street depending upon residential building design and site access requirements. Several residences located in other regions of Dawson have accommodated these sloping areas through the construction of elevated walkways.
