**Geotechnical Evaluation  
Proposed 2<sup>nd</sup> Avenue Upgrades  
Dawson City, Yukon – 2014**

**Prepared For:** Yukon Government – Energy, Mines and Resources

**Date :** December 30, 2014

**File No:** 200-003-14

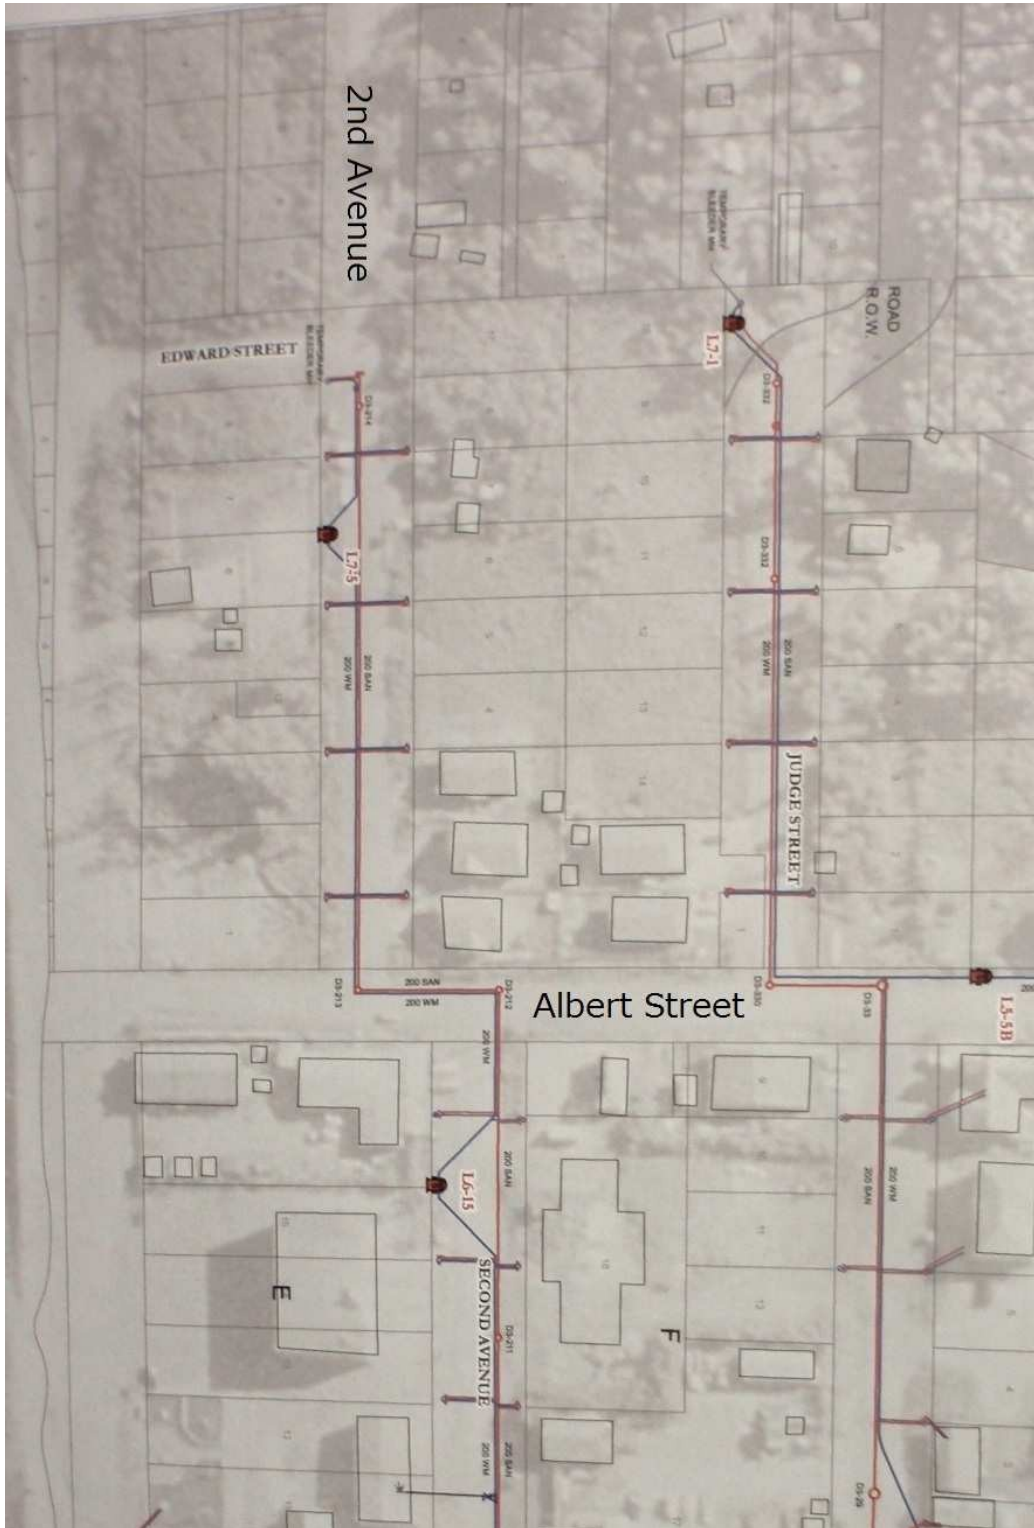
FIGURE 4 –Subsurface Utilities

The *City of Dawson – Public Works Department* was contacted to obtain plans which denoted the locations of nearby sub-surface utilities. In brief, the sub-surface utility plans noted the presence of water lines and sanitary sewers located on 2<sup>nd</sup> Avenue, south of Edward Street. The storm drains were noted along Albert Street.

Utility locates were conducted prior to drilling in order to confirm that the proposed borehole locations were clear of potential underground hazards. This involved contacting *Northwestel*, *Yukon Energy Corporation Ltd (YECL)*, and the *City of Dawson* prior. In brief, while there were local subsurface lines located along 2<sup>nd</sup> Avenue south of Edward Street (as noted in Figure 4), the adjacent roadways, and proposed borehole locations were free of underground utilities.

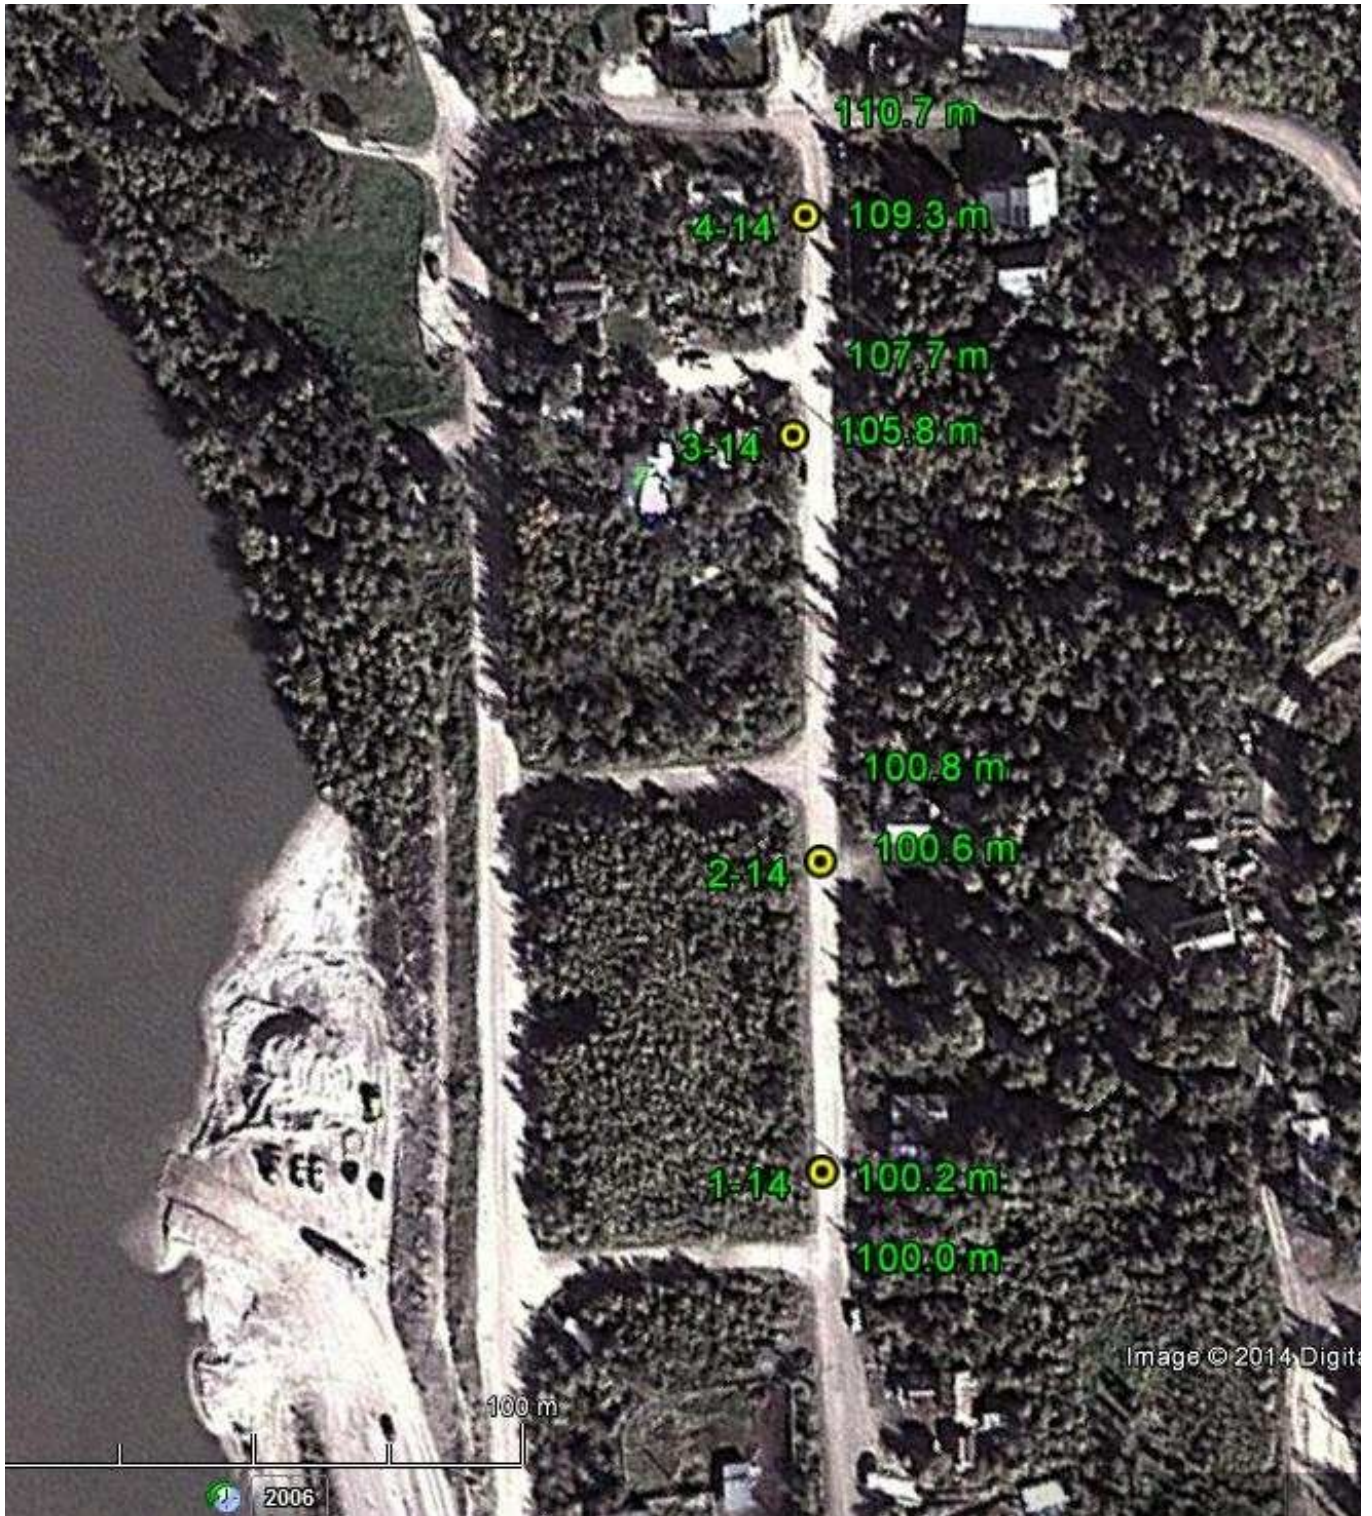
FIGURE 5 –Borehole Locations & Elevations

The approximate locations of the boreholes have been plotted on Figure 5 relative to prominent site features.

Following completion of the drilling, the elevation of the boreholes and prominent roadway features were surveyed relative to the intersection of Edward Street and 2<sup>nd</sup> Avenue, utilizing a (*Leica LR Rugby*) laser level. The road surface at this location was given an arbitrary elevation of 100.00 meters. A level survey noted a vertical relief of ~ 10 meters along 2<sup>nd</sup> Avenue between Edward and Judge Streets. The elevations of the boreholes have been noted on the Soil Logs enclosed in Appendix A and have been plotted on Figure 5.
