**Geotechnical Evaluation
Geohazard Assessment
Block 4 - North End Subdivision
Dawson City, Yukon – 2017**

Prepared For: City of Dawson

Date : June 30, 2017

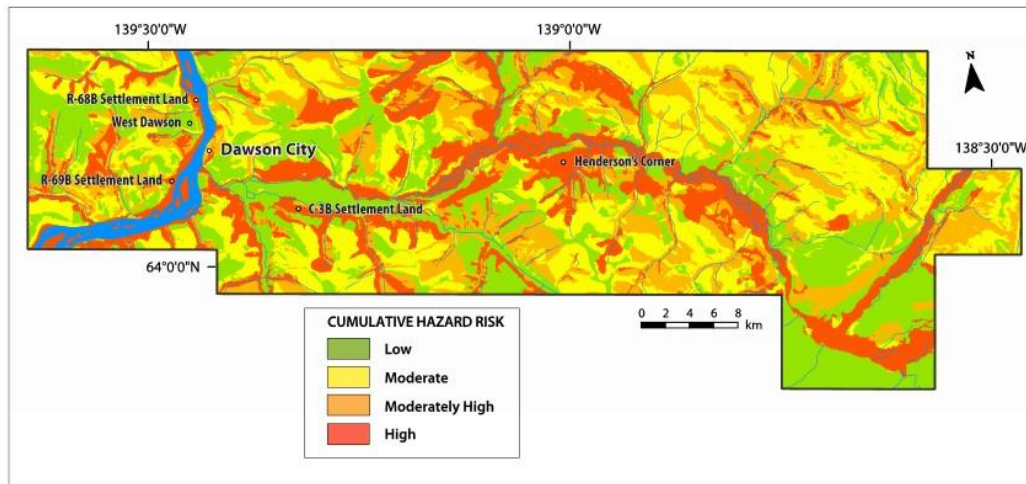
and case studies, data related to slope angle, slope aspect, surficial materials and permafrost probability were input into a raster comprised of pixels which each represented 30 m². The hazard potential relative to each of these criteria was assigned and a map based upon a cumulative weighted risk was generated. The report was clear to indicated that while the hazard map can serve as an initial guide to local conditions, there are limitations due to site specific conditions and so detailed site studies (e.g., geotechnical or engineering studies) would still be required.

A copy of the hazard map which was generated during the work has been attached below.

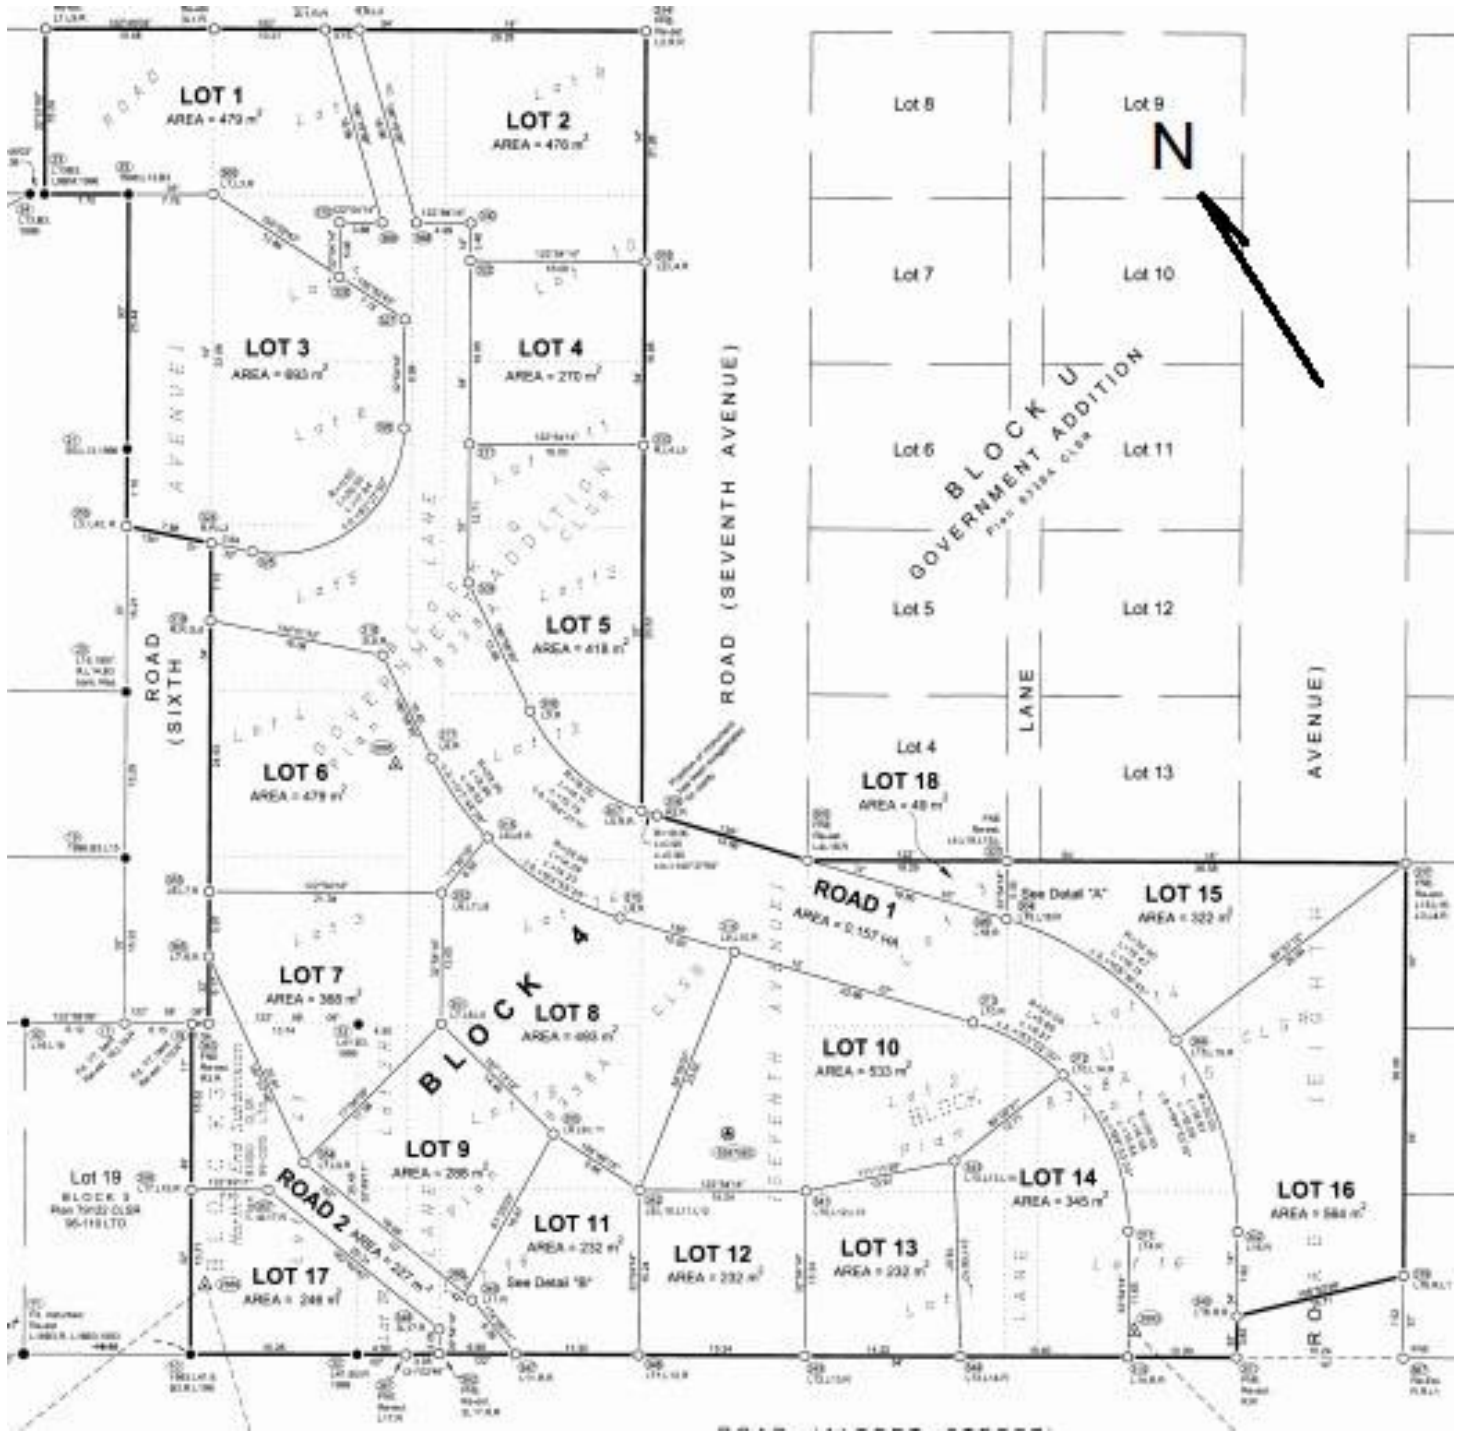
Geotechnical Evaluation – Geohazard Assessment
Block 4 North End Subdivision – Dawson City, Yukon – 2017
Figure 2 – Subdivision Lot Configuration

The subdivision is accessed through a primary and a secondary road which each connect to Albert Street. The primary road bisects the central and upper realms of the site. The secondary road allows for access to lots located at lower elevations as noted in Figure 2.

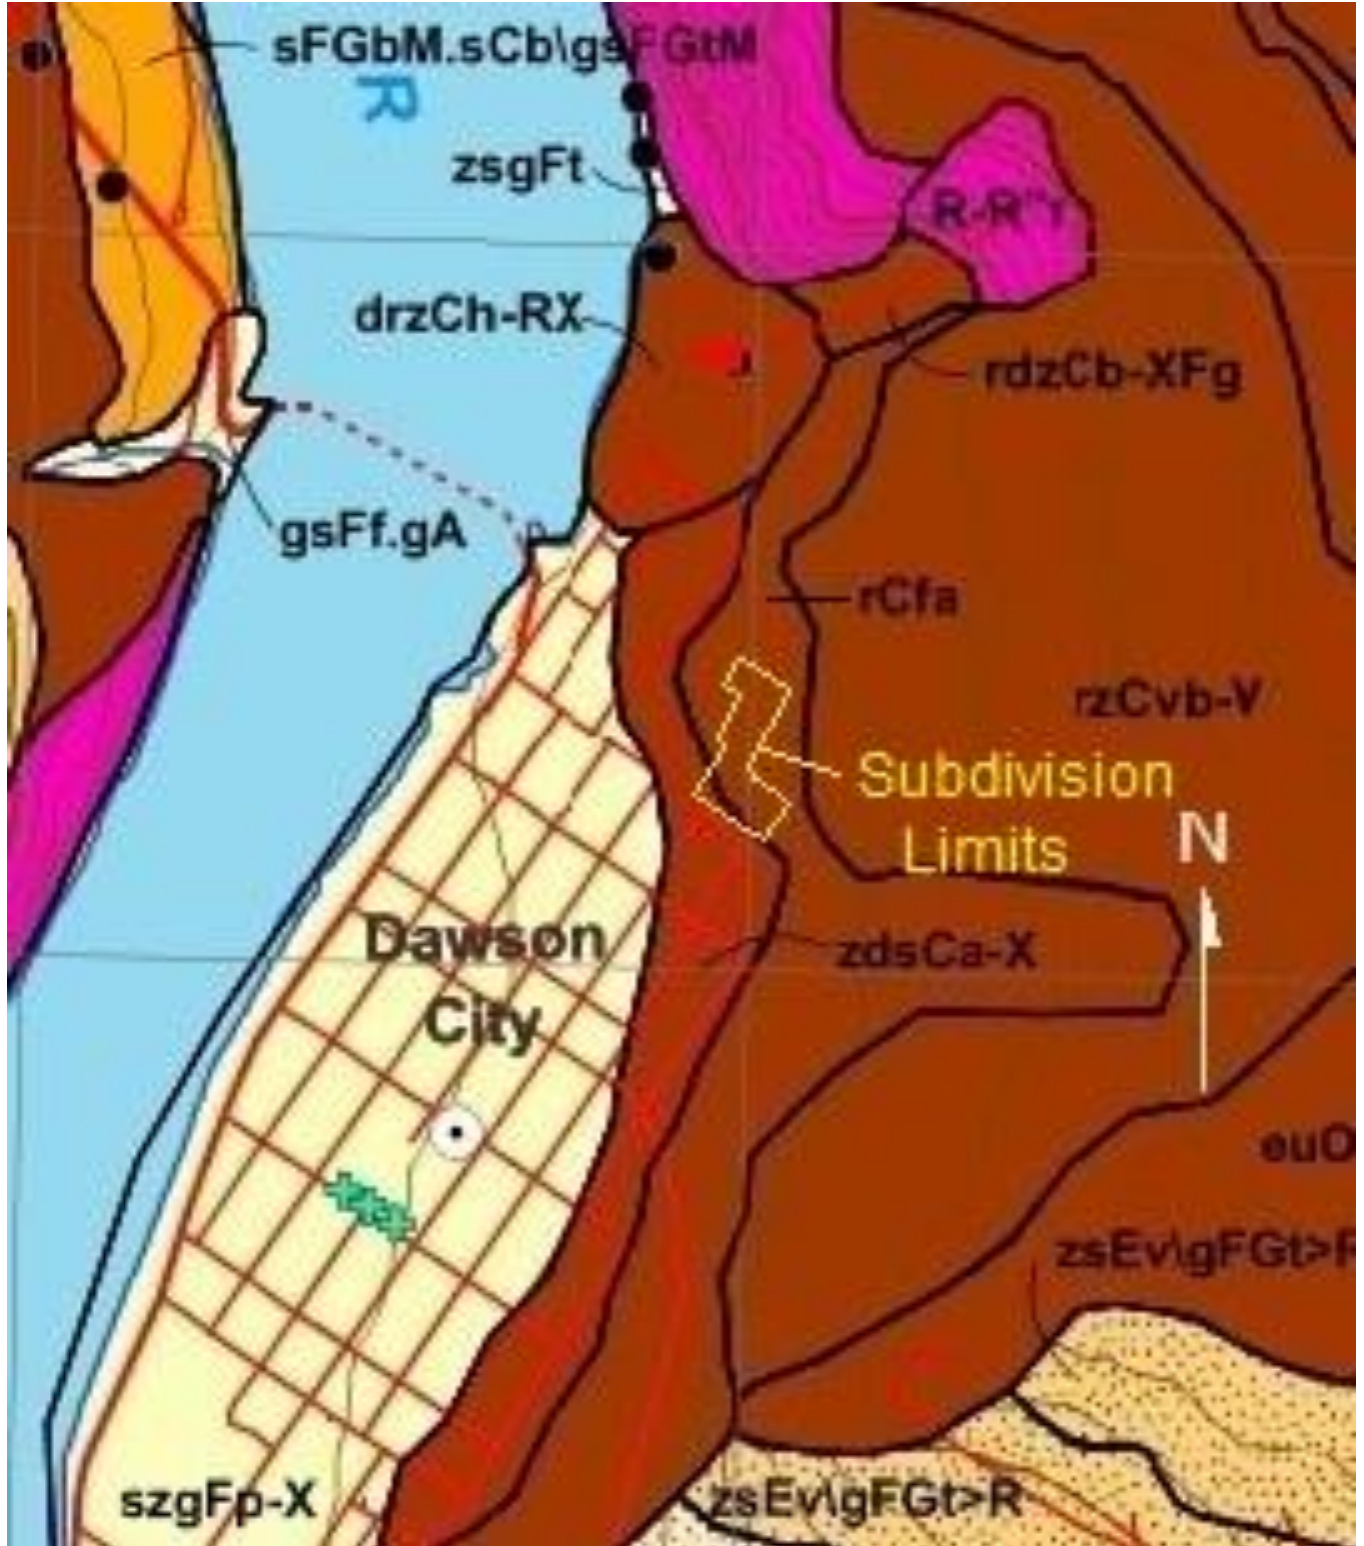
Figure 3
Surficial Geology, Dawson Region

The distribution of these deposits has been illustrated in the Surficial Geology map enclosed as Figure 3.

The distribution of the surficial deposits within the study area have been illustrated in the surficial geology map of Dawson (Open File 2014-12) enclosed as Figure 3. The map described the deposits within the study area as being comprised of colluvial materials.

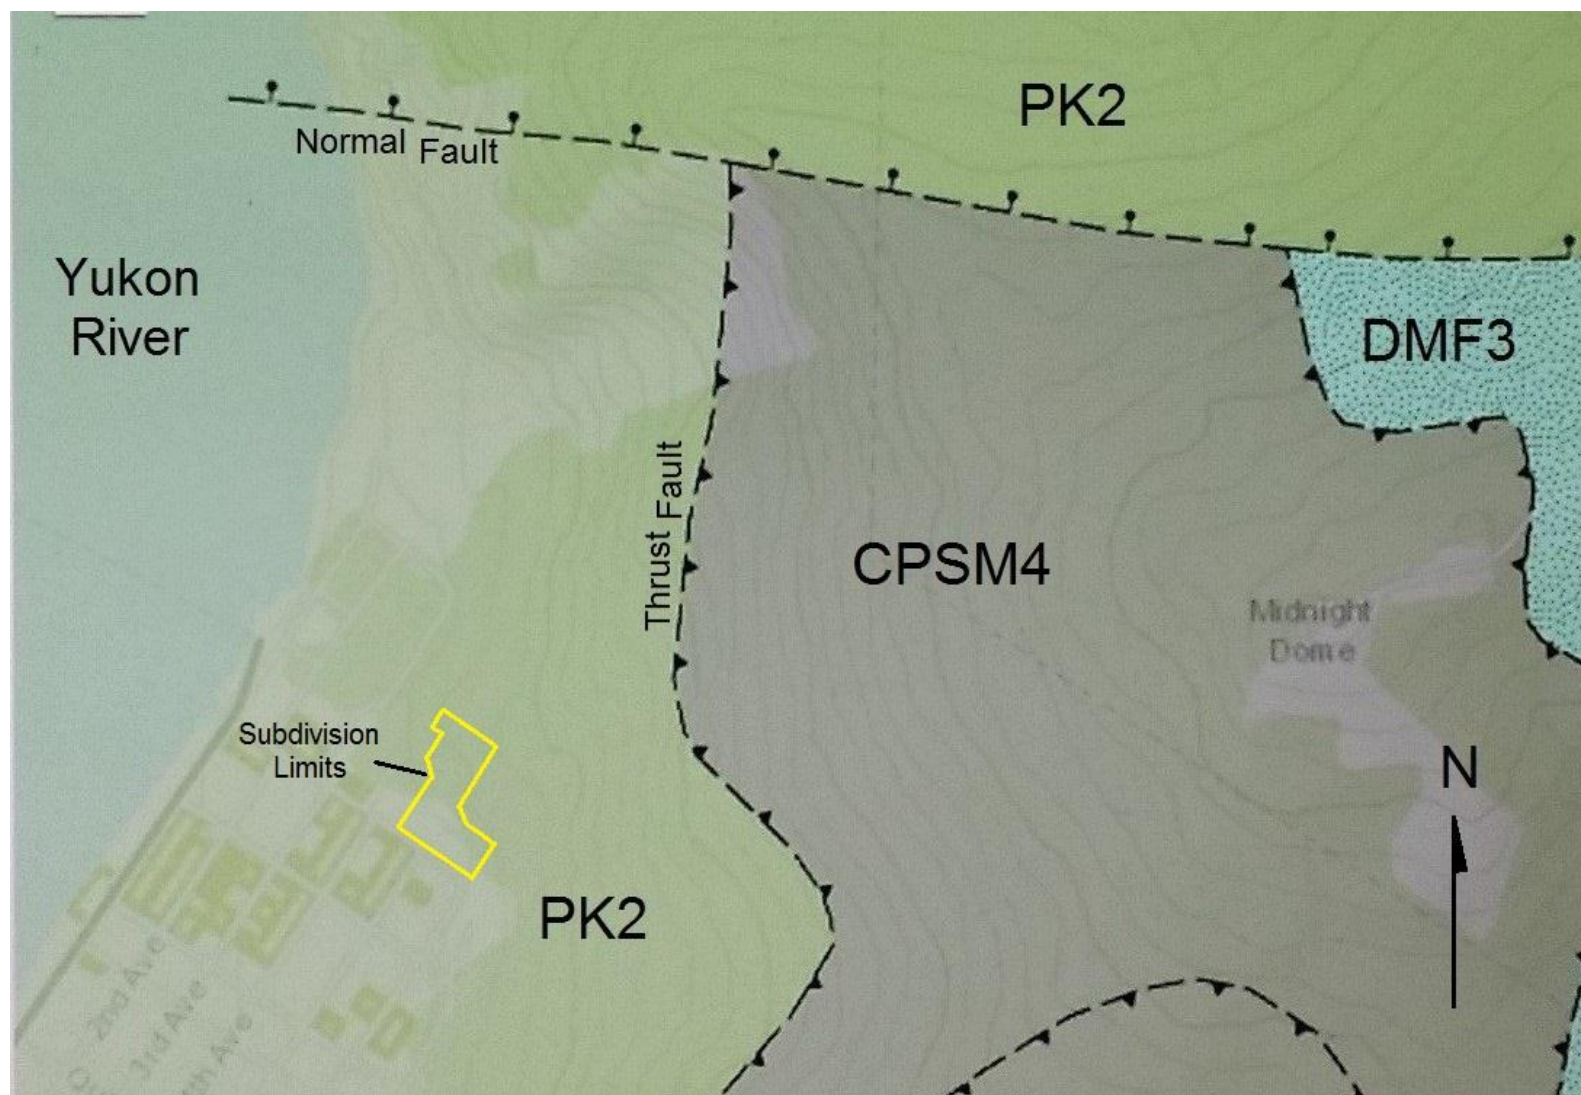
Figure 4
Bedrock Geology

The regional geology in the Dawson area is comprised of two complex assemblages comprised of the Intermontane (Yukon-Tanana) and Slide Mountain Terrane as illustrated in Figure 4. These assemblages consist of an intensely deformed, variably metamorphosed and sheared group of ultramafic, igneous and metamorphosed rocks which include serpentine, diorite, amphibolites and schist (Yukon-Tanana) and a weakly deformed assemblage comprised of shale, siltstone and sandstone which contains some phyllite (Slide Mountain).

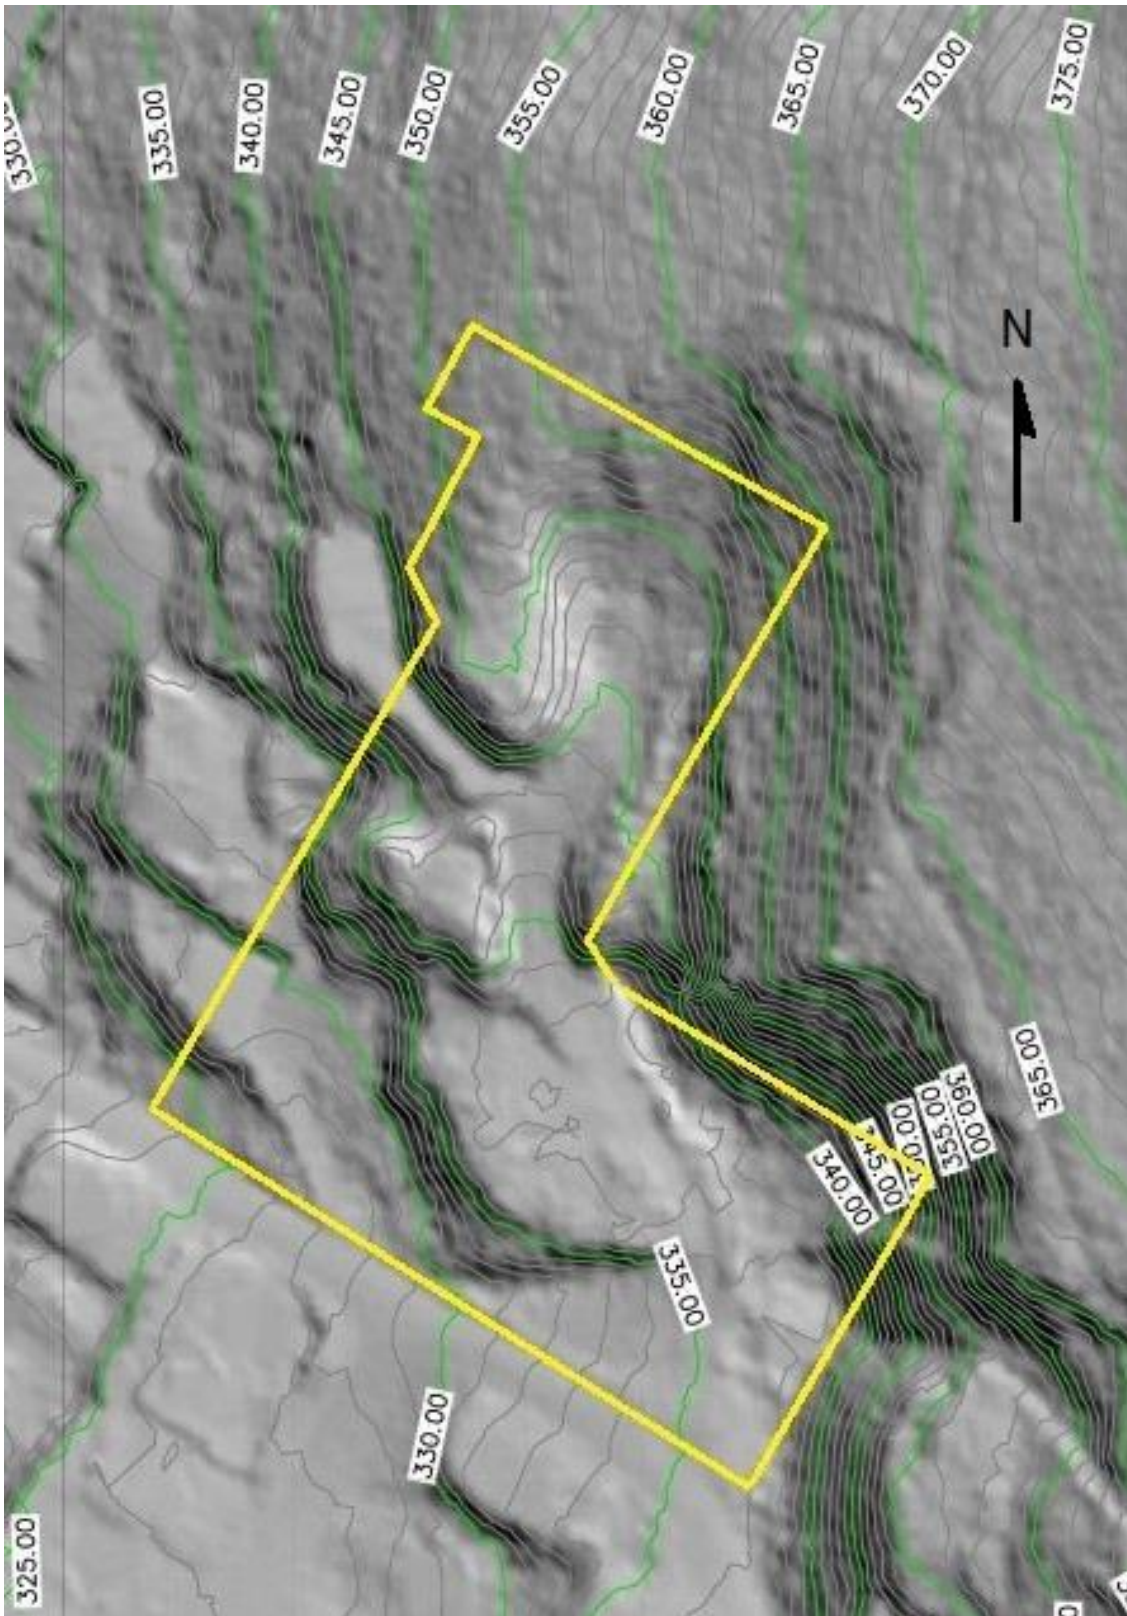
Geotechnical Evaluation – Geohazard Assessment
Block 4 North End Subdivision – Dawson City, Yukon – 2017
Figure 5 – Local Topography – 2017 Lidar Survey

While the topography within the limits of the subdivision varies, regionally the terrain ascends towards the north-east. The subdivision lies at elevations which range between approximately 322 meters to 360 meters as noted in Figure 5. The Midnight Dome lies approximately 1.3 km north-east of the site at an elevation of approximately 880 meters. The Yukon River lies at an elevation of approximately 316 meters.

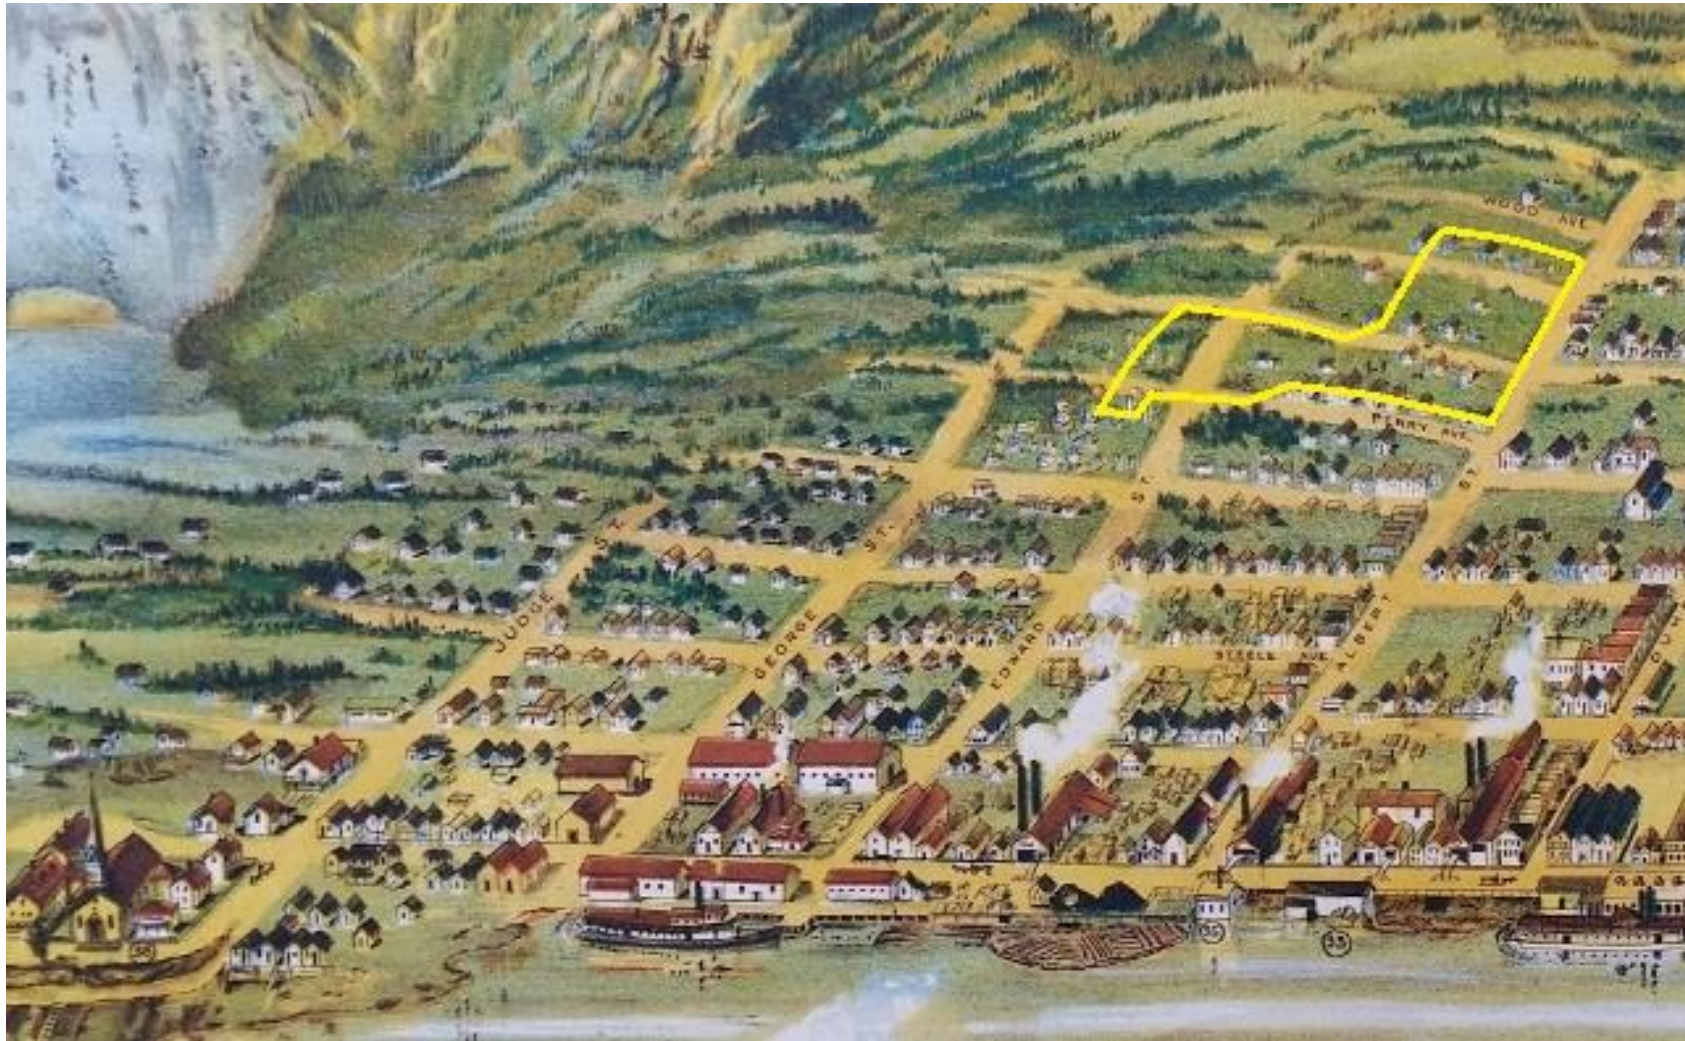
Figure 6
Historical (1903) Setting

The 1903 drawing by Dr. Bell (enclosed as Figure 6) shows that historically, the study area was once a residential part of Dawson comprised of houses and wall tents. These structures were all situated on a well-developed system of roads. Otherwise, since then, the area appears to have lain dormant relative to housing development.
