CHILKOOT GEOLOGICAL ENGINEERS LTD.

Geotechnical Evaluation Proposed North End Subdivision Dawson City, Yukon – 2016

Prepared For: Yukon Government – Energy, Mines and Resources

Date : September 18, 2016

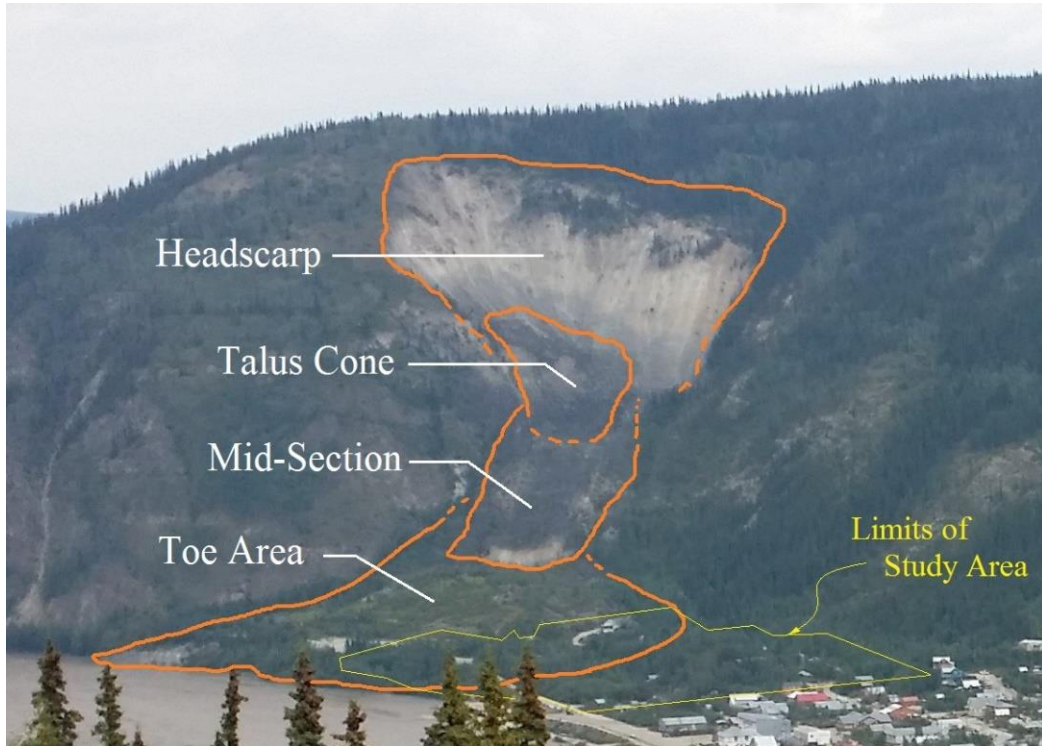
View of slide and study area facing north-east. Photo taken from road to Sunnydale in West Dawson.

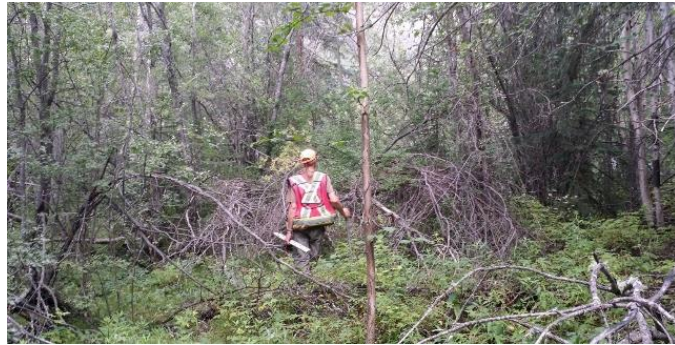
Site Reconnaissance - Conditions along Steele Avenue

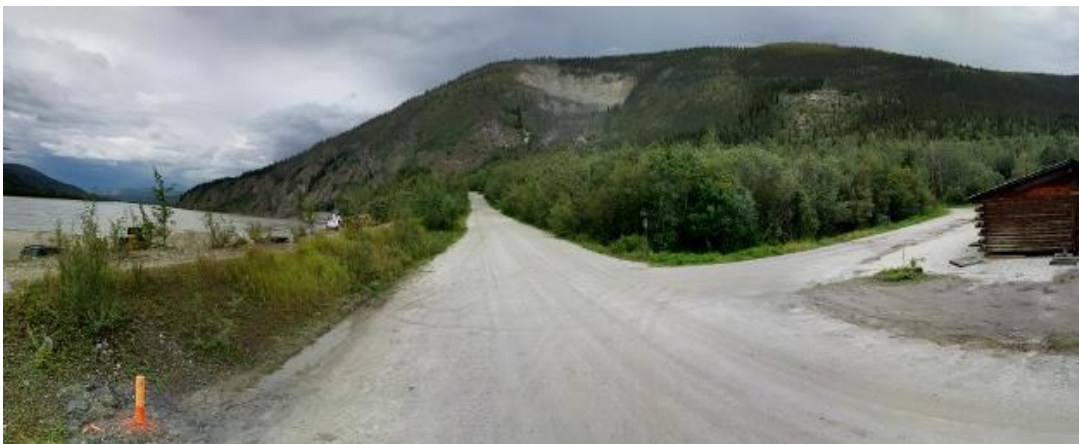
Panoramic view of study area from intersection of Front and Edward facing north-east. BH 3-16 well on lhs

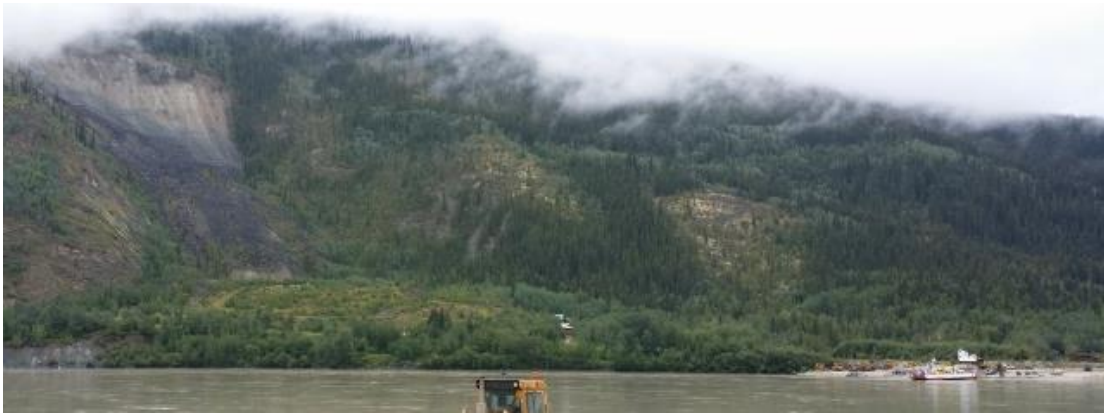
Area 12

View of slide and study area from West Dawson facing east.

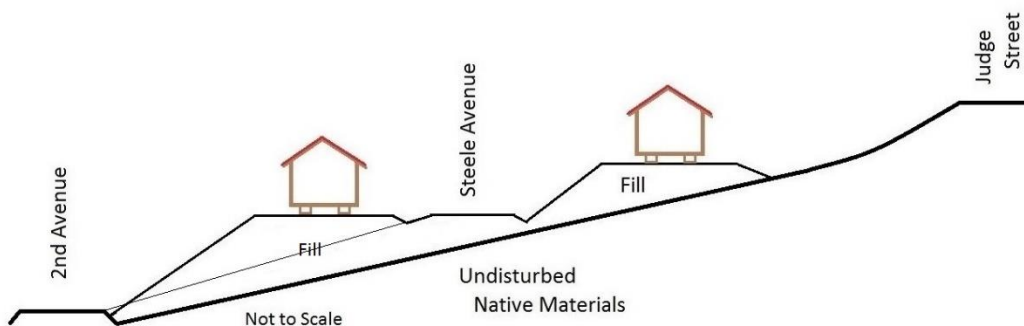
A conceptual plan which illustrates the envisioned nature of the structural pads and road fills in the region between 2nd Avenue and Judge Street has been provided below.

While the intent is to minimize disturbance to the underlying colluvial materials, so as not to induce (or increase rates of) creep, sliver fills should be incorporated at the interface between fill and native materials. Large side-cuts into the colluvial deposits (> 0.25 m) should however be avoided.

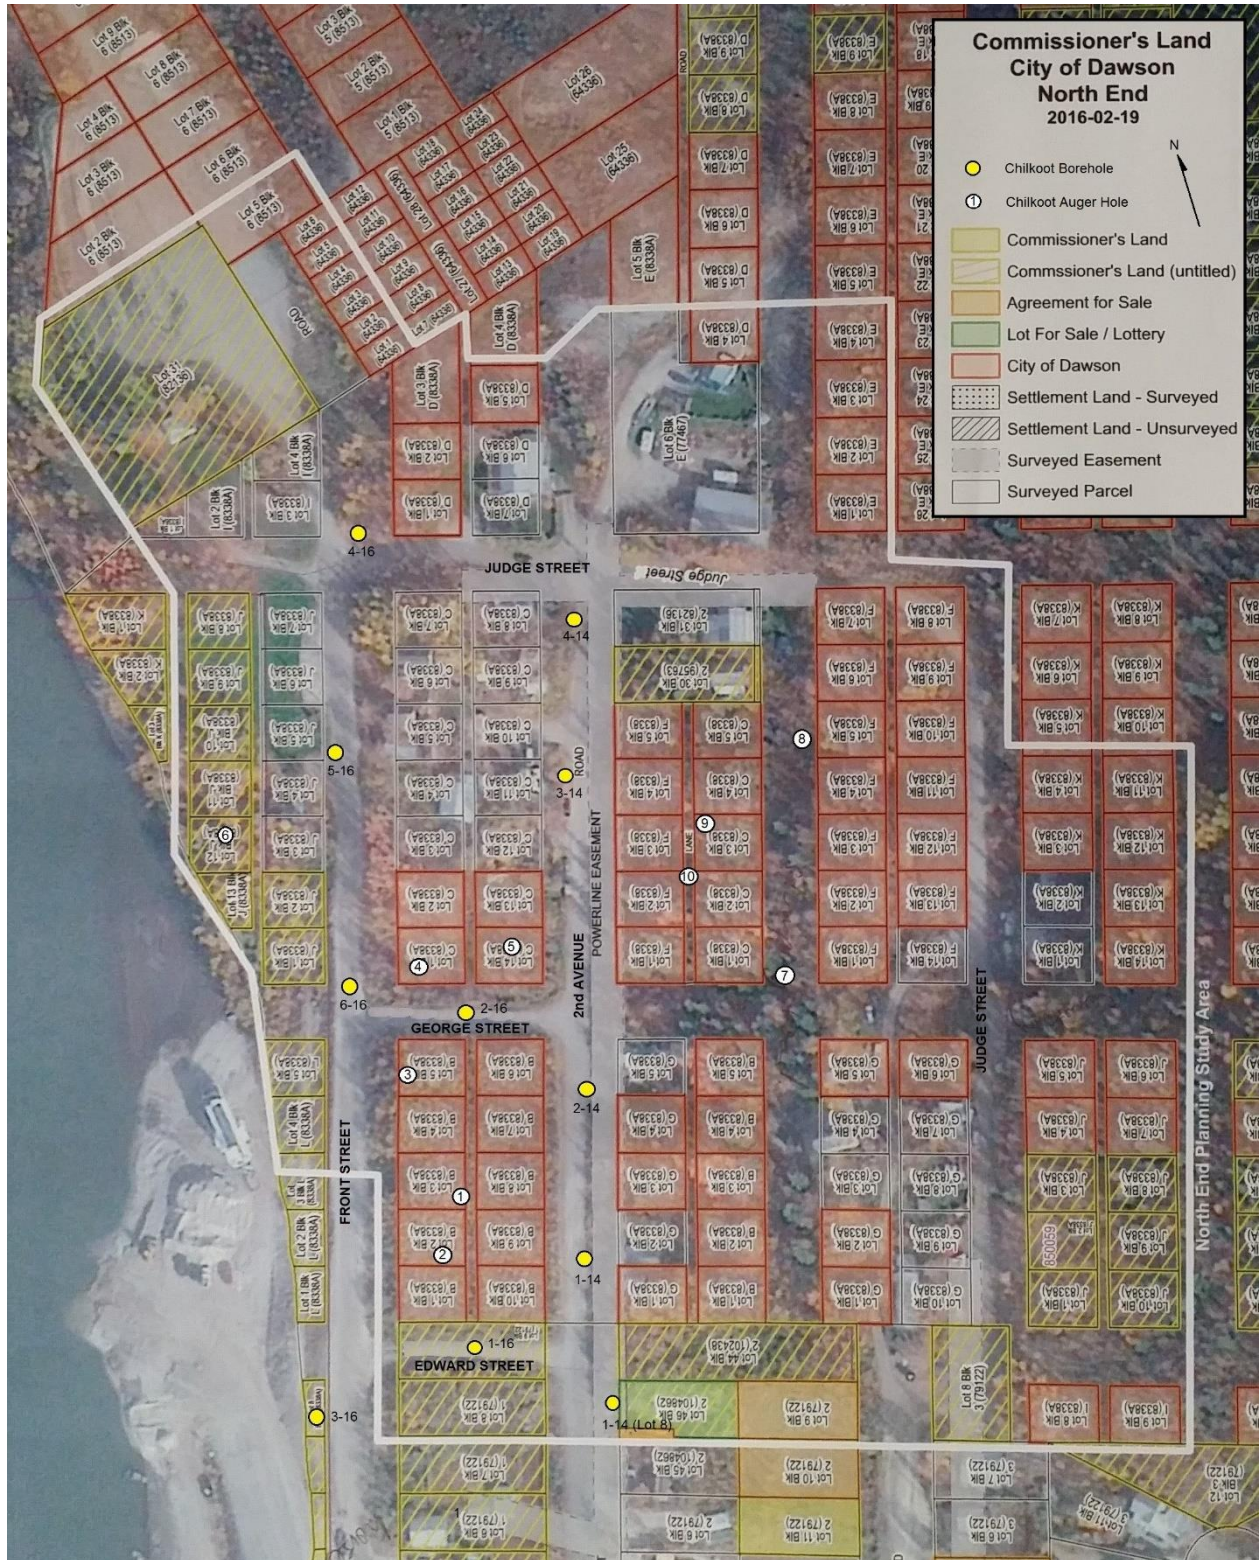
Figure 2
 Study Area, Borehole and Hand Auger Locations

A total of four (4) boreholes were advanced during the evaluation at the locations noted in Figure 2. BH 1-14 and BH 2-14 were advanced within fluvial deposits. BH 3-14 encountered colluvial slide deposits which overlay these fluvial deposits. BH 4-14, which was advanced at higher elevations, encountered predominately colluvial slide deposits.

As much of the study area is treed and thus inaccessible to the drill rig, a hand sampling program was conducted through hand excavation methodologies in order to access select regions in the study area. In all, a total of ten (10) locations were sampled (A1 through A10) as noted in Figure 2. The sample locations were recorded utilizing a hand-held GPS unit.

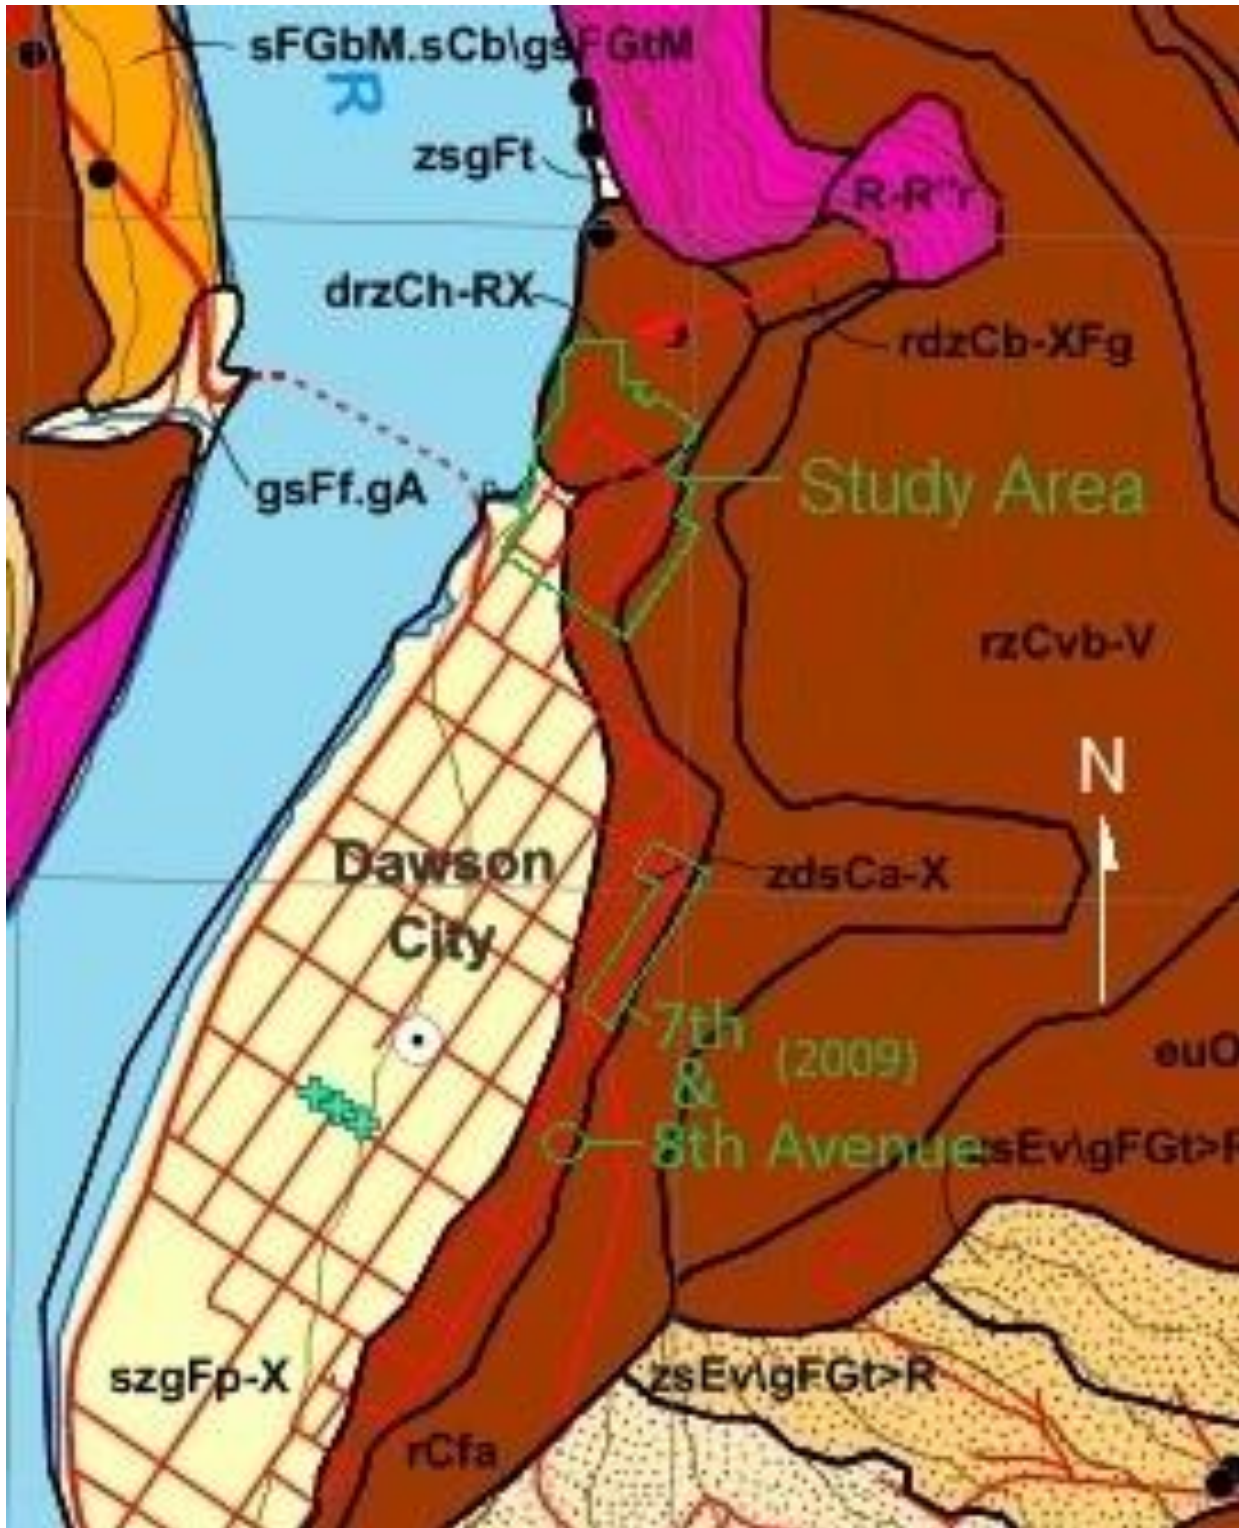
Figure 3
Surficial Geology, Dawson Region – Open File 2014-12

Lower portions of Moosehide Slide, which is the remnants of a prehistoric landslide, are located within the north-western realms of the study area. The approximate limits of the slide and contacts between the surficial deposits have been denoted on the surficial geology map enclosed as Figure 3 and Figure 10 – Development Potential.

The distribution of the surficial deposits within the study area have been illustrated in the surficial geology map of Dawson (Open File 2014-12) enclosed as Figure 3. The map described the deposits within the study area as being comprised of colluvial and fluvial materials. The colluvial materials are located in regions where higher elevations prevail. These materials are differentially weathered and unsorted. The fluvial materials are generally comprised of deposits which are derived from more recent depositional events. These deposits accumulate in lower elevations, near valley (creek/river) bottoms.

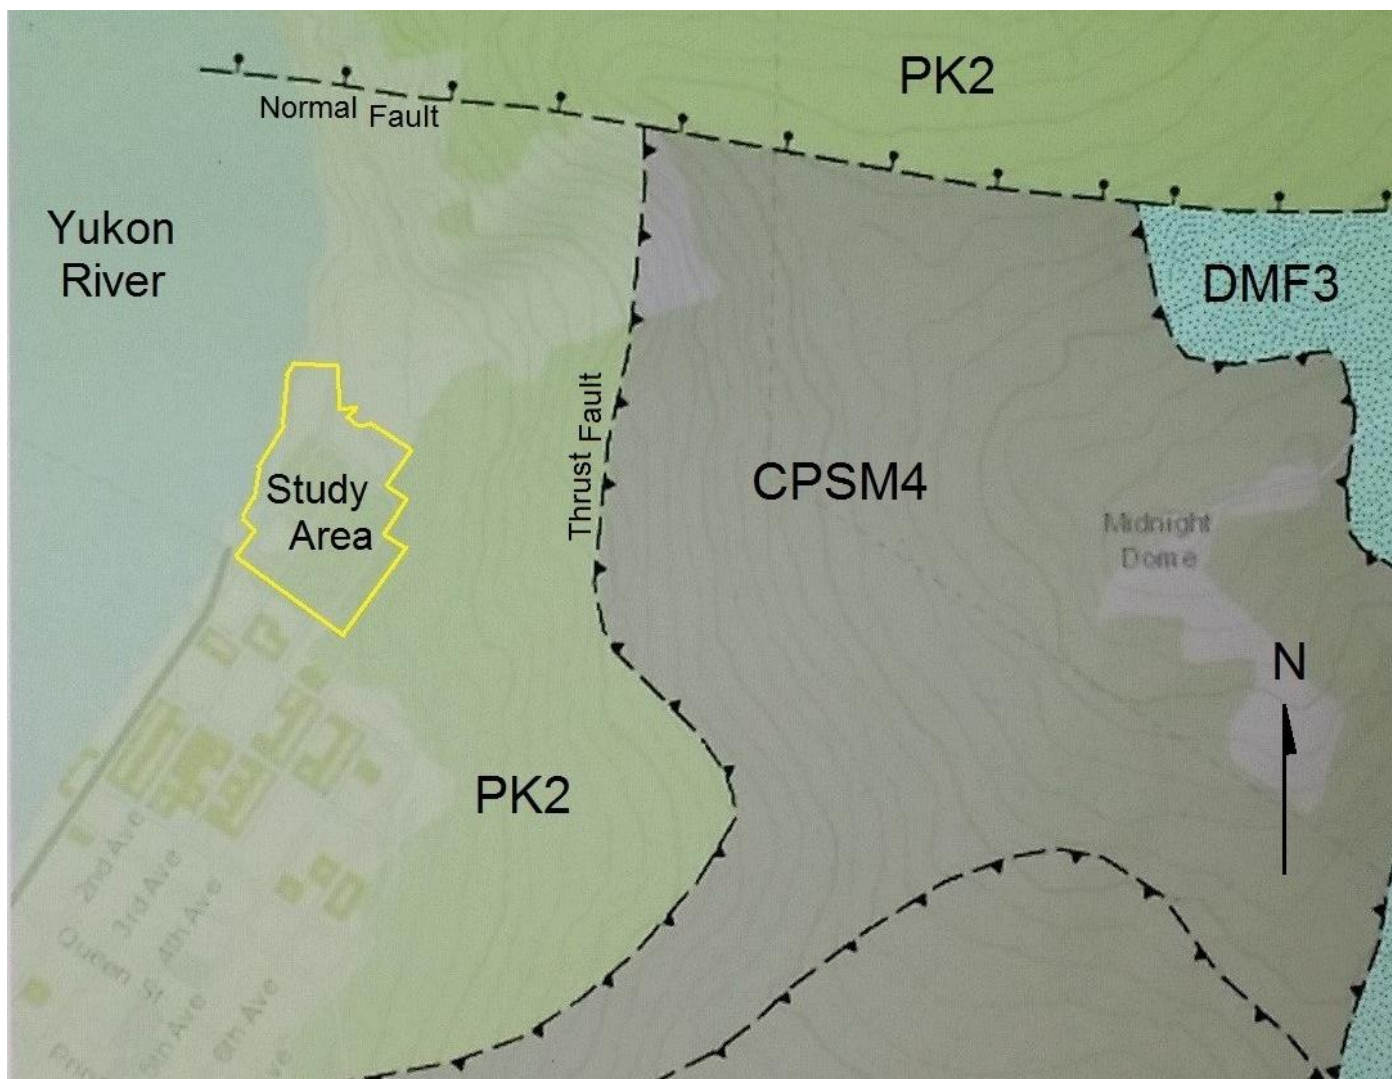
Figure 4
Bedrock Geology

The prominent Moosehide Slide, the toe of which is located within the study area, is thought to have occurred in the order of 1700 years ago as the result of two (2) separate geological events. The failure is thought to have occurred at/near a contact between serpentine and metasedimentary rocks as the result of high pore-water pressures and seismic activity (Brideau, et al, 2012). The structural geology suggests the headscarp, located ~ 600 meters north of the study area, is near the intersection of a normal and (several) thrust faults as noted in Figure 4 – Bedrock Geology.

The regional geology in the Dawson area is comprised of two complex assemblages comprised of the Intermontane (Yukon-Tanana) and Slide Mountain Terrane as illustrated in Figure 4. These assemblages consist of an intensely deformed, variably metamorphosed and sheared group of ultramafic, igneous and metamorphosed rocks which include serpentinite, diorite, amphibolites and schist (Yukon-Tanana) and a weakly deformed assemblage comprised of shale, siltstone and sandstone which contains some phyllite (Slide Mountain).

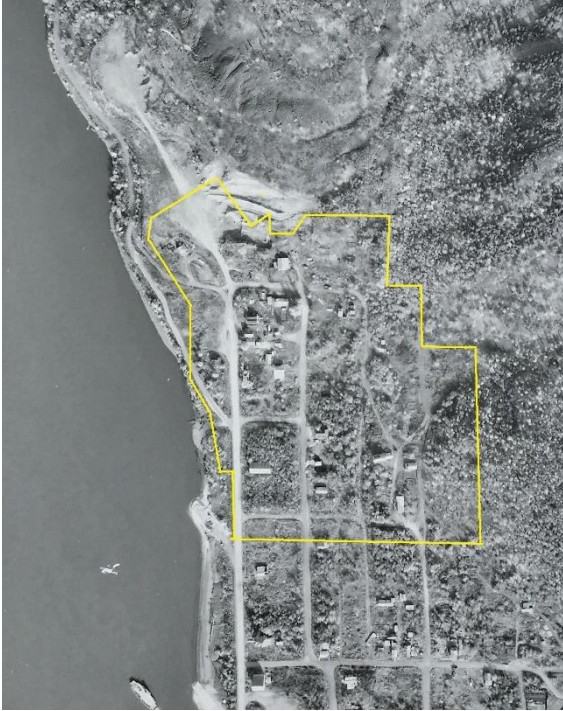
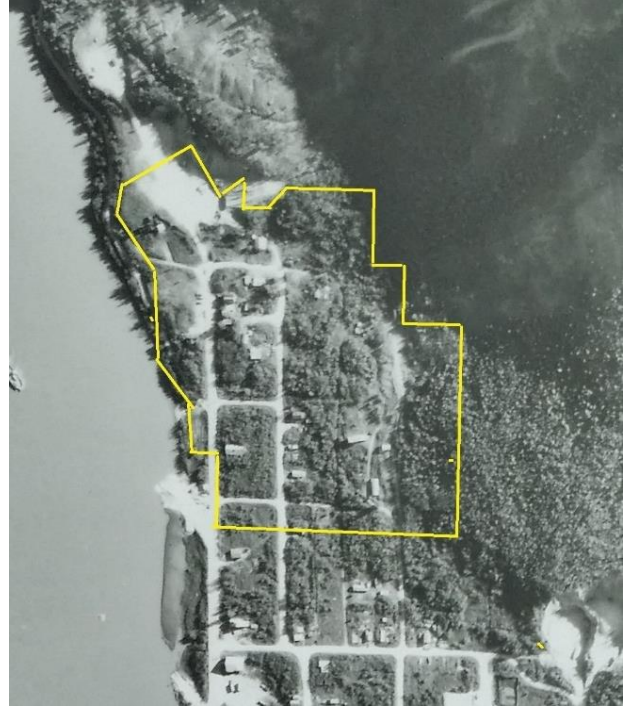
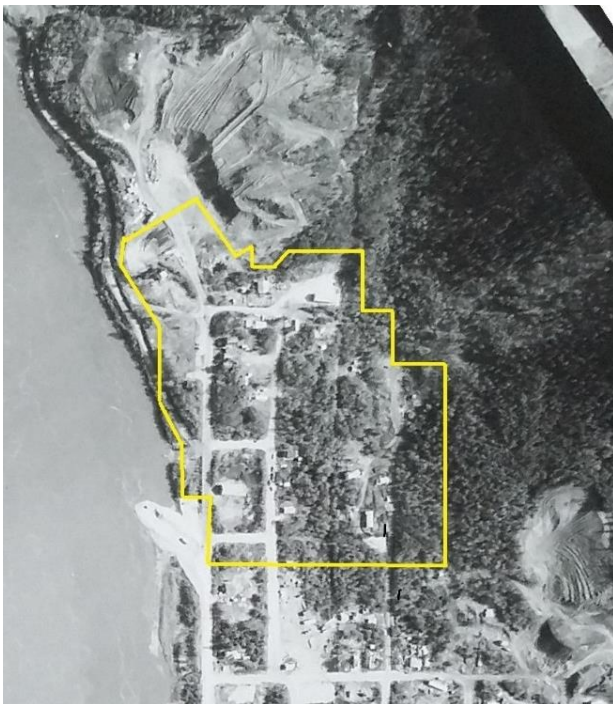
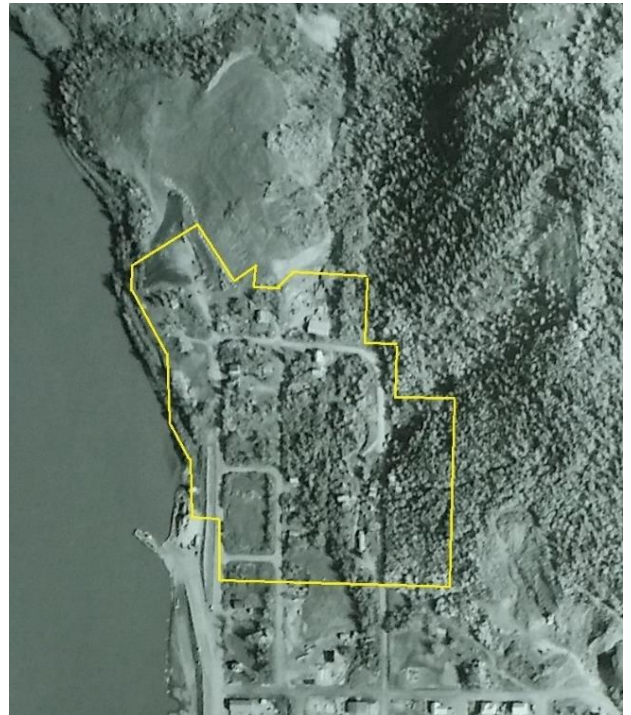
Figure 7
Selection of Air Photos

A selection of the above noted aerial photographs have been attached in Figure 7 – Selection of Air Photos.

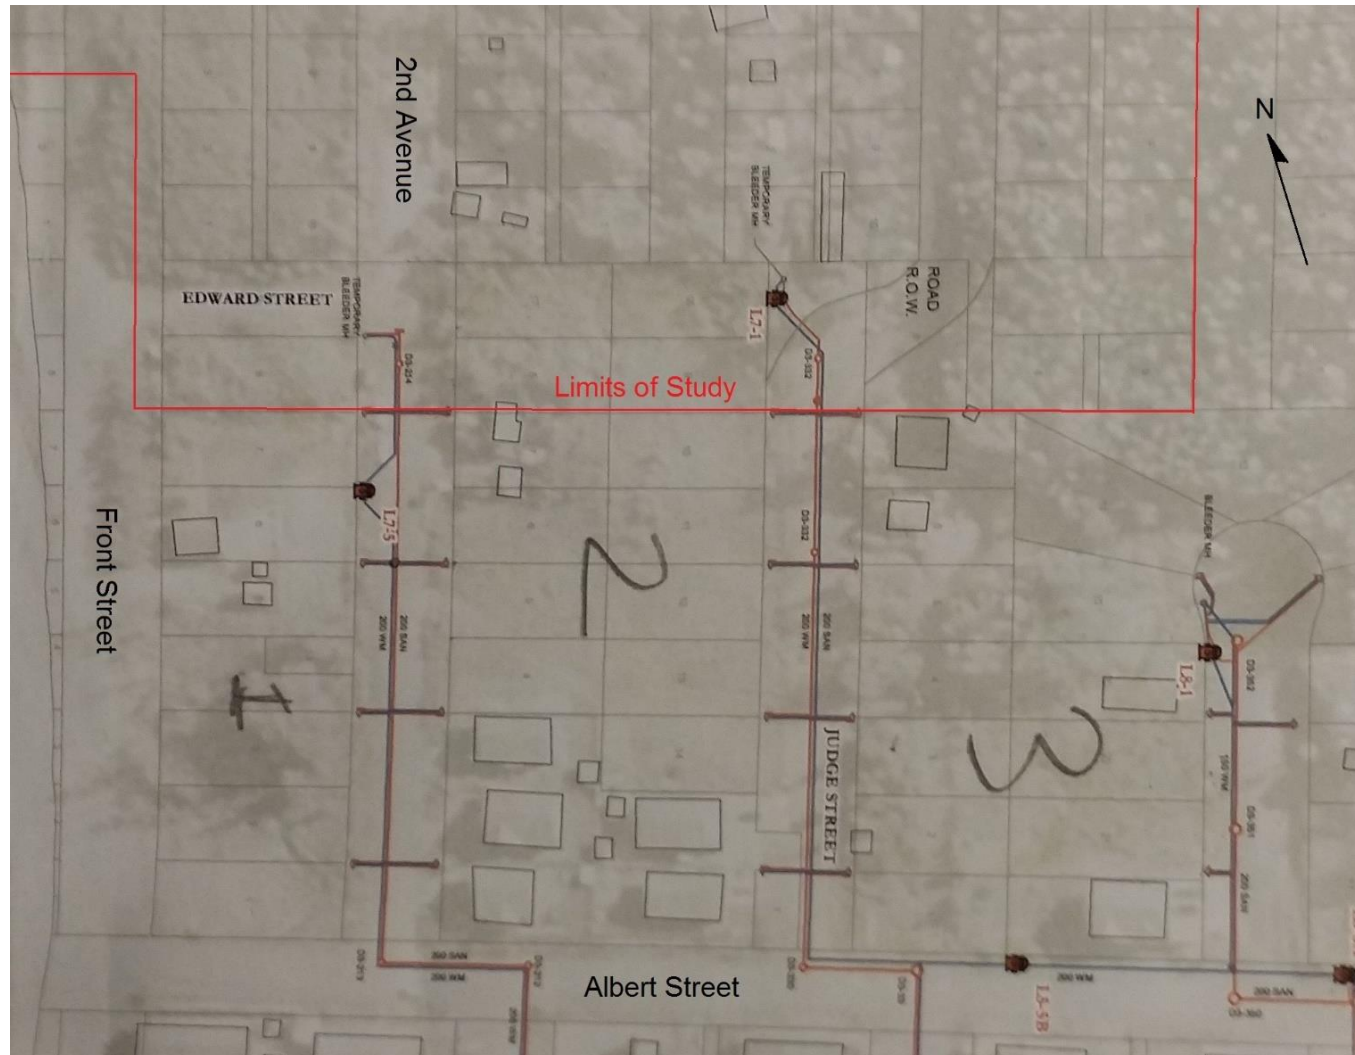
Geotechnical Evaluation
Proposed North End Subdivision
Dawson City, Yukon – 2016
Figure 8 A
Utility Plan – Sanitary & Water

The sub-surface utility plans noted the presence of (200 mm Ø) sanitary and water lines within the extreme southern realms of the study area extending into 2nd Avenue and Judge Street as noted in Figure 8a.

In brief, *Northwestel* and *YECL* indicated that their infrastructure was comprised of overhead lines. The *City of Dawson* indicated that sanitary, water and storm water drainage lines were located as noted in Figures 8a & 8b. It was understood that the existing sanitary and water utilities are located in the order of 3 meters below the existing road grades.

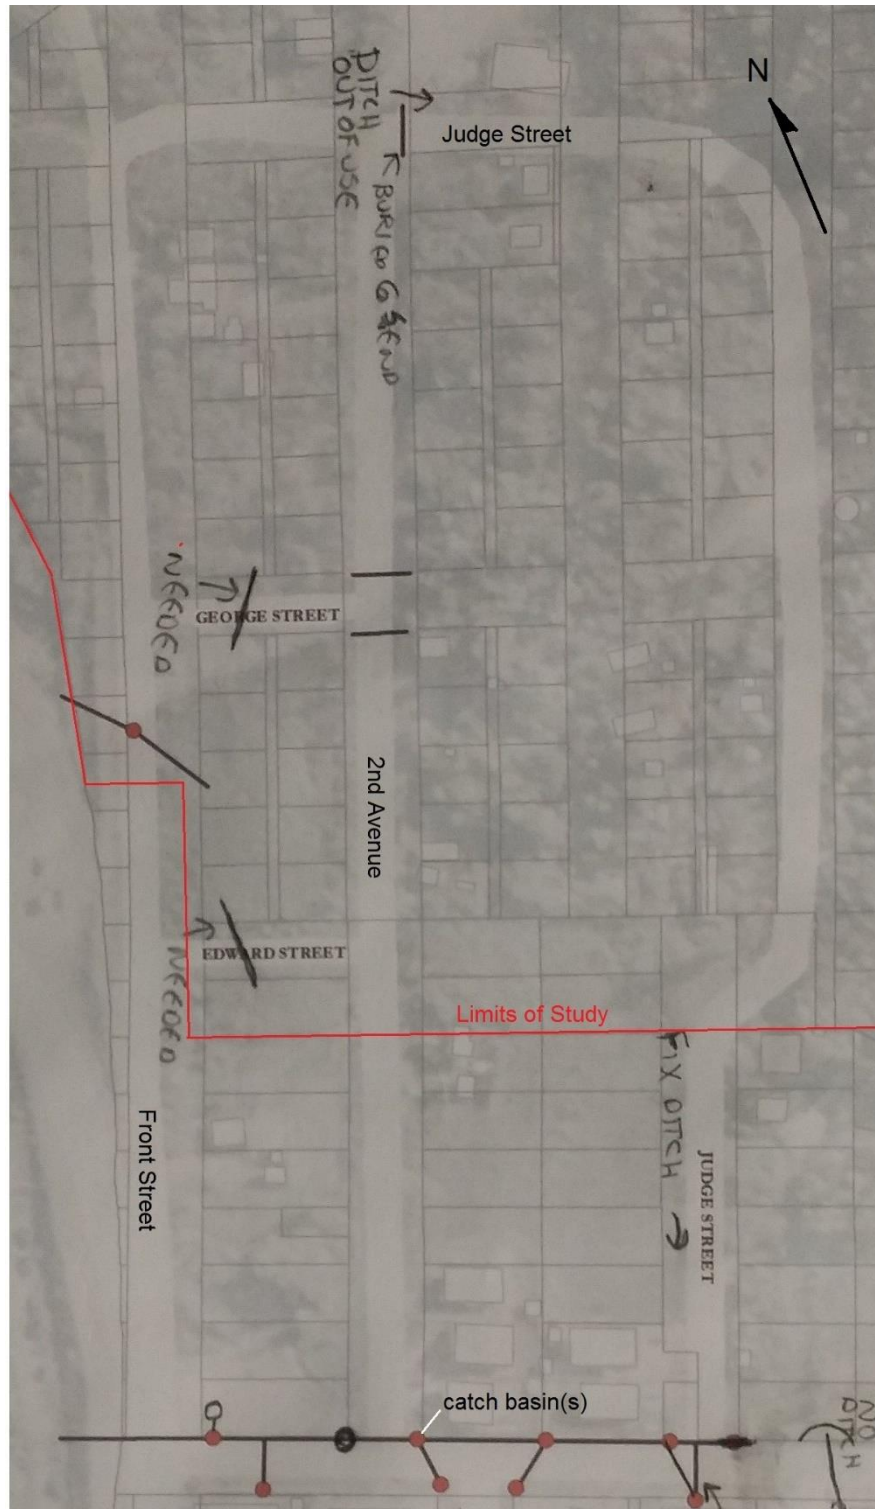
Geotechnical Evaluation
Proposed North End Subdivision
Dawson City, Yukon – 2016
Figure 8 B
Utility Plan – Storm Water Drainage

The storm water drainage system noted the presence of a catch basin (on Front Street) and several area culverts as illustrated in Figure 8b. The plan also shows *City of Dawson – Public Works Department* hand written comments regarding (essential requirements for) envisioned culverts and ditches to assist in regional drainage.

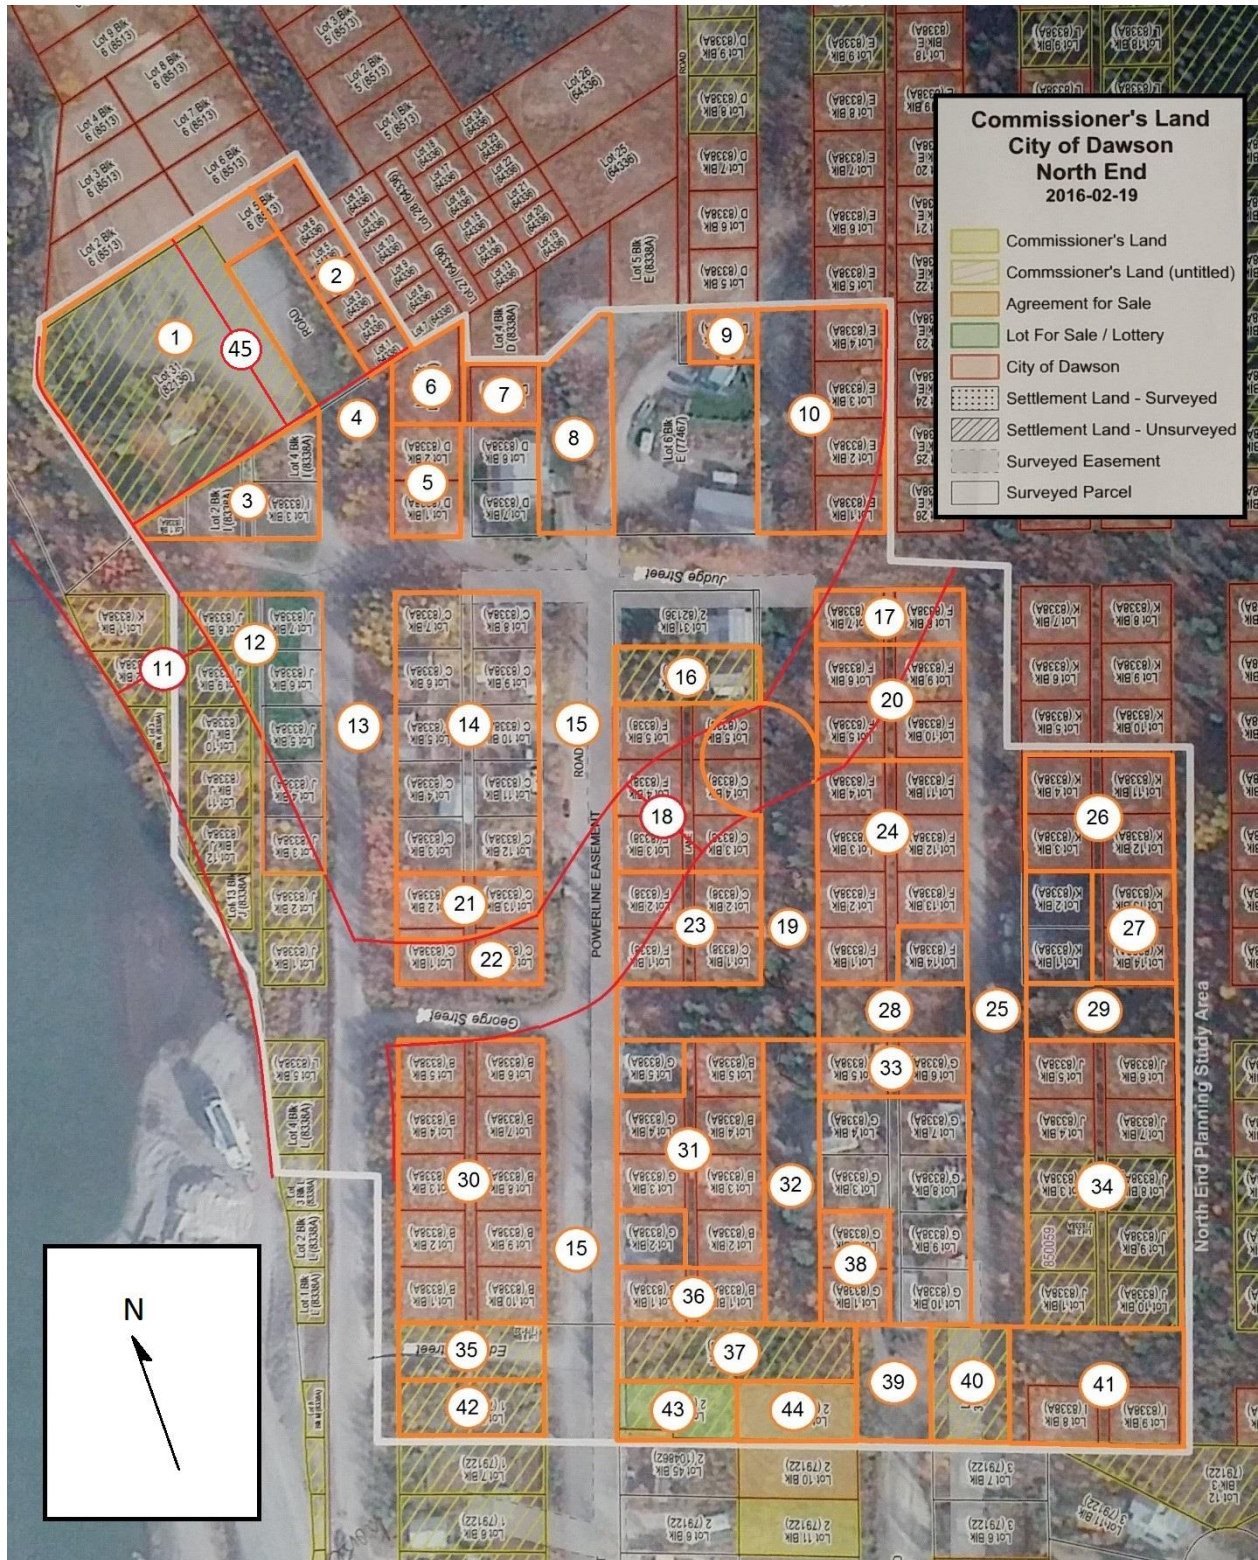
Figure 9
 Assessment Areas

The following discussions have been provided relative to the areas noted in Figure 9 to address site specific observations which were made during the course of our evaluation.

A geotechnical evaluation should be conducted by means of test pit or drilling methodologies to better assess the soil conditions in the regions of Steele Avenue and Area 30 (Figure 9) if these areas are to be developed. The intent would be to

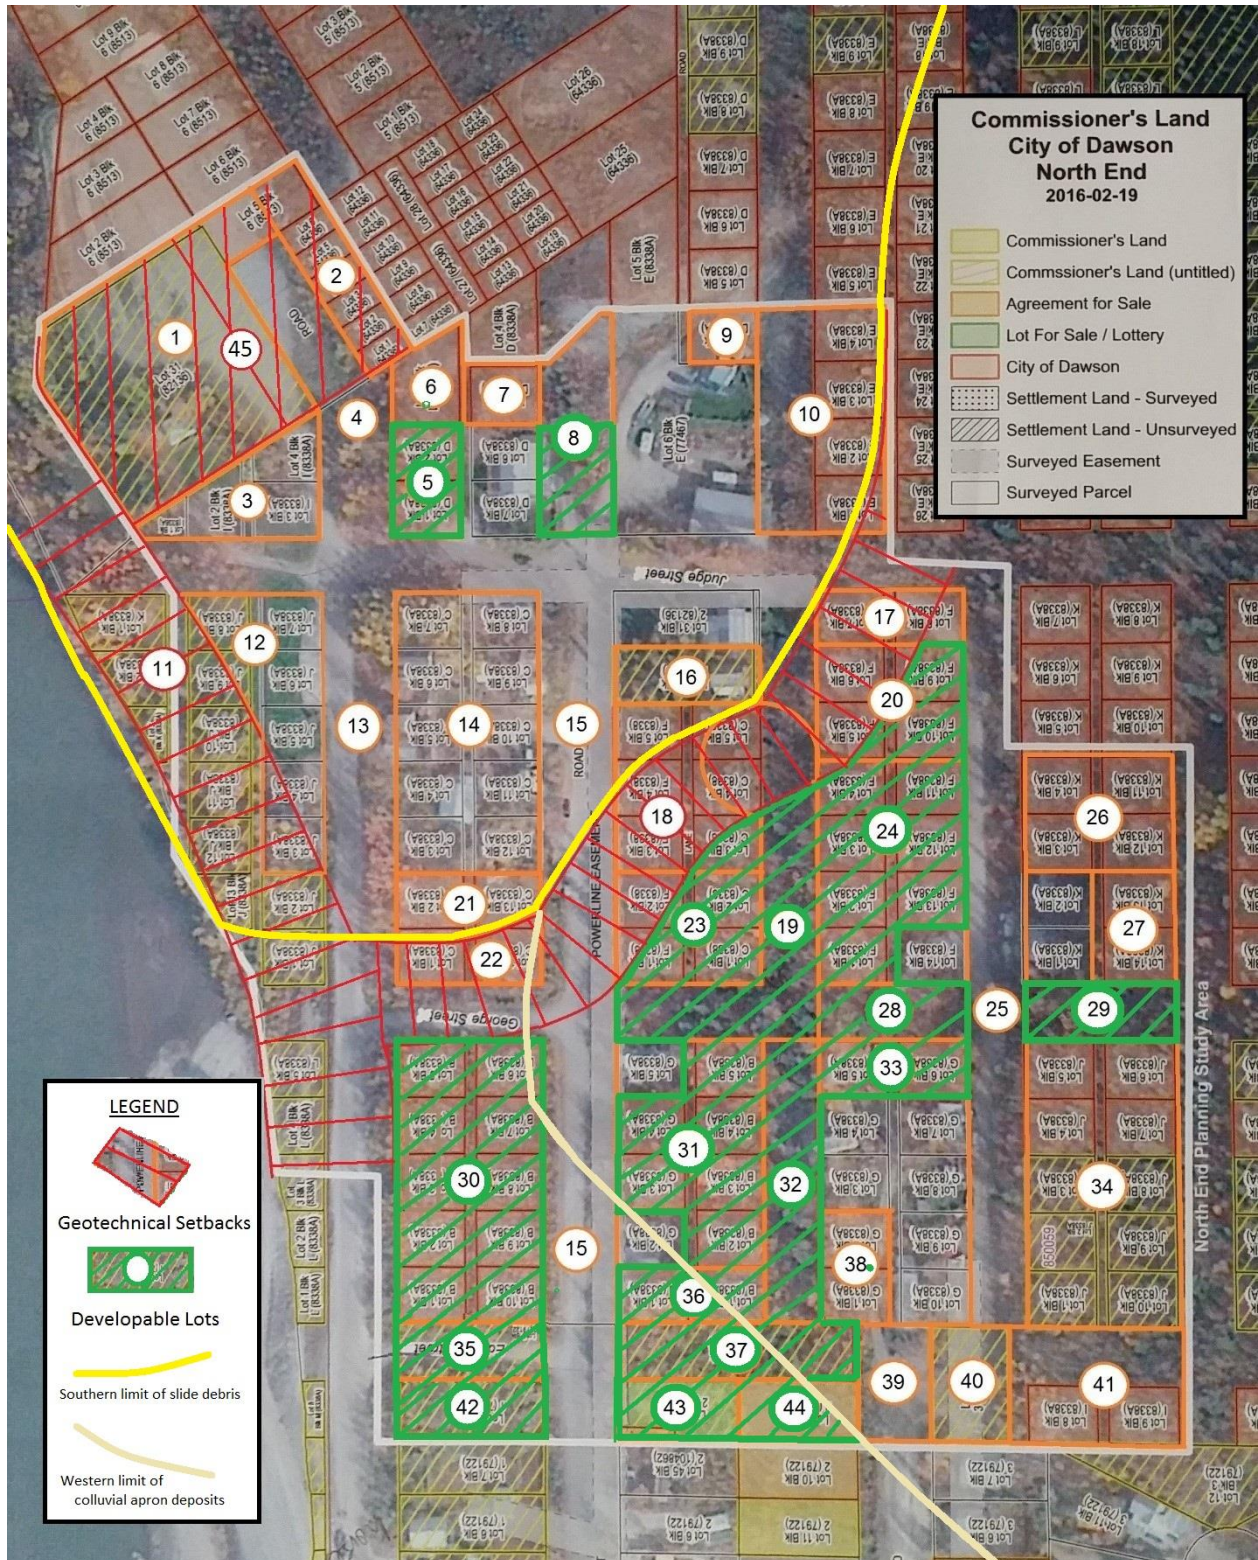
Figure 10
 Development Potential

The distribution of these deposits has been illustrated in the Surficial Geology map enclosed as Figure 3 and in Figure 10 – Development Potential.

A site plan which illustrates the approximate regions of the study area which should be suitable for residential building development has been attached as Figure 10 – Development Potential.
