**Geotechnical Reconnaissance
Lot 1191 Henderson Corner (2014-0027 LTO)
Dawson City, Yukon – 2016**

Prepared For: Yukon Government – Energy, Mines & Resources
Date : August 17, 2016

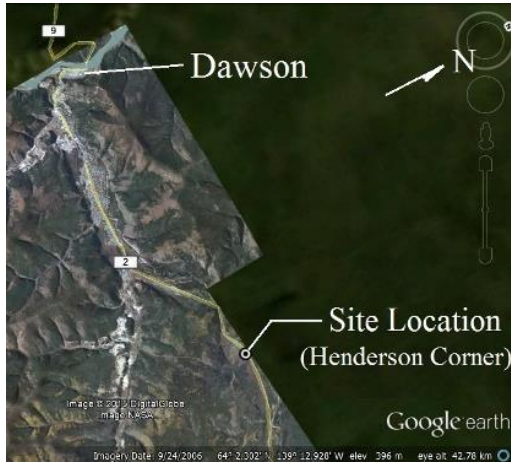
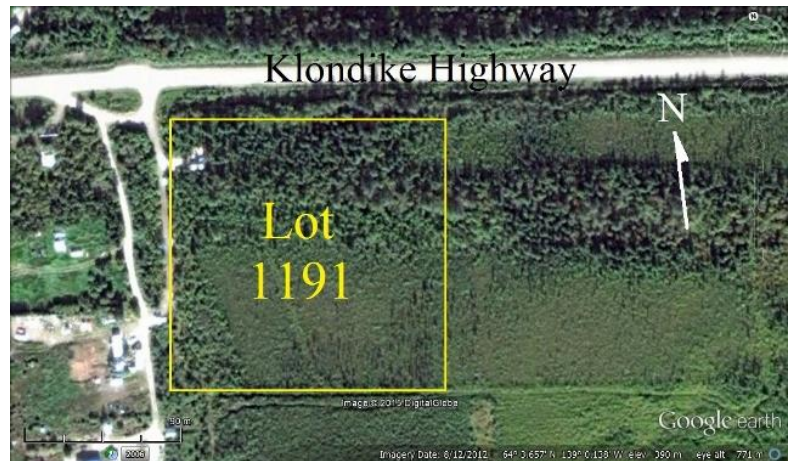
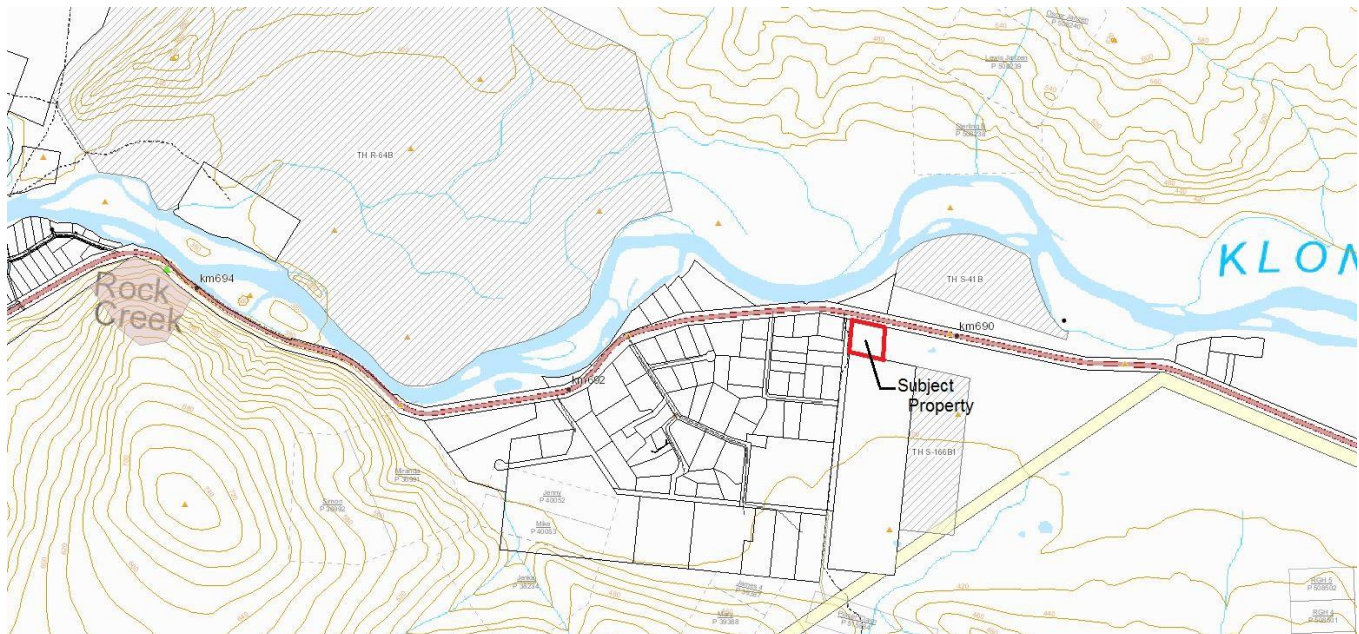
FIGURE 1 – Site Location

A portion of the *Yukon Water Placer Atlas* which illustrates the regional contour elevations has been included in Figure 1. The maps note that the site lies within a region of relatively low relief within the limits of the Klondike River floodplain. Regionally, higher elevations lie to the south.

The lot is located at Henderson Corner, approximately 23 km south of Dawson City, Yukon on Klondike Highway # 2 as noted in Figure 1. This region has been associated with both historical and more recent agricultural activities. The subject property itself is comprised of historically disturbed land which is currently vacant.

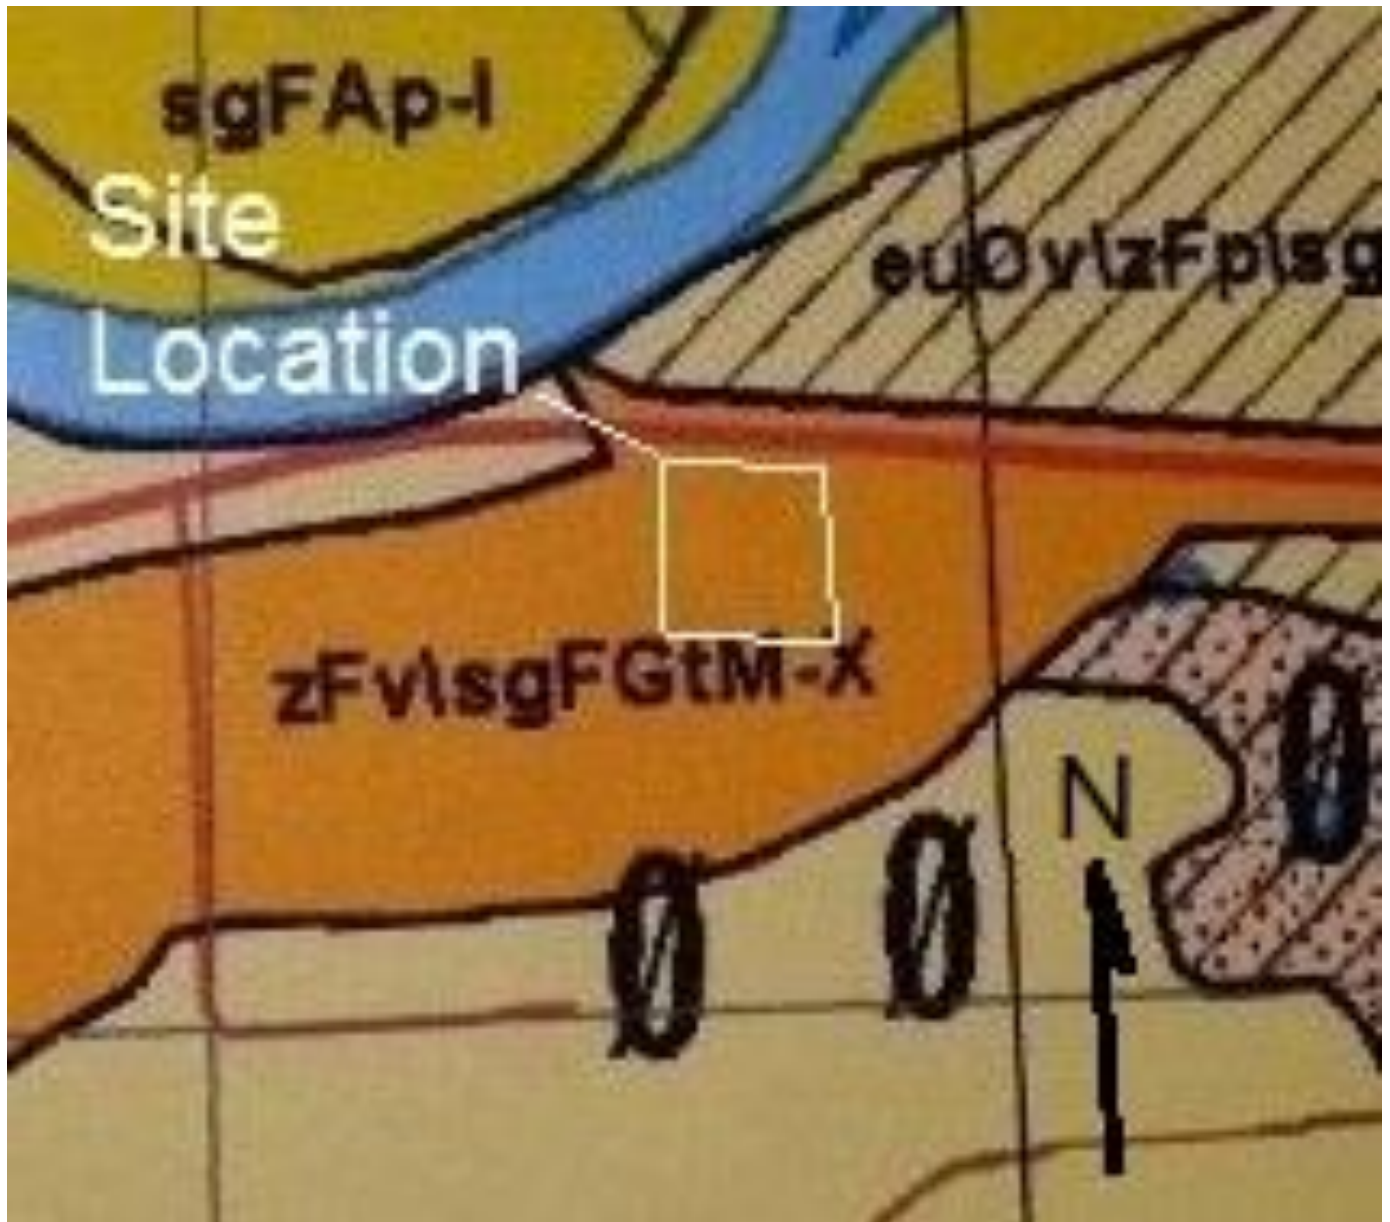
FIGURE 3 – Surficial Geology

the map unit with terraced sand and gravel glaciofluvial and morainal (till) deposits where permafrost is prevalent (zFv\sgFGtM-X).

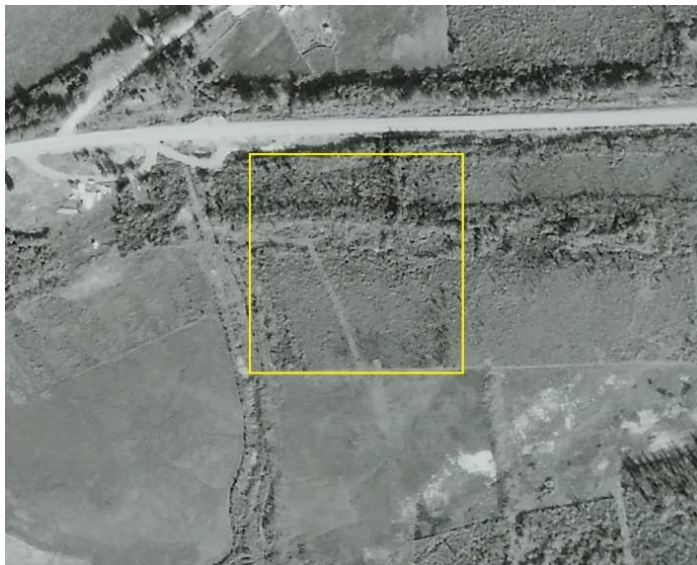
The 1960 and 1977 air photos noted that the site and much of the surrounding area was generally void of trees. A centrally located granular region traversing the site (east-west) can be seen as evidenced by the lighter colored band in the 1977 air photo.

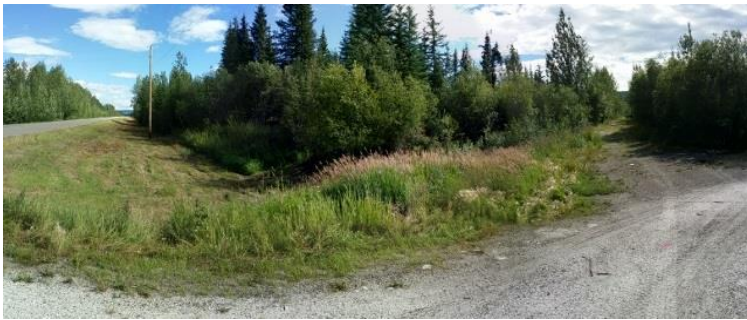
Above – Site as viewed from access from Klondike Hwy.
