## Geotechnical Evaluation – Geohazard Assessment

### Moosehide Slide Area

Dawson City, Yukon – 2017

**Date :** August 31, 2017

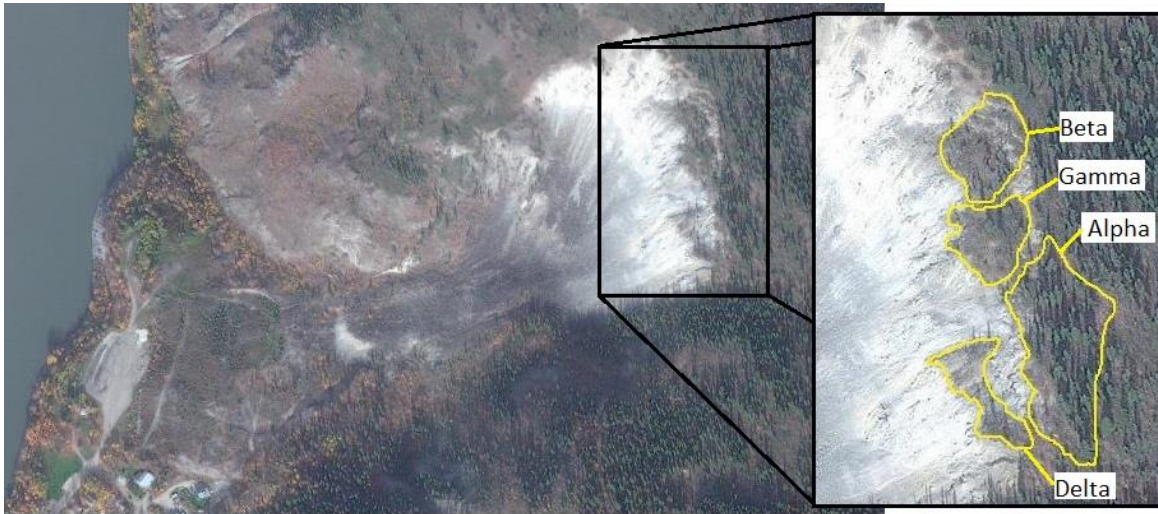
Our firm established a series of survey stakes at ~ 15 meter intervals immediately above a headscarp (near elevation 660 meters) which is associated with an unstable block (identified in the Brideau et al, 2007 paper). These stakes were established as control upon which future monitoring could be based. In addition to the survey control, notation for the terrain blocks located in the region referred to as the 'unstable block' was established for ease of reference. As each of these blocks were deemed to be unstable, the original 'unstable block' was renamed as Alpha Block to avoid confusion during discussions.

A diagram which illustrates the block notation and their approximate extent relative to the established survey stakes has been attached below.

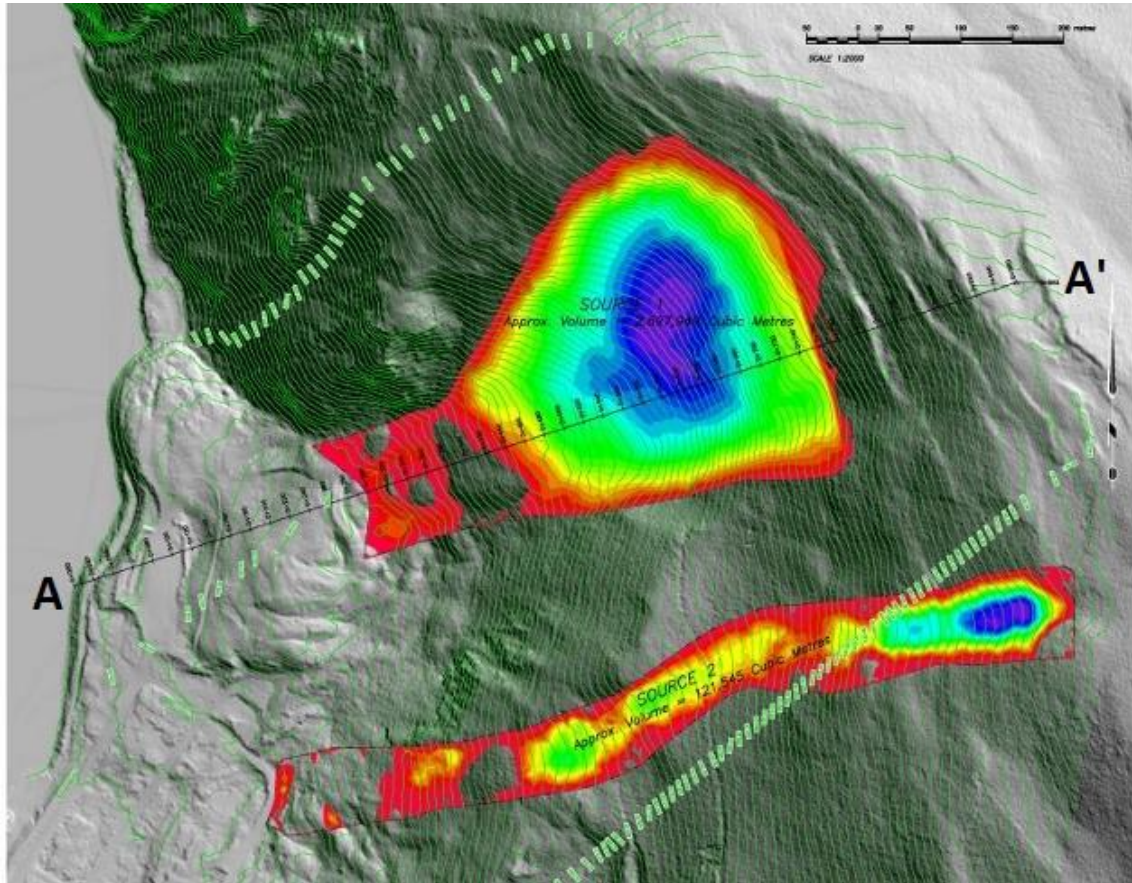
Underhill Geomatics Ltd. depleted mass isopachs of Source No.1 and Source No.2 (above)

The volume of the depleted mass from Source Area # 1 was estimated to be in the order of 2,697,949 m<sup>3</sup>.

The volume of the depleted mass from the selected area within Source Area # 2 (Gully # 4) was estimated to be in the order of 121,545 m<sup>3</sup>. As the gully within this area extended an approximately 100 meters beyond the iterated area, the actual volume within Source Area # 2 has been estimated to be ~137,000 m<sup>3</sup>.

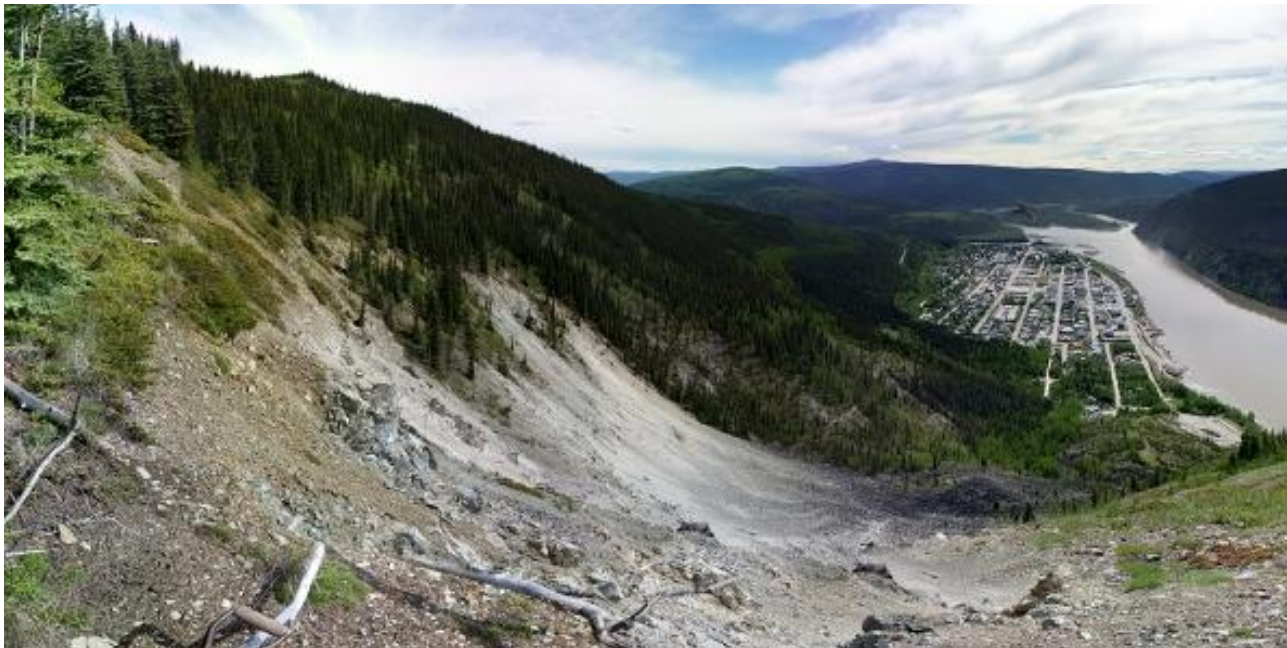
The failure is thought to have occurred as the result of high pore-water pressures and seismic activity (Brideau et al, 2012). Continued slope instability has been recorded in each of these slide areas. Rockfall is ongoing in the upper (headscarp) realms of the failure. Evidence (from Brideau et al) suggests the unstable portion of the headscarp is moving at rate of 4-12 cm/year while the mid-section of the landslide deposit is moving at higher rate of 9-27 cm/year.

*June 1<sup>st</sup>, 2017 panoramic view of slide from headscarp facing south.*

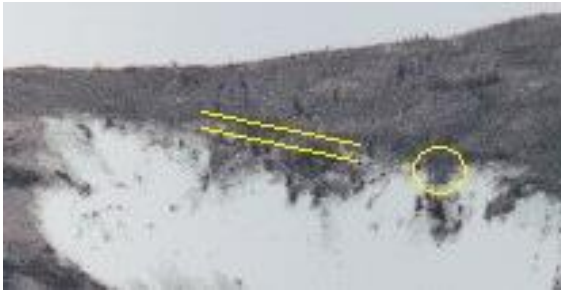
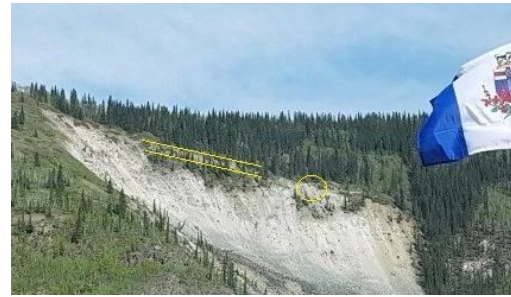
A comparison of photographs from 1904 (as noted in the Parks Canada Interpretative Kiosk located on the dike) and one taken during our assessment, shows how the headscarp has become more distinct above Beta, Gamma and portions of Alpha Blocks, likely due to disintegration of the vegetation and surficial cover which makes the headscarp more easily visible. While the lidar imagery suggests that the headscarp above Beta and Gamma Blocks is in the order of 20 meters in height, there does not appear to be perceptible movements relative to changes in their respective elevations when comparing the two photos. The disintegration of vegetative features is however clearly evident.

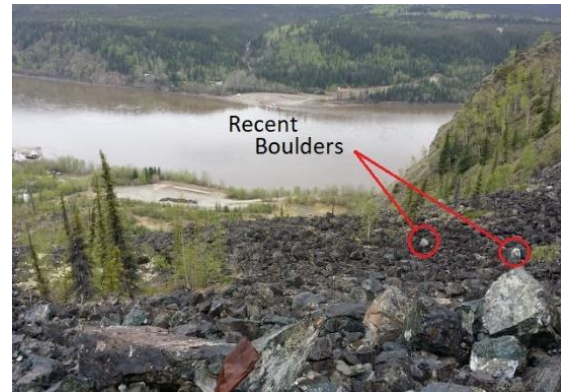
Recent boulders were noted a distance of ~ 150 meters up-slope of the mid-sections slip-face and approximately 430 meters from the shore of the Yukon River. Based upon the angle of repose of the contour data in this area, it appears that rockfall does not generally tumble further than this area (elevation ~ 450 meters).

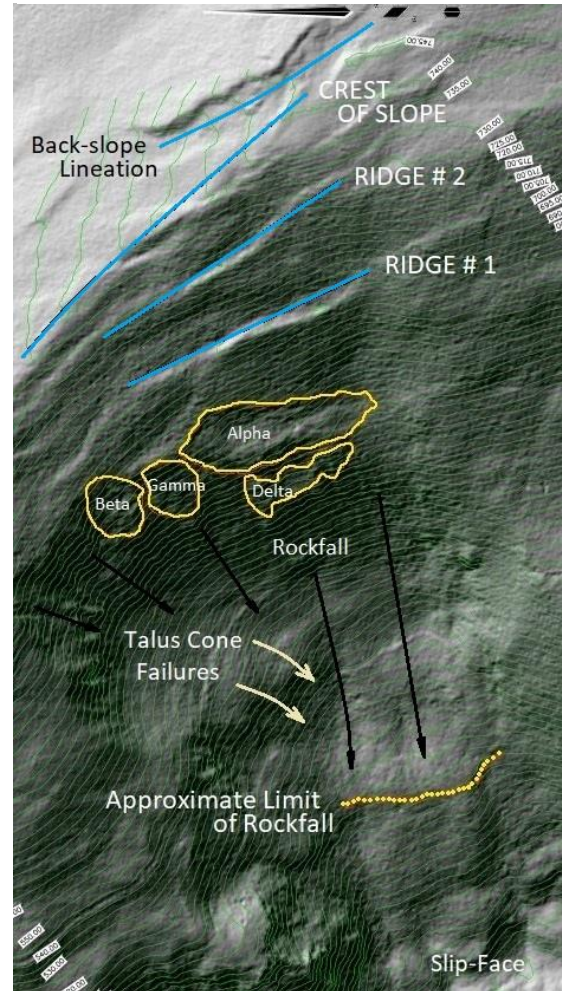
A lineation terrain feature located approximately 250 meters NNW of the Midnight Dome was assessed on May 22<sup>nd</sup>, 2017. This feature trended approximately north-west to south-east. The gully-like feature, which measured ~ 30 meters in width and was flanked by a 5 meter high ridge on its north side, directs local drainage towards the north-west. Although there was no sign of rock outcrops, the feature likely formed within the confines of an ultramafic discontinuity.

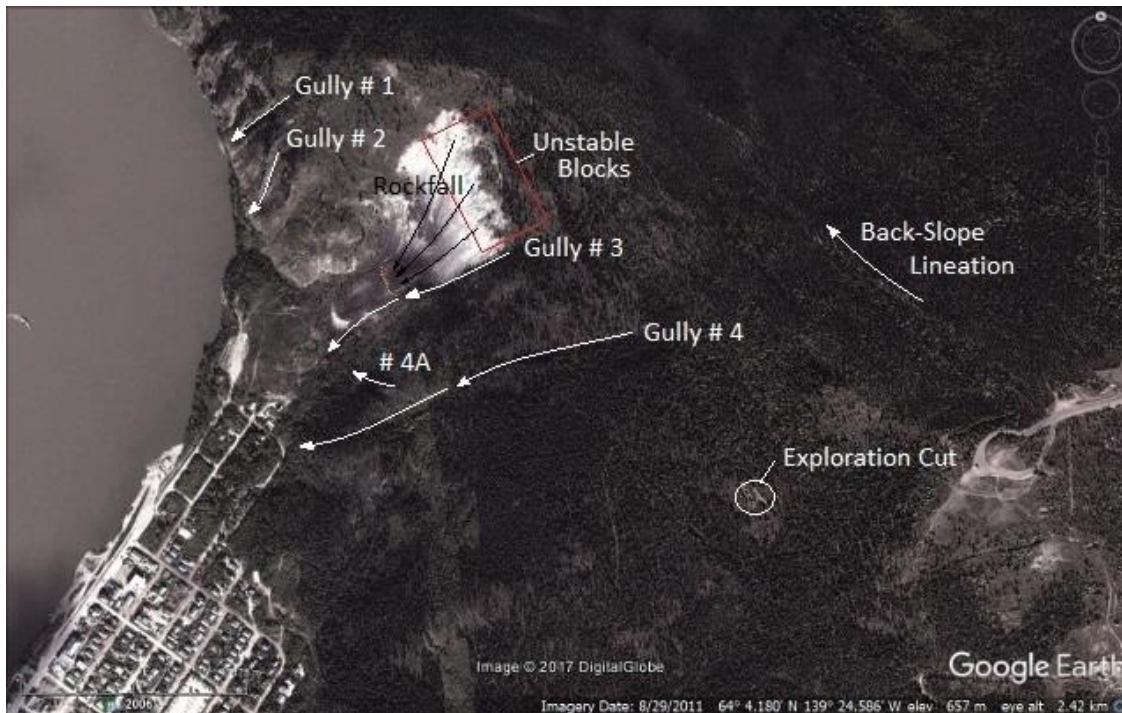
A series of erosion of gullies are located within and just north of the study area. Four of these gullies have been numbered in sequence from north to south in the figure noted below for reference purposes.

Gullies # 1 and # 2, which are located ~ 260 meters and 75 meters north side of the slide debris, respectively (as measured along the Yukon River), show signs of active rockfall as debris fans are present at their base. Rockfall from Gully # 1 discharges into the Yukon River while rockfall debris from Gully # 2 terminates on a sliver of alluvial deposits. Local residents (living on Albert Street) indicated that they had heard the sound of rockfall originating from these gullies in mid-May, 2017. They described the sounds of boulders plunging into the Yukon River and indicated that the event spanned the course of 15-20 minutes.

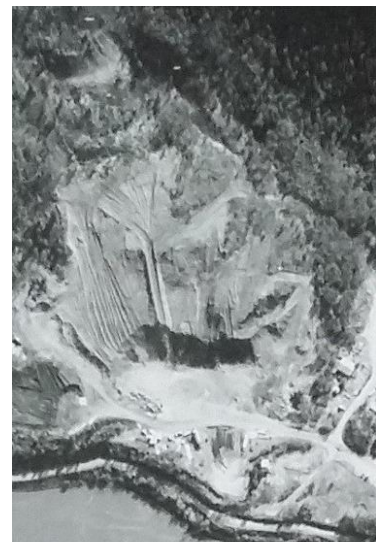
One of the roads located at the toe of the slide (noted in 1951 to 1987 airphotos) has since been covered by slide debris. As the road is clearly visible in the 1987 airphoto when the quarry appears to have already been closed (as evidenced by the presence of a series of

*1984 Airphoto noting quarry operations*

boulders which were established at the toe of the recontoured slope), it appears the road has become covered as a result of the ongoing movement of the slide. The rate of movement of this northern lobe of the slide debris is likely quite high relative to other regions as surface and groundwater are concentrated in this area due to morphological constraints.

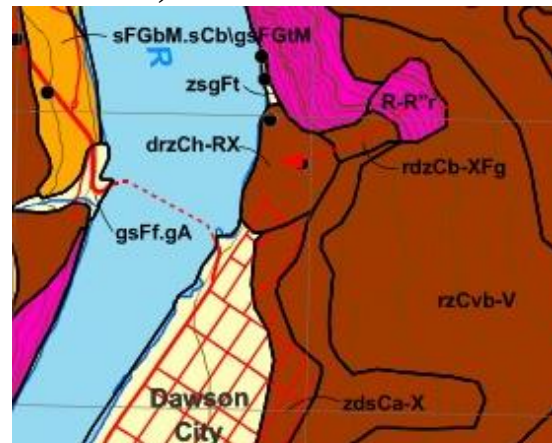
Figure (above) from Surficial Geology Map (File 2014-12)

The map described the deposits within the study area as being comprised of colluvial and fluvial materials. Both types of materials are geomorphologically modified through various mechanisms such as erosional, fluvial, mass movement and/or periglacial processes such as cryoturbation and permafrost processes.

Colluvial Slide Deposits (drzCh-RX) which are hummocky and comprised of mixed fragments, rubble and silt materials which are ‘transported by down-slope, gravity-driven processes such as creep, solifluction, landslide and snow avalanches’. Permafrost is widespread throughout these deposits.

Colluvial Apron Deposits (zdsCa-X) which are comprised of silt, mixed fragments and sand colluvium. The surficial geology map describes colluvial aprons as being found on lower gentle slopes where slower mass wasting processes such as sheetwash, solifluction and creep occur. These regions are commonly fine-grained and ice-rich. Permafrost is widespread.

Colluvial Fan and Apron Deposits (rCfa) which are comprised of colluvial rubble. As these deposits are found on moderate slopes, the material is ‘generally derived from weathered bedrock and loess, resulting in a silt-rich diamicton containing angular, local bedrock clasts’.

Fluvial Plain Deposits (szgFp-X) which are comprised of sands, silts and gravels. These materials have been deposited by modern rivers and are subject to frequent flooding. Permafrost is widespread throughout these deposits.

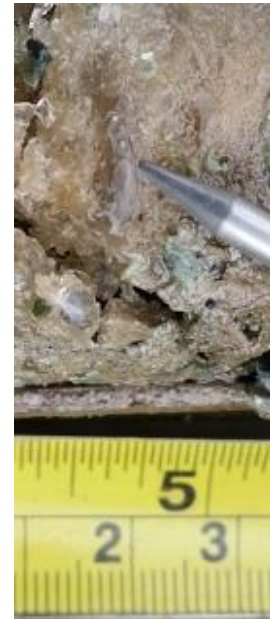
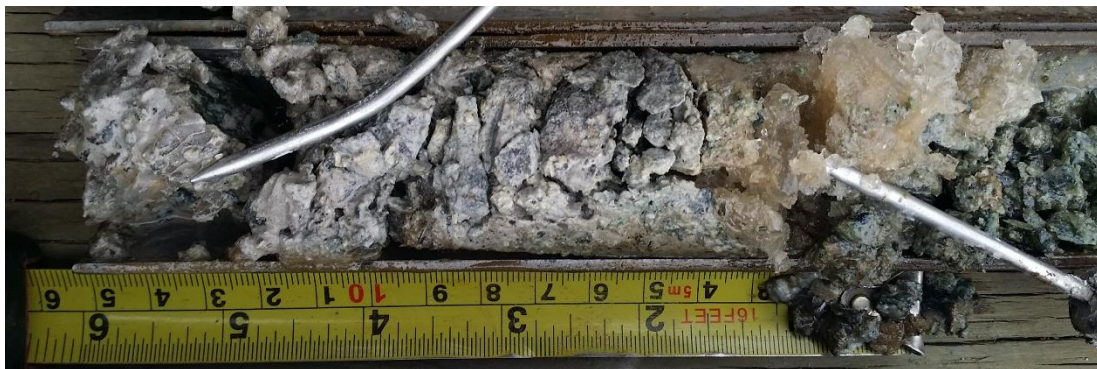
BH 6-17 - Sample No.60 - Depth = 14.94-15.15 meters

- 25 mm of highly fractured green serpentine rock which overlay,
- 30 mm of light brown (silty) granulated ice which encased a 3 mm thick by 13 mm wide lens of clear ice, which overlay,
- 125 mm of light grey fractured rock interspersed with light grey (silty) ice with some rock particles coated in up to 3 mm of clear ice.

USCS = GM (Silty Sandy Gravel)

Moisture Content = 23.0 %    Silt = 22.4%    Sand = 18.1%    Gravel = 59.5 %

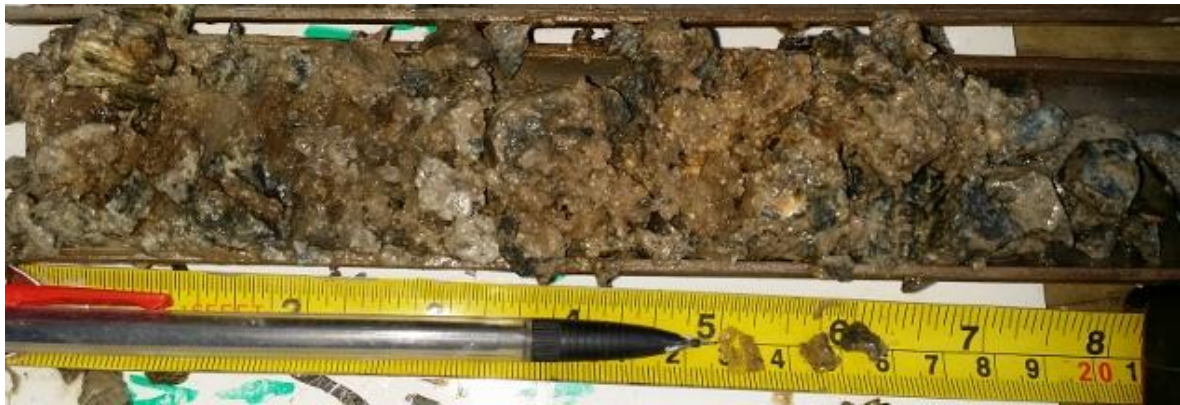
80 mm of highly fractured green serpentine rock which overlay,  
50 mm of light brown (dirty) granulated ice and fractured serpentine rock  
which encased clear ice lens which measured in size to 5 mm, which overlay,  
30 mm fractured serpentine encased in clear and dirty granulated ice, over  
50 mm of light grey fractured rubble.

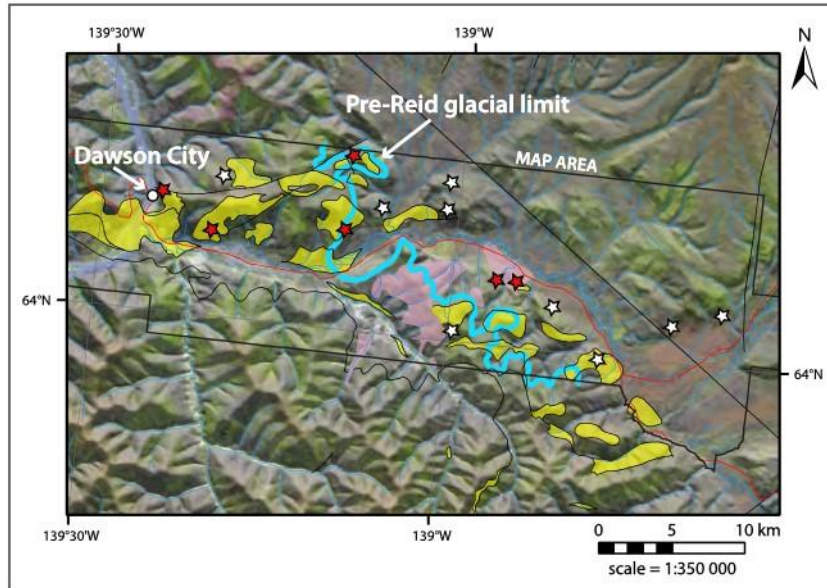
In the case of Moosehide Slide, the primary reason for failure was due to the presence of weak ultramafic rocks. As such, it’s important to characterize regional occurrences of ultramafic rocks relative to the distribution of slope failures. These occurrences

**Figure 45.** Map area illustrating ultramafic Slide Mountain terrane rocks (yellow), volcanic rocks (pink) and landslides (stars). Red stars indicate deep-seated bedrock slides; and white stars are small landslides, and landslides in glacial moraine material.

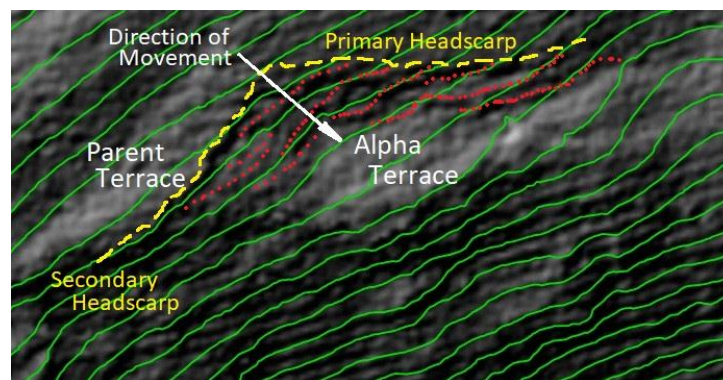
As per Moosehide Slide, Alpha Block appears to have a similar headscarp configuration, having both a primary and secondary scarp feature. The Alpha Block terrace feature appears to have propagated approximately 15 meters (in elevation) downslope from the parent terrace where it originated. Fragments of parent material appear to successively separate from the Alpha Block terrace (at 5 meter intervals) as it pulls further away from the parent terrace area. These features and the possible direction of movement have been noted in the figure noted below;

Subtle remnants of failure features, which extend to elevations above the recognized headscarp can be noted above the parent terrace in the lidar topography.

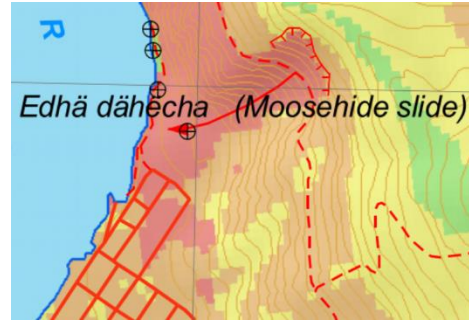
Figure (above) from  
*Dawson Natural Hazards Planning study*

The Dawson Natural Landscape Hazards – Geoscience Mapping for Climate Change Adaptation Planning prepared by the *Northern Climate ExChange* noted the hazard risk for the 3<sup>rd</sup> Avenue area as being high. This was likely due to the presence of steep terrain which was once in a state of heavy erosion, particularly during the Gold Rush Era when it was deforested.

This region appears to have since stabilized through natural revegetation. As such, our assessment did not identify any hazard beyond those identified in Section 5.4, that would preclude development of this area so long as slope drainage is well controlled. Additional revegetation would assist in promoting the long-term stability of this region.

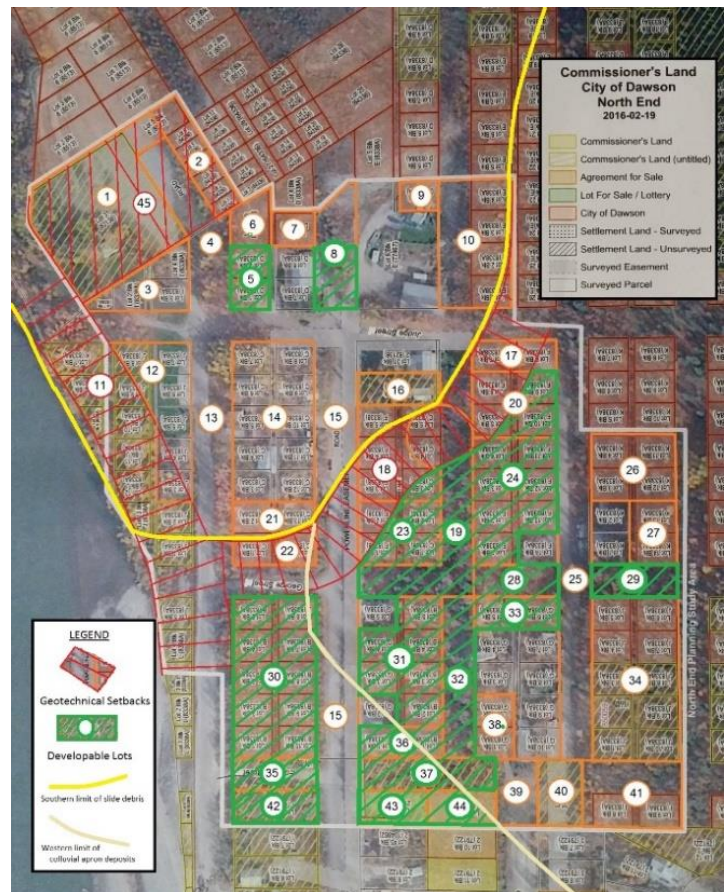
Figure 10 (above) from North End Subdivision  
Geotechnical Report

The geotechnical setbacks which were established in the North End Subdivision Report should be maintained. The locations of these setbacks (noted in Figure 10 of the report) were established in three primary zones described as Areas 11, 18 and 45.

These geotechnical setbacks should be observed to allow for a factor of safety from potential long-term geotechnical hazards related to the proximity to the Yukon River (Area 11), higher rates of slope movements (Areas 11 & 45) and potential discharge from Gully # 4 (Area 18). A reduction in the width of Area 18 (from 30 meters to 15 meters) could be considered so long as the drainage ditch through this region maintains adequate capacity to accommodate peak flows and storm events. The design criteria period (ie 1 in 100 year event, etc.) should be increased for design purposes. The use of an impermeable liner should be considered so long as it is covered with rock to reduce its thermal impact upon the underlying permafrost. The use of an exposed black liner is not recommended.

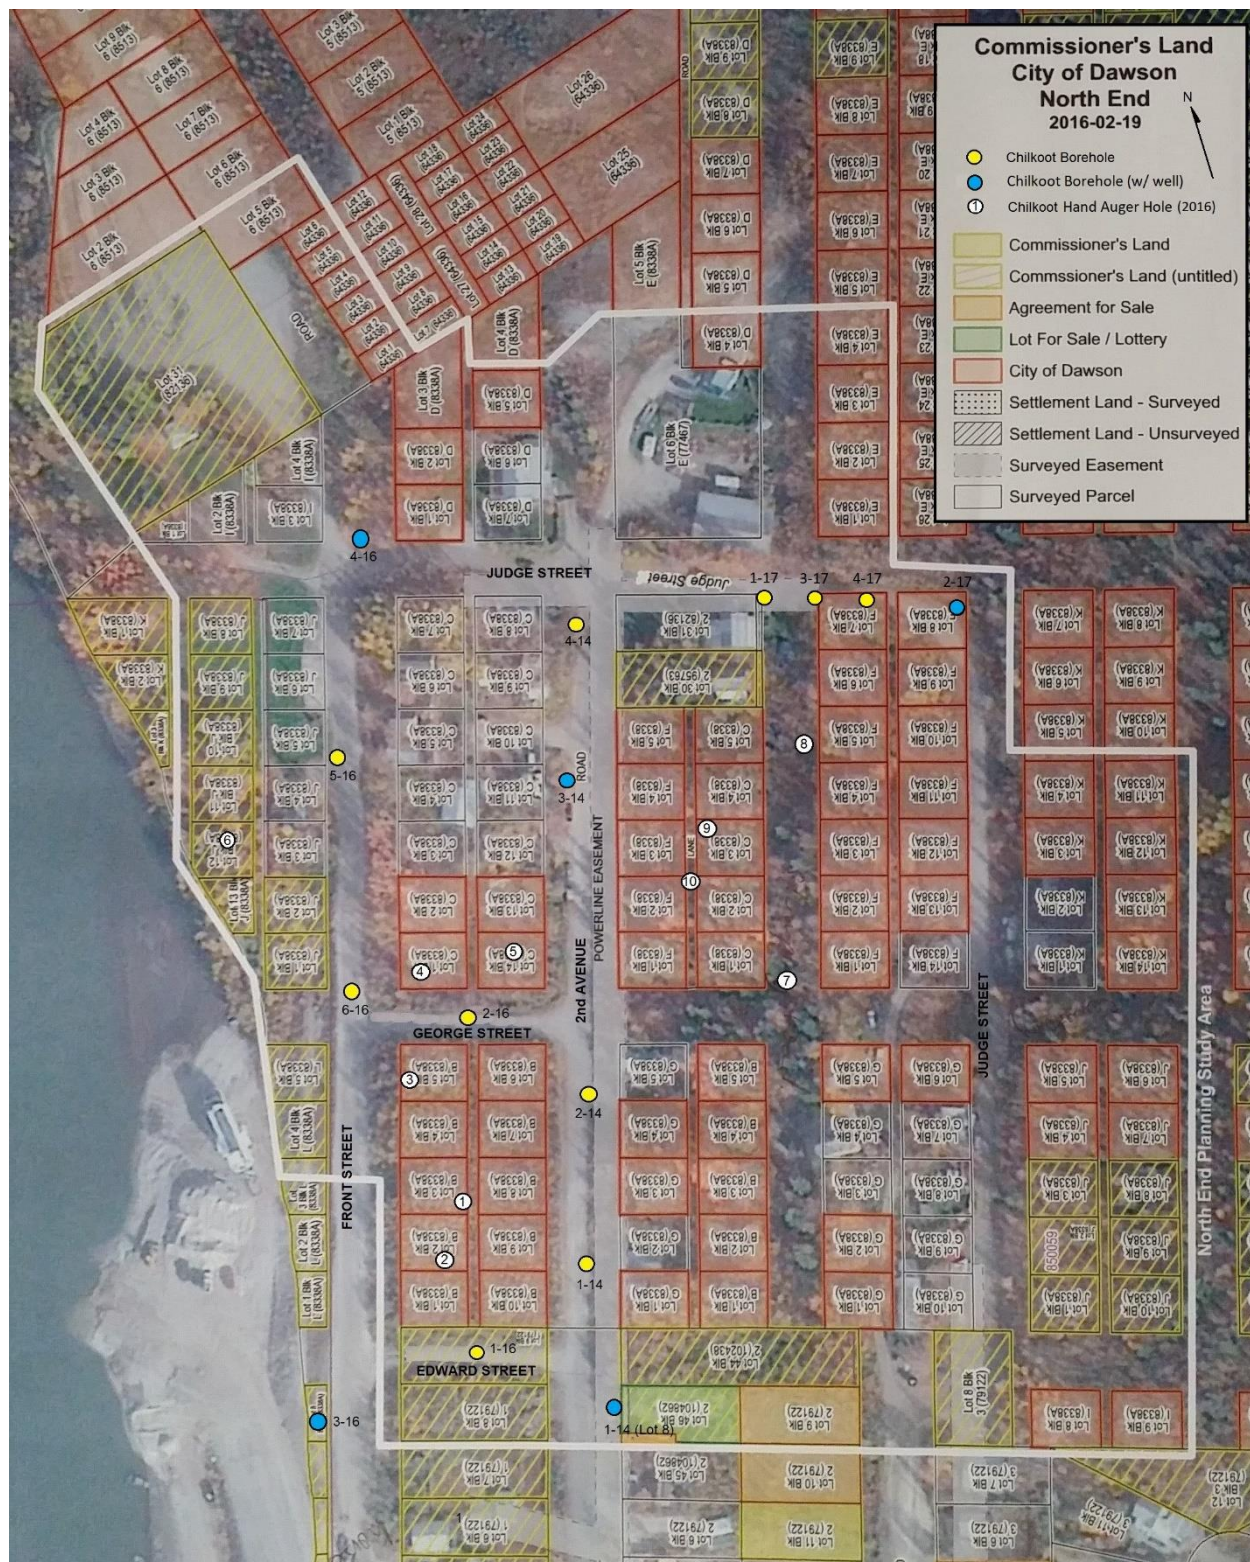
Figure 2  
Borehole Locations

A number of internal reports which were prepared for YG-EMR were reviewed to re-evaluate the stratigraphy of boreholes which were previously advanced in the region of the slide. The locations of these boreholes have been illustrated on Figure 2.

The program was comprised of advancing five (5) boreholes (BH 1-17 to BH 5-17) utilizing both 150 mm Ø solid-stem and 200 mm Ø hollow-stem continuous flight augers. The augers were utilized to obtain soil samples and characterize the subsurface conditions. Boreholes BH 1-17 to BH 4-17 were drilled at the approximate locations noted in Figure 2. Borehole BH 5-17 was advanced through the slide rubble near the ERT line as noted below.
