**KLUANE TERRAIN
HAZARD MAPPING STUDY**

FINAL REPORT

Report
to
Yukon Land Use Planning Office

Thurber Consultants Ltd.
Vancouver, B.C.

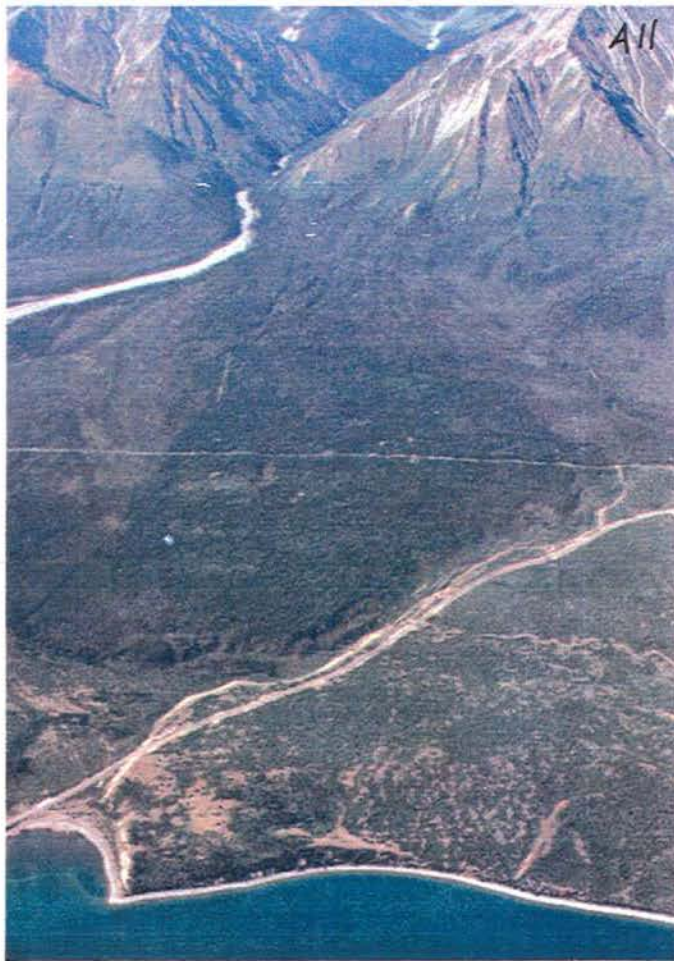
- Photo A-10 Helicopter view west showing large colluvial-alluvial fans just north of Williscroft Creek. Km 1722 and Congdon Creek alluvial fan is at lower center. Flank of this large fan extends upwards to the right. Note the steep, gullied alpine basins above each fan and lack of evidence for significant debris activity in the 1988 storms. 07/.89
- Photo A-11 Helicopter view southwest showing the enigmatic Congdon Creek deposits in the dark area extending toward Congdon Creek and the mountain front. Note the old pipe line strikes directly across the rocky surface of this feature. The Highway avoids it in the foreground. Congdon Creek is at the upper left. 07/89.
