February 19, 2016

ISSUED FOR USE
FILE: W14103698-02
Via Email: brian.crist@gov.yk.ca

Subject: Slope Stability Assessment
km 195 Robert Campbell Highway, YT

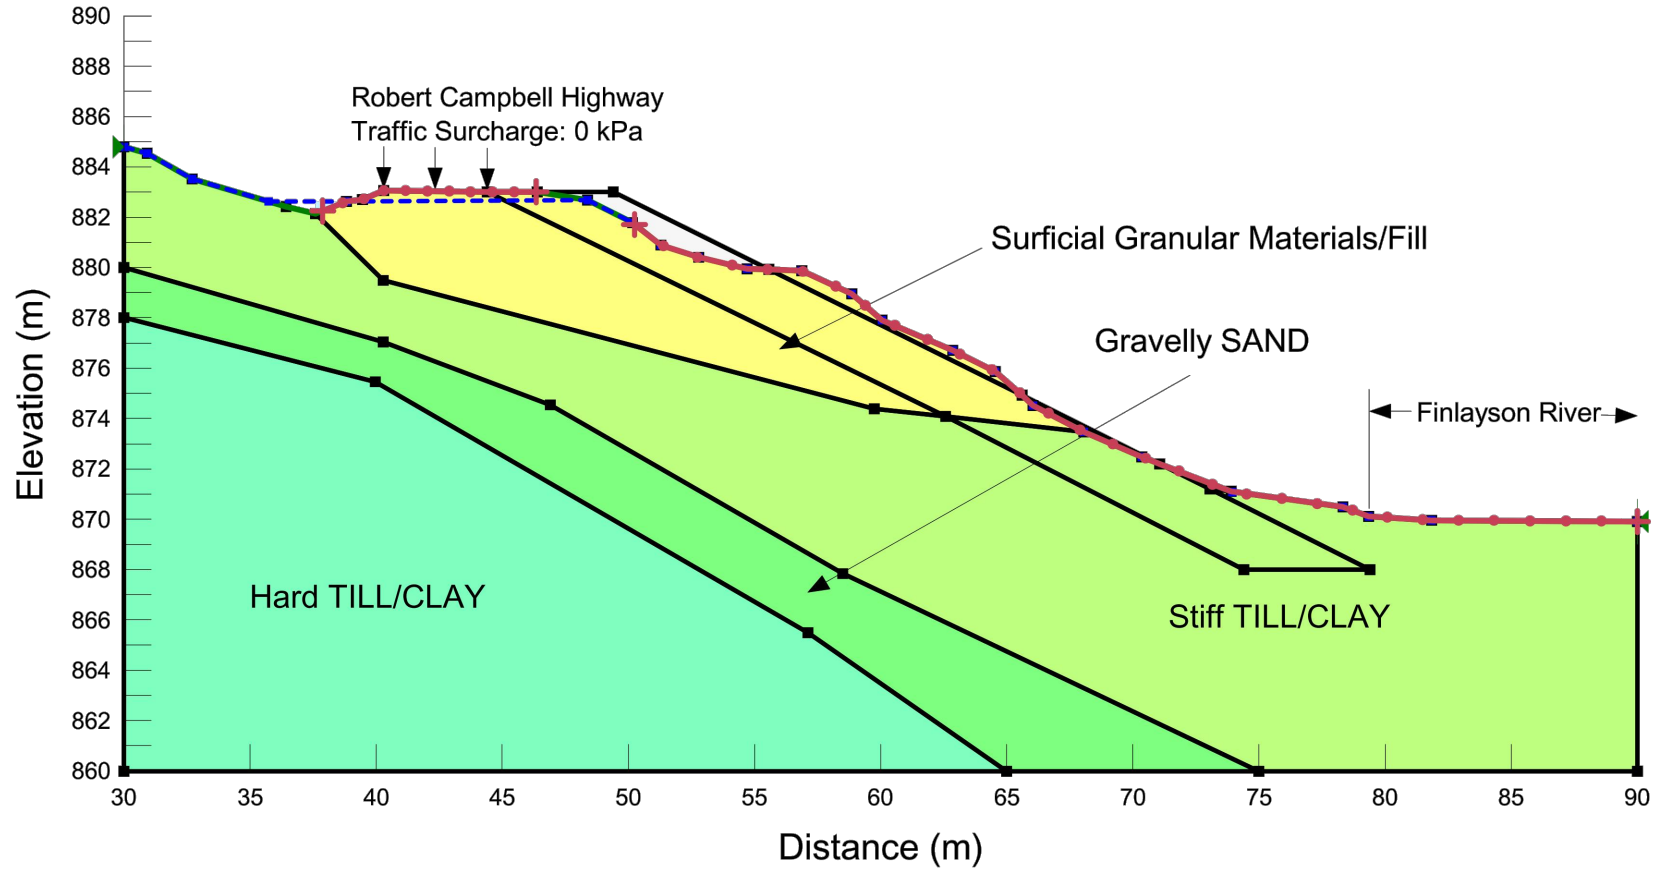
Figure 3

The Slope/W model used in the analysis is shown in Figure 3, for elevated groundwater conditions.

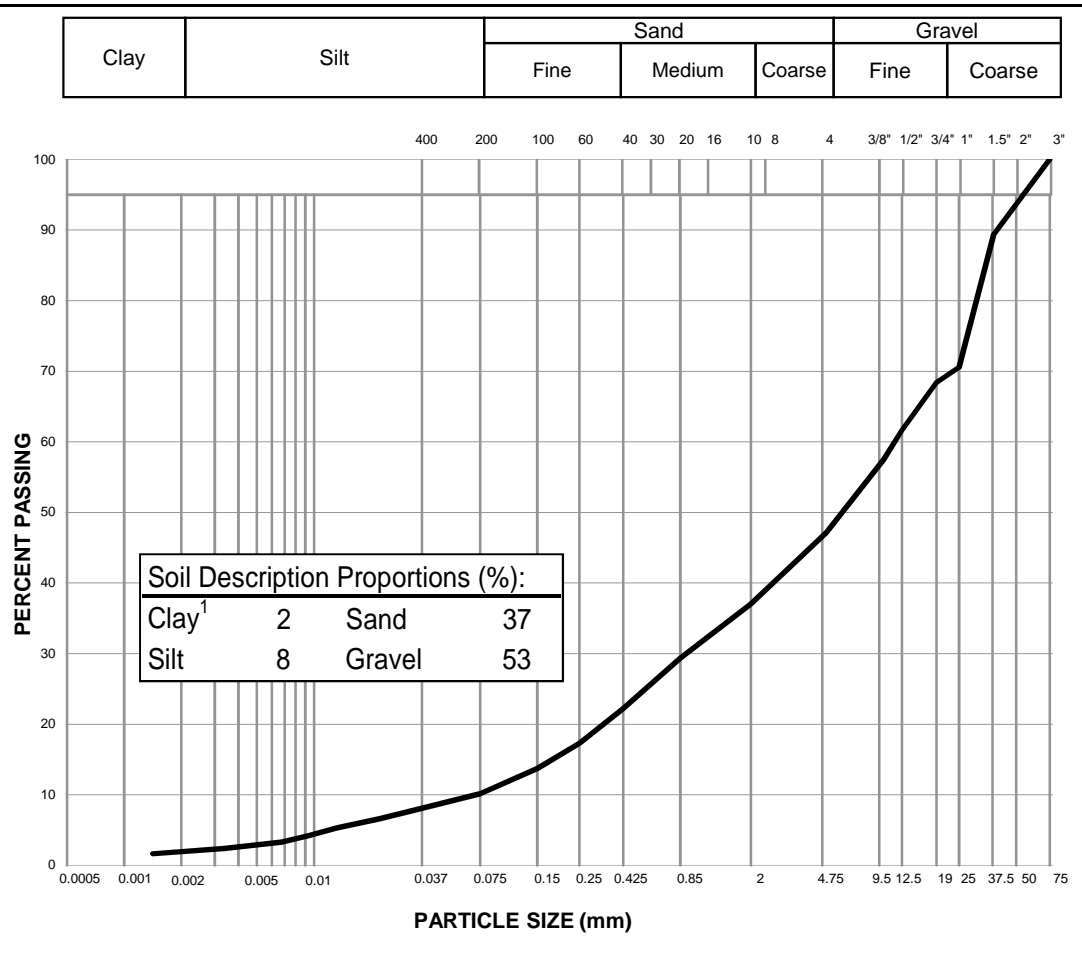
Project:	Slope Stability Assessment	Sample No.:	SA03
Project No.:	W14103698-01	Material Type:	
Site:	km 195 Robert Campbell Highway	Sample Loc.:	BH01
Client:	YG - Highways and Public Works	Sample Depth:	2.1 m
Client Rep.:	Brian Crist	Sampling Method:	Grab
Date Tested:	October 29, 2015	By:	AMT
Date Tested:	October 29, 2015	Date sampled:	October 5, 2015
Soil Description ² :	GRAVEL and SAND - trace silt, trace clay	Sampled By:	AW
Moisture Content:	3.5%	USC Classification:	GW-GM Cu: 158.9 Cc: 1.1

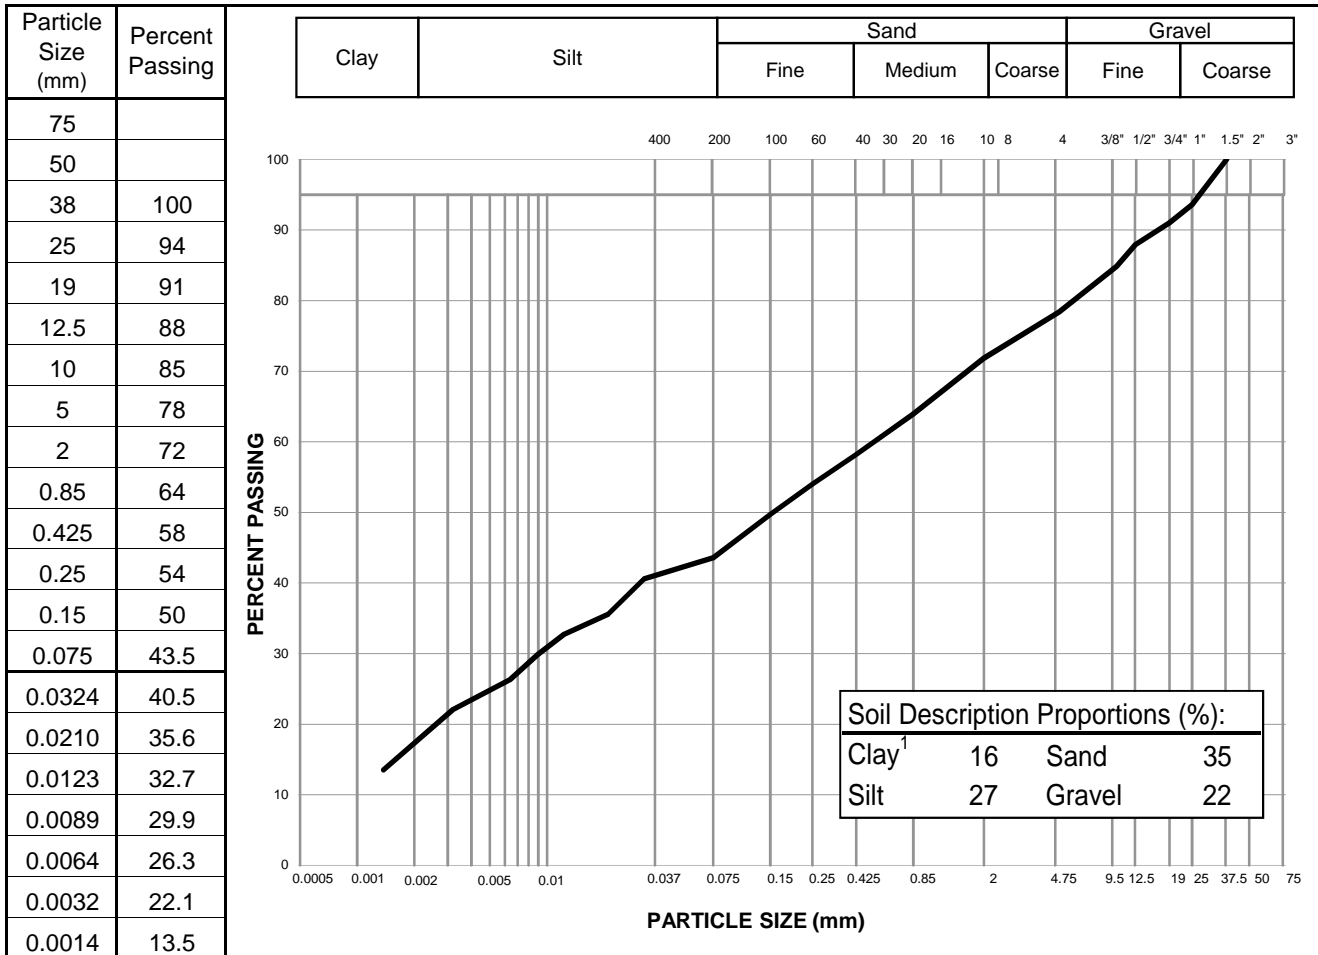
Project:	Slope Stability Assessment	Sample No.:	SA24
Project No.:	W14103698-01	Material Type:	
Site:	km 195 Robert Campbell Highway	Sample Loc.:	BH02
Client:	YG - Highways and Public Works	Sample Depth:	4.3 m
Client Rep.:	Brian Crist	Sampling Method:	Grab
Date Tested:	October 29, 2015	By:	AMT
Date Tested:	October 29, 2015	Date sampled:	October 5, 2015
Soil Description ² :	SAND - silty, gravelly, some clay	Sampled By:	AW
		USC Classification:	SM Cu: #N/A
			Cc: #N/A

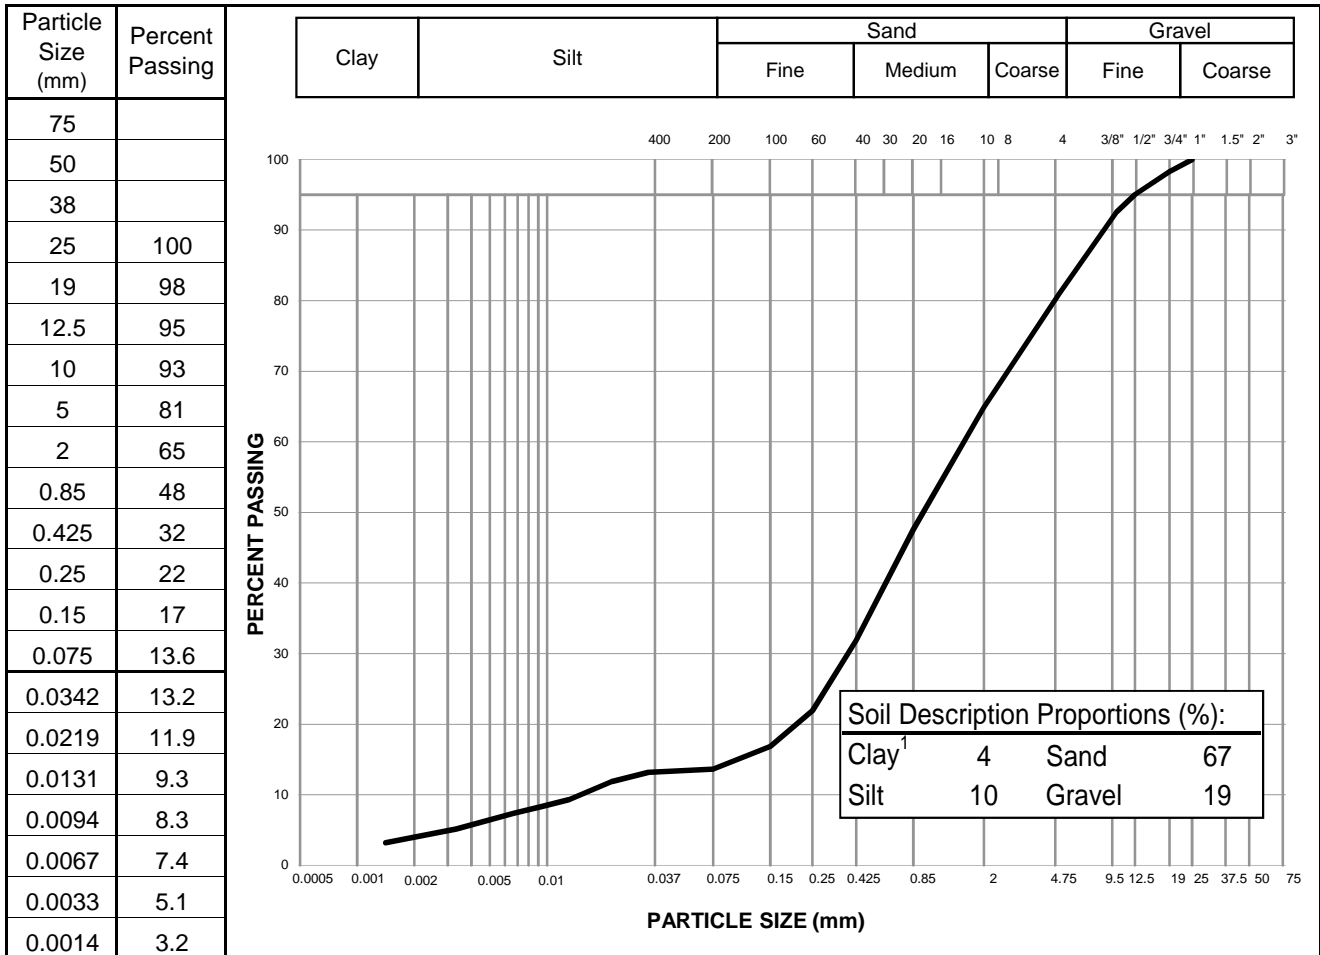
Project:	Slope Stability Assessment	Sample No.:	SA33
Project No.:	W14103698-01	Material Type:	
Site:	km 195 Robert Campbell Highway	Sample Loc.:	BH02
Client:	YG - Highways and Public Works	Sample Depth:	11.6 m
Client Rep.:	Brian Crist	Sampling Method:	Grab
Date Tested:	October 29, 2015	By:	AMT
Date Tested:	October 29, 2015	Date sampled:	October 5, 2015
Soil Description ² :	SAND - some gravel, trace silt, trace clay	Sampled By:	AW
Moisture Content:	9.4%	USC Classification:	SM Cu: 108.4 Cc: 5.9
