FILE: 2147-27-0

PROPOSED RIPRAP SOURCES
BLACKSTONE RIVER AREA
Km 139-145

DEMPSTER HIGHWAY

MAY 1989

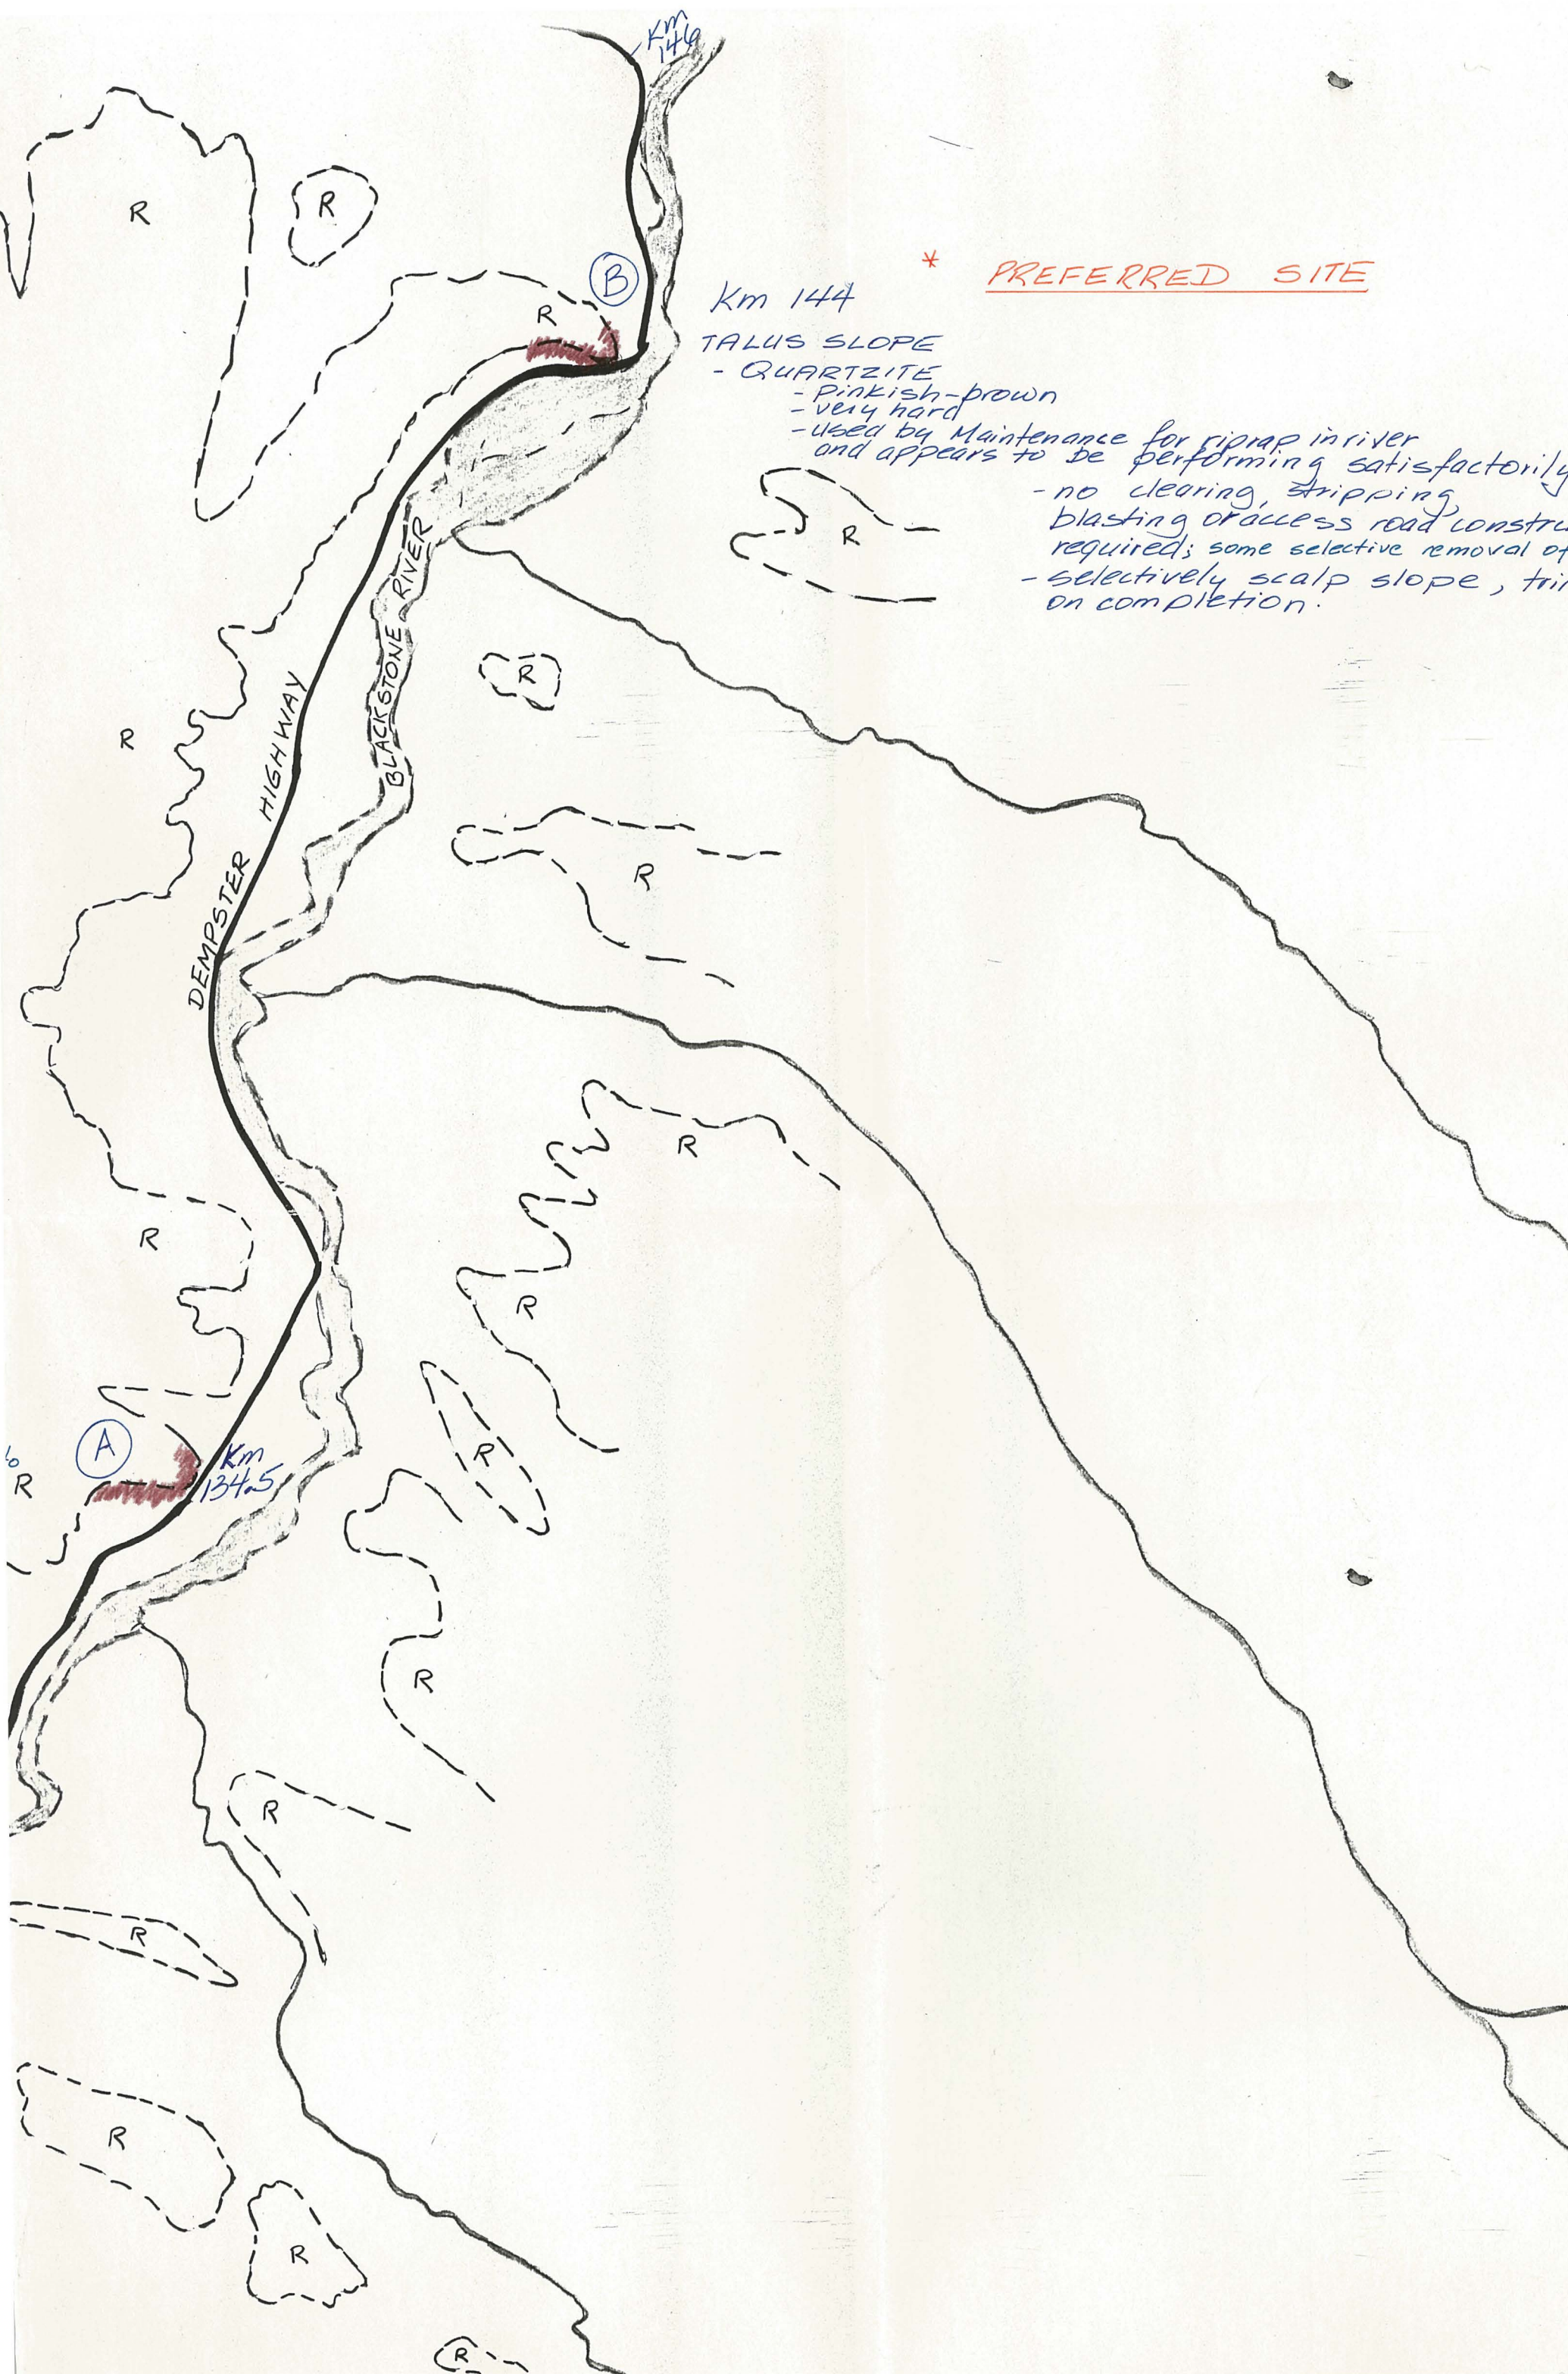
Km 144

This material is very hard, pinkish-brown quartzite. The largest sizes noted were about 800 mm equivalent diameter. See Photos 89-01-06 to 10 in Appendix A. The largest rock sizes tend to be slabby, although in general the particle shape is acceptable for riprap.

* PREFERRED SITE

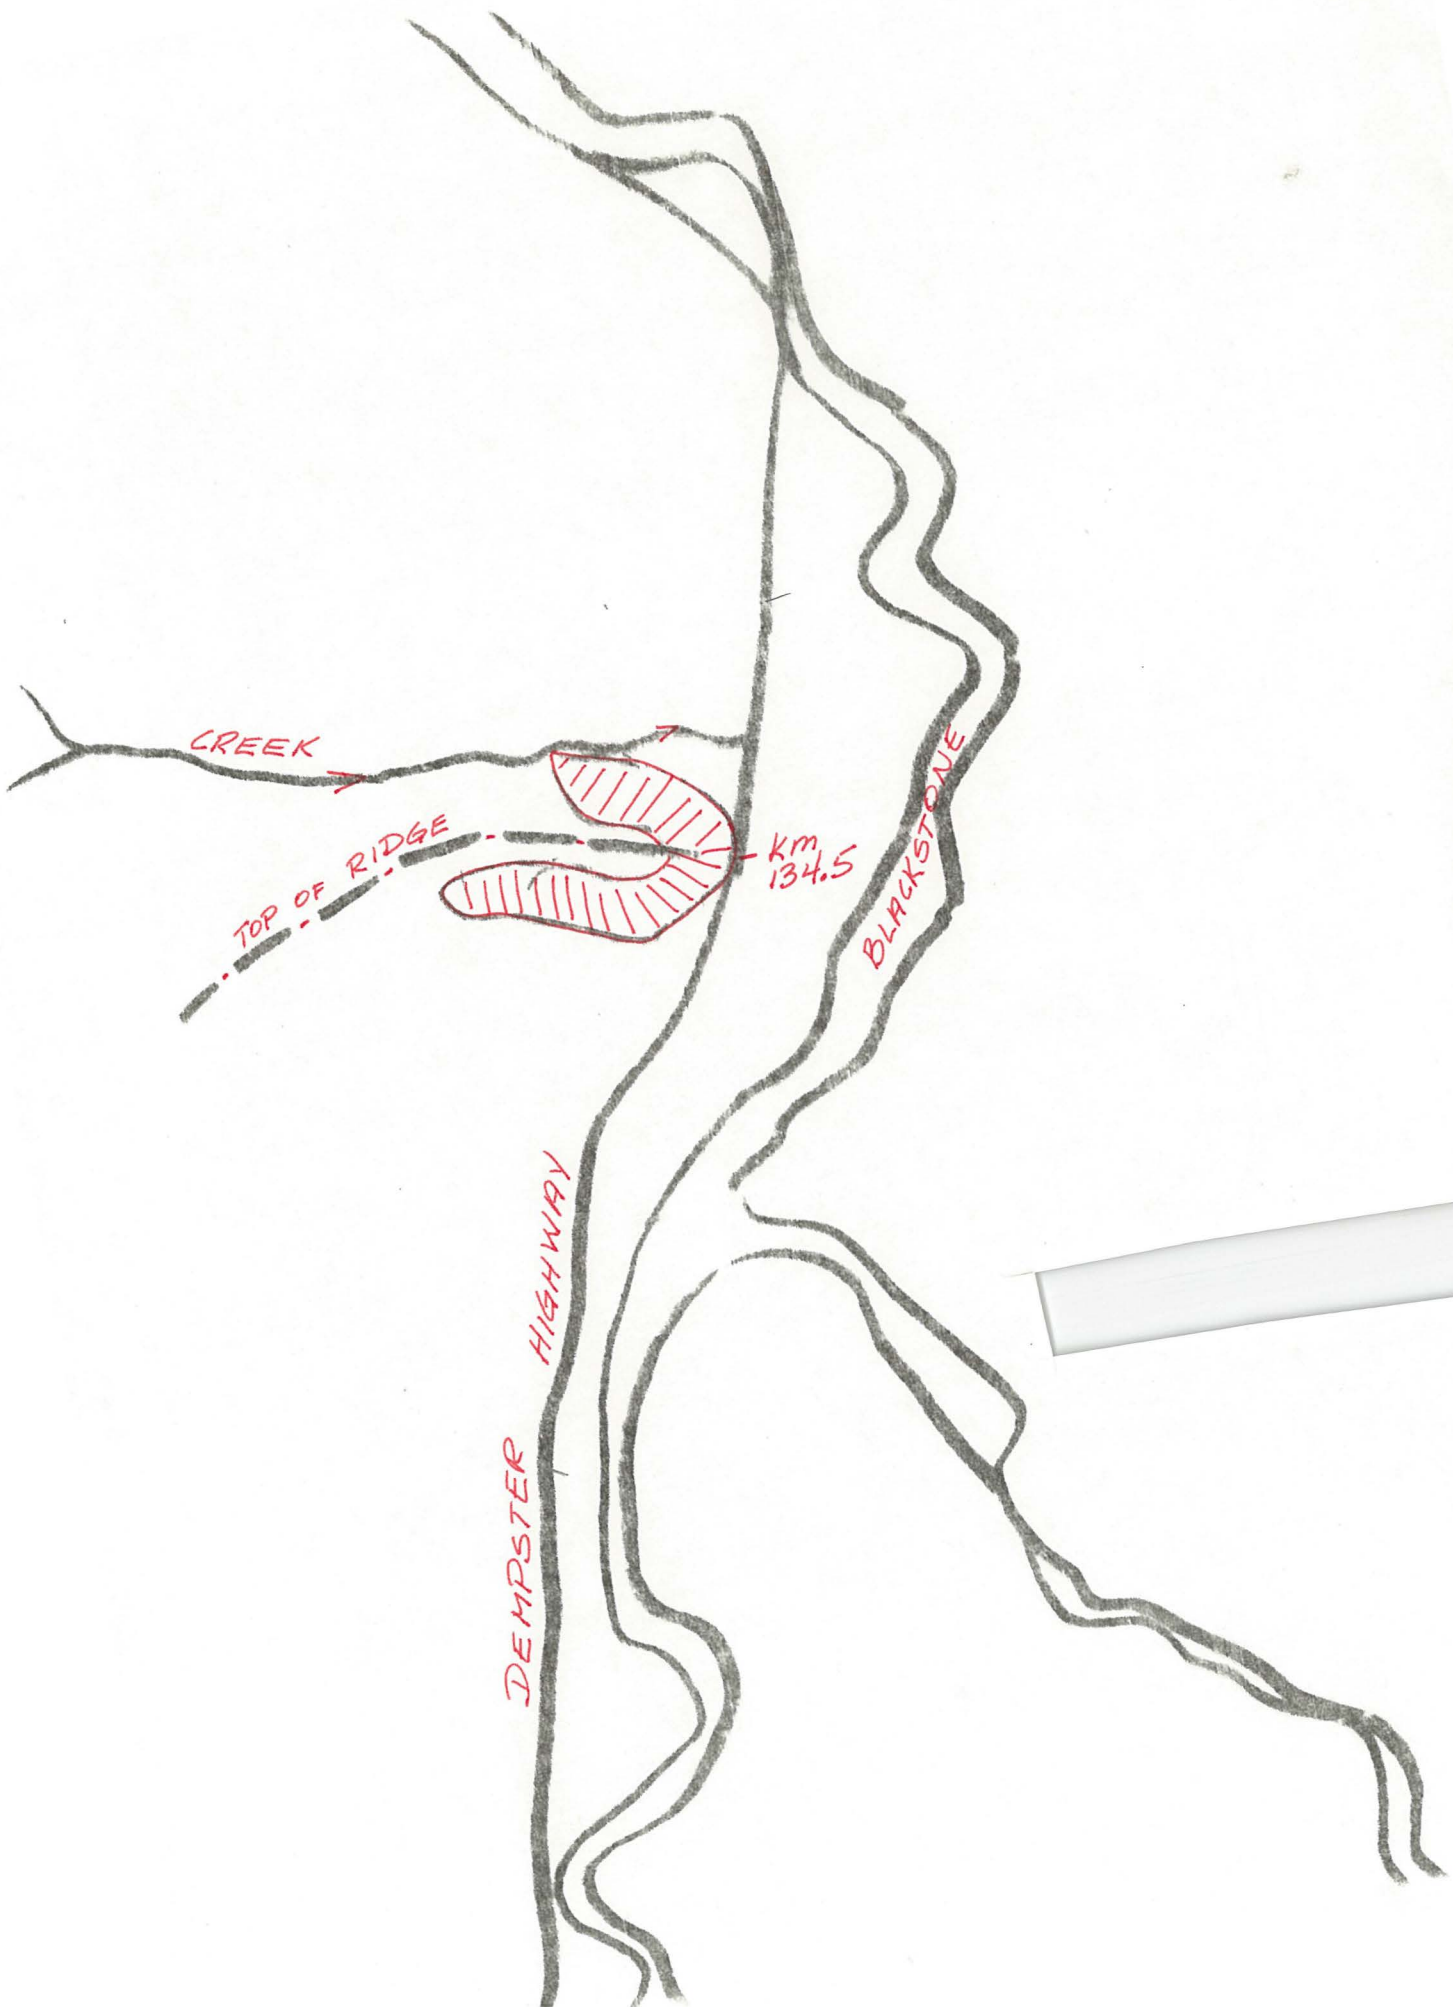
km
134.5

This source is shown on Photos 89-01-01 to 04 in Appendix A. The rock type is well-indurated, layered argillite with some weaker siltstone layers. The largest sizes noted were about 500 mm equivalent diameter. Because the rock is layered, it tends to break in asymmetric slabby and blocky pieces.

The rock type and particle shape is less than ideal, and the maximum particle size is less than the 800 mm specified for Class II riprap. However, as noted above, the material has been used by Maintenance forces for bank protection and channel works and has performed satisfactorily without noticeable deterioration in the installations I observed.

This is a well-developed talus deposit with a large slope area available for exploitation.
