INSTALLATION REPORT - PREPARED BY D.P.W.

Laid M. 237.2 - Dempster Highway  
Henderwood Industries Ltd.  
"Permabed" Test Section

PUBLIC WORKS  
CANADA

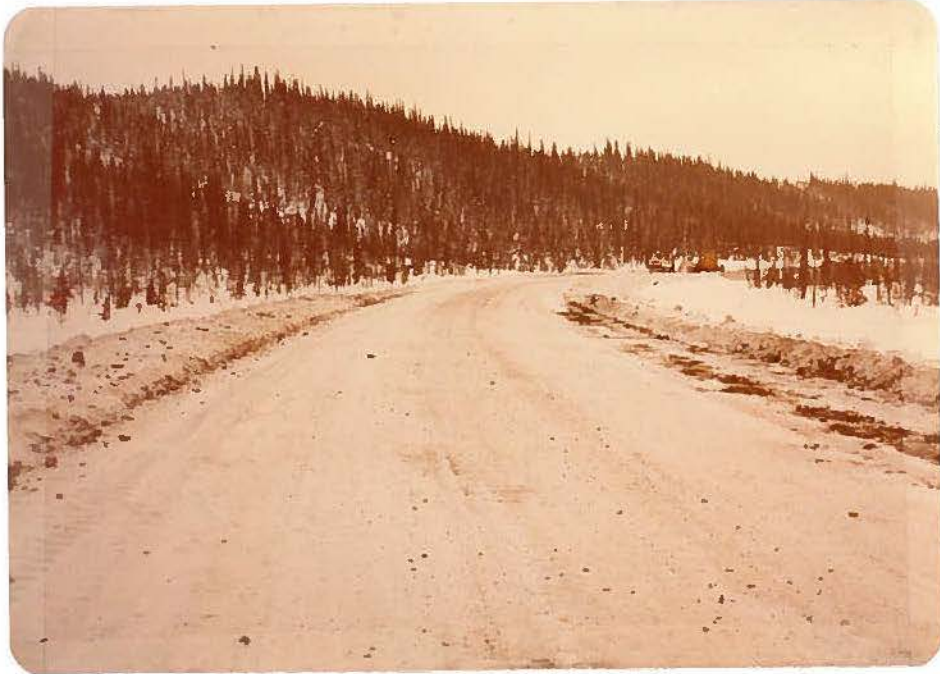
1. The insulation test section from Station 1021+00 looking east. The snow has been bladed off the surface in preparation for excavation.

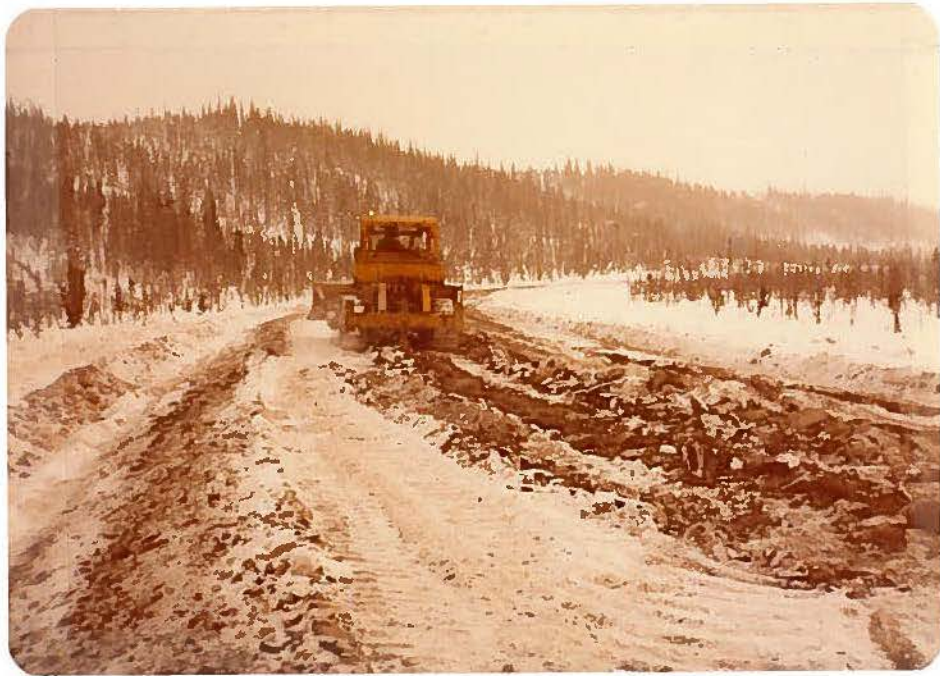
2. D/8 cat ripping Station 1020+00 to 1025+00 in preparation for removal of pad to within one foot of original ground.

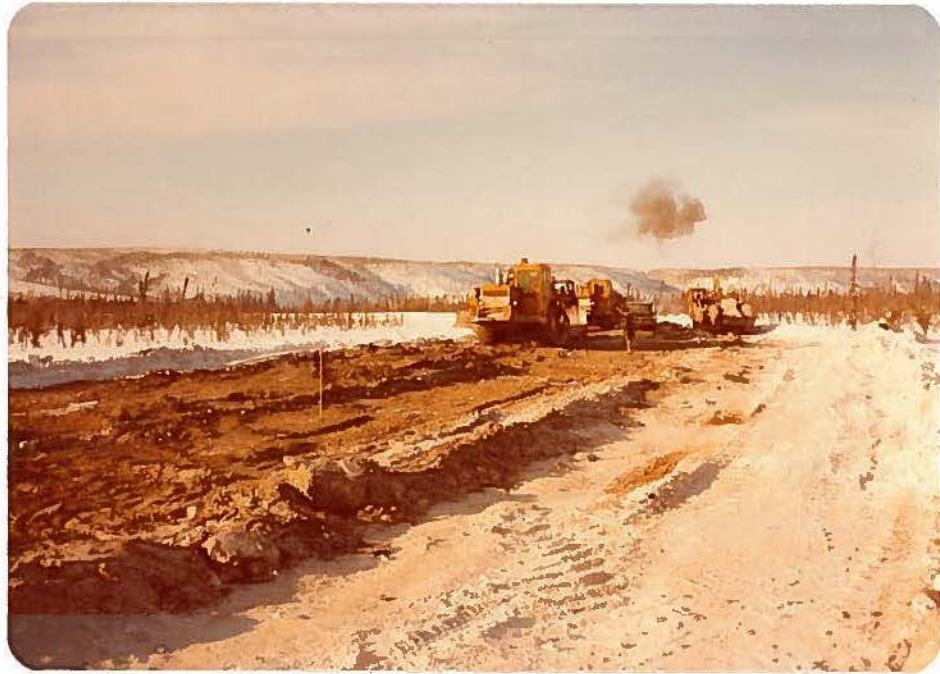
3. Excavation of test section using Cat 631-C scrapers. Photo taken looking west with the by-pass road, around the site, in the right foreground. The excavated material was stockpiled at the east end of the test section prior to backfilling.

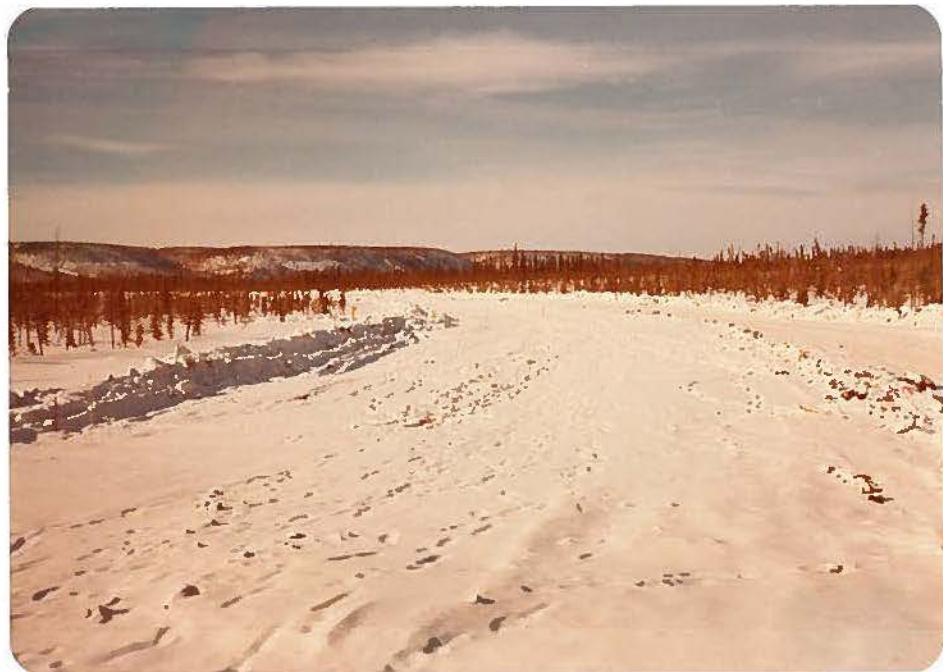
4. Test section after final blading in preparation for the foam sheeting. The sheeting was laid on the snow which had fallen after the blading.

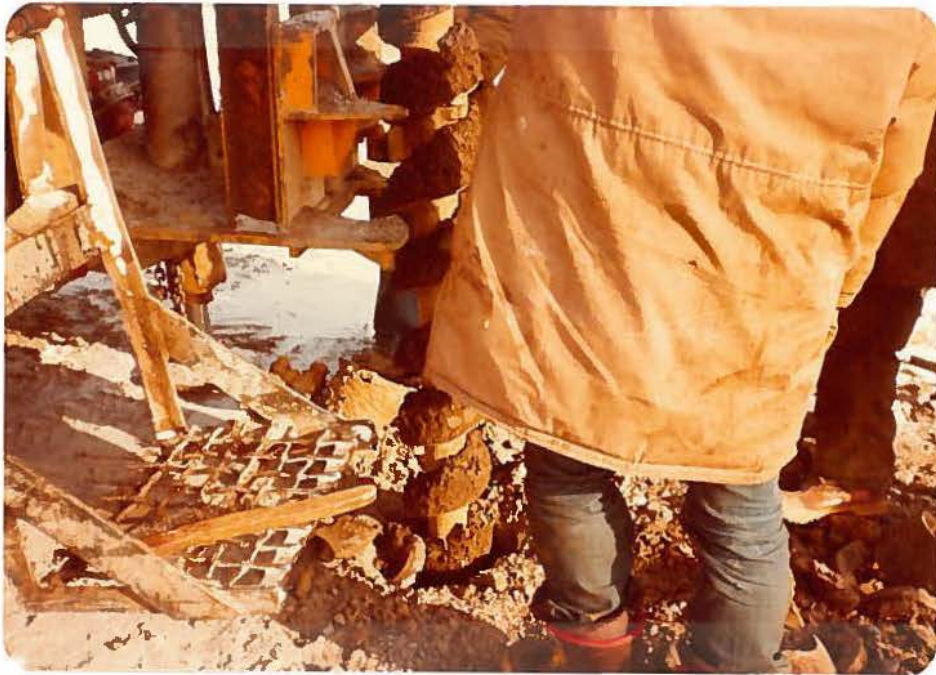
5. The D.P.W. drill crew taking a core sample at Station 1023+00.

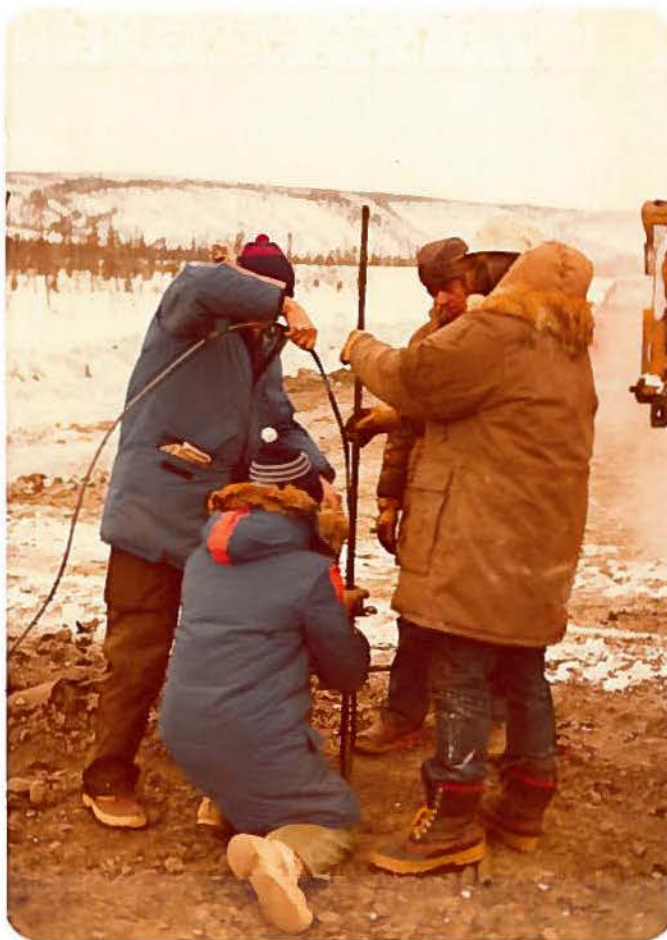
8. The installation of the monitoring system by NRC. The thermistor cables reach to a depth of about eleven (11) feet with thermistors at one to two foot intervals.

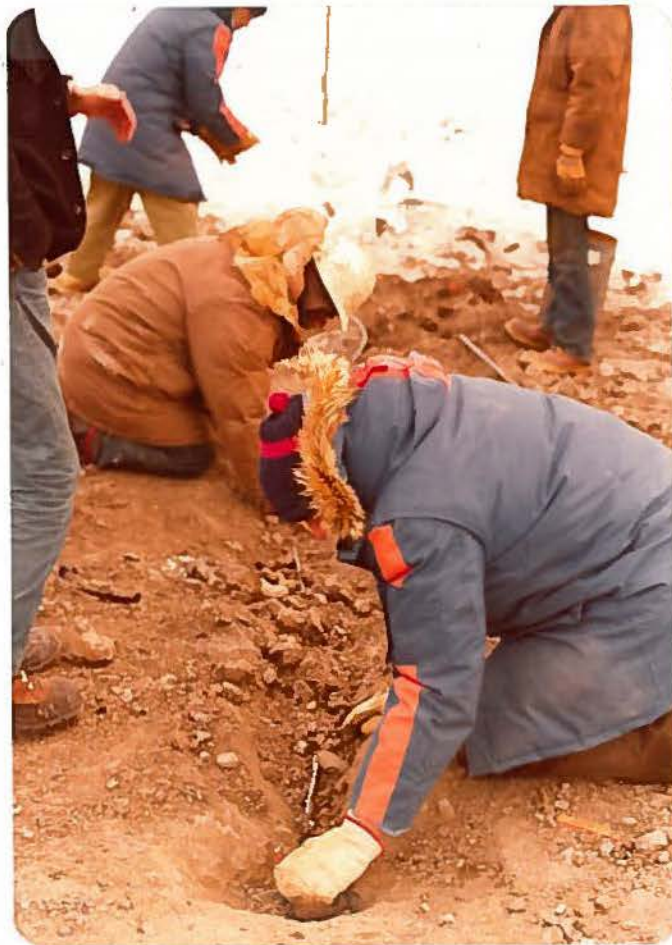
9. The thermistor cables were buried by hand to prevent damage. The top thermistor can be seen at the ground surface where it would rest at the bottom surface of the foam sheeting. The cable holes were back-filled with a dry sand.

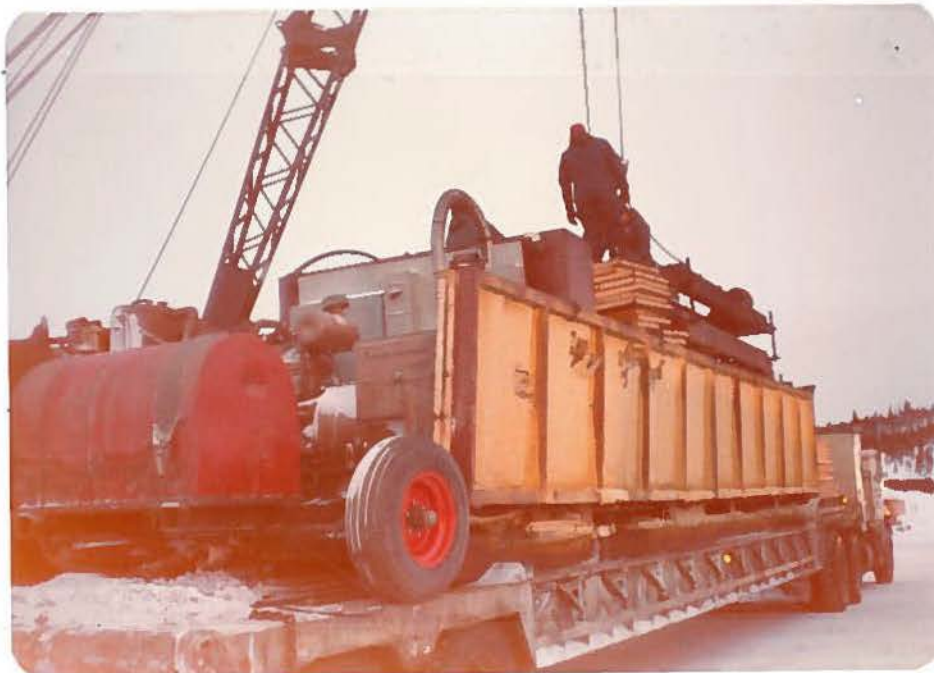
10. The foam producing machine being off-loaded from the transporting flatbed. The machine was being assembled as it was off-loaded.

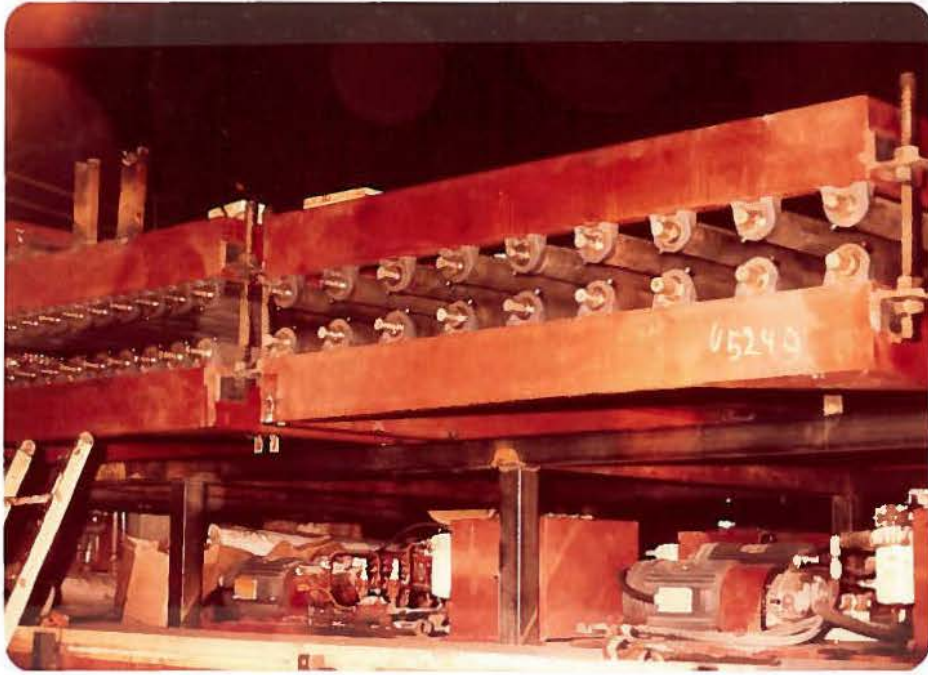
11. The interior of the machine. The two banks of rollers, that restrict the rising foam and form the sheet, can be seen. Beneath the rollers are the hydraulic systems which operate the entire machine.

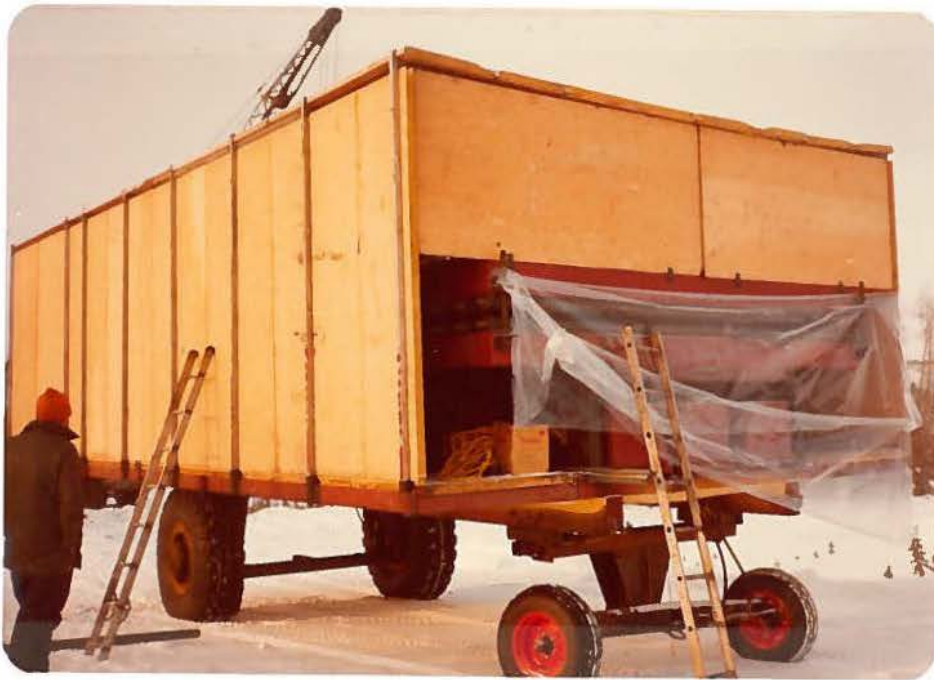
12. The assembled machine encased in urethane sheathing and plywood. Inside the final bank of rollers can be seen; beneath them are the hydraulic fluid reserves.

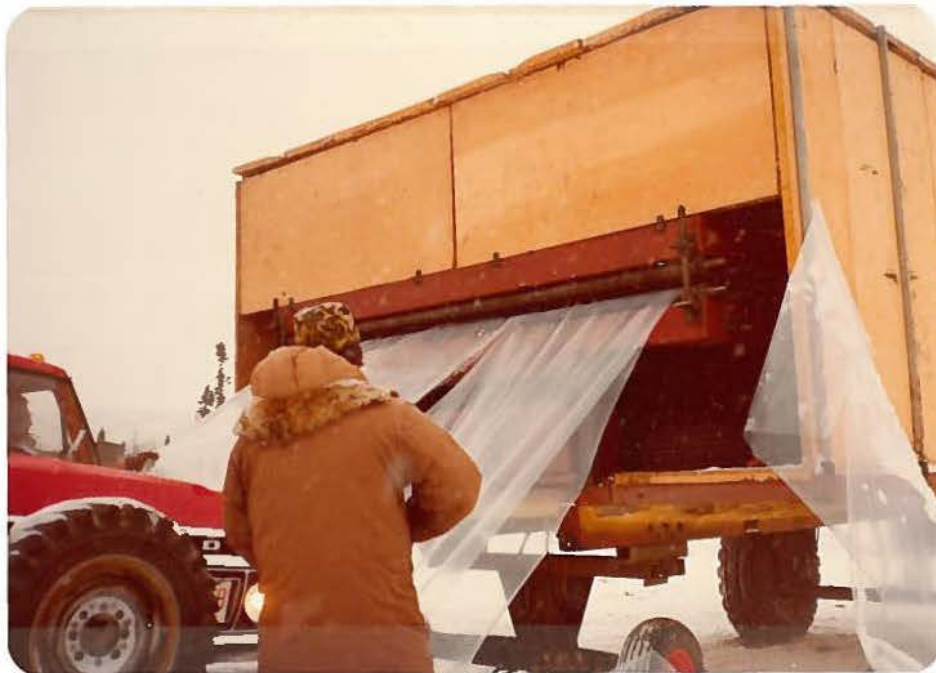
14. The polyethelene sheeting in place in preparation for production. The truck was positioned to prevent the sheeting from being dragged along as the foam was produced.

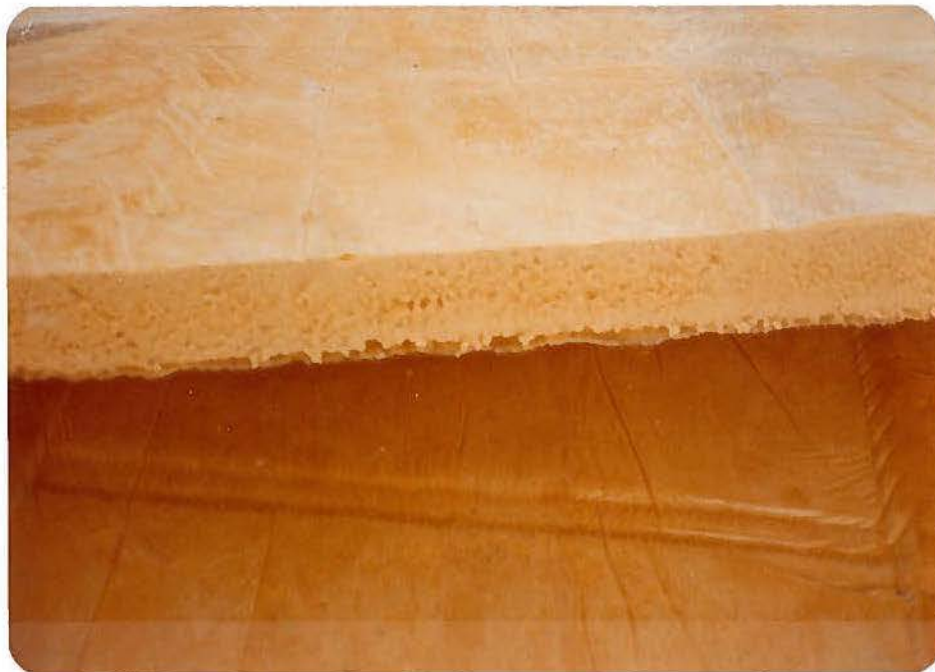
17. The porosity of the foam and the heat bonding of the polyethelene is seen in this cut off section of sheeting.

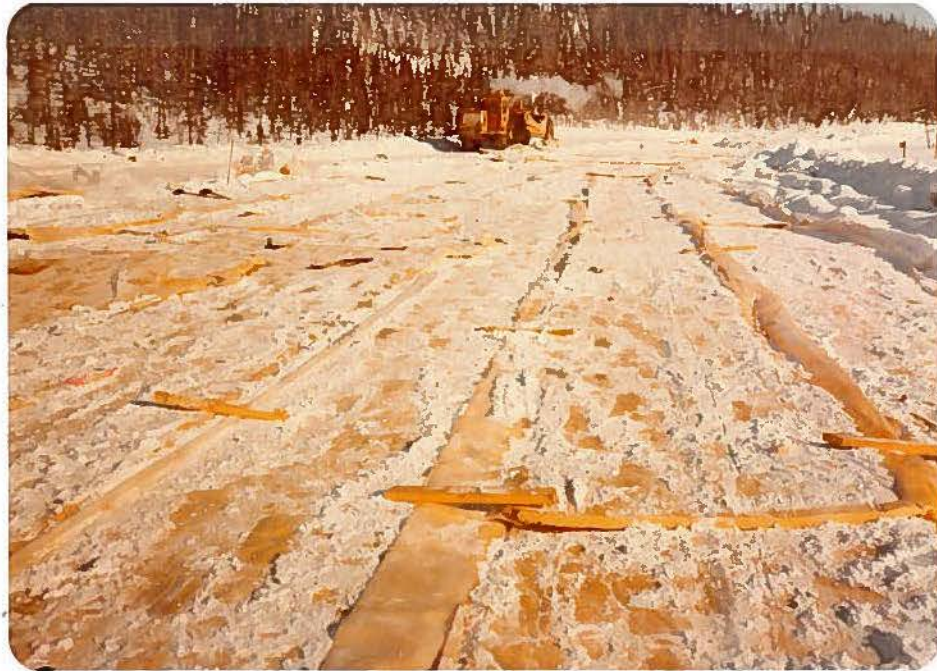
During the test run it had been snowing and thus the foam sheeting was layed over a thin layer of snow. It was found that the polyethelene when cold would slide around very easily. This greatly hampered the small scale backfill test. As the three short strips were being back-filled it is estimated they moved approximately 10 feet. To reduce the possibility of a reoccurrence with the final backfilling of the main portion of the urethane foam, the sheeting was nailed down with 8" spikes and wood scraps. This apparently solved the problem as no serious movement of the sheets was noted upon backfilling.

23. The insulation just prior to backfilling. The sheets have been attached together and also to the ground, with wood scraps and 8 inch spikes. This was a precaution taken to prevent movement of the sheets during backfilling.

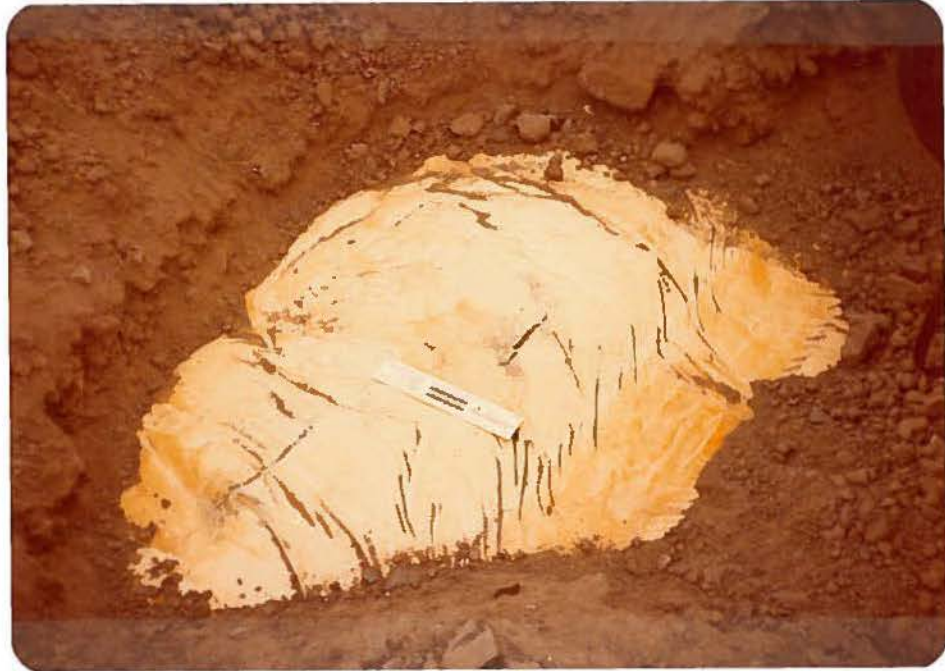
The polyethelene was not only intended as a form for the urethane, but also as a vapour-barrier since urethane is apt to absorb water, reducing its insulative properties. As a vapour barrier it was found that it tended to be weak in the lengitudinal direction and was subject to tearing. This was observed in the backfilling exercise carried out. Tension cracks were observed at both sections which were excavated after backfilling. It was also found that rocks in the backfill material could puncture the polyethelene reducing its efficiency. For this reason Henderwood suggested the backfill material be of 1" minus material to reduce the possibility of puncturing the polyethelene.

25. After the backfilling exercise two spots were randomly selected and excavated by hand to see if the vapour barrier had been punctured.

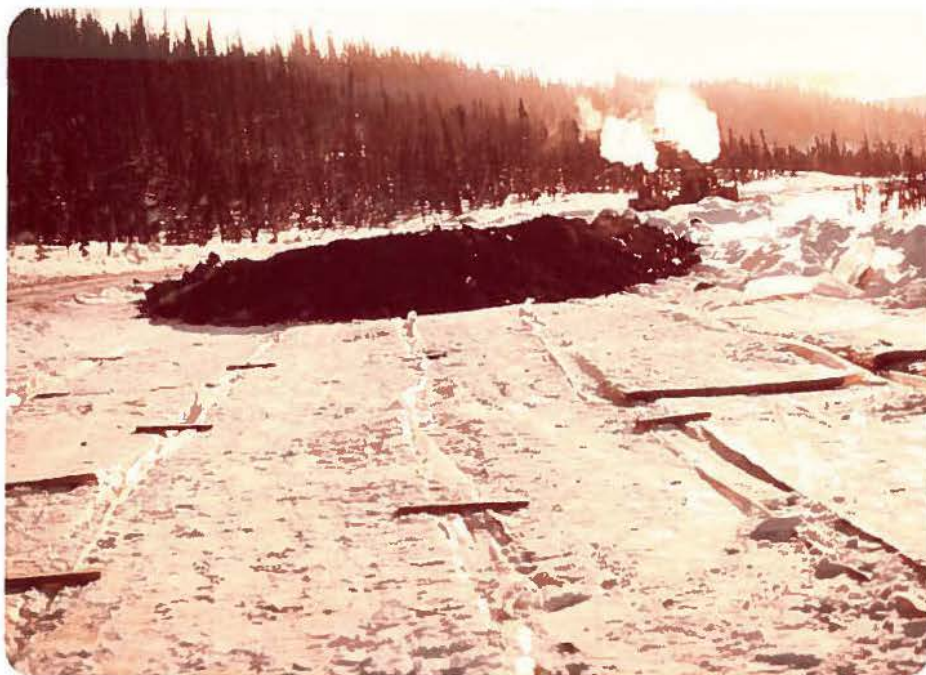
28. The final backfilling of the insulation was accomplished by pushing a two foot pad over the sheeting. The sheeting did not move during backfilling so it is believed that the tacking of the sheets was successful.

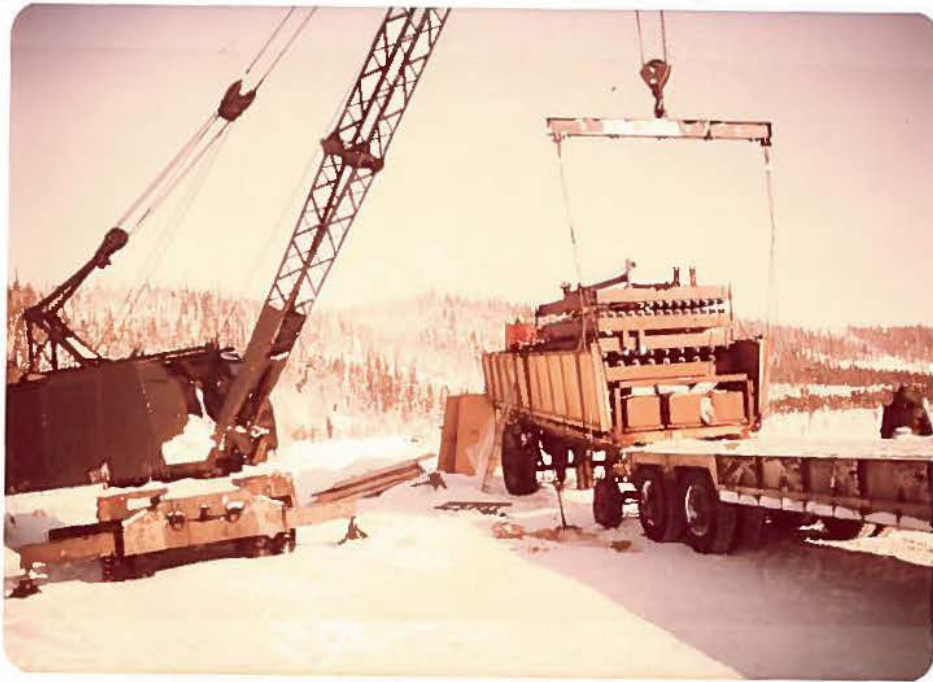
29. The loading of the machine was done at the test site with the aid of the Army's crane.
