**AIRPORT IMPROVEMENTS
DAWSON CITY AIRPORT
DAWSON CITY, YUKON
1998**

REPORT NO.: 8002-252

PROJECT: Airport Improvements

LOCATION: Dawson City Airport
Dawson City, Yukon

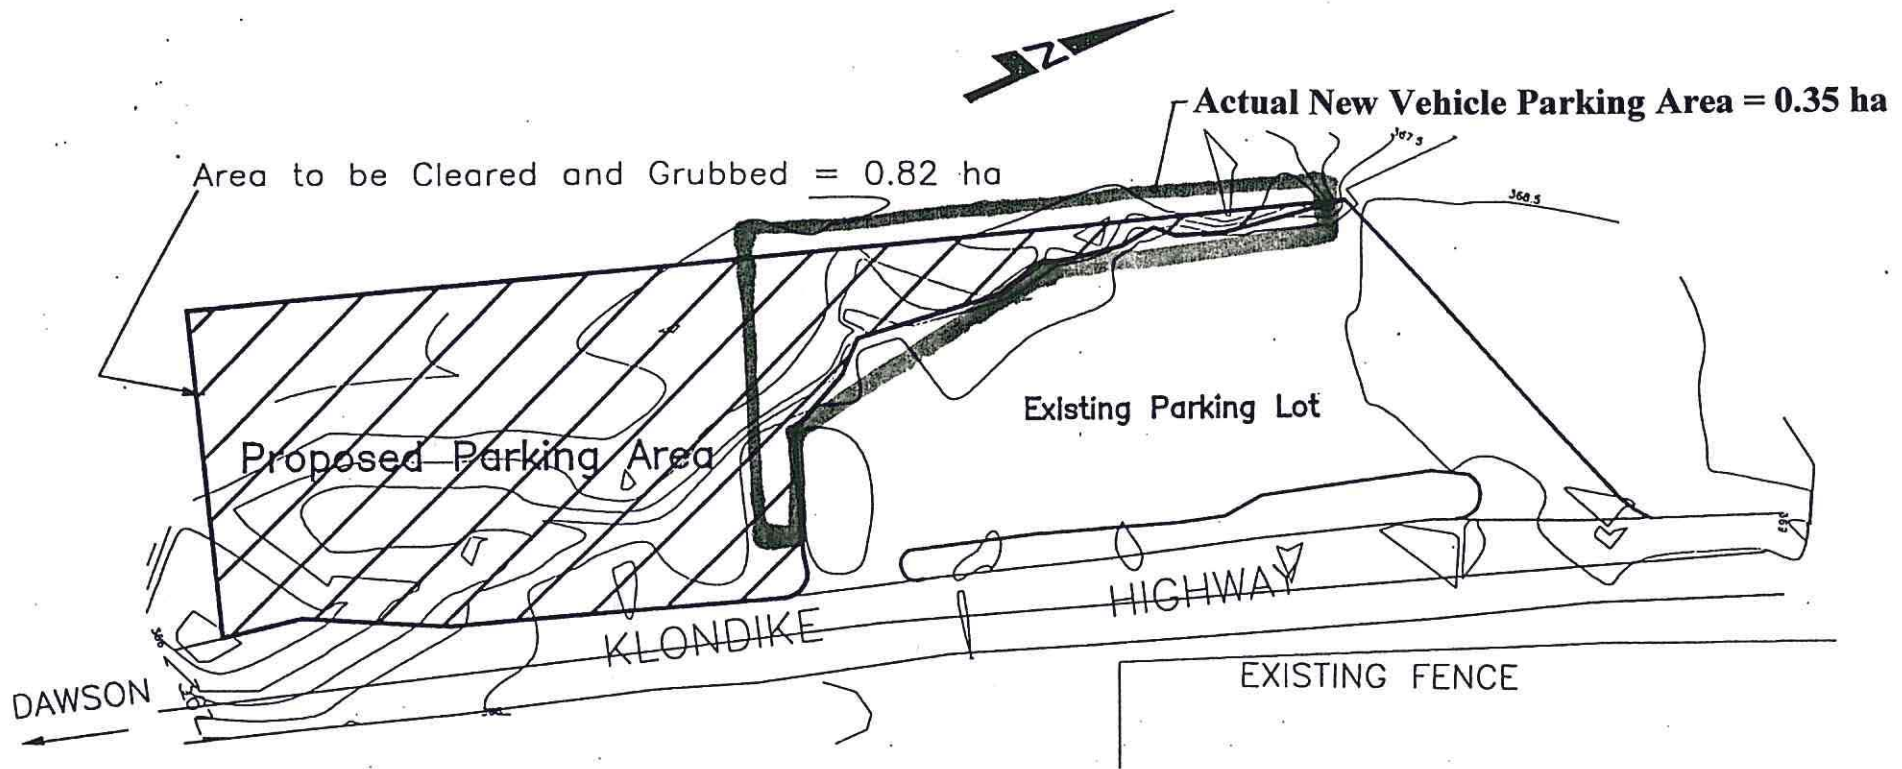
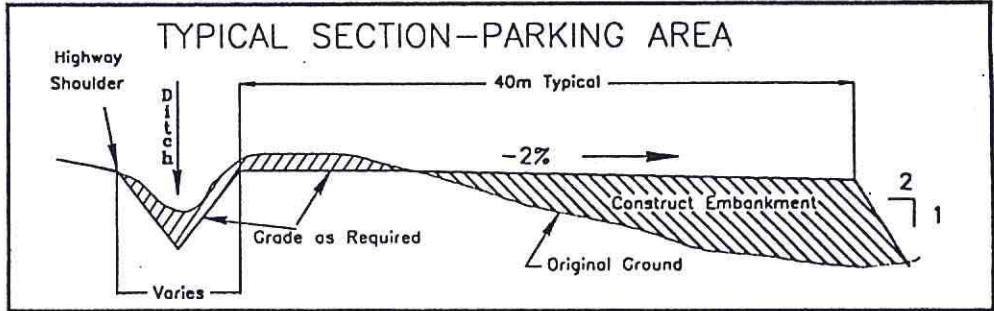
FIGURE 1 – New Vehicle Parking Area

Clearing and grubbing operations were conducted on August 28 & August 29, 1998 utilizing a John Deere 790 Backhoe at the new area identified immediately west and south of the existing vehicle parking lot. This included clearing and grubbing approximately 0.35 ha as identified in figure 1. Due to the limited number of trees within the cleared area the material was buried in a trench along the Southwestern corner and western edge of the newly created vehicle parking lot.

Expansion to the existing vehicle parking lot was initiated by clearing and grubbing conducted, as described above. Deleterious material excavated from within the repair areas was used to construct the parking lot sub-grade. This material was graded and compacted throughout placement between September 3, 1998 and September 14, 1998 with final work conducted on September 15, 1998.

It should be noted that due to the sensitive nature of the material being used as the parking lot sub-grade, care was taken in compacting the material by using the Dynapac CA-250 Packer without engaging the vibrator.

In addition, it should be noted that inclemental weather (rain) was encountered on September 6, 7, 11, 12, 13 & 14. This extra precipitation increased the moisture content of some of the deleterious materials above optimum moisture content, creating a loss in strength and difficulty in obtaining a fully workable material near the completion of the project. As such, some locations within the newly created parking lot were in less than ideal condition upon completion.
