# Desktop Study - Sinkhole Site Characterization, Dempster Highway, Yukon Territory

SRK Consulting (Canada) Inc.  
1CG023.002  
November 2014

Project No: 1CG023.002

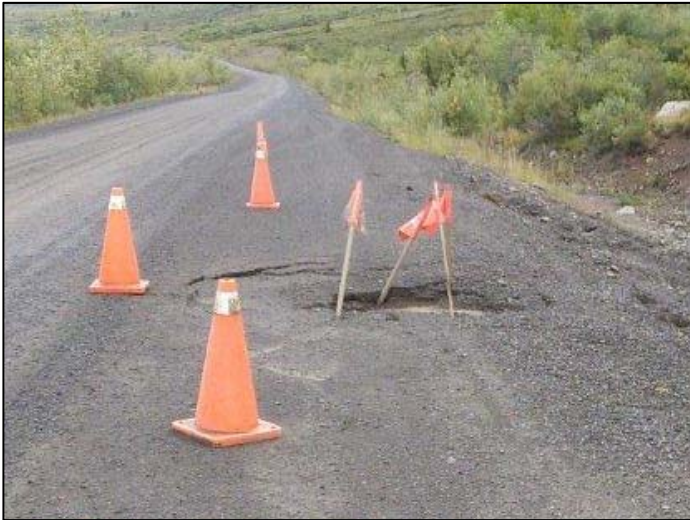
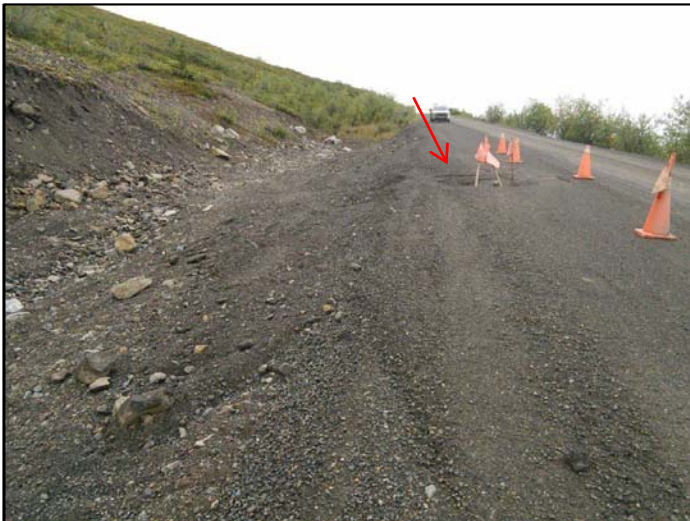
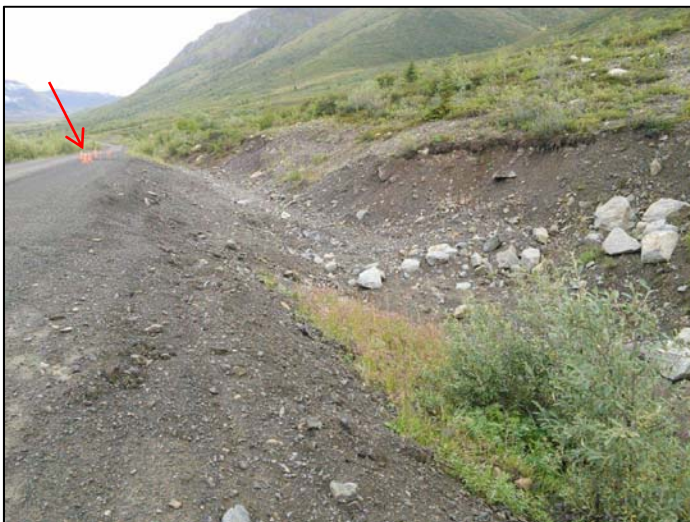
**A-1**

1. Photographs taken on August 14, 2014 near km 82 of the Dempster Highway, Yukon Territory

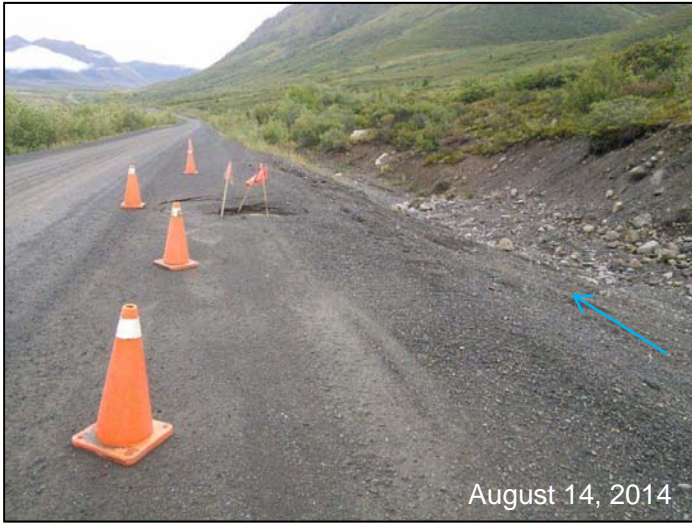
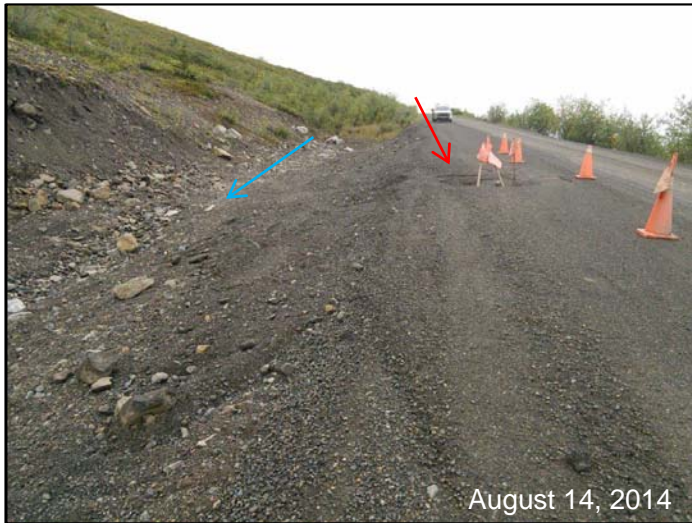
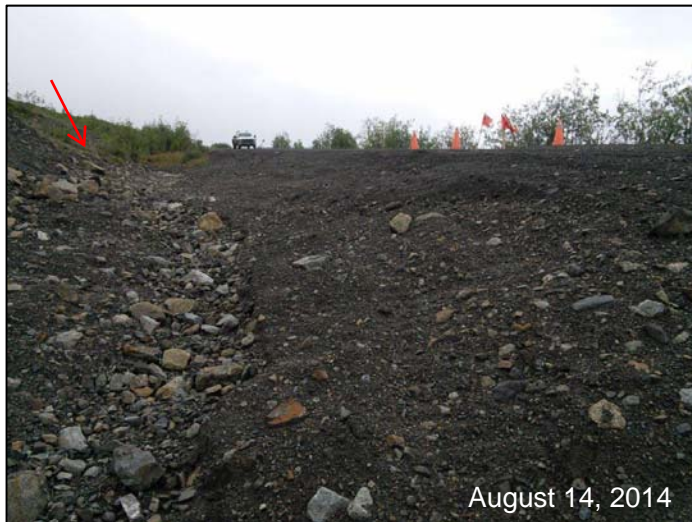
<p>Date: Sept. 12, 2014</p>	<p>Approved:</p>	<p>Figure: <b>A-2</b></p>

1. Photographs taken on August 14, 2014 and August of 2009 near km 82 of the Dempster Highway, Yukon Territory
2. Photographs from August of 2009 taken from Google Earth Street View
3. Blue arrows indicate direction of surface water flow within drainage ditch

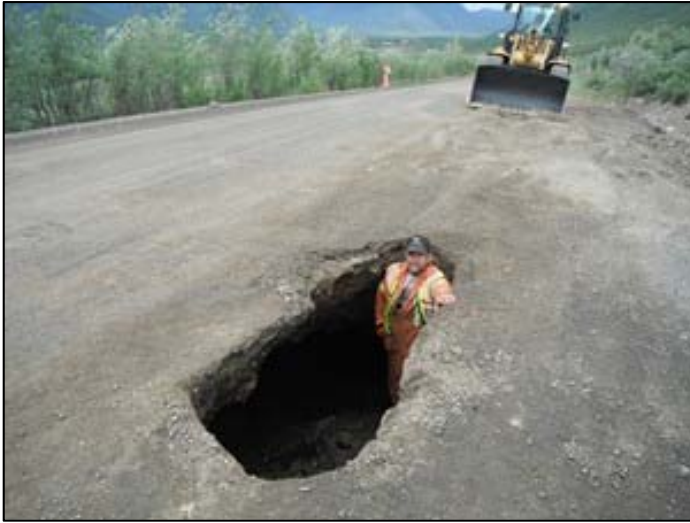
1. Photographs taken near km 82 of the Dempster Highway, Yukon Territory
2. Date of photograph is unknown
3. Vegetation surrounding the site suggests the photograph was taken sometime between June and August
4. Direct field measurement of sinkhole size are not available
5. Sinkhole is estimated from the photograph to be 1.5-2.0 m long, 0.4-0.5 m wide, and 1.2-1.5 m deep near the surface opening

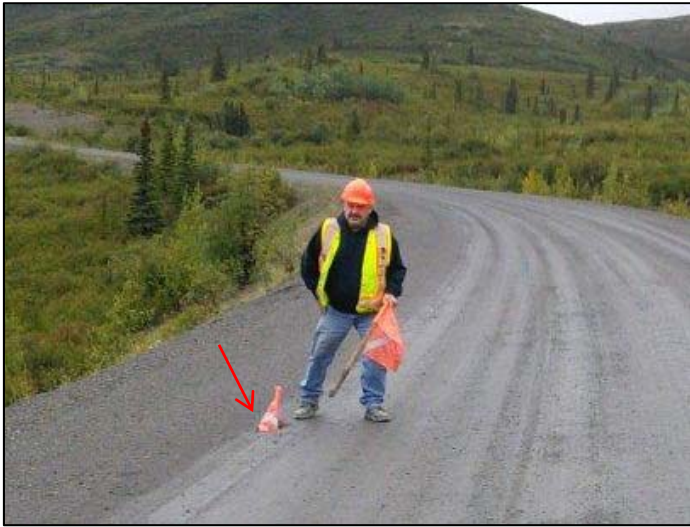
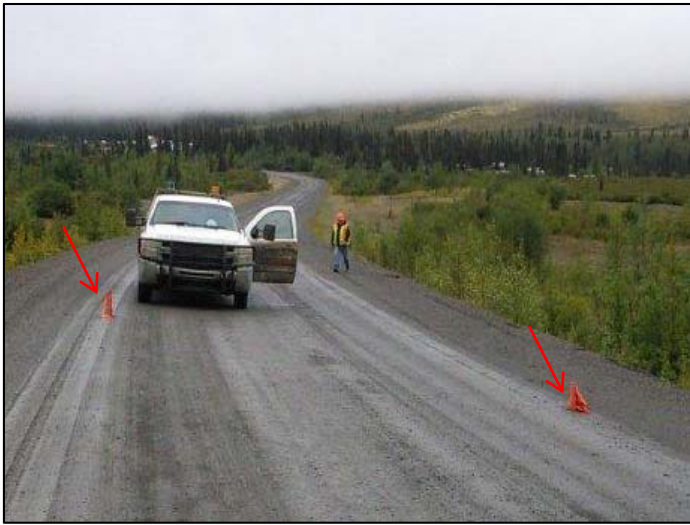
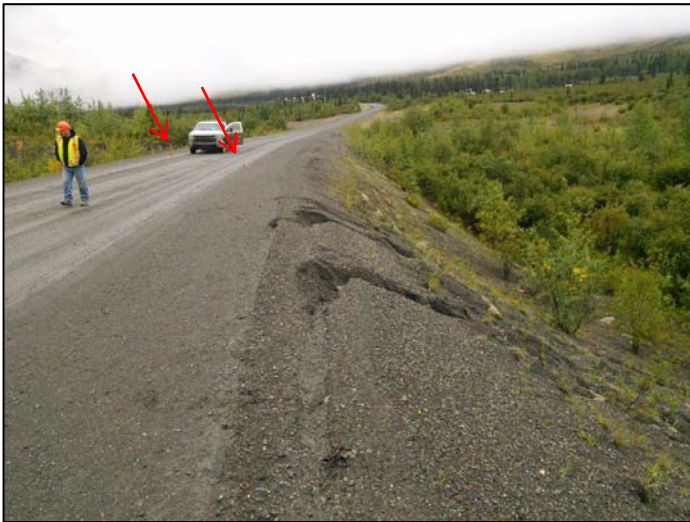
<b>Dempster Highway,</b> <b>Highway km 82</b>		
Job No: 1CG023.002 Filename: Sinkhole Photographs_Unknown Date_km 82		Date: July 15, 2014	Approved:	Figure: <b>A-4</b>

1. Photographs taken on August 14, 2014 near km 72 of the Dempster Highway, Yukon Territory
2. Red arrows indicate location of sinkholes

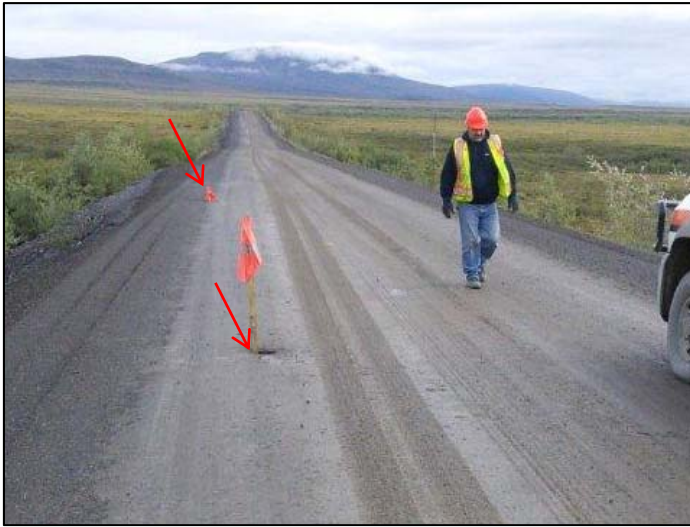
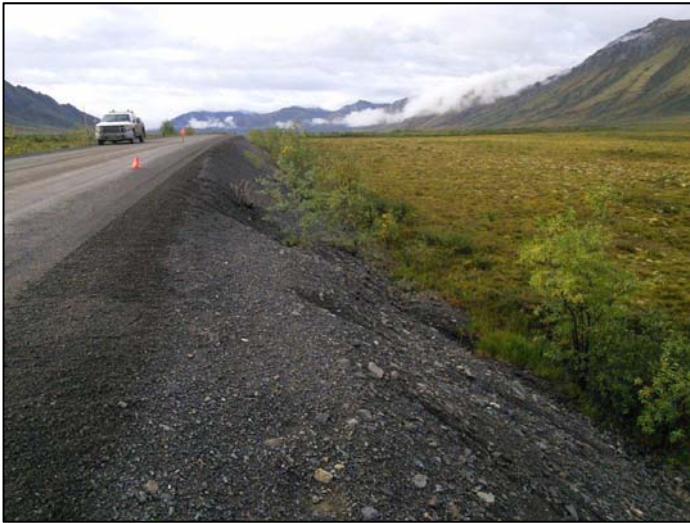
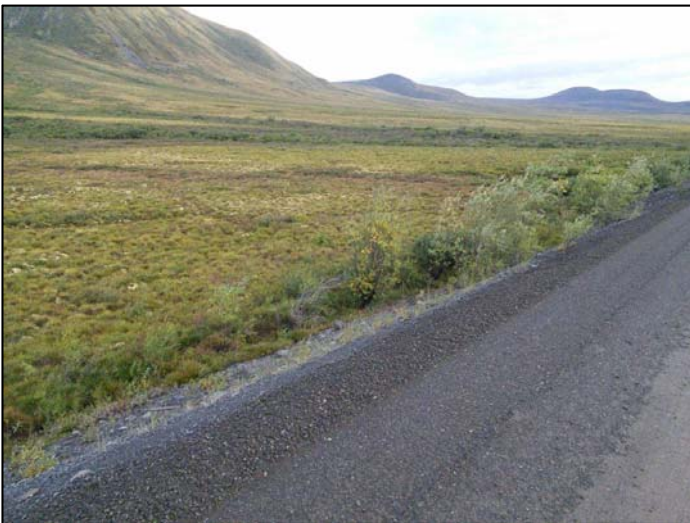
**A-5**

1. Photographs taken on August 14, 2014, South of Chapman Lake along the Dempster Highway, Yukon Territory
2. Red arrows indicate location of sinkholes

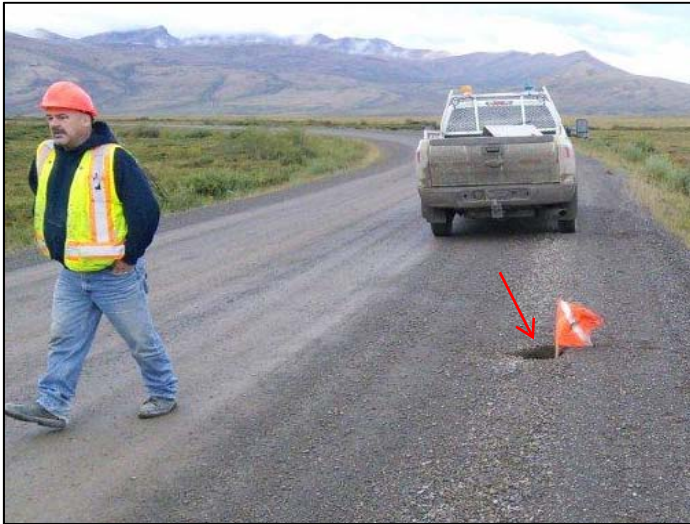
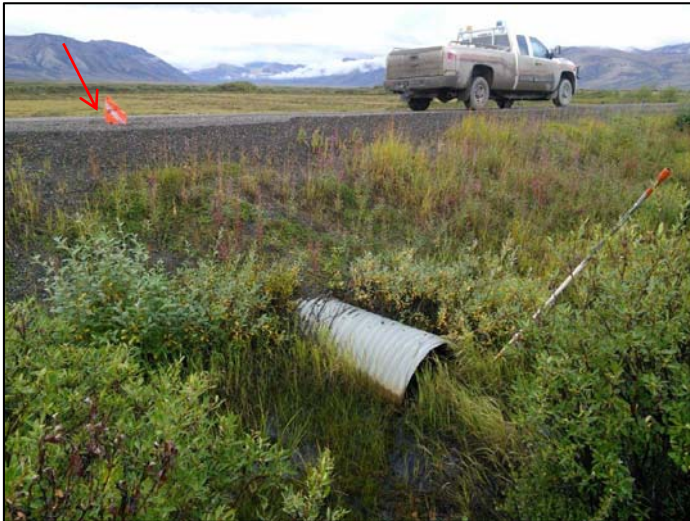
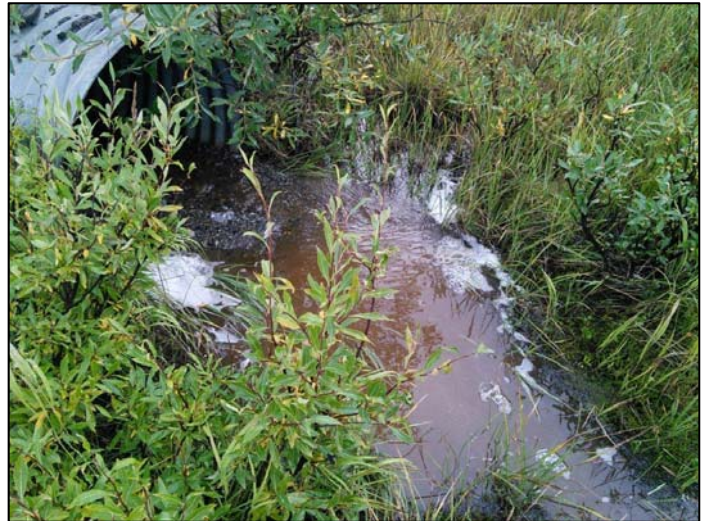
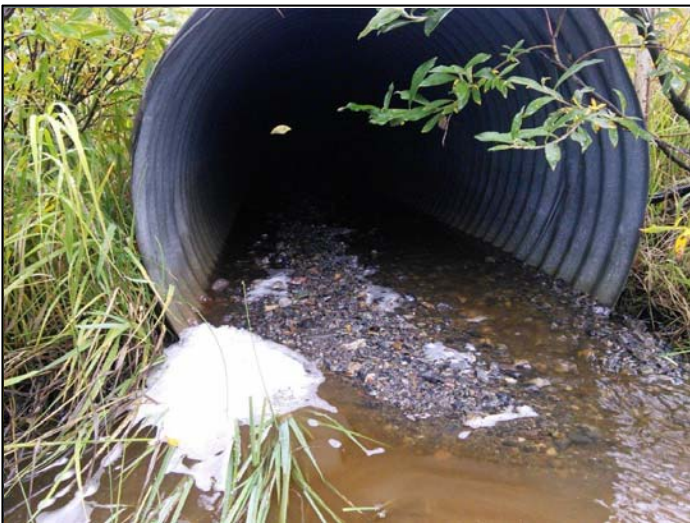
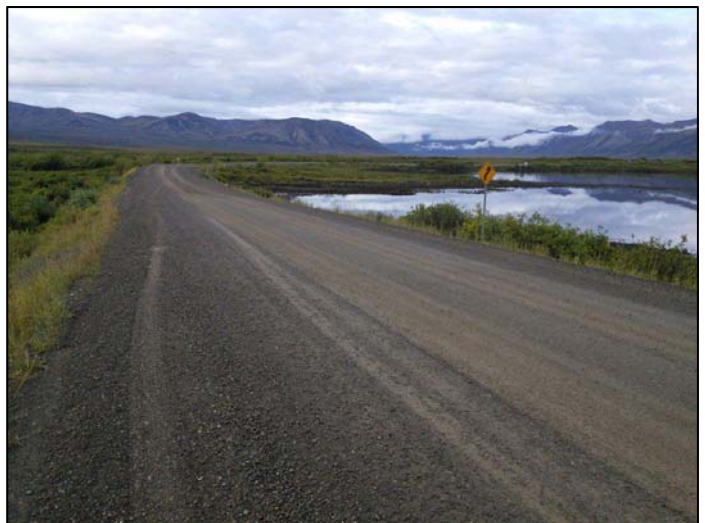
**A-6**

1. Photographs taken on August 14, 2014 near Two Moose Lake along the Dempster Highway, Yukon Territory
2. Red arrows indicate location of sinkholes
