GEOTECHNICAL EVALUATION OF ROAD SETTLEMENT HAMILTON BOULEVARD SECTION 4+640 TO 4+860, WHITEHORSE, YT

INTERIM REPORT

DECEMBER 24, 2013
ISSUED FOR USE
EBA FILE: WI4103046-02

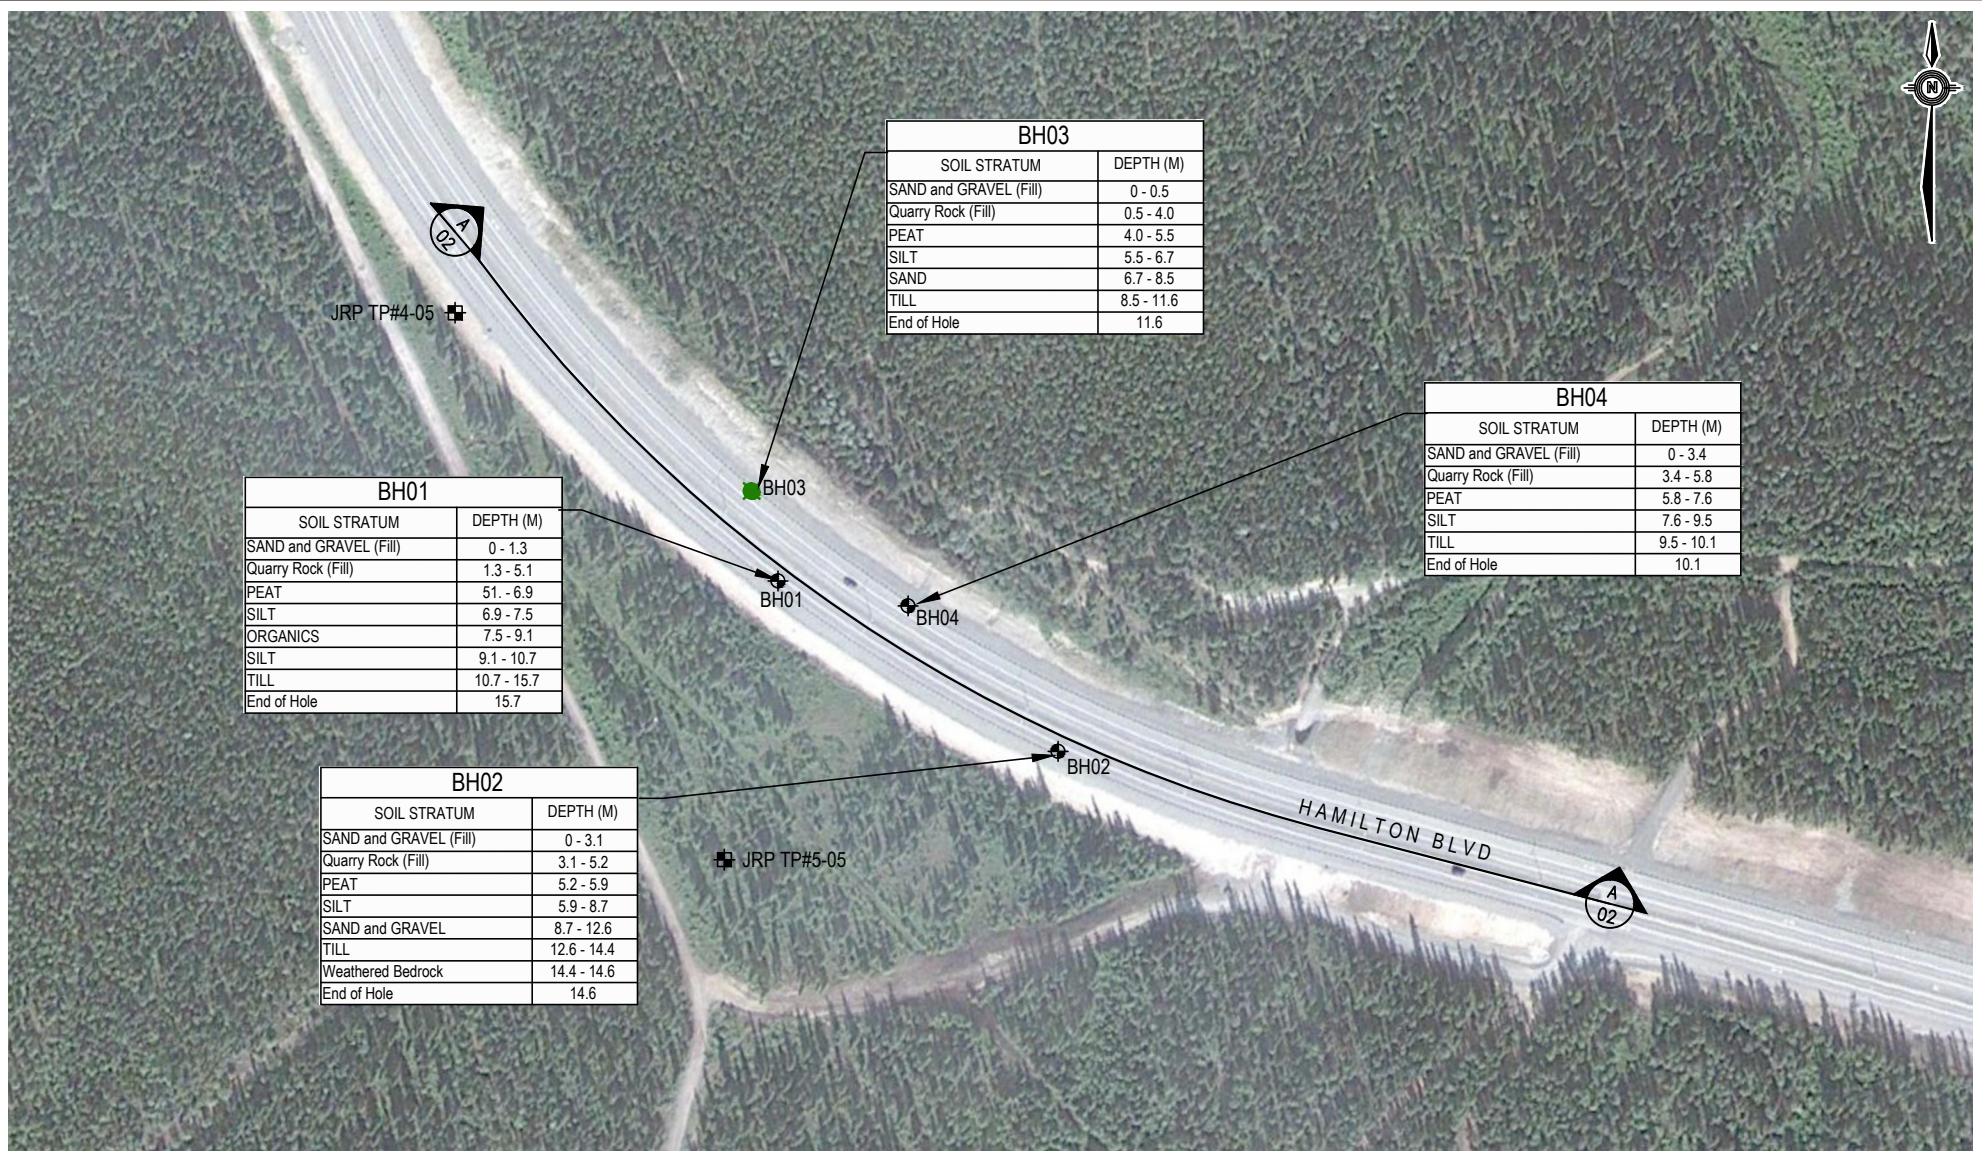
Figure 1

provide geotechnical data on areas experiencing the most settlements and distributed evenly along the section under investigation. The location of each borehole is presented on Figure 1.

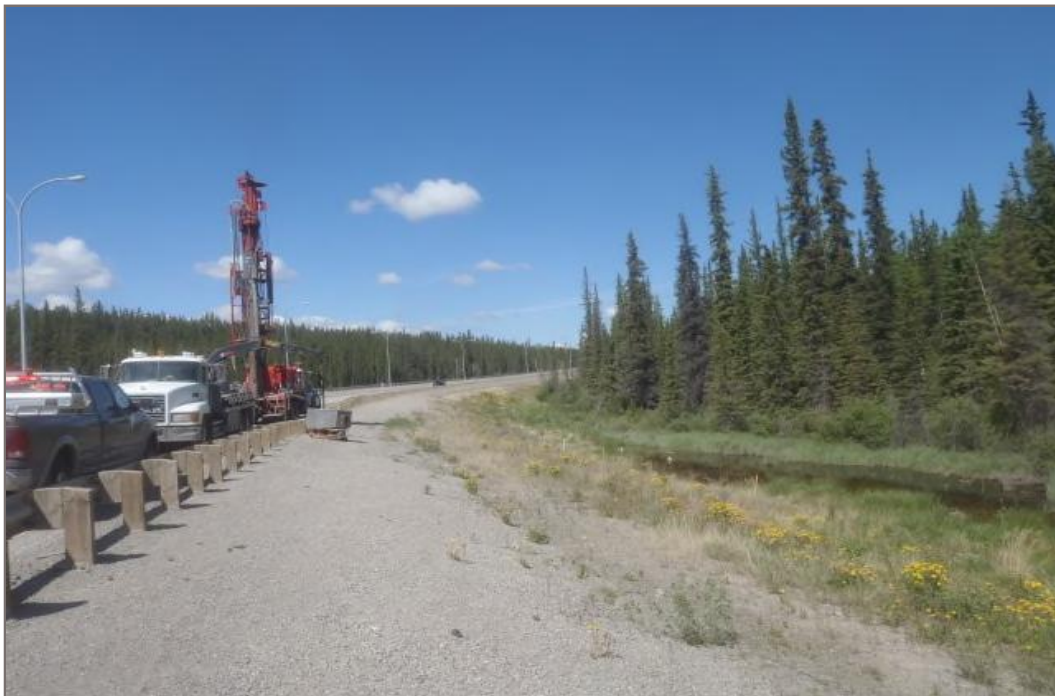
Photo 8: BH03 Setup, aspect NW

One GTC was installed at Borehole BH03, the borehole with the most ICE content, to a depth of 11.3 m. Monthly readings for July, August, September, October, and December 2013, are included in Figure 3. Monthly readings will continue for a full year, at which time EBA will prepare a final report with the updated monitoring results and any changes to the settlement data.

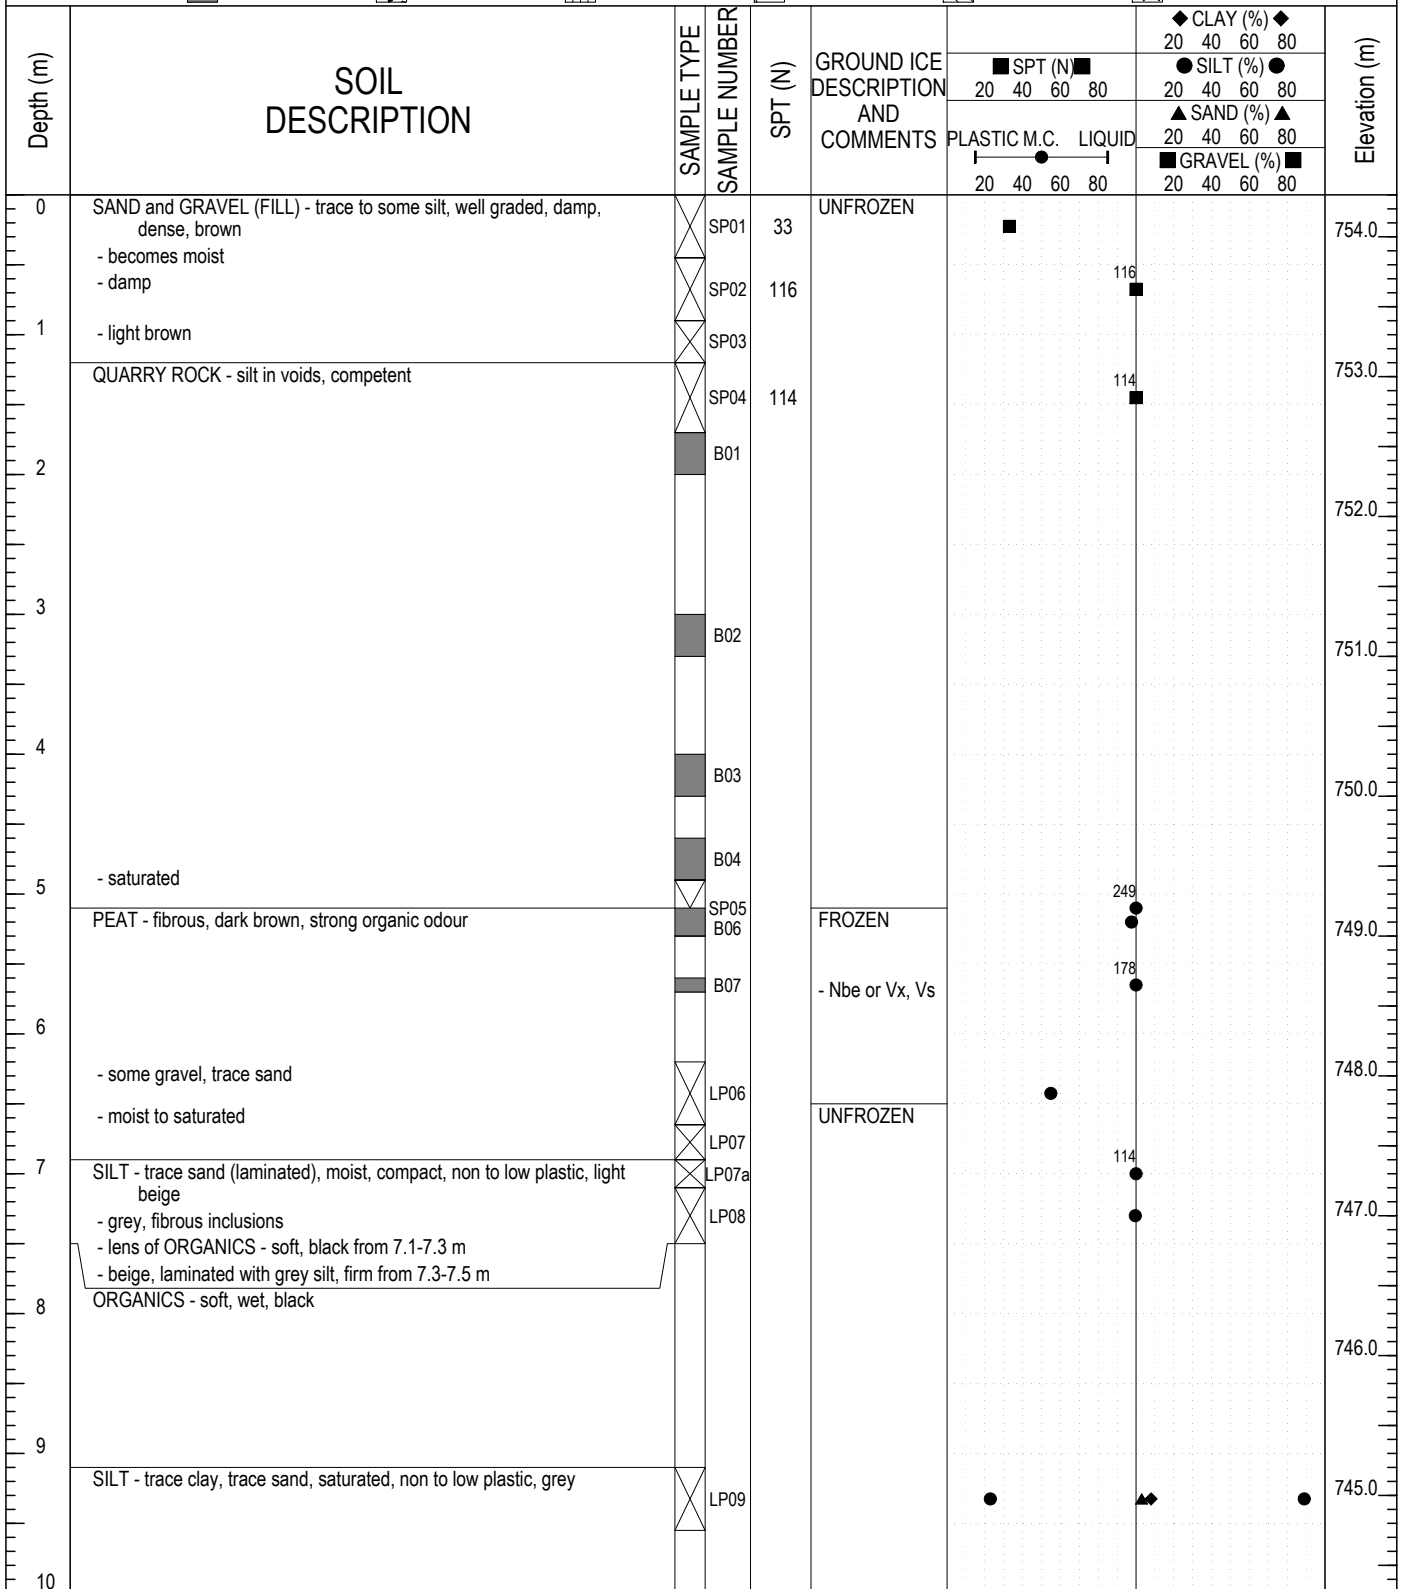
Geotechnical Evaluation	CLIENT: YG - Community Services	PROJECT NO. - BOREHOLE NO.
Hamilton Boulevard STA 4+755	DRILL: Sandvic M5 ODEX (Air Rotary)	W14103046-BH01
Whitehorse, YT	6728929N; 494751E; Zone 8	ELEVATION: 754.3 m

Permafrost was encountered in three of the four boreholes advanced, within the underlying PEAT and SILT. The thickness of permafrost varied from 0.8 m of frozen PEAT in Borehole BH01, 2.0 m of frozen SILT in Borehole BH02, and 1.4 m of ICE and frozen SILT in Borehole BH03. The PEAT in Borehole BH01 had an moisture content of 178% (by weight), the frozen SILT in Borehole BH02 contained 27% moisture content (by weight), and the ICE and frozen SILT in Borehole BH03 contained 60% moisture content (by weight). No permafrost was encountered in Borehole BH04.
