# Yukon Government Rural Land Development

## Grizzly Valley Road Preliminary Assessment

**August 2015**

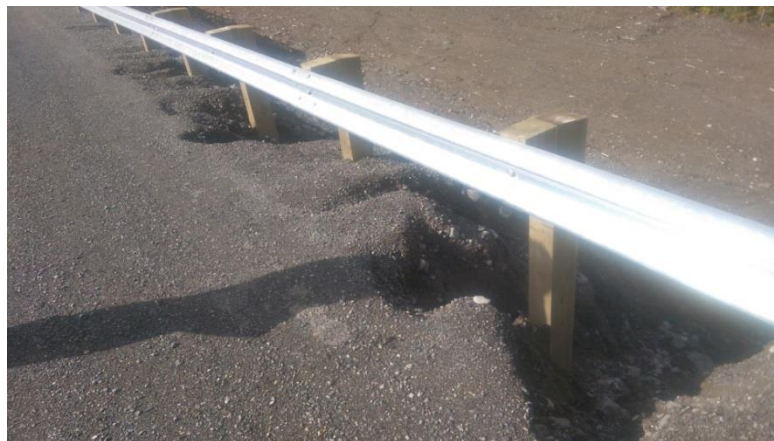
Large erosion rills have developed and led to damage of the BST road surface, guide rails and ditches. Relatively steep side and back slopes of approximately 1.5H:1V, constructed using native soils susceptible to erosion, have contributed significantly to the erosion. No measures to direct and control runoff were installed along the embankments. Ditches and slopes showed little sign of revegetation since original construction and no root mass was present to stabilize the slope. Poor compaction of road sub-base, observed by TT EBA field staff during original construction, may have contributed to extensive scouring as the material on the surface of the road side slopes would be unconsolidated. The embankments on the inside of superelevated corners were eroded significantly more than the outside embankments on the same corner due to the additional catchment area from the road surface.

**Figure 3-4 Major erosion around guard rail posts and scouring on side slope on inside of corner above wildlife crossing at approx. 2+160. Picture from fall 2014.**

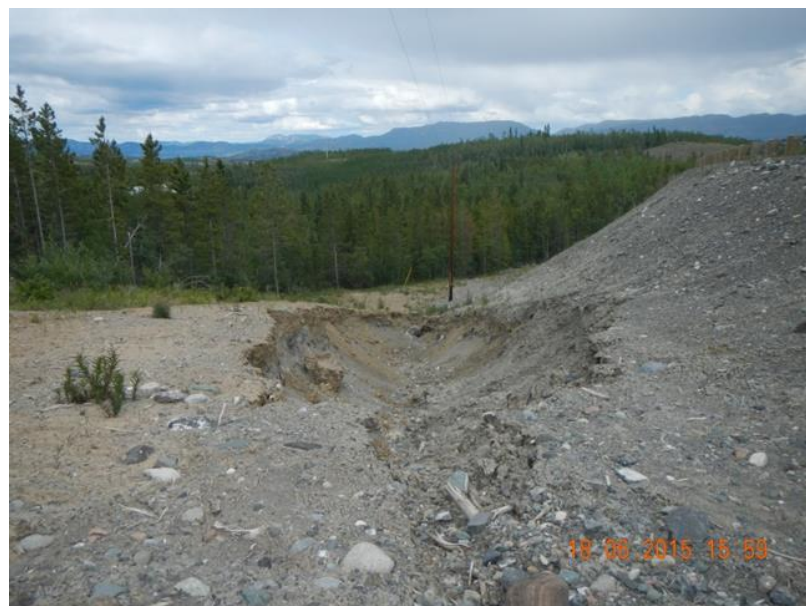
The topography of the Grizzly Valley Subdivision has resulted in long relatively steep ditch runs. No erosion protection measures were installed during original construction. As noted by TT EBA in their assessment, all ditches in excess of 3% were scoured with material deposited downstream in areas with a relief in grade. The extent of damage ranged from minor to severe.

Figure 3-6 Major scour in ditch around 6+400 on the left hand side.

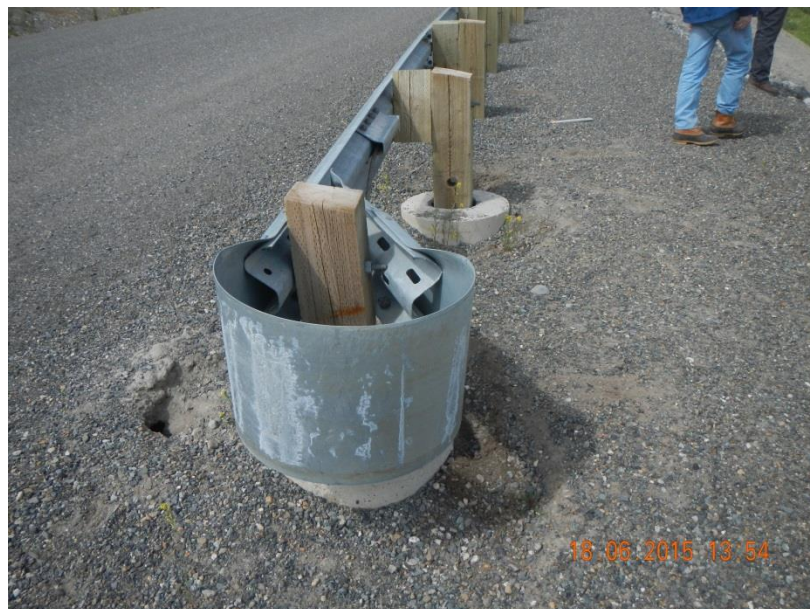
The guiderails throughout the subdivision were consistently installed too close to the top of embankment slopes. Typical installation would have one metre from the back of the guiderail posts to the top of the road embankment slope to provide a solid foundation. Poor compaction around the concrete abutments at the end of each guiderail was noticed and water had infiltrated and eroded the road subbase.

**Picture 3-10 Erosion around concrete guiderail abutments.**

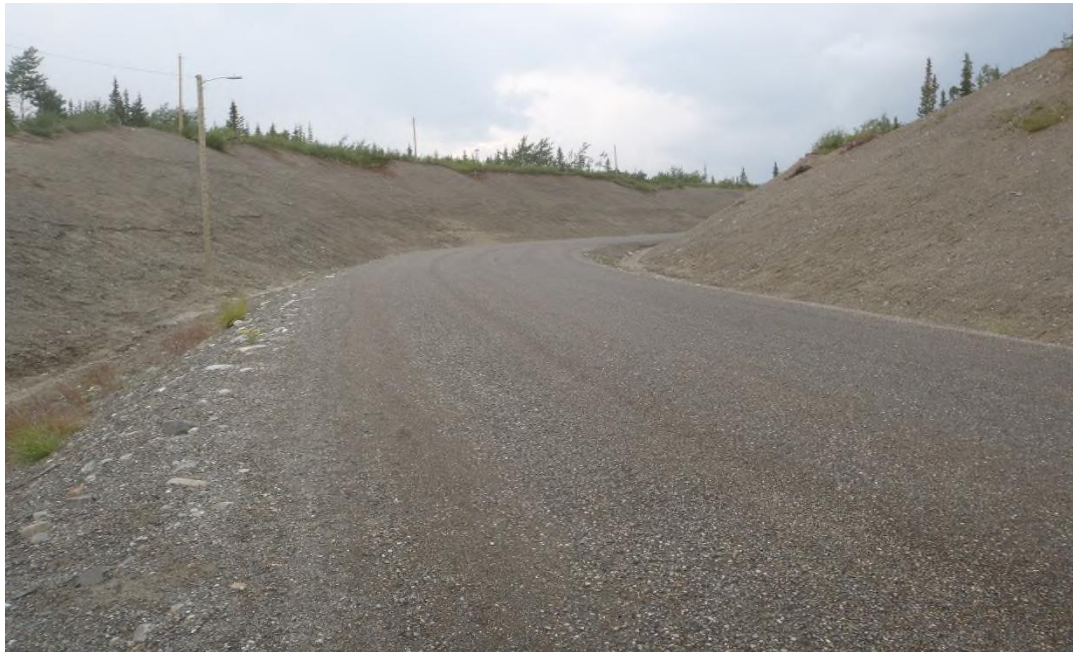
**Photo 4:** July 9, 2015 – Surficial Erosion Along High Backslopes at Sta 5+550 – Ditches Carrying Sediment

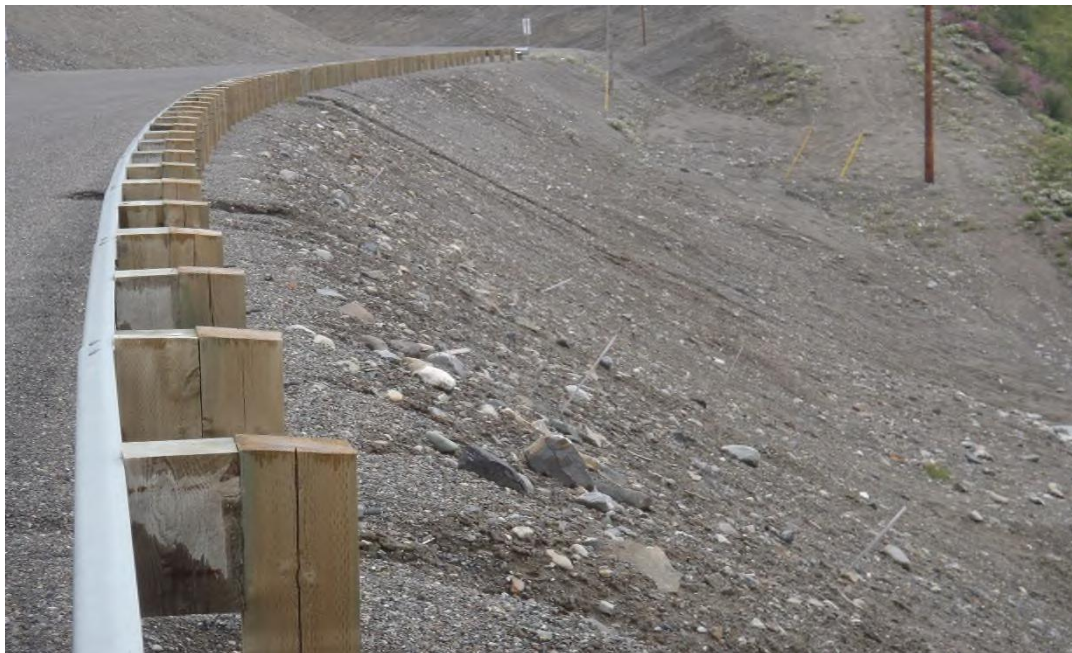
**Photo 5:** July 9, 2015 – Sta 5+280 RHS – Wash-outs Along Guard Rail

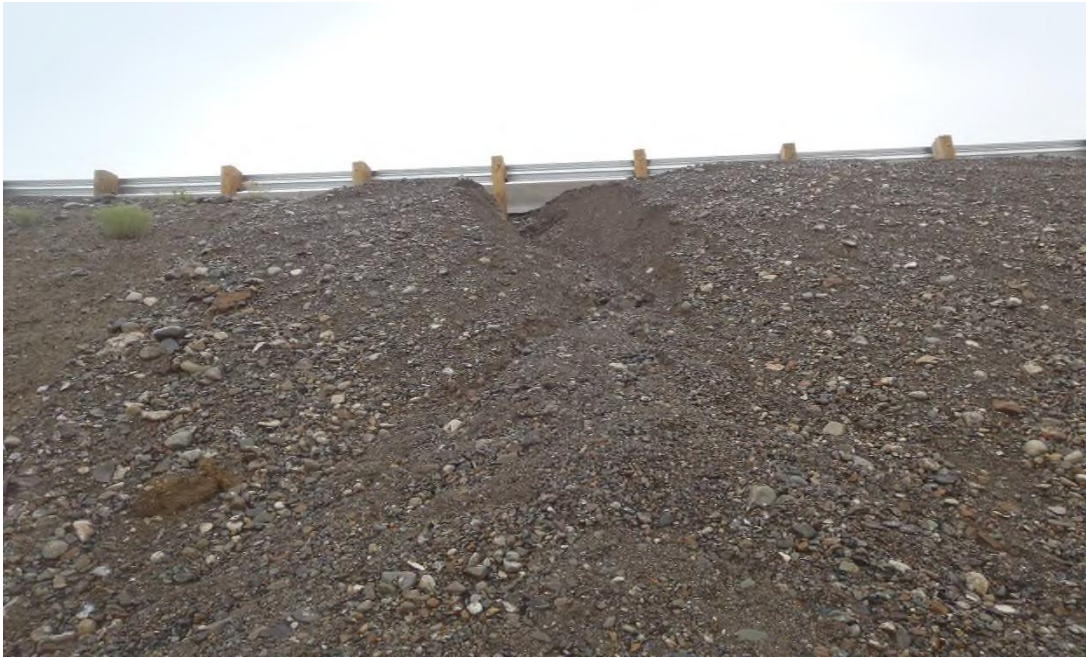
**Photo 6:** July 9, 2015 – Sta 2+060 to Sta 2+300 – RHS – Washouts Extending Under Guardrail & Barrier Curb

- The wildlife crossing from Sta 2+060 to Sta 2+300. The granular fill dumped on this slope in fall of 2014 as a temporary erosion protection measure has failed in multiple locations. A concrete jersey barrier was also installed in fall of 2014 in place of the compromised guiderail, however erosion of the embankment has since undermined the barrier and compromised its integrity.

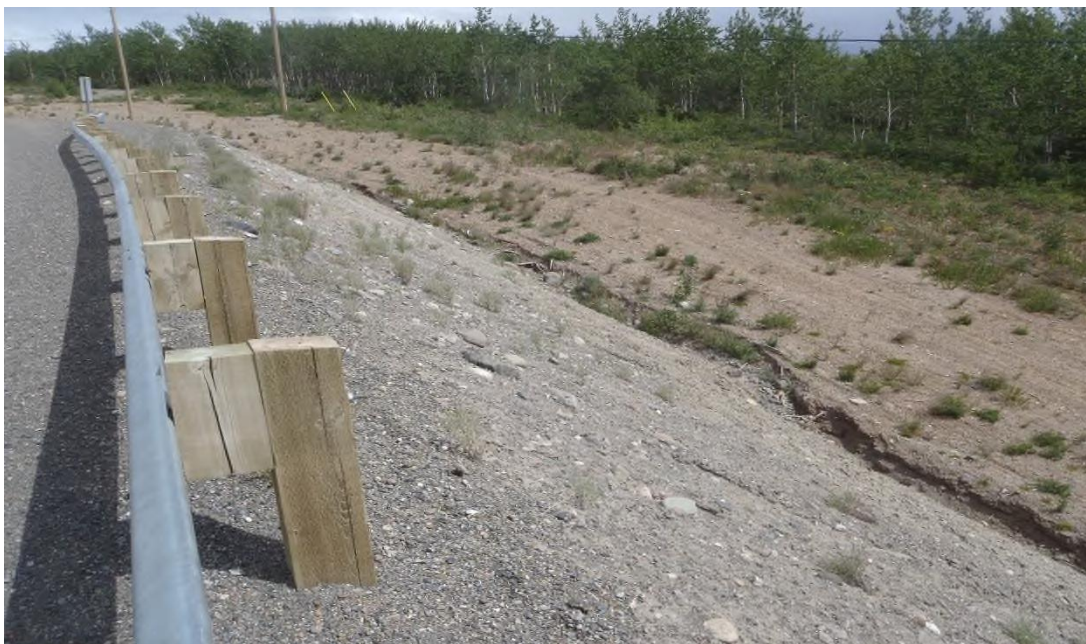
**Photo 7:** June 18, 2015 – Sta 2+150 – LHS – Ditch Line Scour Down-gradient of Transition to Large Fill Area

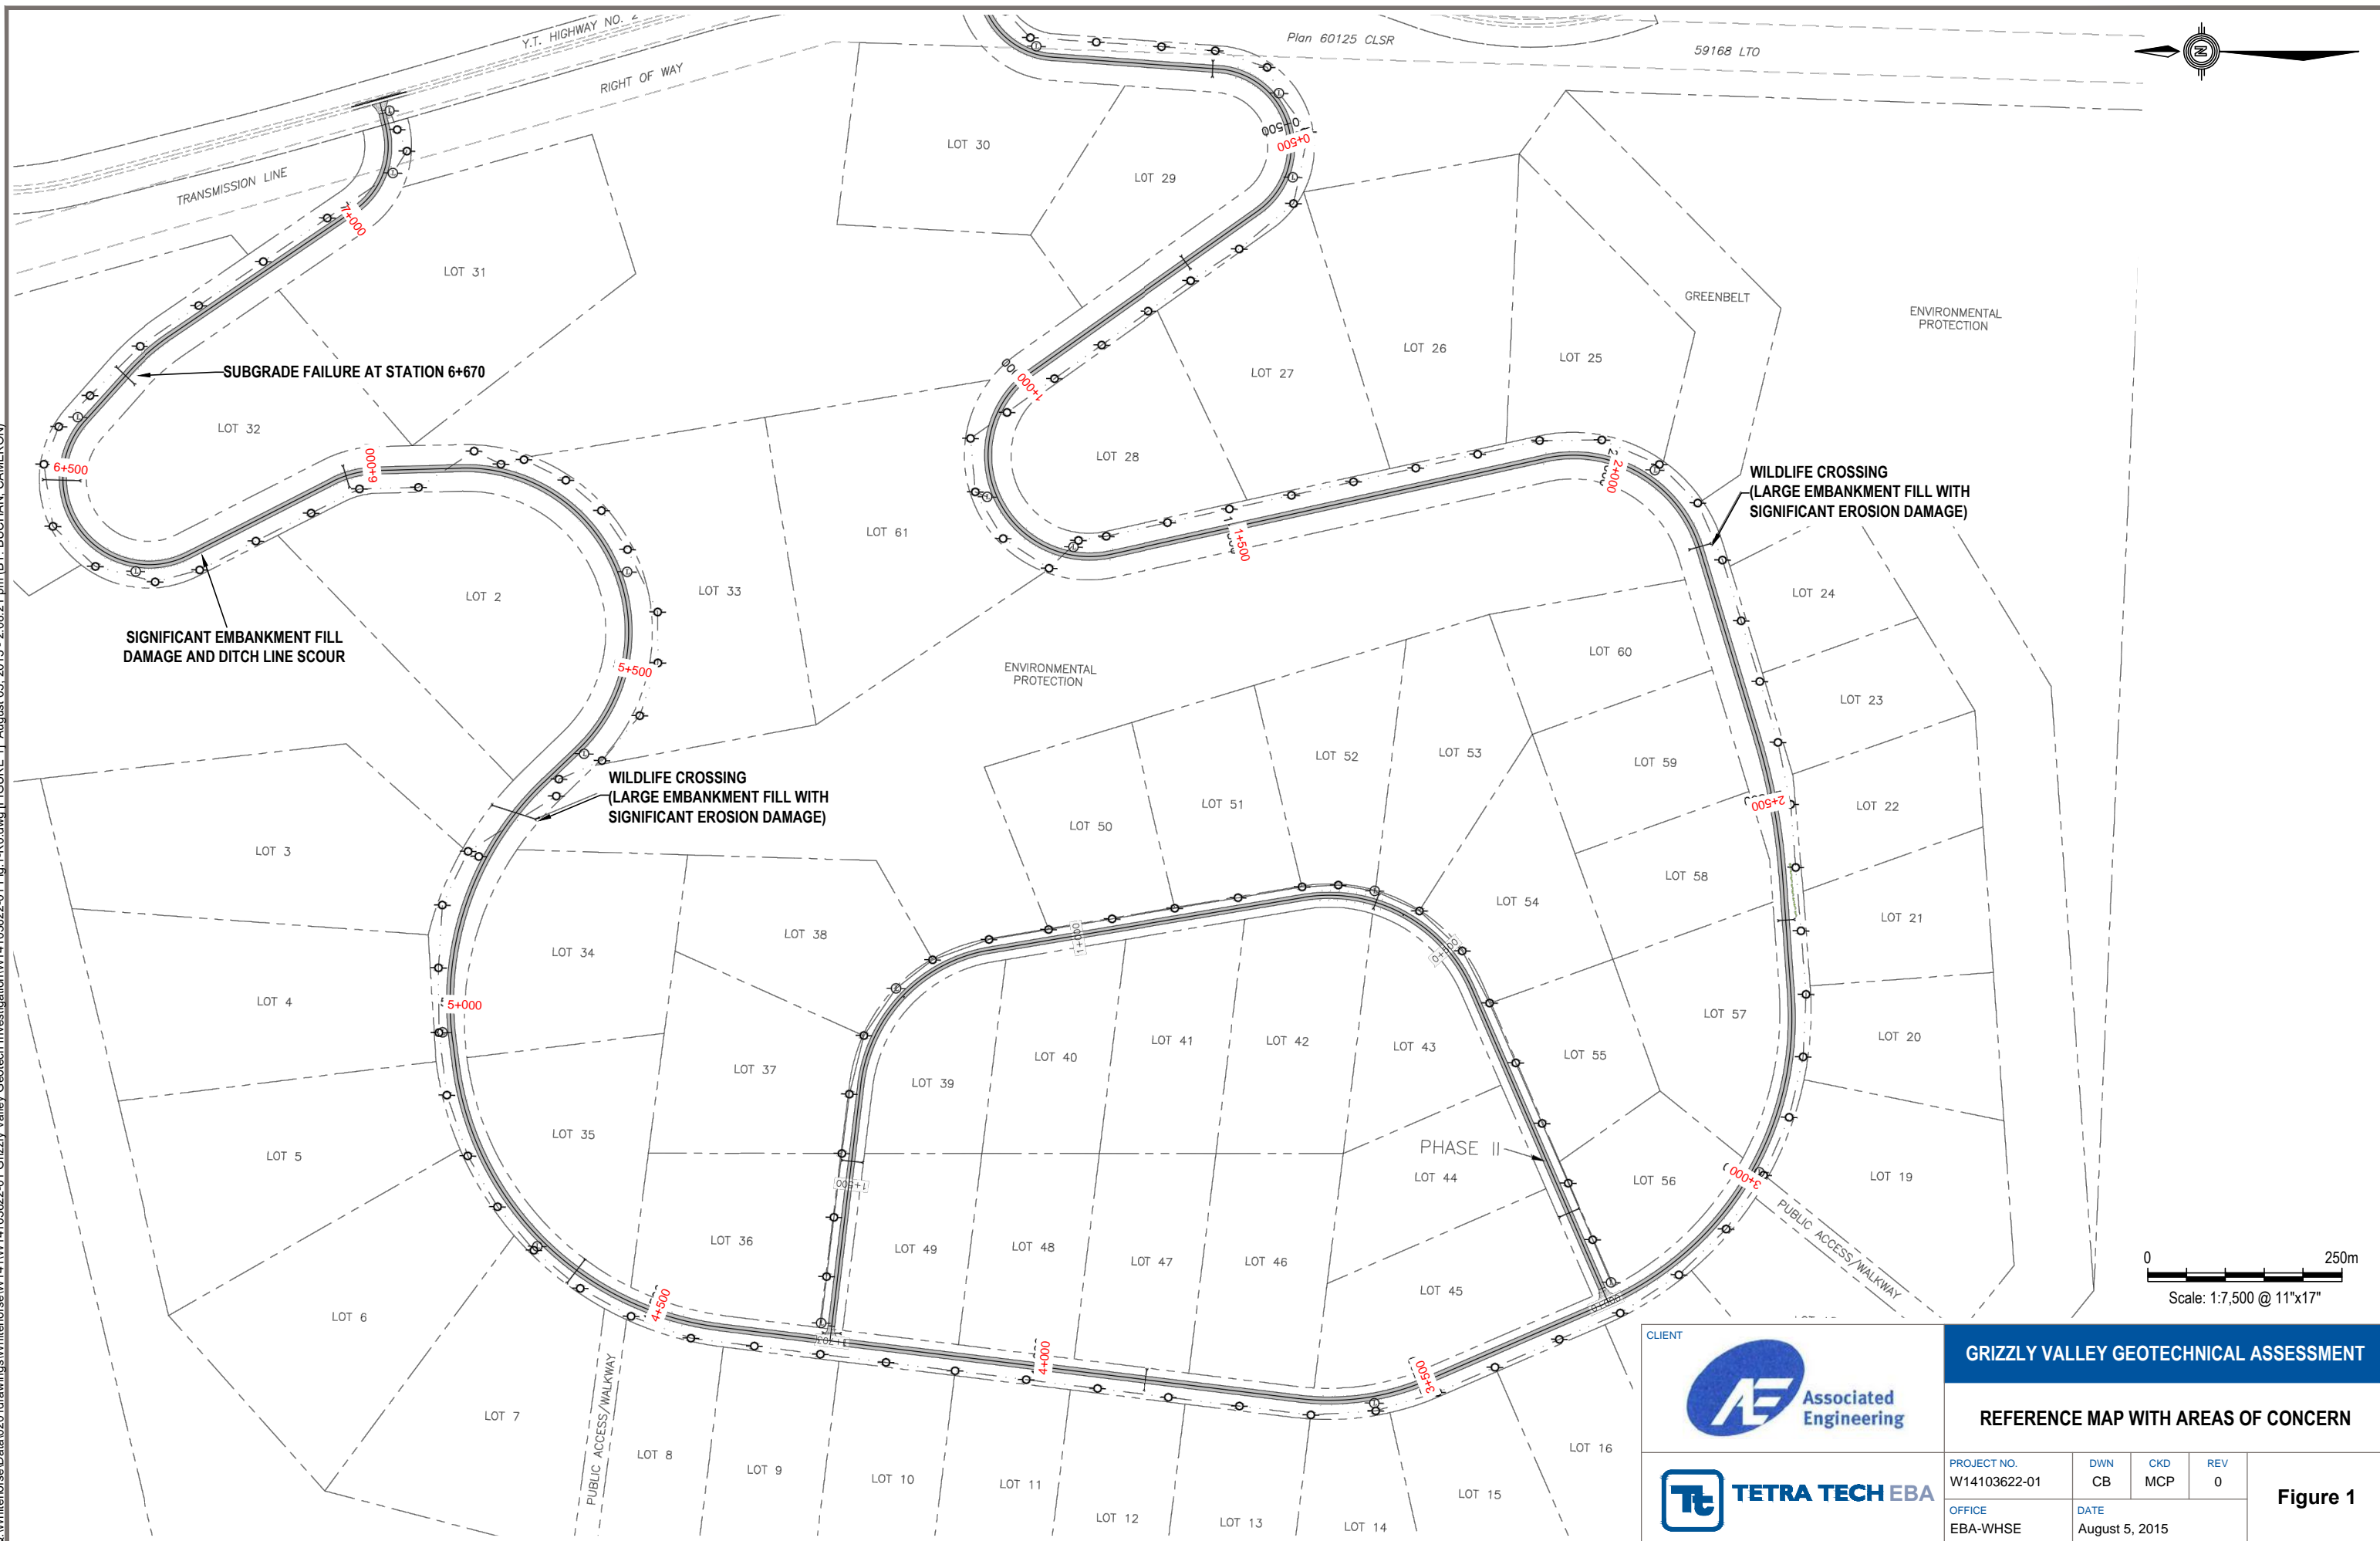
Figure 1      Grizzly Valley Site Plan

<b>REFERENCE MAP WITH AREAS OF CONCERN</b>			
PROJECT NO.	DWN	CKD	REV	<b>Figure 1</b>	
W14103622-01	CB	MCP	0		
OFFICE	DATE				
EBA-WHSE	August 5, 2015
