16.0 BUILDING 3201: BURWASH LANDING AIRPORT BUILDING

16.1 Background and Description of Existing Water Supply System

SMALL PUBLIC WATER SYSTEMS ASSESSMENT
 WESTERN REGION

BURWASH LANDING AIRPORT
 BUILDING # 3201
 SITE LOCATION DIAGRAM
 WELL ID: 3201-A,B,C

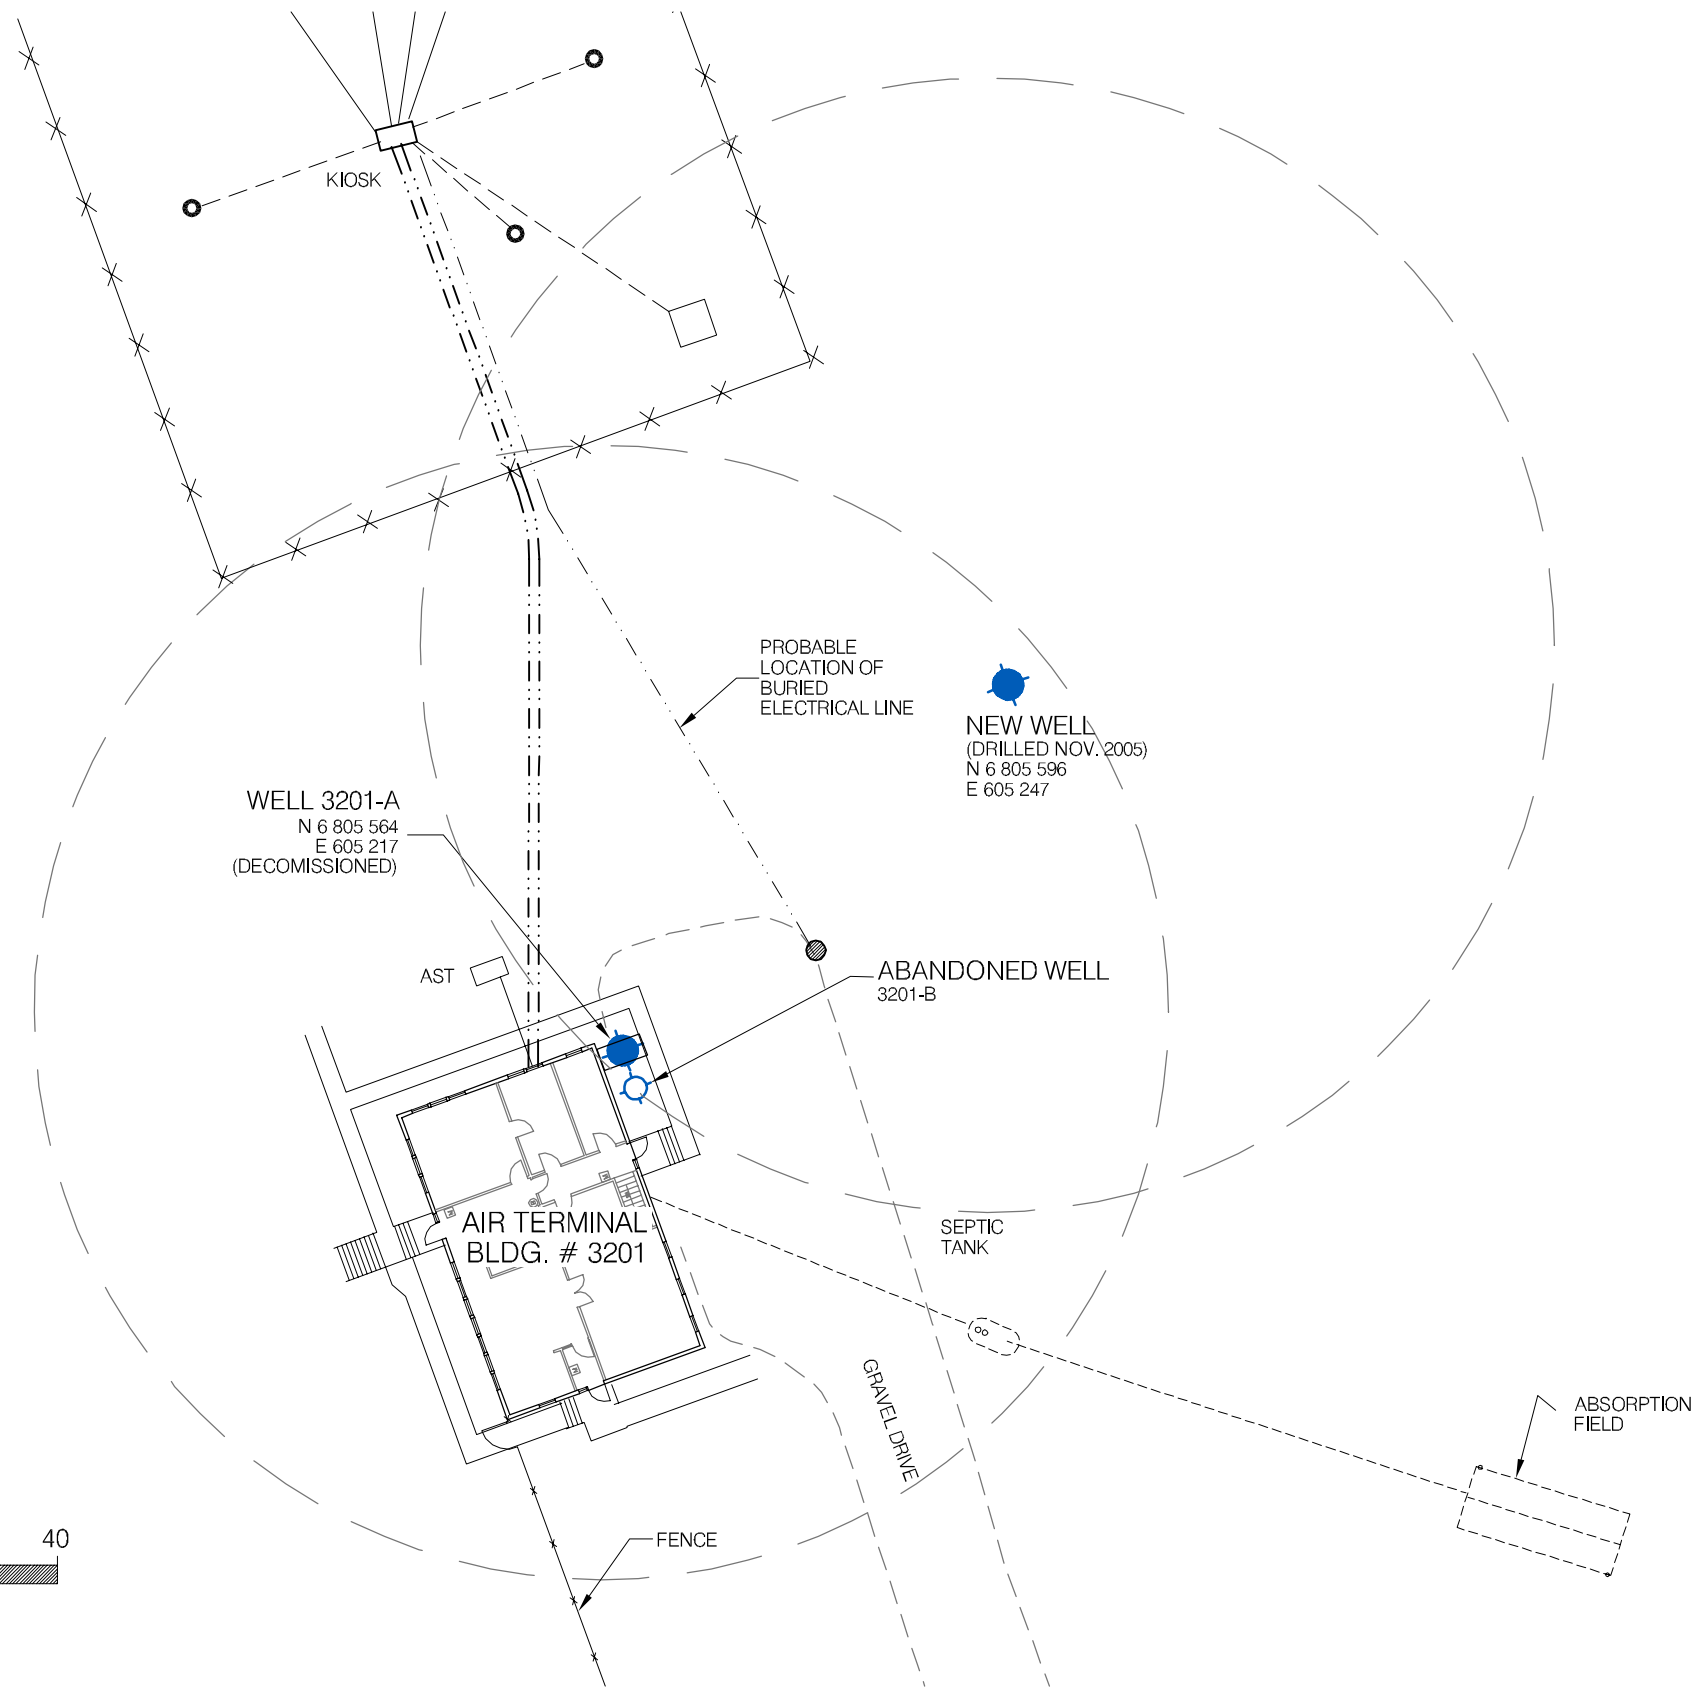
FIGURE No.
 FIGURE 3201-A

The septic tank that serves this building is located east of the building approximately 23 m southeast of the well. Septic effluent is discharged to the southeast of the tank approximately 40 m from the well. A site plan showing the septic system is given by Figure 3201-A in Appendix A16.

The closest point of the existing septic field is approximately 40 m downgradient from the well, and although the septic tank and sewer service lines are within 30 m of the well, it is not likely that this is the cause of high nutrients in the water system. One potential cause of the elevated nitrates and chlorides is the poor surface completion of the well. The well is located in a wooden enclosure containing fiberglass insulation. This type of enclosure is especially subject to inhabitation by rodents. At the time of the water system assessment there were mouse feces and other evidence of rodents in the wellhead enclosure. The well is also equipped with a jet pump rather than a submersible pump. Because of the depth of the well it was required that two drop pipes be installed as opposed to only one. Having two drop-pipes in the well makes it difficult to find a proper double-holed well cap to install on the well casing, and likely due to this, there was no well cap present. Because the well is open without a cap on the casing, and because the wellhead enclosure is constructed in a manner such that it is appealing to rodents for habitation, it is likely that the well is subject to animals and animal feces falling directly into the well. It is possible that the elevated nitrate and chloride concentration, as well as the positive bacteriological results for total coliform, is being caused by fecal matter and/or decaying rodent carcasses in the well.

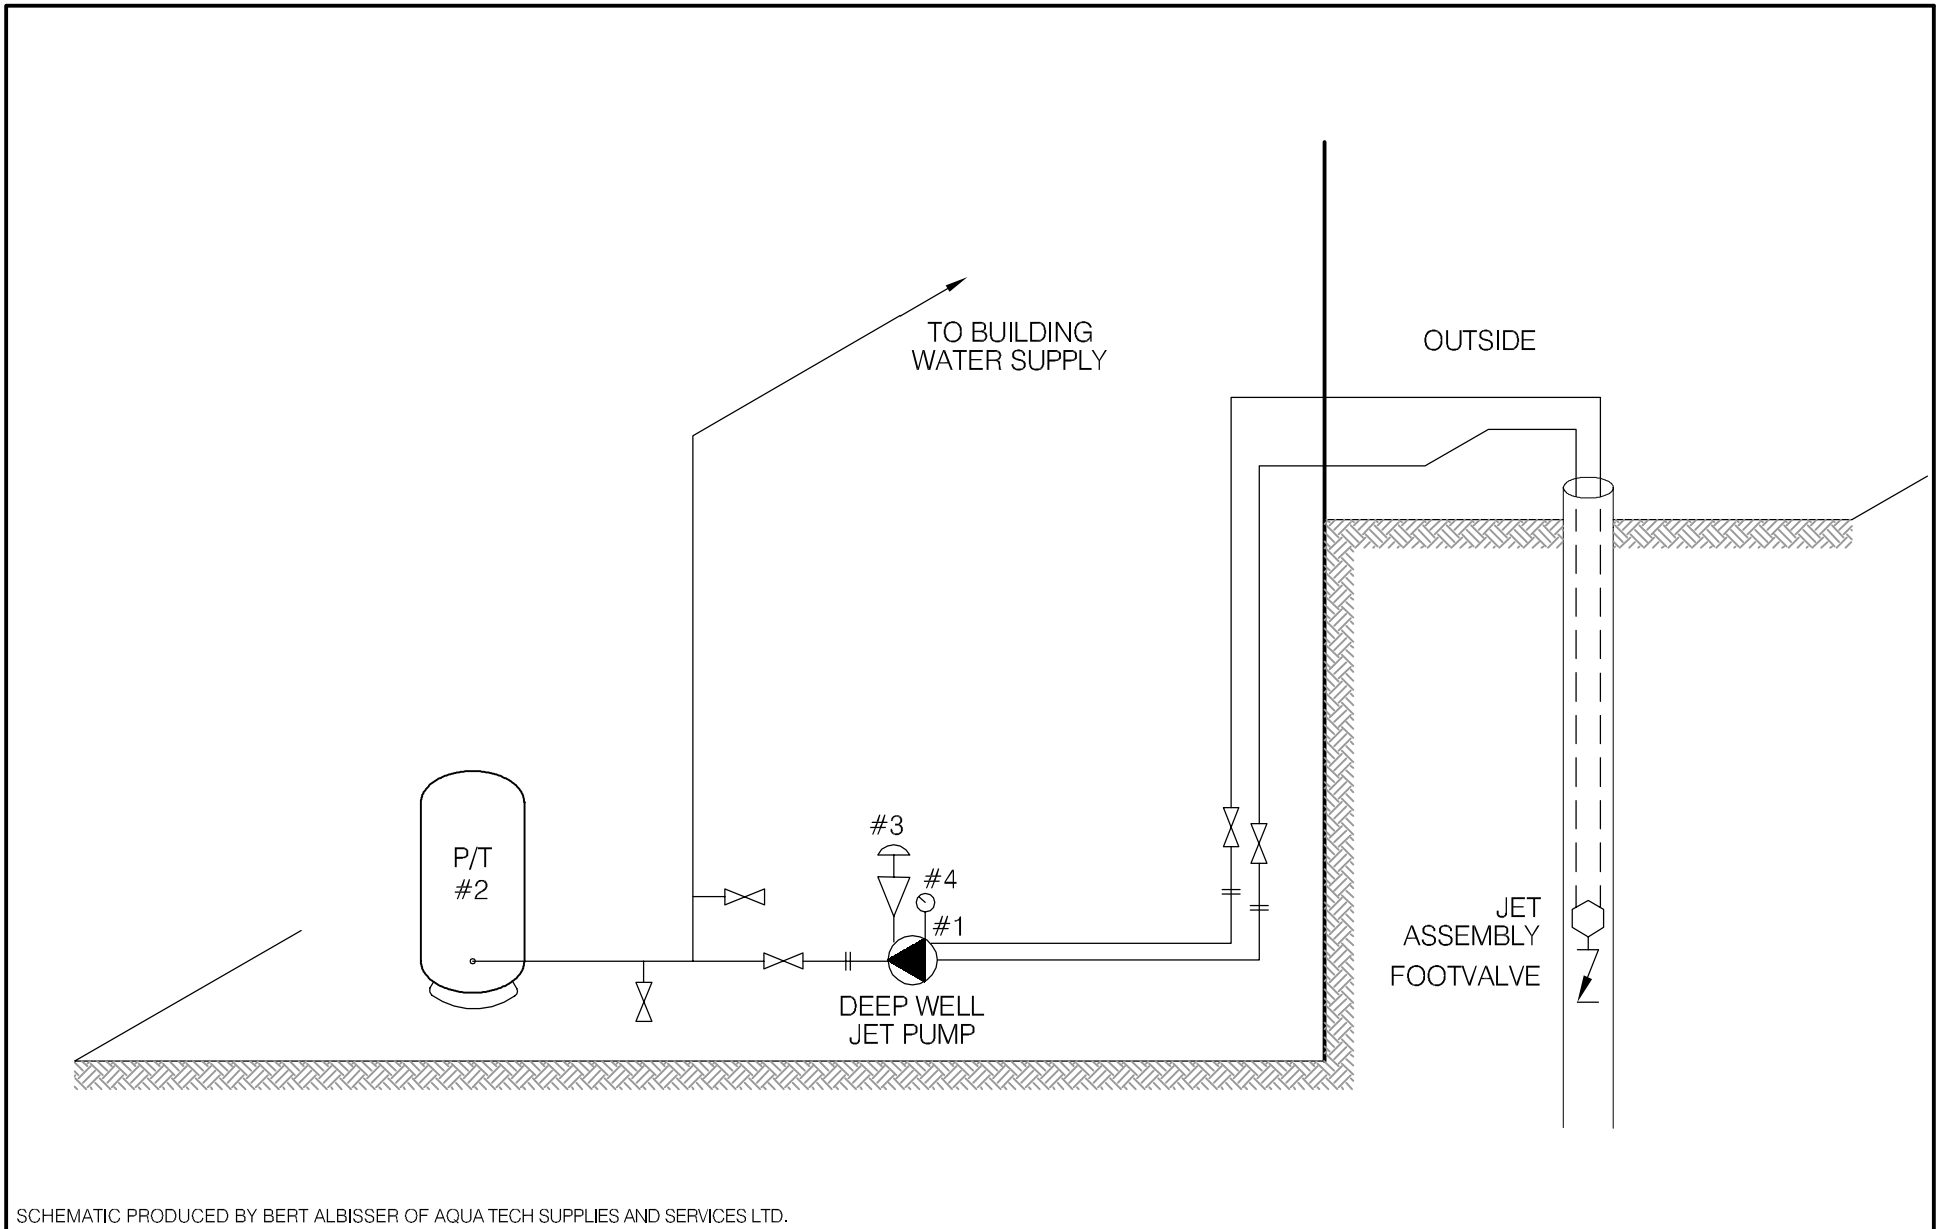
TITLE WATER SYSTEM DISTRIBUTION/TREATMENT SCHEMATIC SYSTEM ID.: 3201 BURWASH LANDING AIRPORT	
DATE	SEPT. 2005	DWN.	JSB
CHKD.	FMM	FILE NO.	1260002.003
		DWG.:	FIGURE 3201-B

There is no treatment or disinfection system for the water supplying this system. A schematic detailing the well water supply system is provided as Figure 3201-B in Appendix A16.
