15.0 BUILDING 1955: MOUNT LORNE FIRE HALL

PROJECT SMALL PUBLIC WATER SYSTEMS ASSESSMENT
WHITEHORSE REGION

TITLE WATER SYSTEM DISTRIBUTION/TREATMENT SCHEMATIC SYSTEM ID.: 1955 MOUNTE LORNE FIRE HALL - WELL ID.: 1955	
DATE	JULY 2005	DWN.	JSB
CHKD.	FMM	FILE NO.	1260002.002
		DWG.:	FIGURE 1955B

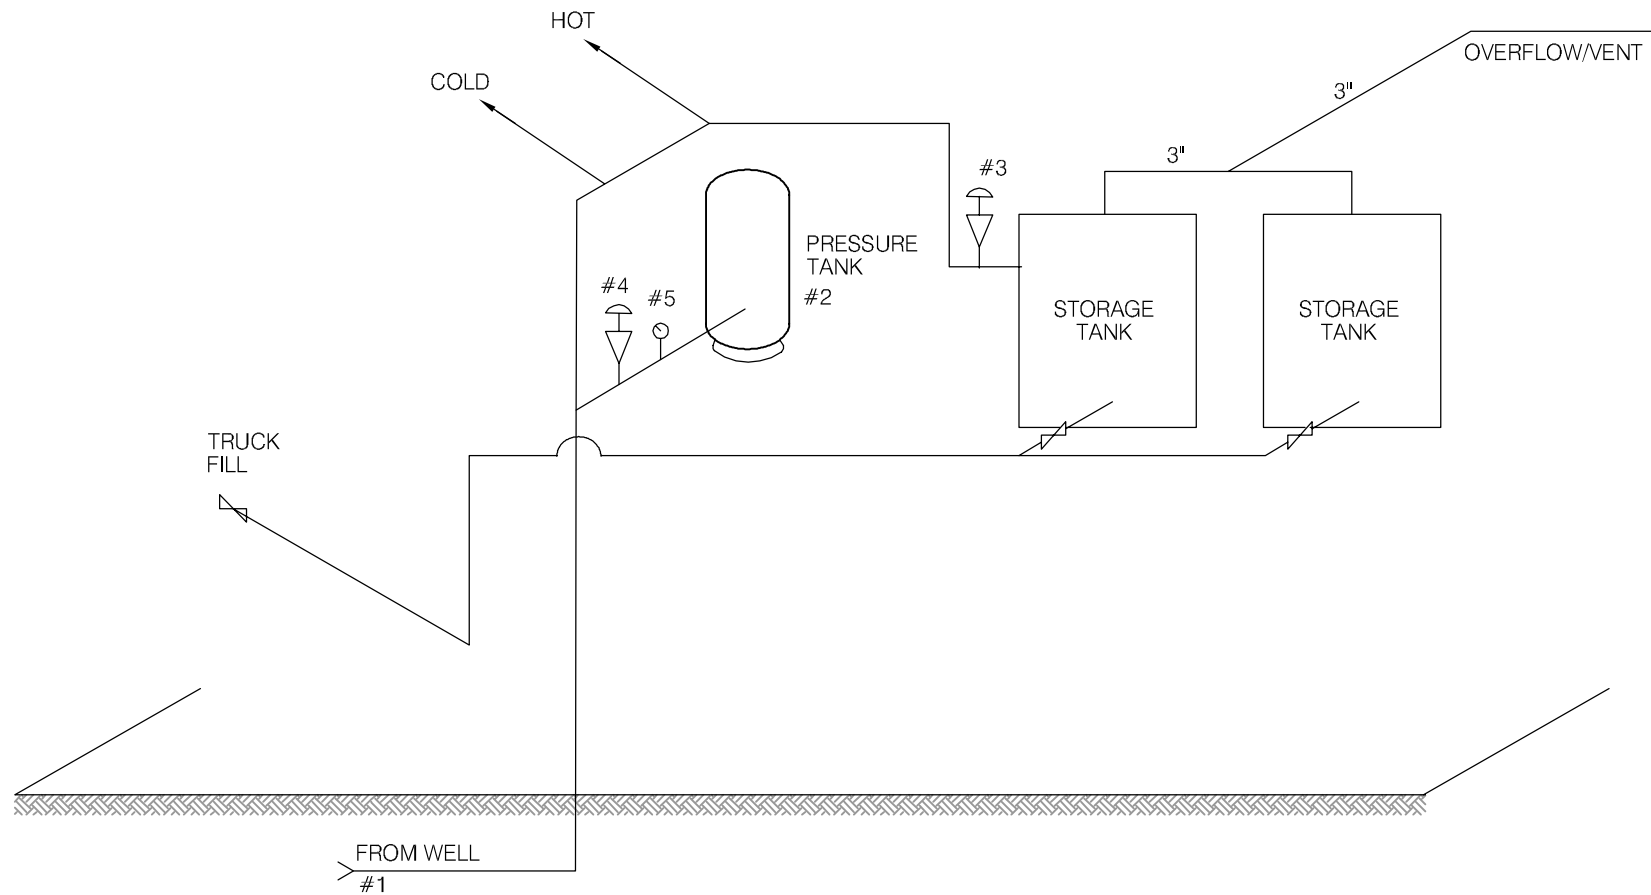
The water is delivered from the well to a pressure tank and then splits to serve the domestic water supply and two 5000 L water storage tanks for fire fighting use. A system schematic is shown by Figure 1955-B in Appendix A15. There is no treatment or disinfection system installed for this water supply system.

SCHEMATIC PRODUCED BY BERT ALBISSER OF AQUA TECH SUPPLIES & SERVICES LTD.
