## **11.0 BUILDING 1421: MENDENHALL FIRE HALL**

PROJECT SMALL PUBLIC WATER SYSTEMS ASSESSMENT  
WHITEHORSE REGION

**Whitehorse Region – Mendenhall Firehall  
Building # 1421**

## SMALL PUBLIC WATER SYSTEM ASSESSMENT

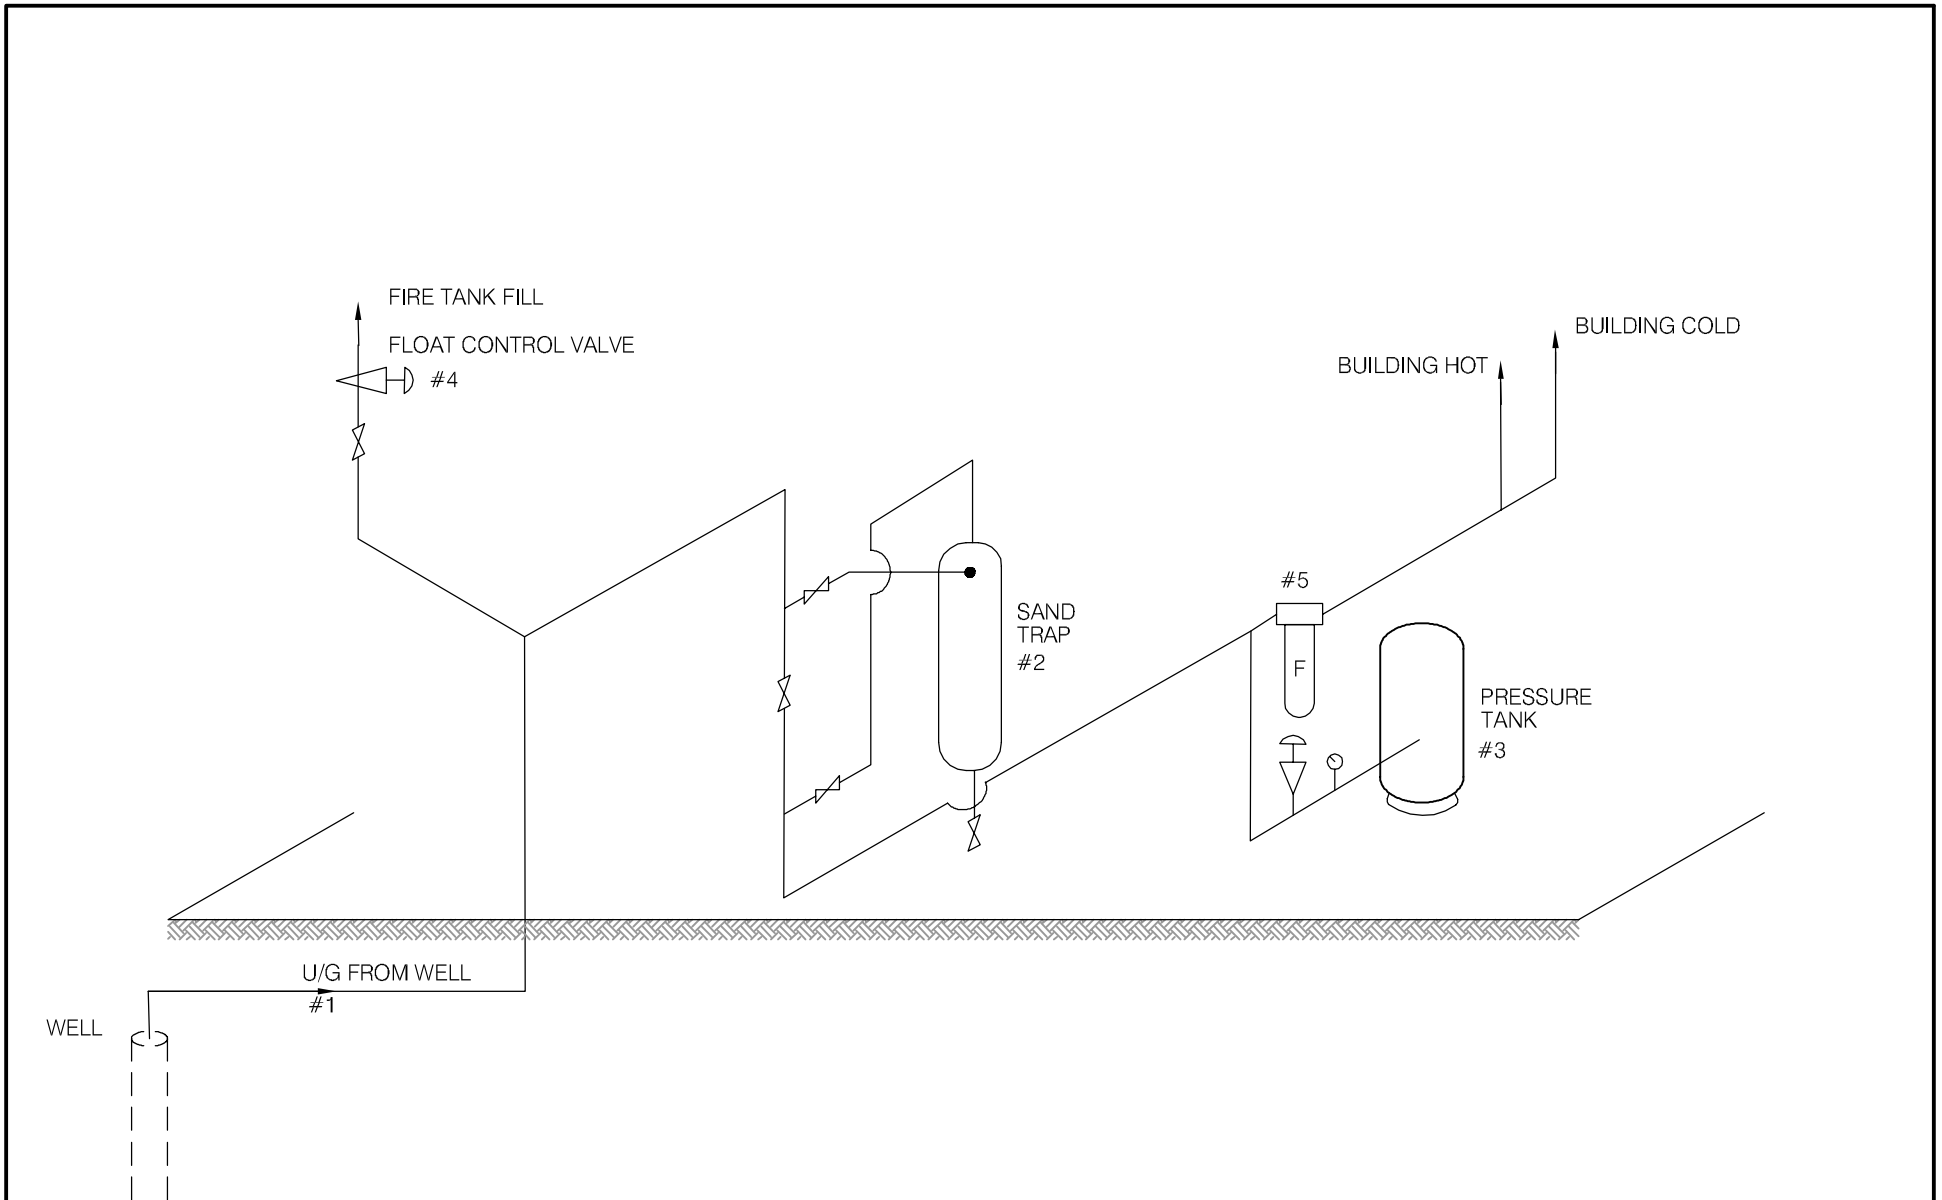
Water from the well is delivered to an 8000 L storage tank located in the well house. From the initial storage tank the water is then pumped to a water fill station attached to the well house for use of local residents, a pressure tank inside the fire hall for domestic use, and two 5000 L storage tanks for fire fighting use. There is no treatment or disinfection system anywhere on the water supply system.

- Install a point of entry (POE) treatment system for uranium removal. It is recommended that a suitable POE system be designed through small scale pilot testing, and that the system be installed in advance of the potable water storage tank. Uranium removal to below the CDWQG is necessary to utilize this water source as a drinking water supply.

- It is recommended that a commercially sized 1-micron NSF 61 certified filtration system (to reduce turbidity below 1 NTU, and prevent passage of protozoa) and a chlorine disinfection system be installed at the POE. The system should be equipped with a suitable digital dosing chlorine injection pump with spill containment deck and appurtenances.

- The 2000 US gal polyethylene tank should be dismantled and removed from the building and replaced with a sectional tank that can meet the demand of the fire hall and water pick-up station. It is anticipated that the tank could be replaced with a 1250 US gal tank of suitable design for potable water storage and with an accessible cleaning port. Once the tank is replaced, it is recommended that a regular cleaning program (every 6 months) be initiated.
