27.0 BUILDING 6746: ROSS RIVER HALL

SMALL PUBLIC WATER SYSTEMS ASSESSMENT
 EASTERN REGION

ROSS RIVER FIRE HALL
 BUILDING # 6746
 SITE LOCATION DIAGRAM
 WELL ID: 6746-A

SMALL PUBLIC WATER SYSTEM ASSESSMENT

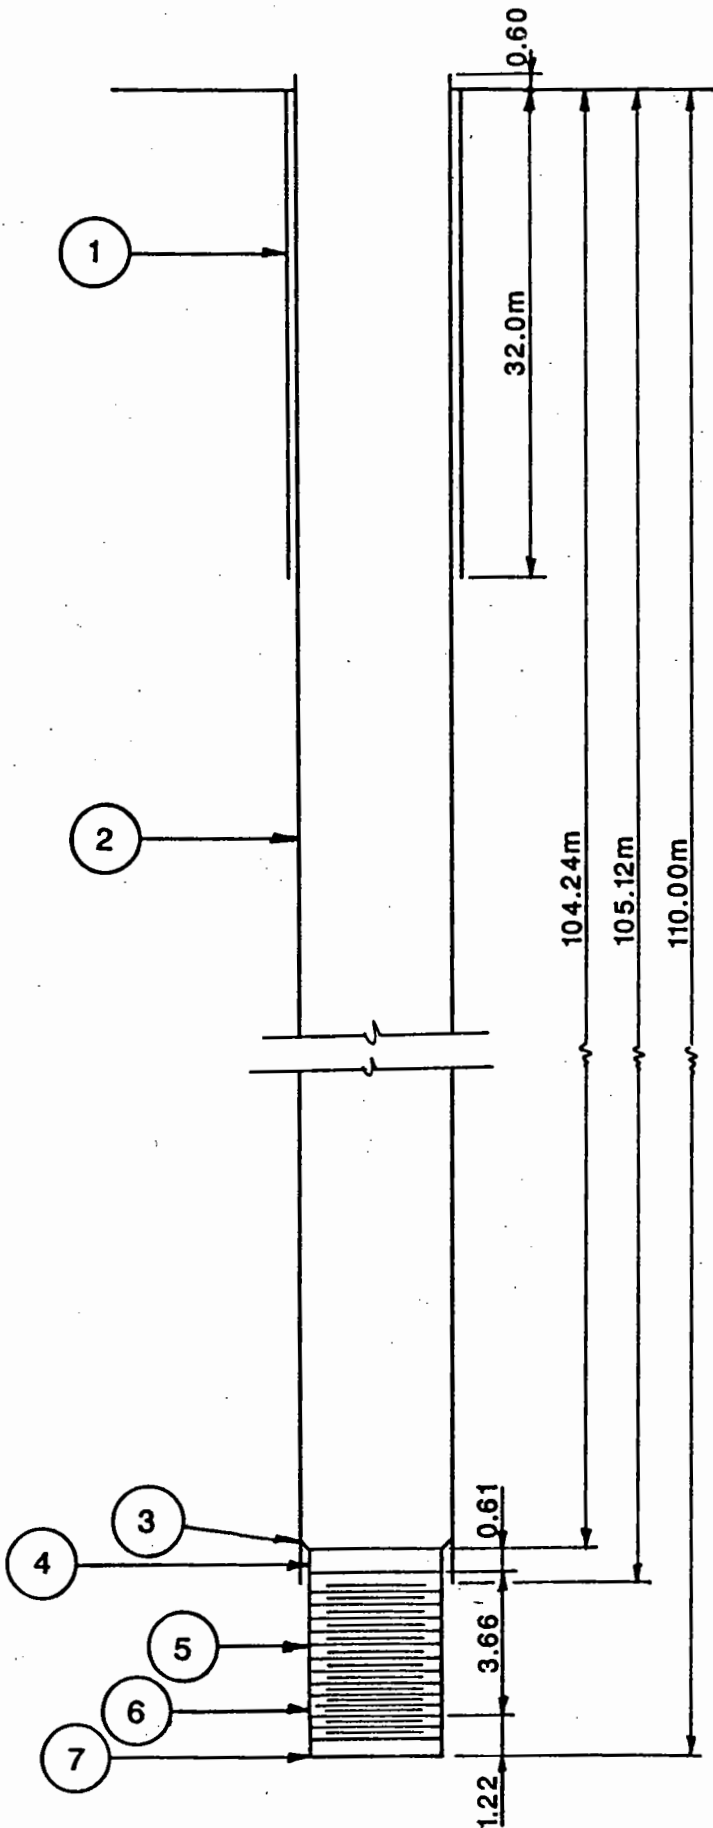
**ROSS RIVER
LITHOLOGY**

Depth (m)	Lithology	Comments
0 - 2.7	Till - sandy - silty, pebbles to 15 mm, gravel lens from 2.1 - 2.74 m (no noticeable water)	
2.7 - 8.2	Till - dry, sandy to 4.57 m increase in moisture, dark grey, top of permafrost at approximately 8.23 m	Begin injecting water at 7.62 m
8.2 - 18.5	Till - sandy, silty, some bedrock	
18.5 - 60.0	Till - silty clay, some sand, black, continue injecting water	
60.0 - 101.5	Till - silty sandy, some clay, becomes saturated with depth	Sand is running and sloughing on each connection
101.5 - 110.0	Gravel to 25 mm size, round to sub-round, producing water in excess of 25 L/sec

- 1 203mm O.D. STEEL CASING
- 2 168mm O.D. X 0.280mm WALL STEEL CASING
- 3 JOHNSON LEAD PACKER
- 4 141mm O.D. STEEL RISER
- 5 143mm O.D. X 124mm I.D. STAINLESS STEEL WELL SCREEN SLOTTED 0.64mm
- 6 143mm O.D. X 124mm I.D. STAINLESS STEEL WELL SCREEN SLOTTED 0.76mm
- 7 END CAP
