**1995 ANNUAL GEOTECHNICAL
PERFORMANCE EVALUATION
and
INSTRUMENTATION DATA REPORT
FARO MINE
YUKON
VOLUME I**

**Anvil Range Mining Corporation
Faro, Yukon
Y0B 1K0**

March 1996

RE: 1995 ANNUAL GEOTECHNICAL PERFORMANCE EVALUATION- FARO MINE

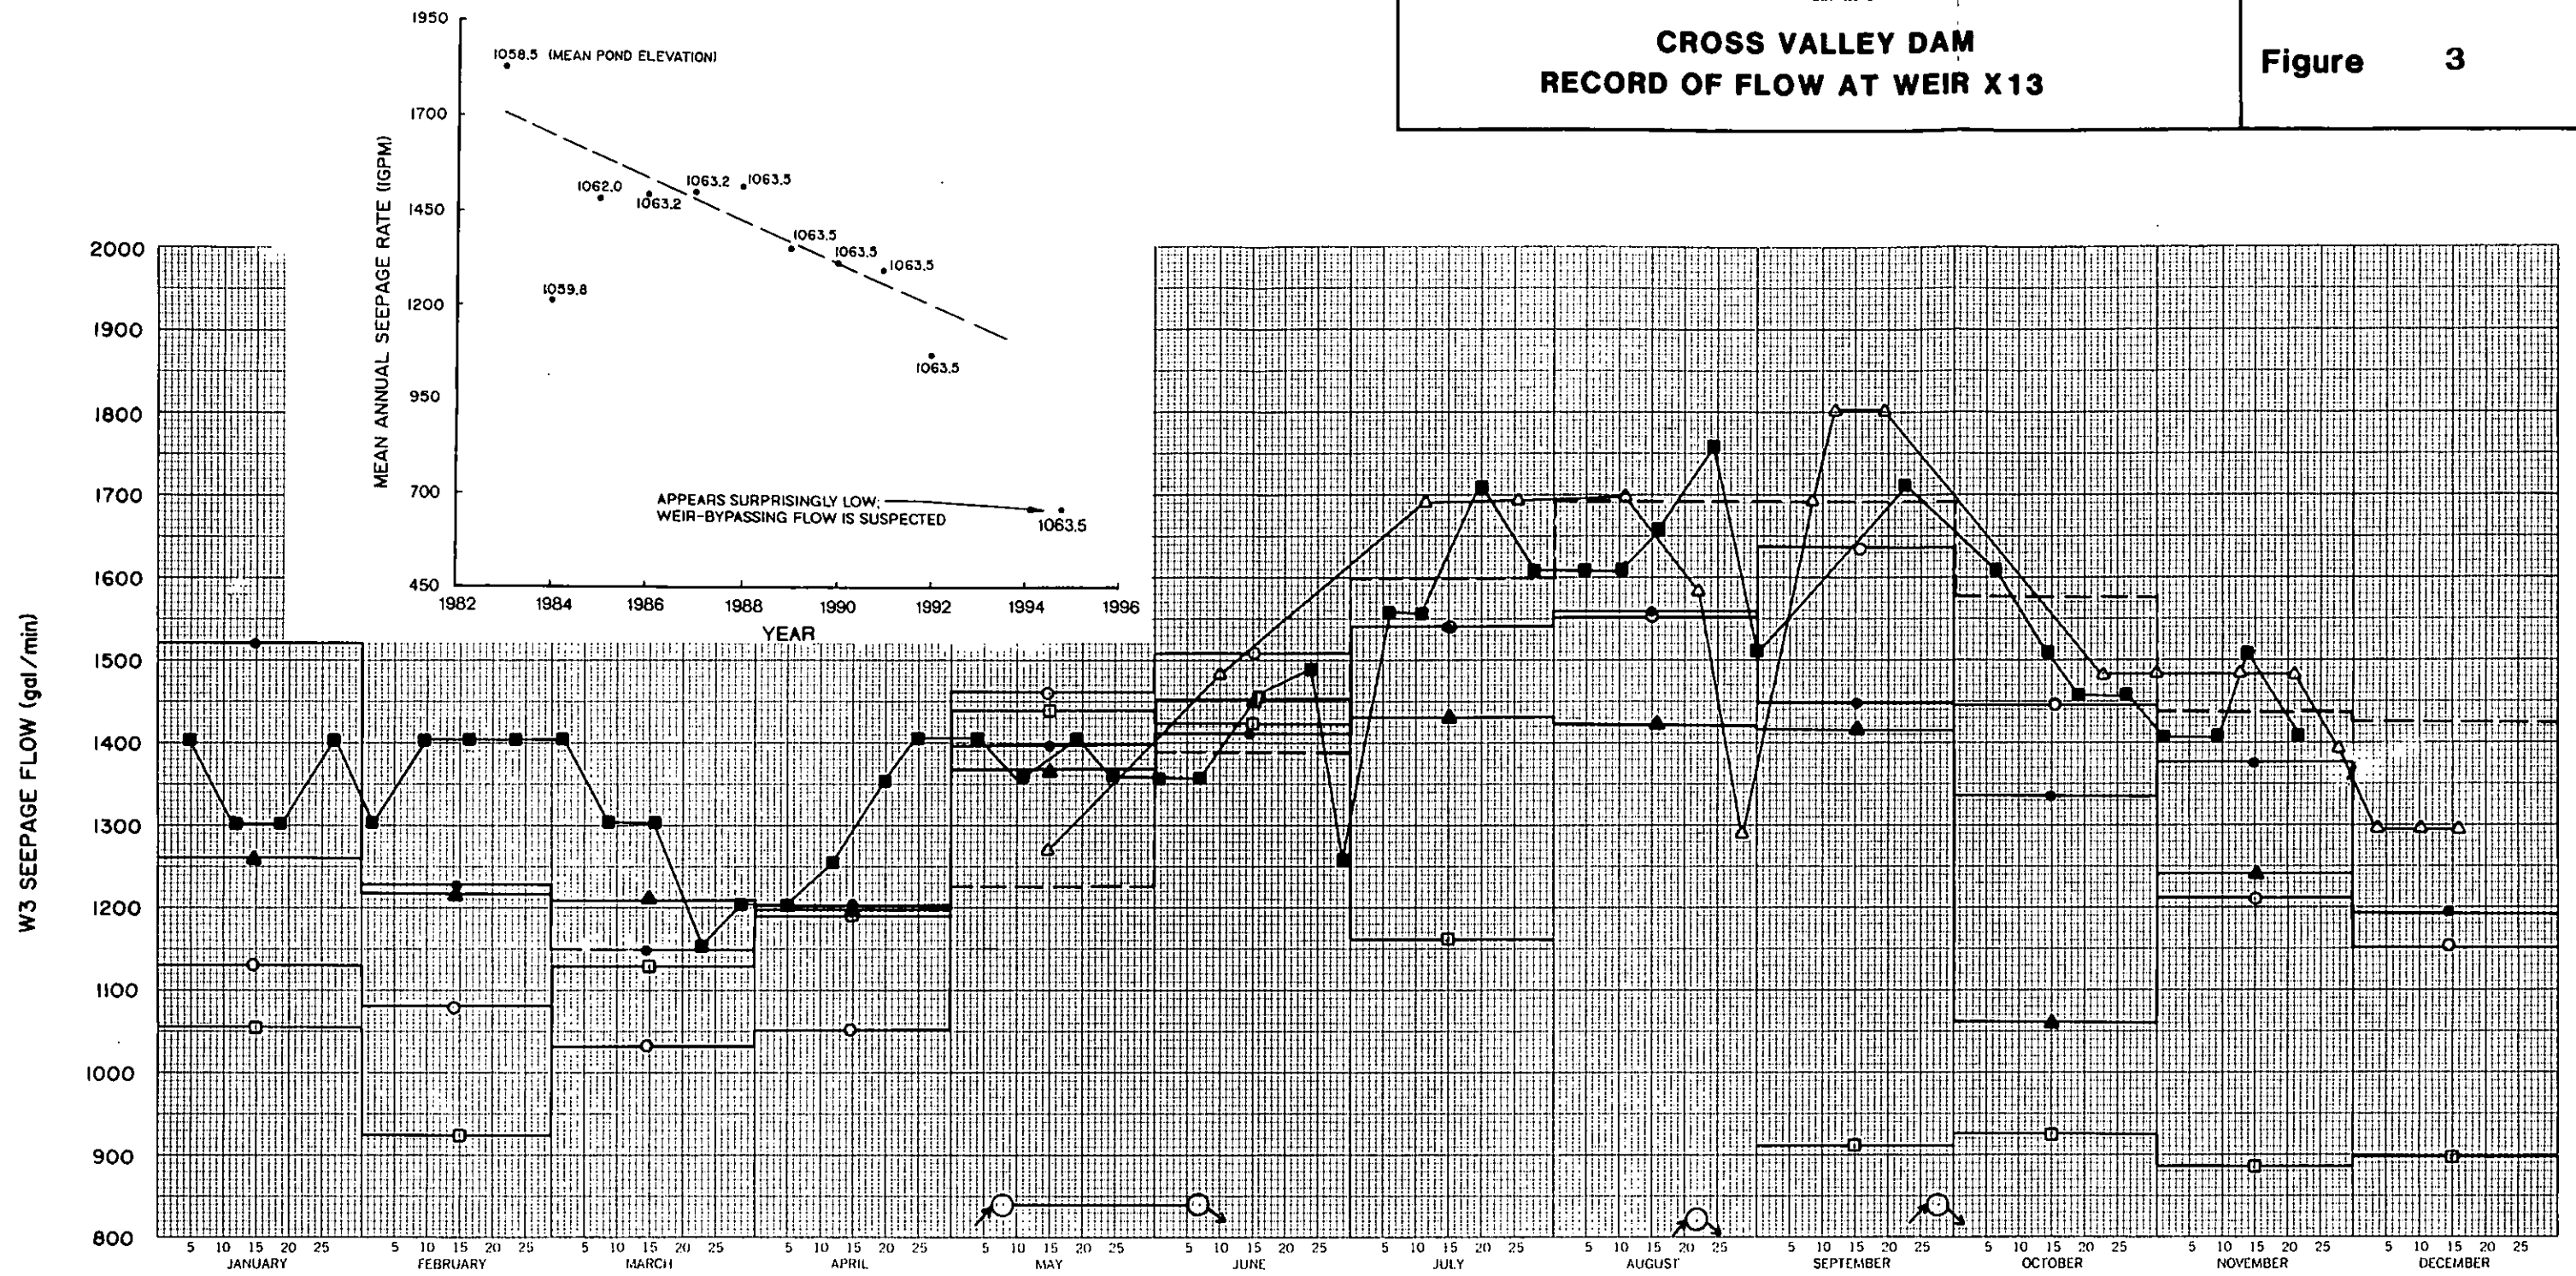
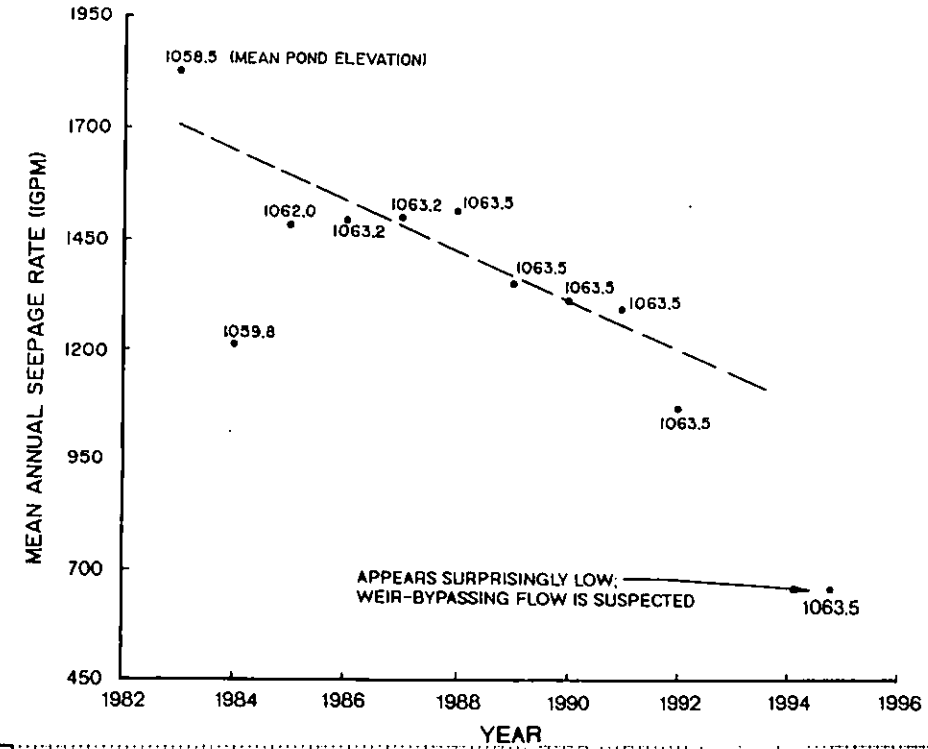
Figure 3

On the basis of the available data it appears that the average annual seepage rate is substantially lower for 1995 than has been measured previously (reduction in mean annual seepage rate of about 40 percent compared with 1992 data). This reduction has occurred in spite of the fact that weirs X-11 and X-12 do not consistently support this trend toward lower flows. While it may be possible that the central weir, W3 (see Figure 1 for location), has had a dramatically reduced flow during 1995, it is more likely that Weir X-13 has been damaged and that some of the flow is bypassing the weir, hence reduced flows are reported. According to annual September photographs of the W3 site, there is no support for the flow reduction needed to satisfy the X-13 measurements. It is suspected that Weir X-13 is leaking and that the data should be disregarded pending inspection (and repair) of the weir.

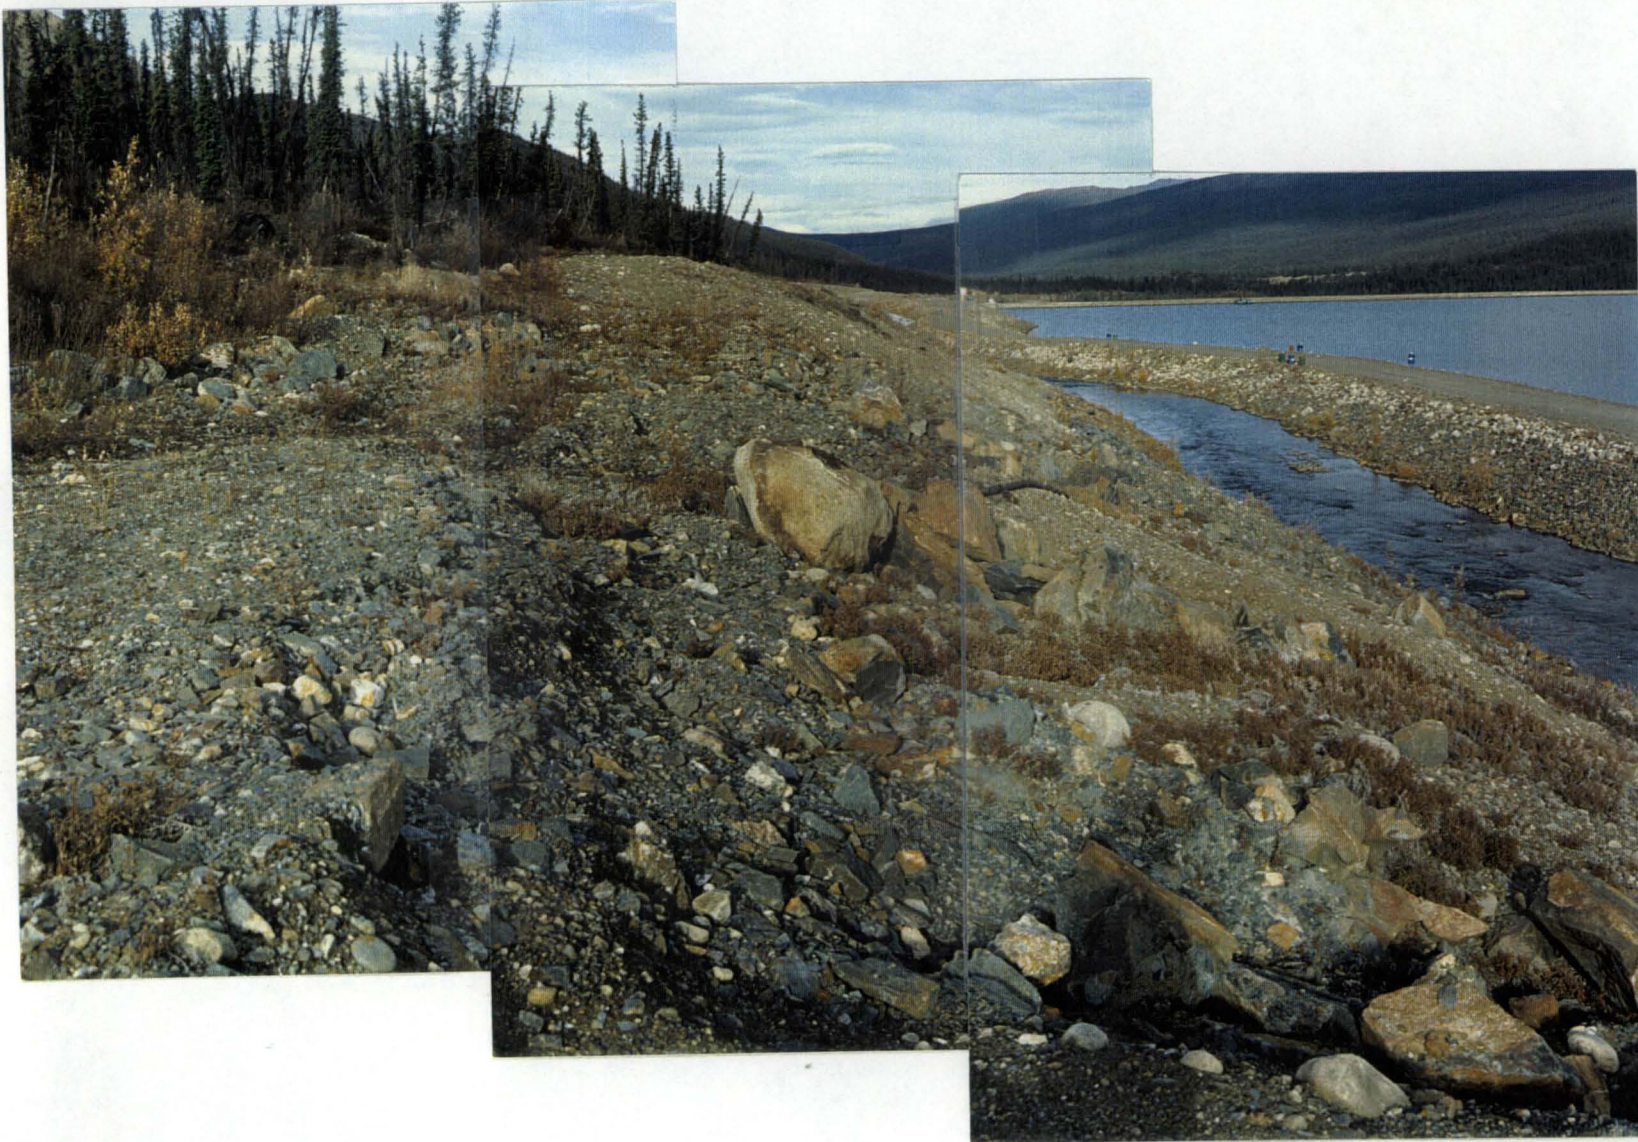
Figure 7

Inspection of the top of the thermal liner in the vicinity of Sta. 1+900 indicates little or no additional movement since 1994. Details of the area are provided by the photographs of Figures 7 and 8. Some surface drainage was flowing across the surface at one location at the time of the inspection. While the site had been deteriorating until about 1983, the fact of relatively little change since that time is encouraging with respect to diminished possibility of a new and major displacement. And, knowing from instrumentation data that the natural strata behind the thermal liner now appear to be in a new thermal equilibrium, it is recommended that the area be observed for another year before implementing repair work recommended by previous reports. Contention that a new thermal equilibrium has been attained is supported by the fact of little or no movement having occurred during the past two years, such movement likely having been at least partially due to melting of ice-rich ground behind the thermal liner.

3. To inspect in June, just after spring runoff is completed, the top of the thermal liner on the backslope of the Diversion Canal at the location of the somewhat-sloughed area situated about 500 m upstream of the Intermediate Dam, such inspection to determine if new (sharp-edged) cracking has developed. While there the inspector should redirect surface drainage to keep it from ponding along the back side of the thermal liner crest, and to keep it from unnecessarily entering crest area cracks. This inspection requires some walking, the inspector should carry a hand shovel to direct surface flow. Pictures should be taken for comparison with those in Figures 7 and 8 of this report. Golder Associates should be advised of any evidence that movement has occurred in the area.
