June 26, 1990
Project Number 60619

Curragh Resources Ltd.
117 Industrial Road
Whitehorse, Yukon
Y1A 2T8

RE: Room and Pillar Review

The following is a brief report of the visit by Chris Page and Jim Mathis to the room-and-pillar operations at Faro during the week of 19 July.

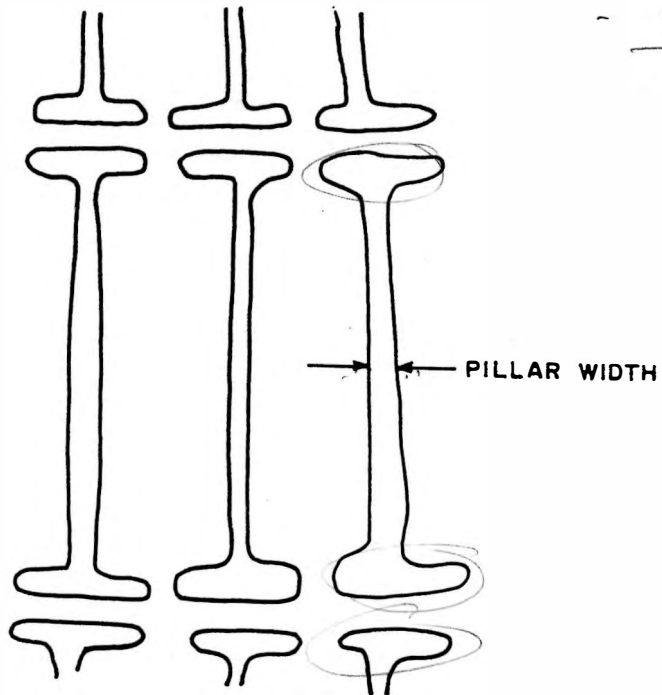
It is important to note that Hedley did most of his work on pillars that had the following shape:

Plan view of room and pillar layout at Elliot Lake
