U/G PILLAR  
INSPECTION

PIVAR INSPECTION

CURRAGH RESOURCES INC.  
file: PILLAR

FARO U/G PILLAR INSPECTION  
=====

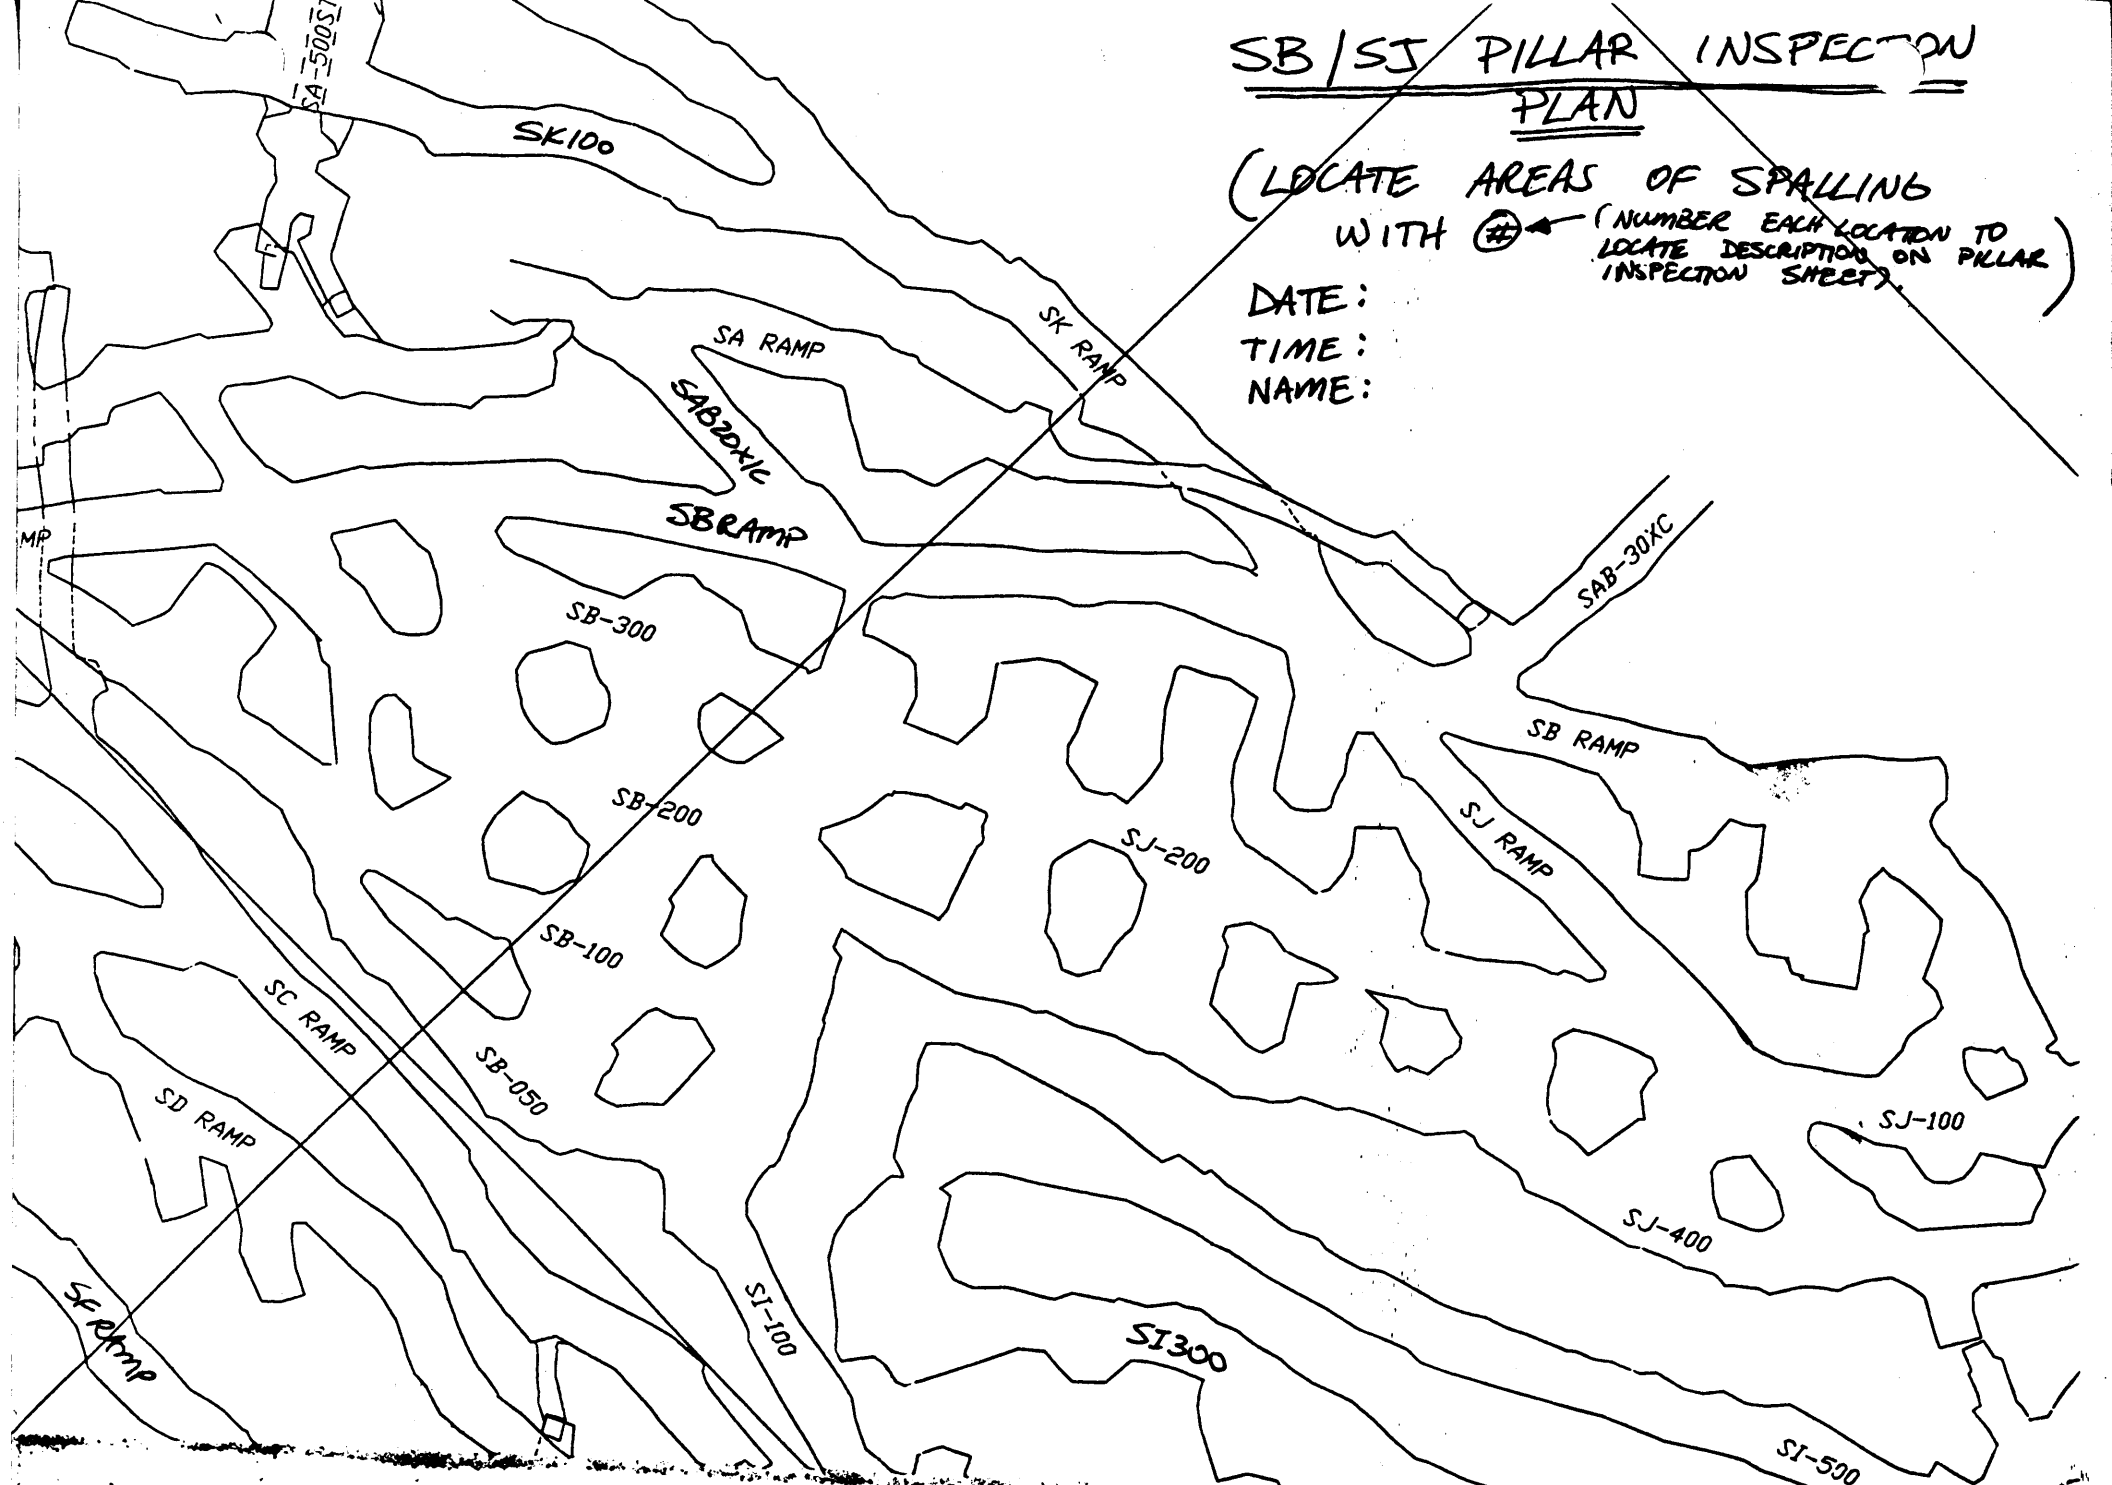
# SB/SJ PILLAR INSPECTION PLAN

A CURSORY VISUAL INSPECTION WAS PERFORMED ON THE SOUTH "B" & "J" STOPS. AS THE PIVARS WERE PAINTED, ONLY ONE PIVAR SHOWED SIGNS OF OPEN FRACTURES AND POTENTIAL SLABBING (#3 ON S3/SJ PIVAR INSPECTION PLAN). SEVERAL PIVARS HAVE YET TO BE PAINTED AND SHOULD BE MARKED ONCE BENCHING IS COMPLETED.

▶ A pillar inspection of the SB stope was conducted with Jim Mathis on March 7/91. #1 on the SB/SJ inspection plan show signs of minor slipping along HW contact. #2 has jointing / fractures, a potential for slabbing.

① Mine sloping along HW contact.  
Clear surface observed.

② Fractures & jointing observed. No fresh  
loose. Potential slabbing here.
