**PITEAU ASSOCIATES**  
TECHNICAL AND  
HYDROLOGICAL CONSULTANTS

June 23, 1995

Re: Current Groundwater Conditions in the Southeast Walls of the Grum Pit

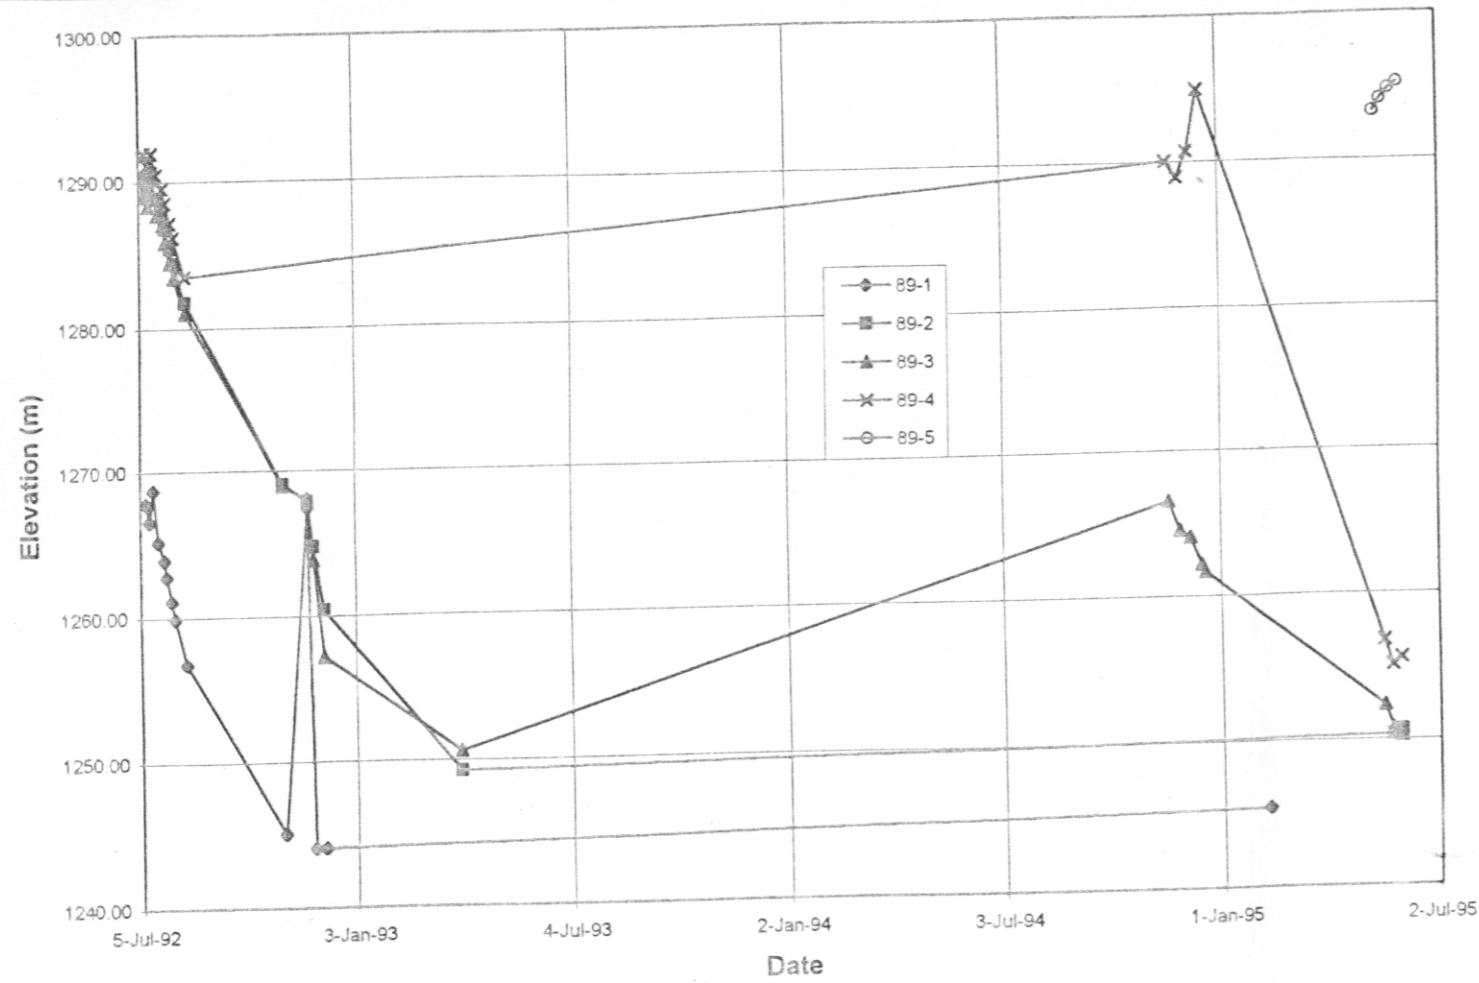
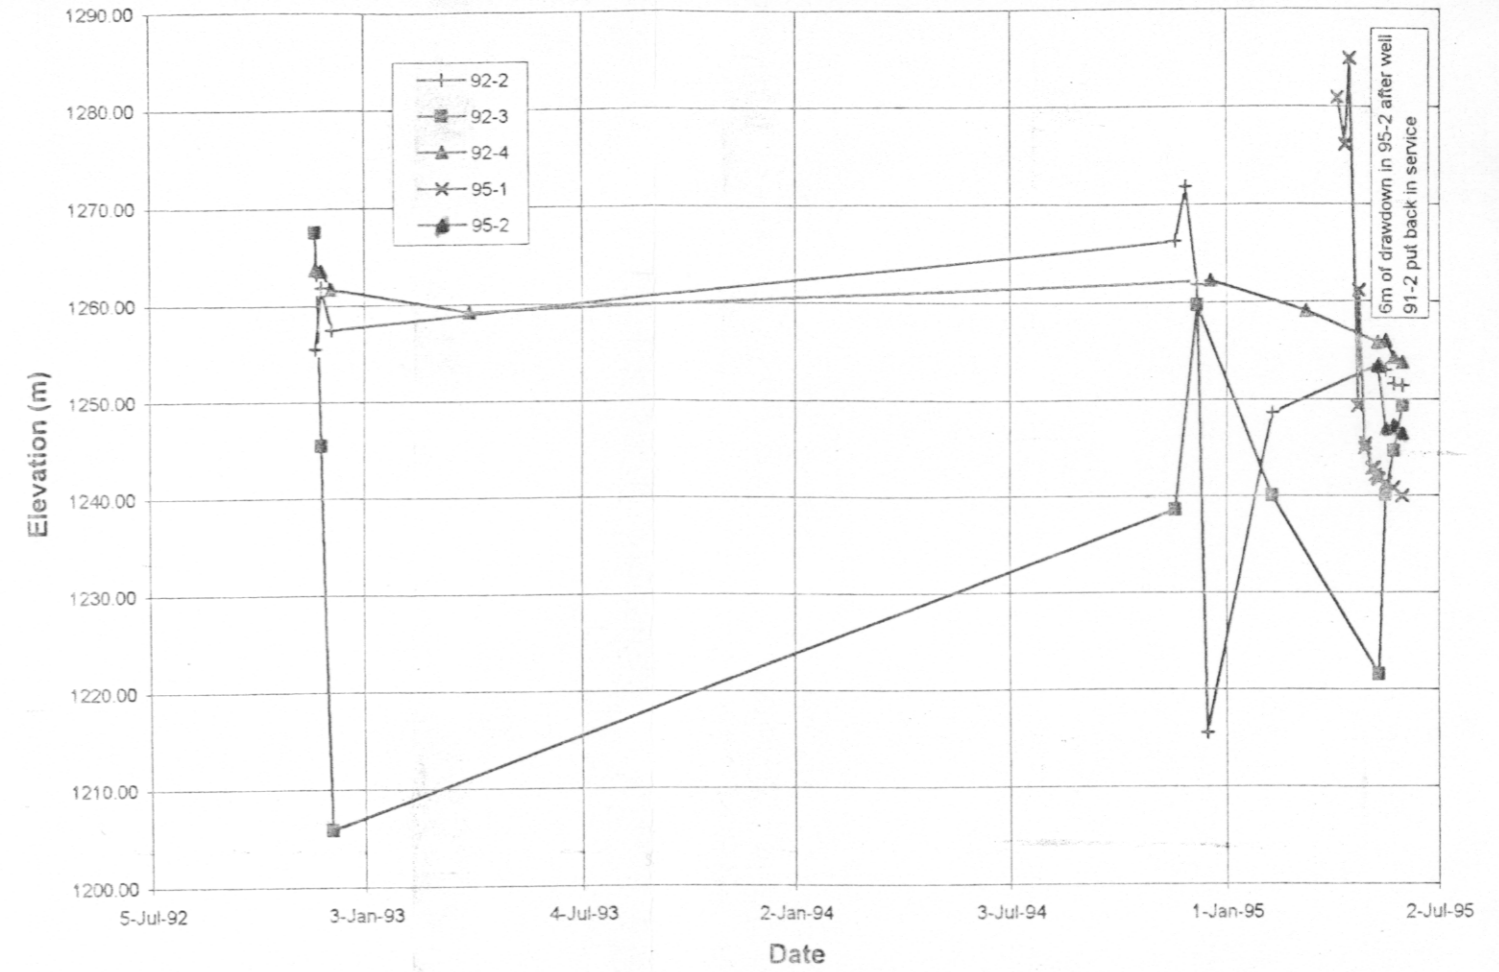
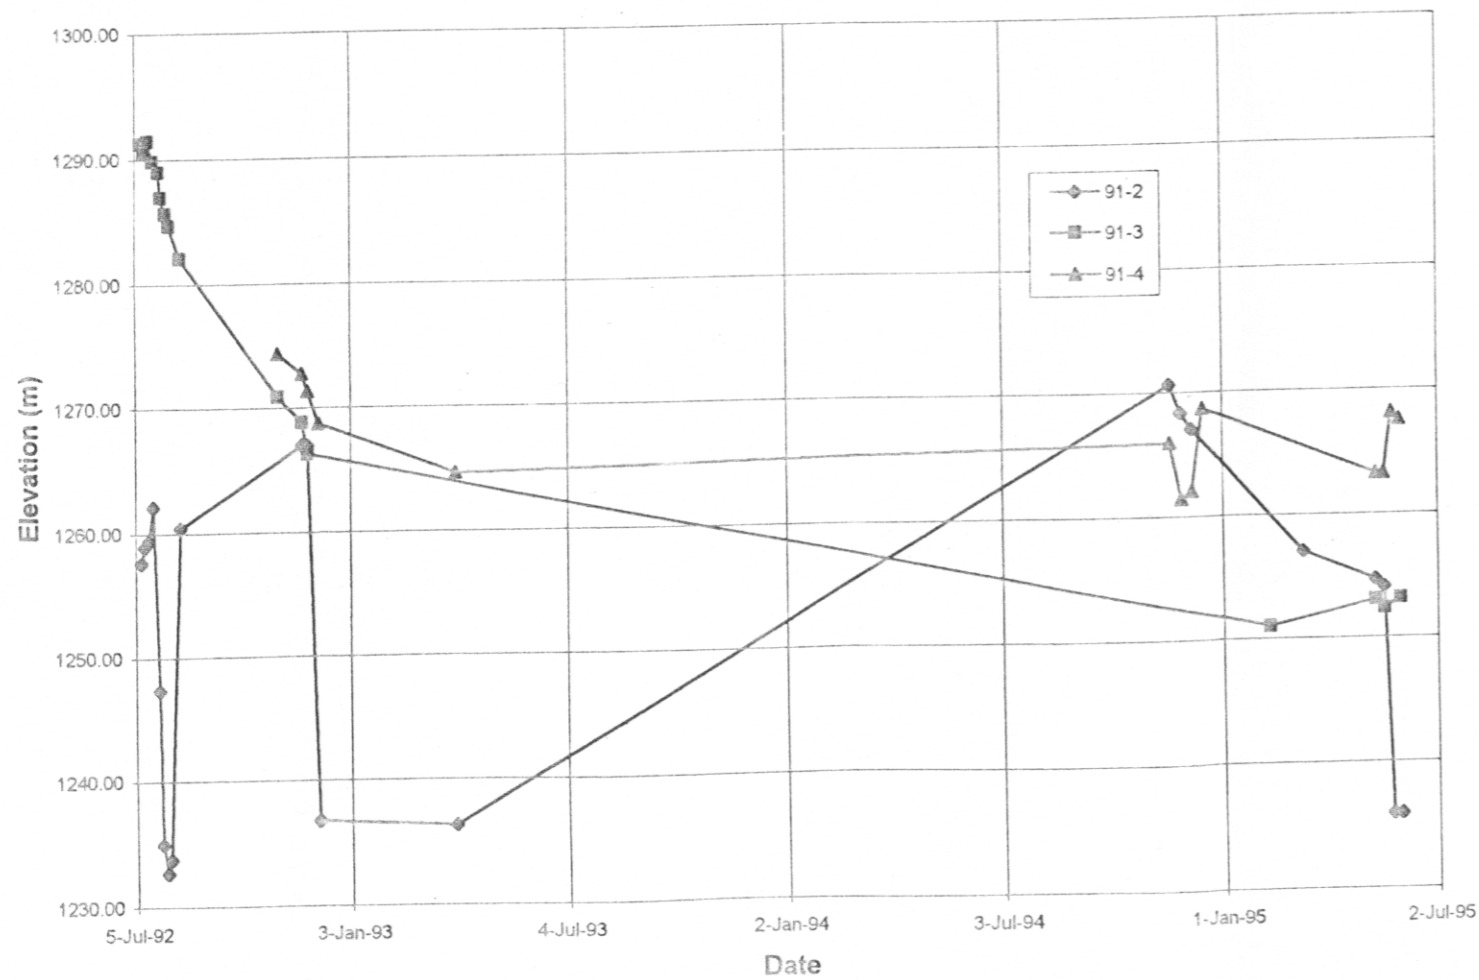
<b>PITEAU ASSOCIATES</b> GEOTECHNICAL CONSULTANTS VANCOUVER      CALGARY
ASSESSMENT OF AQUIFER DEWATERING GRUM PIT		
HYDROGRAPHS FOR PUMPING AND OBSERVATION WELLS		BY: ATH      DATE: JUN 95 APPROVED: <i>[Signature]</i> DWG: 3

Even though the aquifers appear to be depressurizing well in response to pumping and mining, the surrounding sediments are much lower in permeability and are expected to depressurize at a slow rate. Existing slope performance indicates that the soils have sufficient strength to stand in a saturated state. However, if a lens of loose soil is encountered within the generally dense soil mass, some localized slumping could occur. Slopes in the southeast corner of the pit should therefore be inspected frequently for any signs of seepage or slumping.
