CYPRUS ANVIL MINE GEOTECHNICAL EVALUATION  
JUNE, 1984 FIELD TRIP

84-07-05

BERZINS, B.

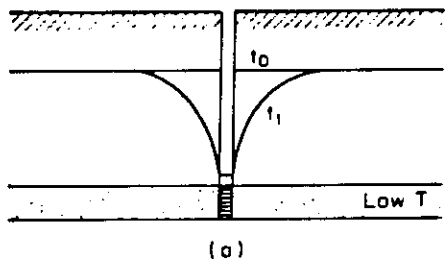
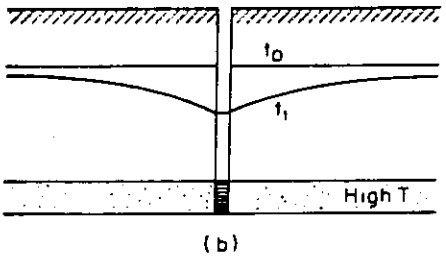
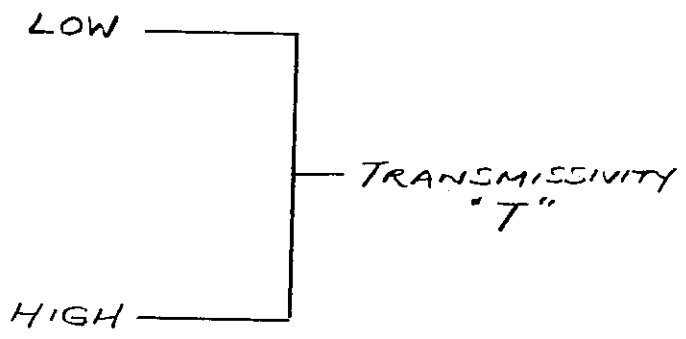
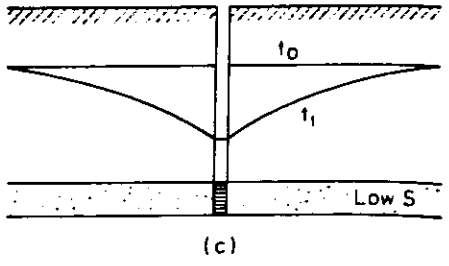
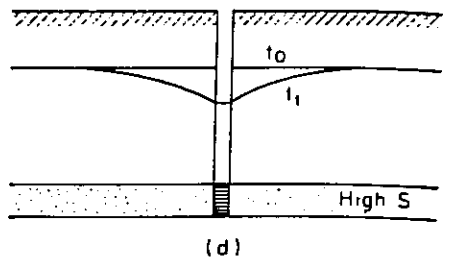
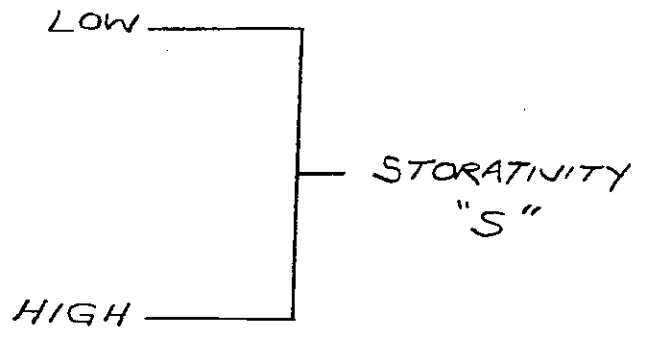
FIGURE 2 - COMPARISON OF DRAWDOWN CONES FOR VARYING TRANSMISSIVITY AND STORATIVITY

transmissivity (Figure 2). This low transmissivity, however, may only be directional, in that the cut faces may be parallel to permeable joint sets. In addition, vertical boreholes may not necessarily intersect steeply-dipping structural features, thereby leading to uncertainty in the interpretation of response during pumping.

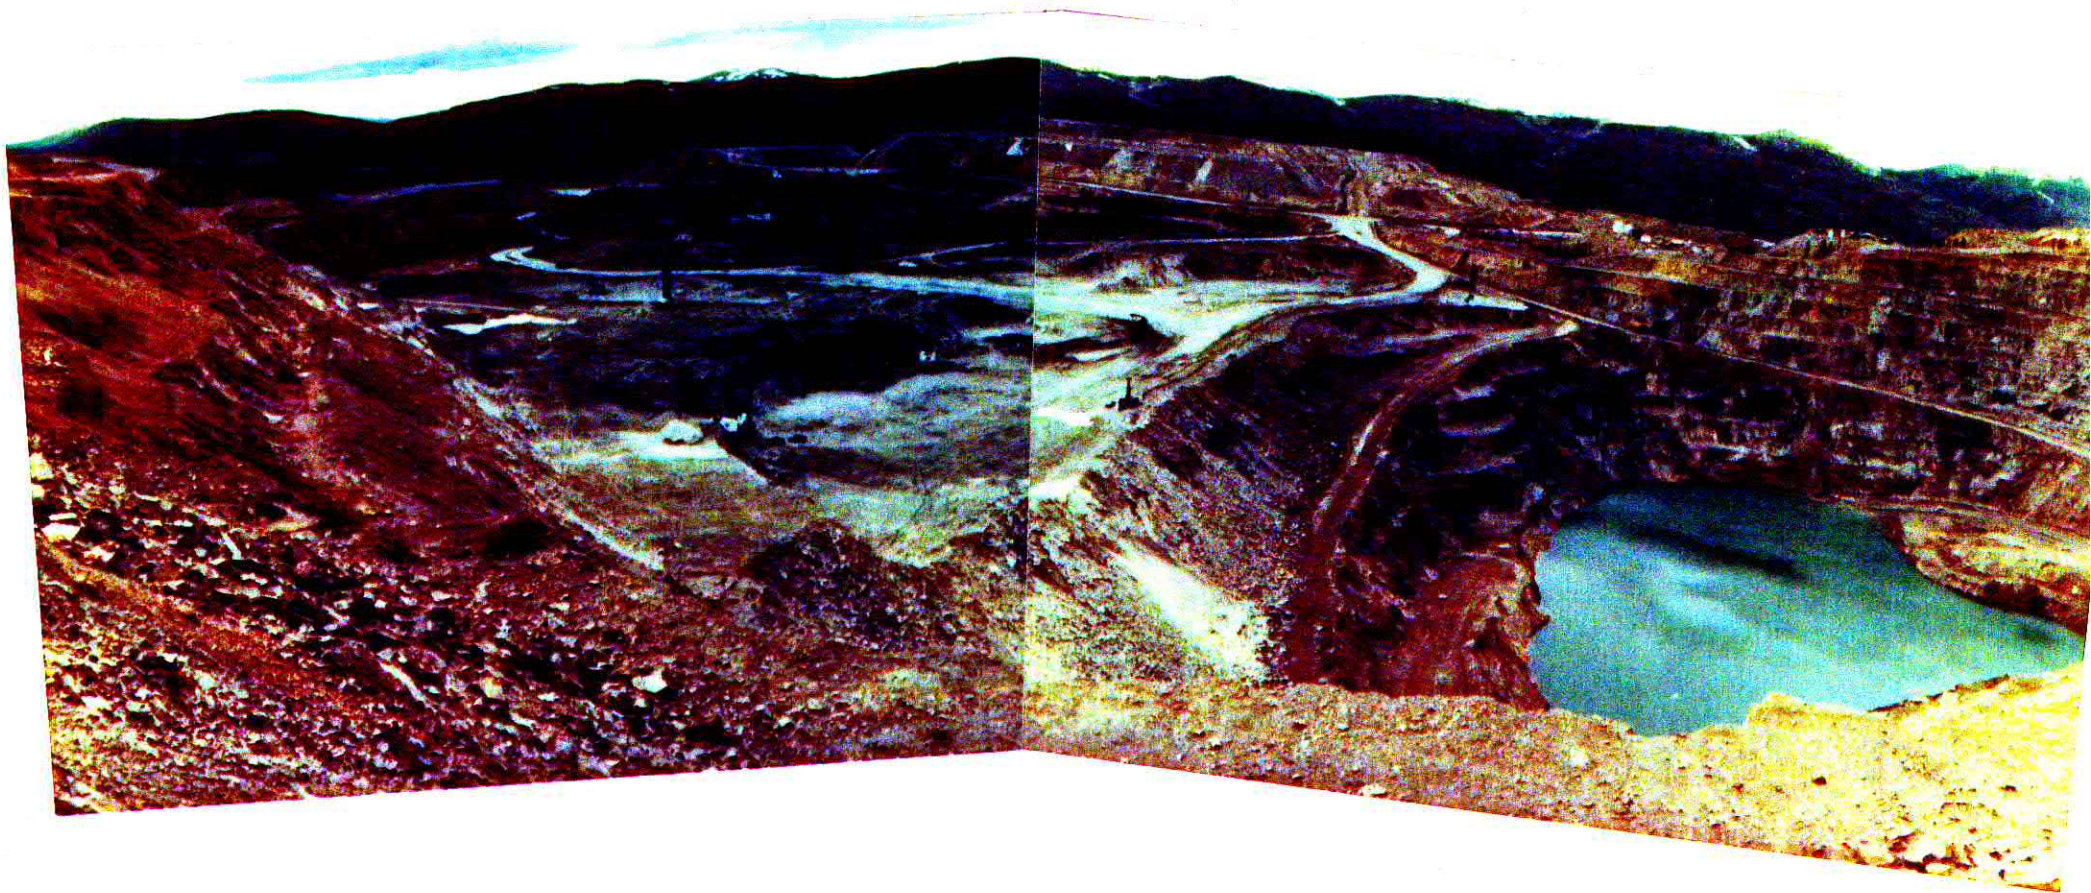
**Pan view of pit**

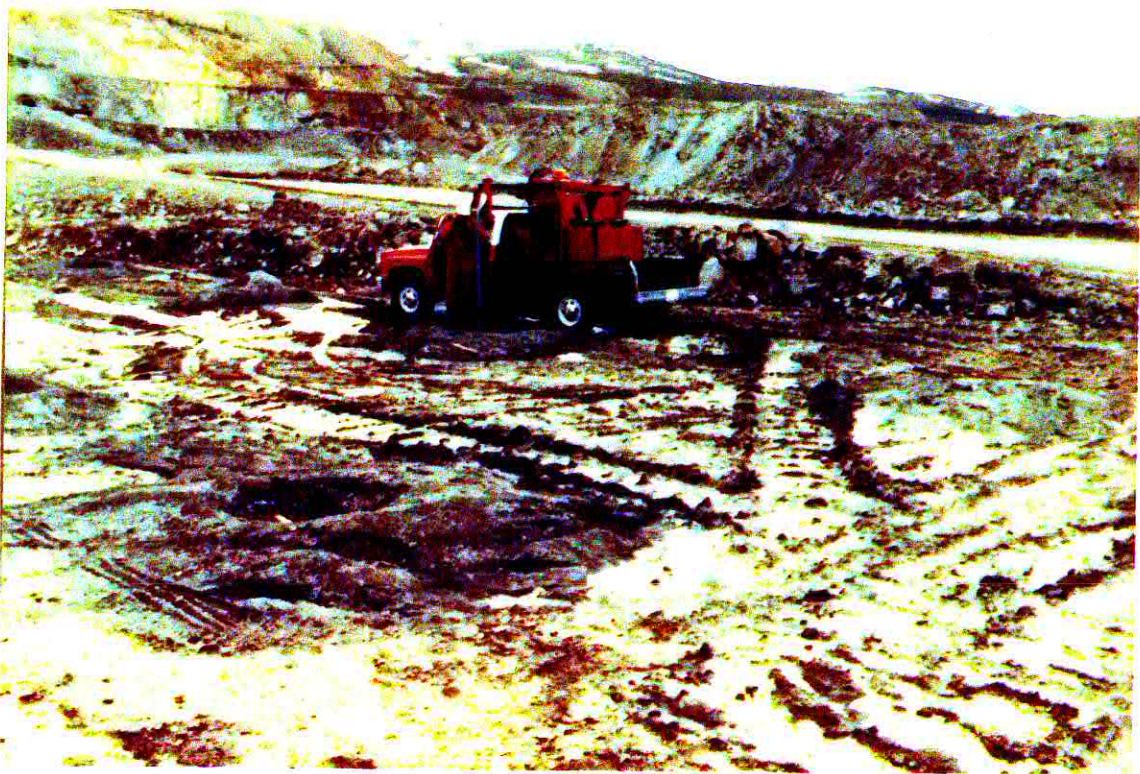
**Photo 28**  
**Pump test on 3870 bench**

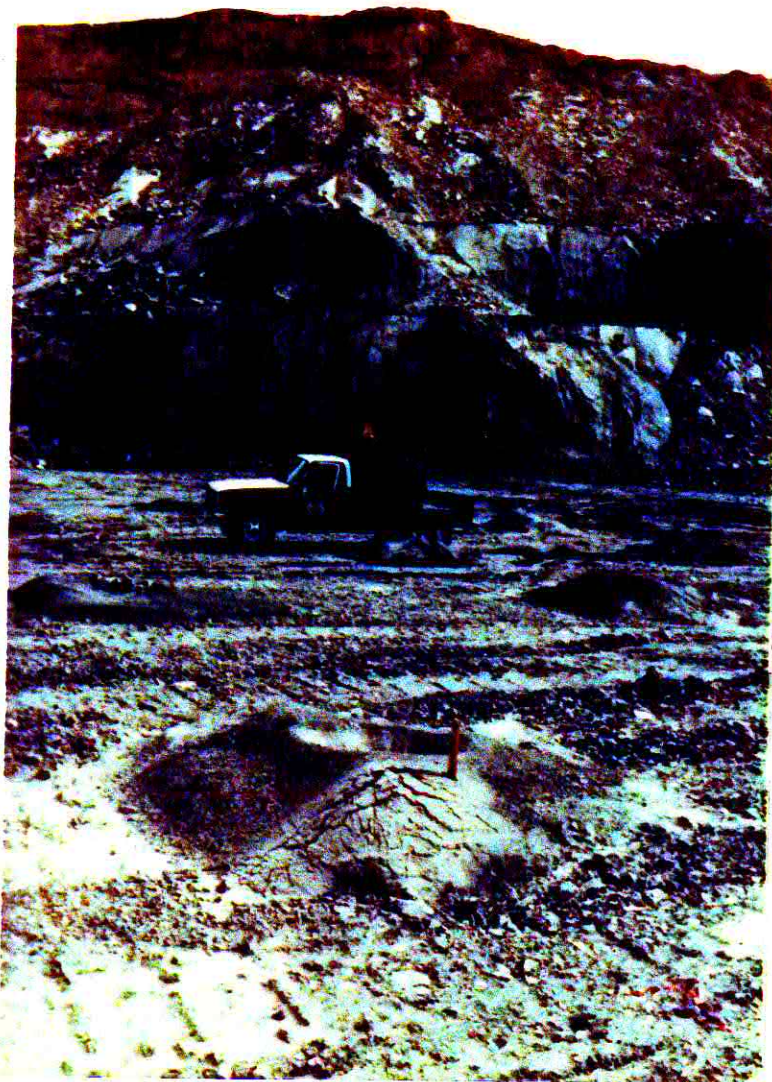
**Photo 29**  
**Pump test on 3910 bench**

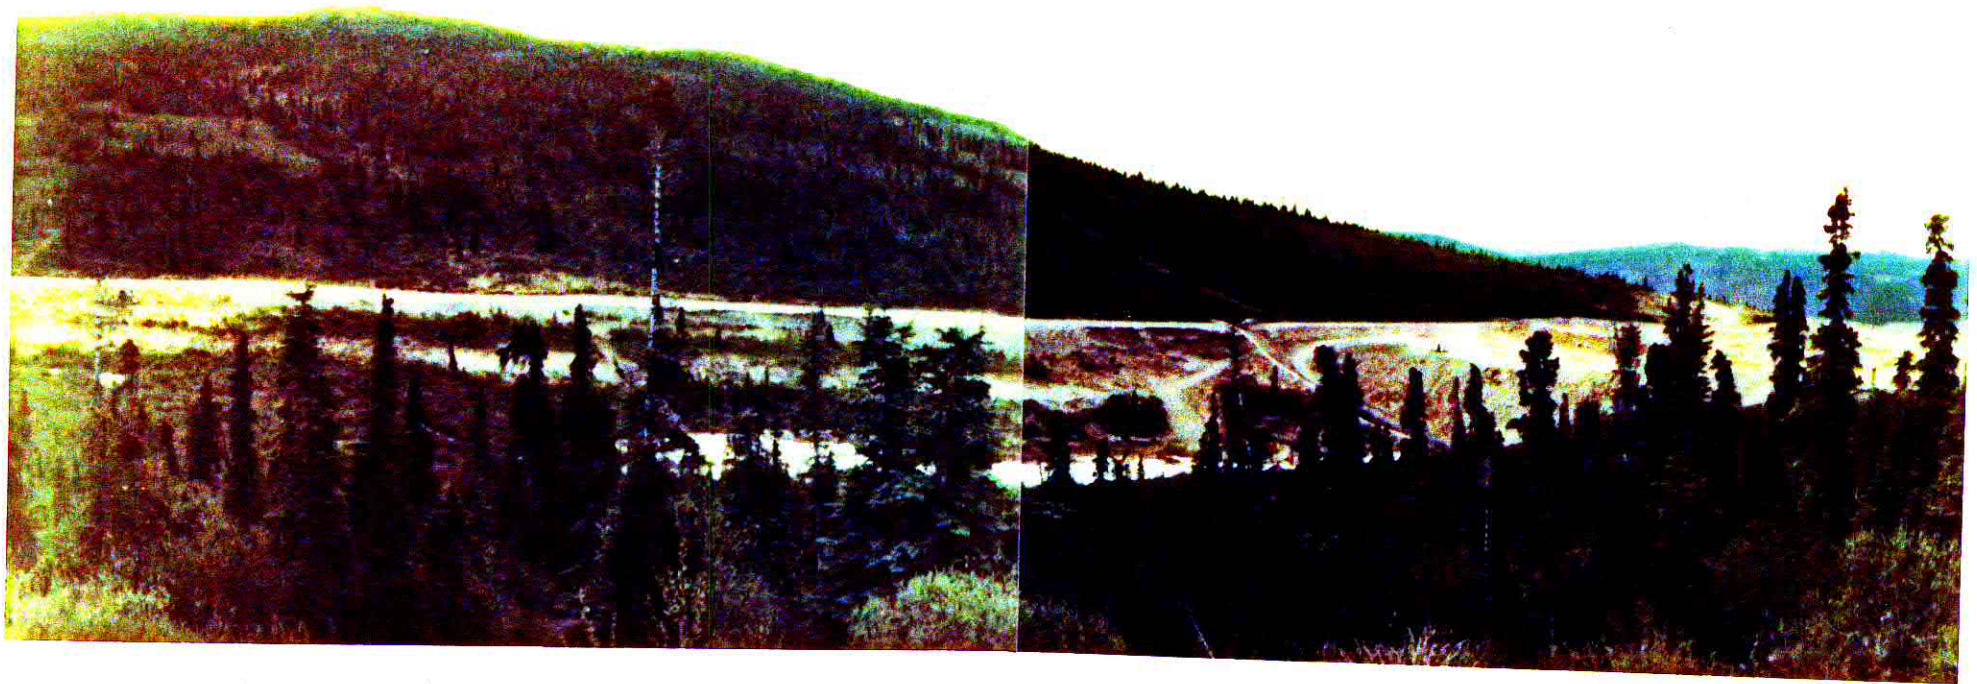
**Pan view of catchment area above Zone 3**

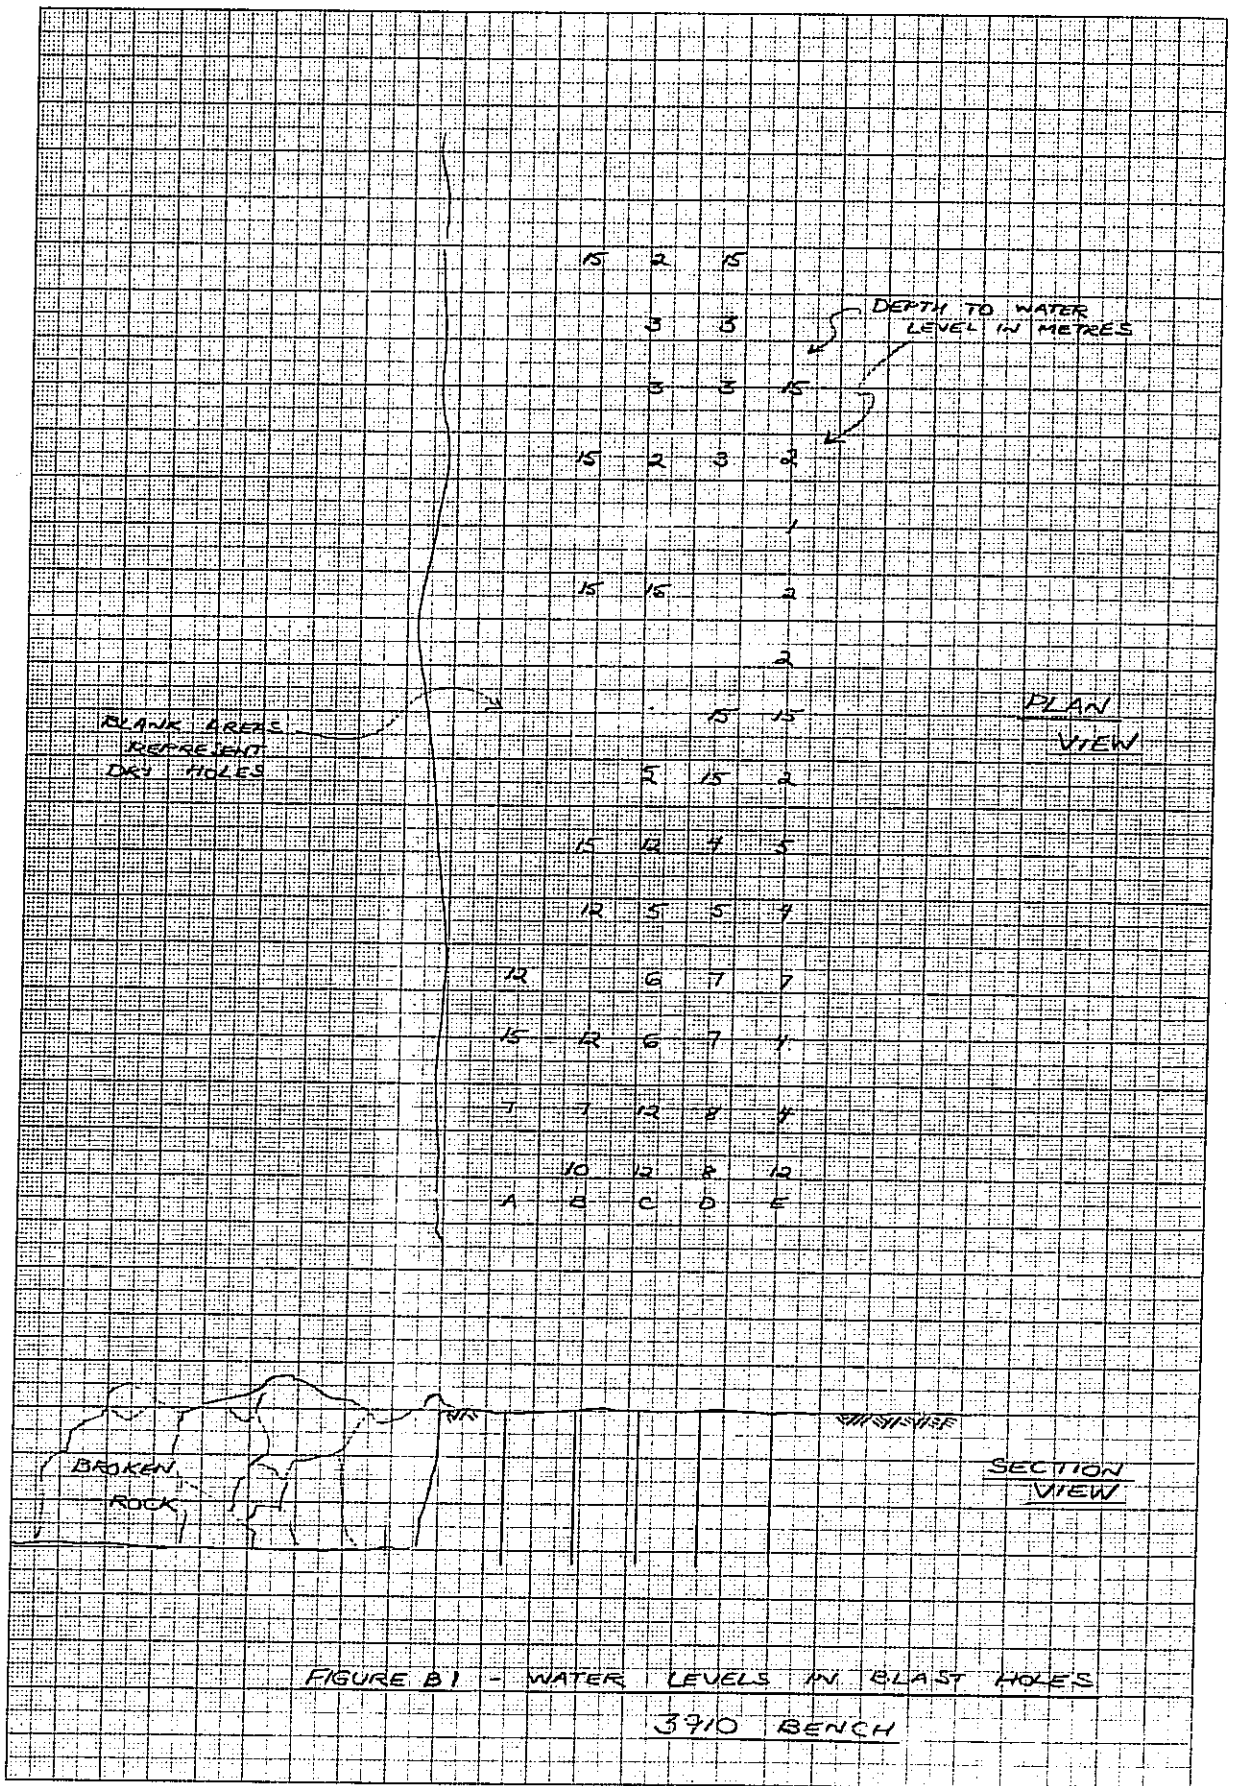
FIGURE B1 - WATER LEVELS IN BLAST HOLES  
3910 BENCH

- Well spacing at 7 m.
- Hole depths 43' (average).
- Hole was dry at 300 seconds.
- Hole would be designated as a "liner" hole when entered into blasting records.

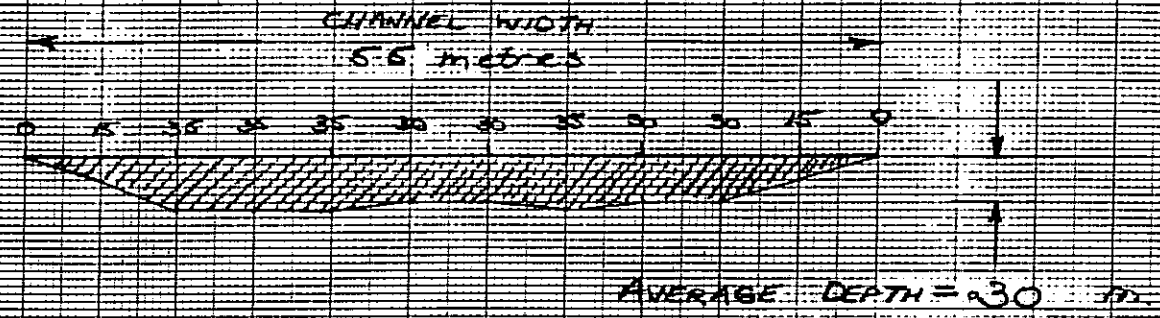
UPSTREAM FLOW ESTIMATE - FARD CREEK DIVERSION

UPSTREAM FLOW =  $(5.5 \text{ m})(.3 \text{ m})(1 \text{ m/s}) = 165 \text{ m}^3/\text{sec}$

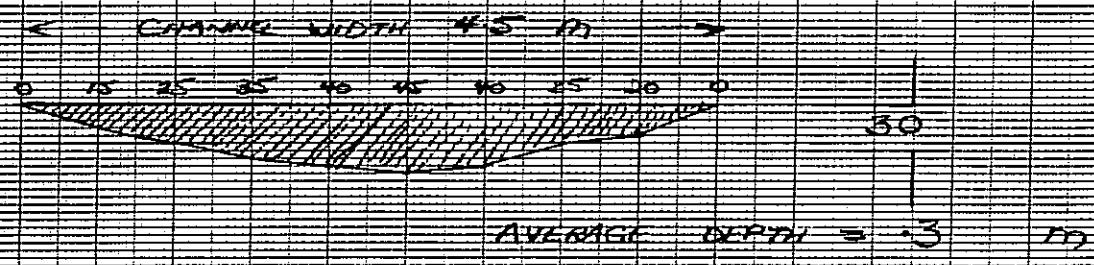
DOWNSTREAM FLOW ESTIMATE - FARD CREEK DIVERSION

DOWNSTREAM FLOW =  $(4.5 \text{ m})(.3 \text{ m})(1.1 \text{ m/s}) = 1485 \text{ m}^3/\text{sec}$

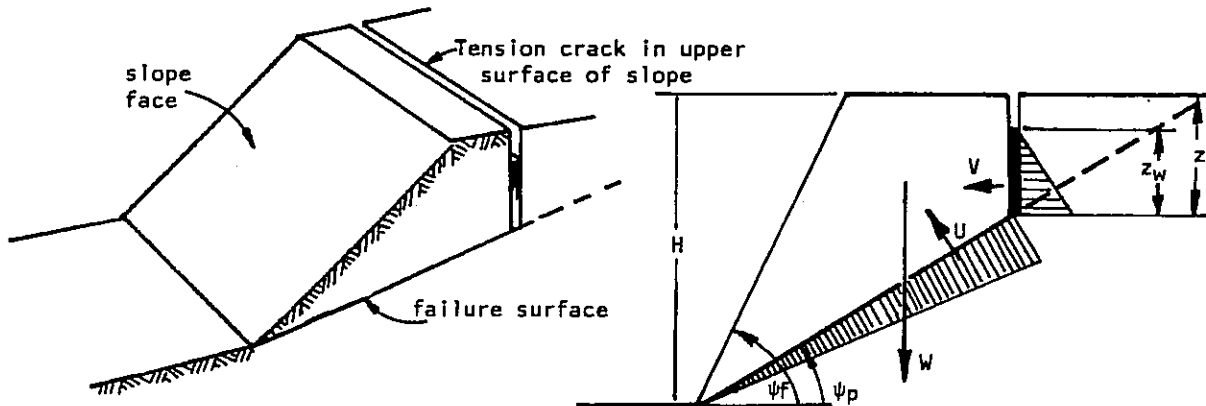
Figure 62a : Geometry of slope with tension crack in upper slope surface.

assuming the slope is marginally stable with a full tension crack,  $F \approx 1$ .

This assumes failure occurs at the bedrock/overburden interface.
