CURRAGH RESOURCES - FARO MINE

REPORT  
ON  
1987 SITE VISIT

Prepared For:  
NORTHERN AFFAIRS PROGRAM  
Whitehorse, Y.T.

July, 1987  
G052-4

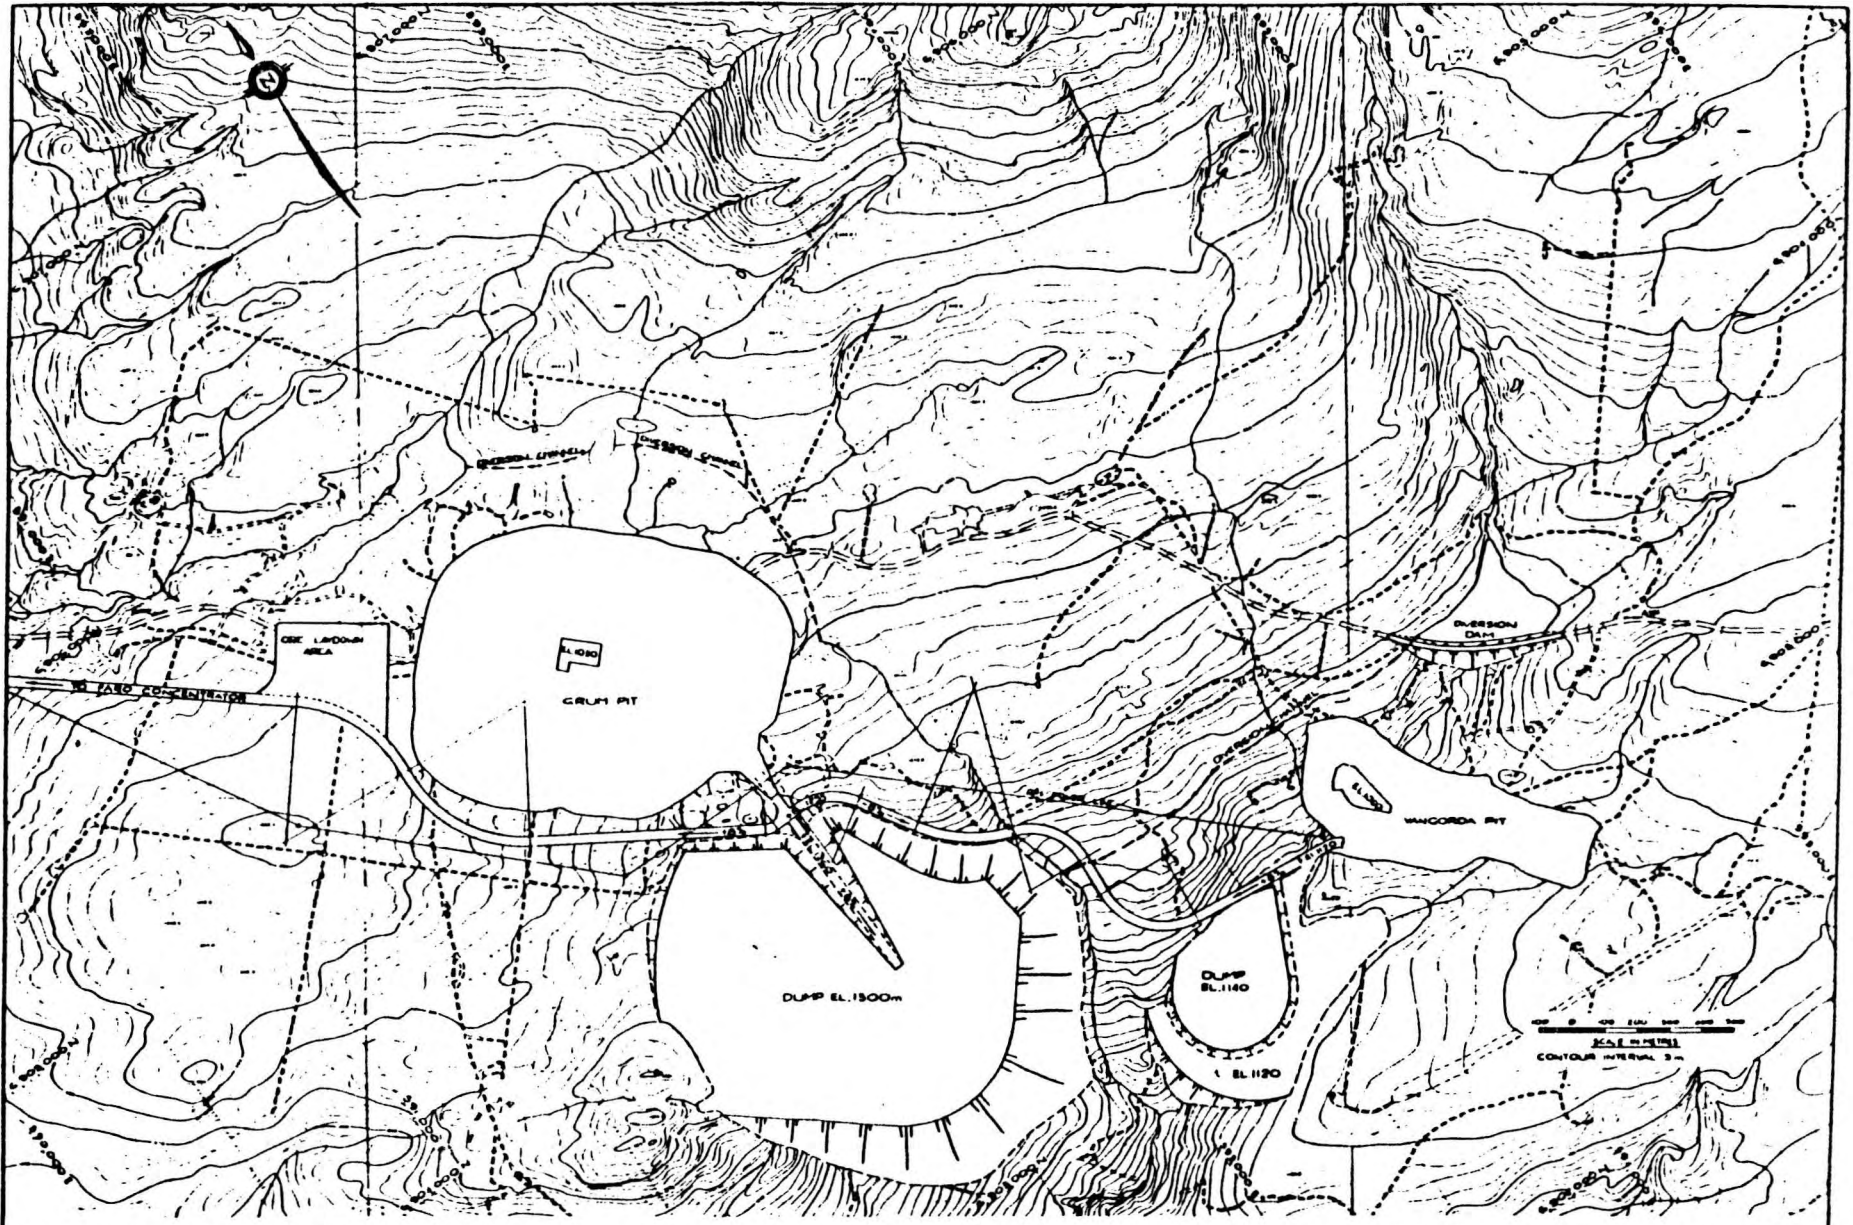
<p>Scale: 1:5000          Drawing No. 107          Date: 10/1/67          Project No. 1167</p>		<p>CURRACH RESOURCES          Mining PARO, YUKON  <b>KILBOURN</b></p>		<p>PARO AREA DEPOSIT          WAGGON PLATEAU          SITE PLAN</p>		<p>FIG. 2</p>
--	--	---	--	---	--	---------------

Curragh Resources presented a conceptual development plan of the Vangorda Plateau deposits in March, 1987. The development of the Grum and Vangorda deposits will eventually replace production from the Faro Pit. Major structures and facilities (Figure 2) which must be put in place prior to the commencement of mining include:

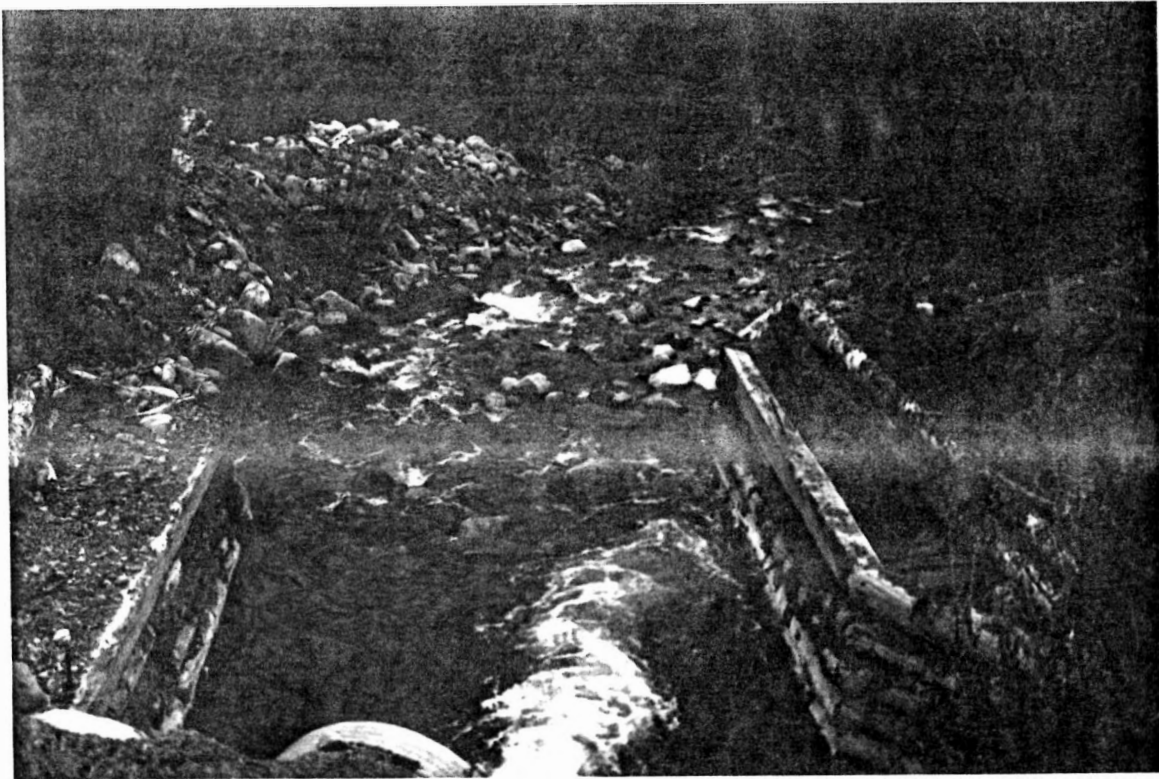
- ° Proposed diversion of Vangorda Creek (Photo 26) will be a major problem at the abandonment stage of the operation. It will be impossible to ensure the long-term integrity of the diversion dam and diversion canal without continuous maintenance.

Photo 26: Vangorda Creek at the proposed diversion dam location.

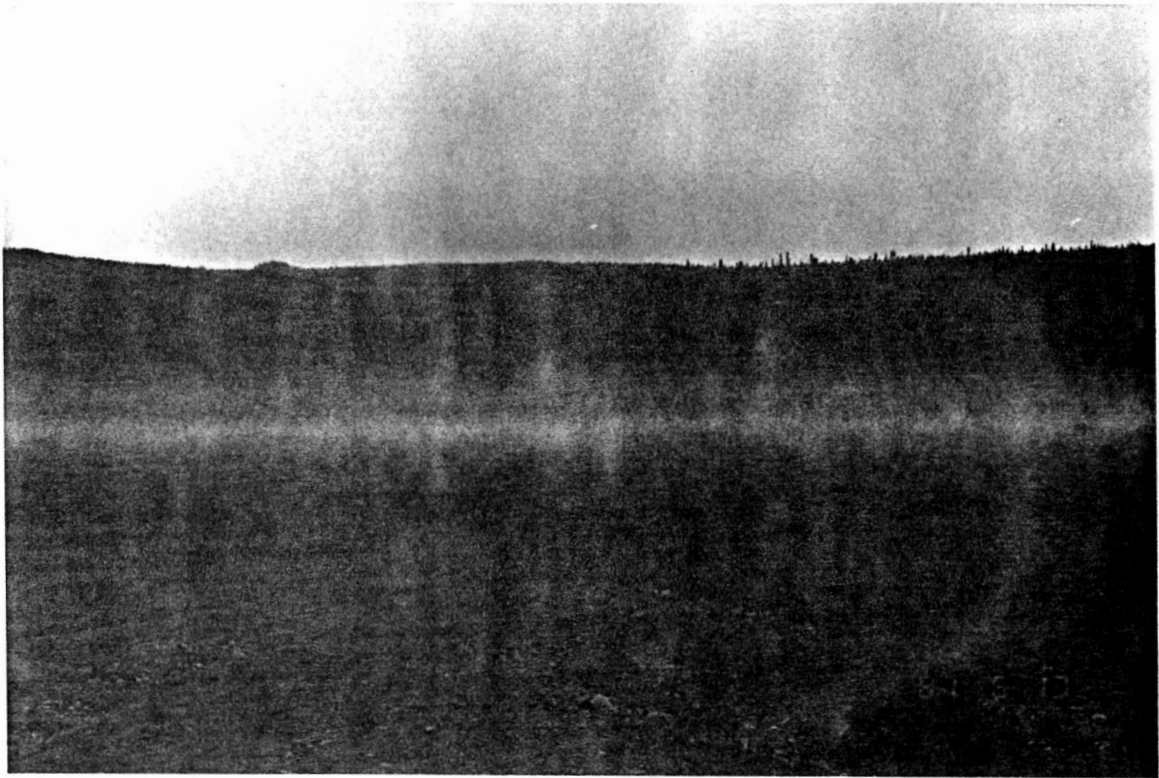
Photo 27: Proposed site of the Vangorda Creek diversion dam.
