MOUNT NANSEN MINES LIMITED

Property Examination - Head of Nansen Creek

June 13/68

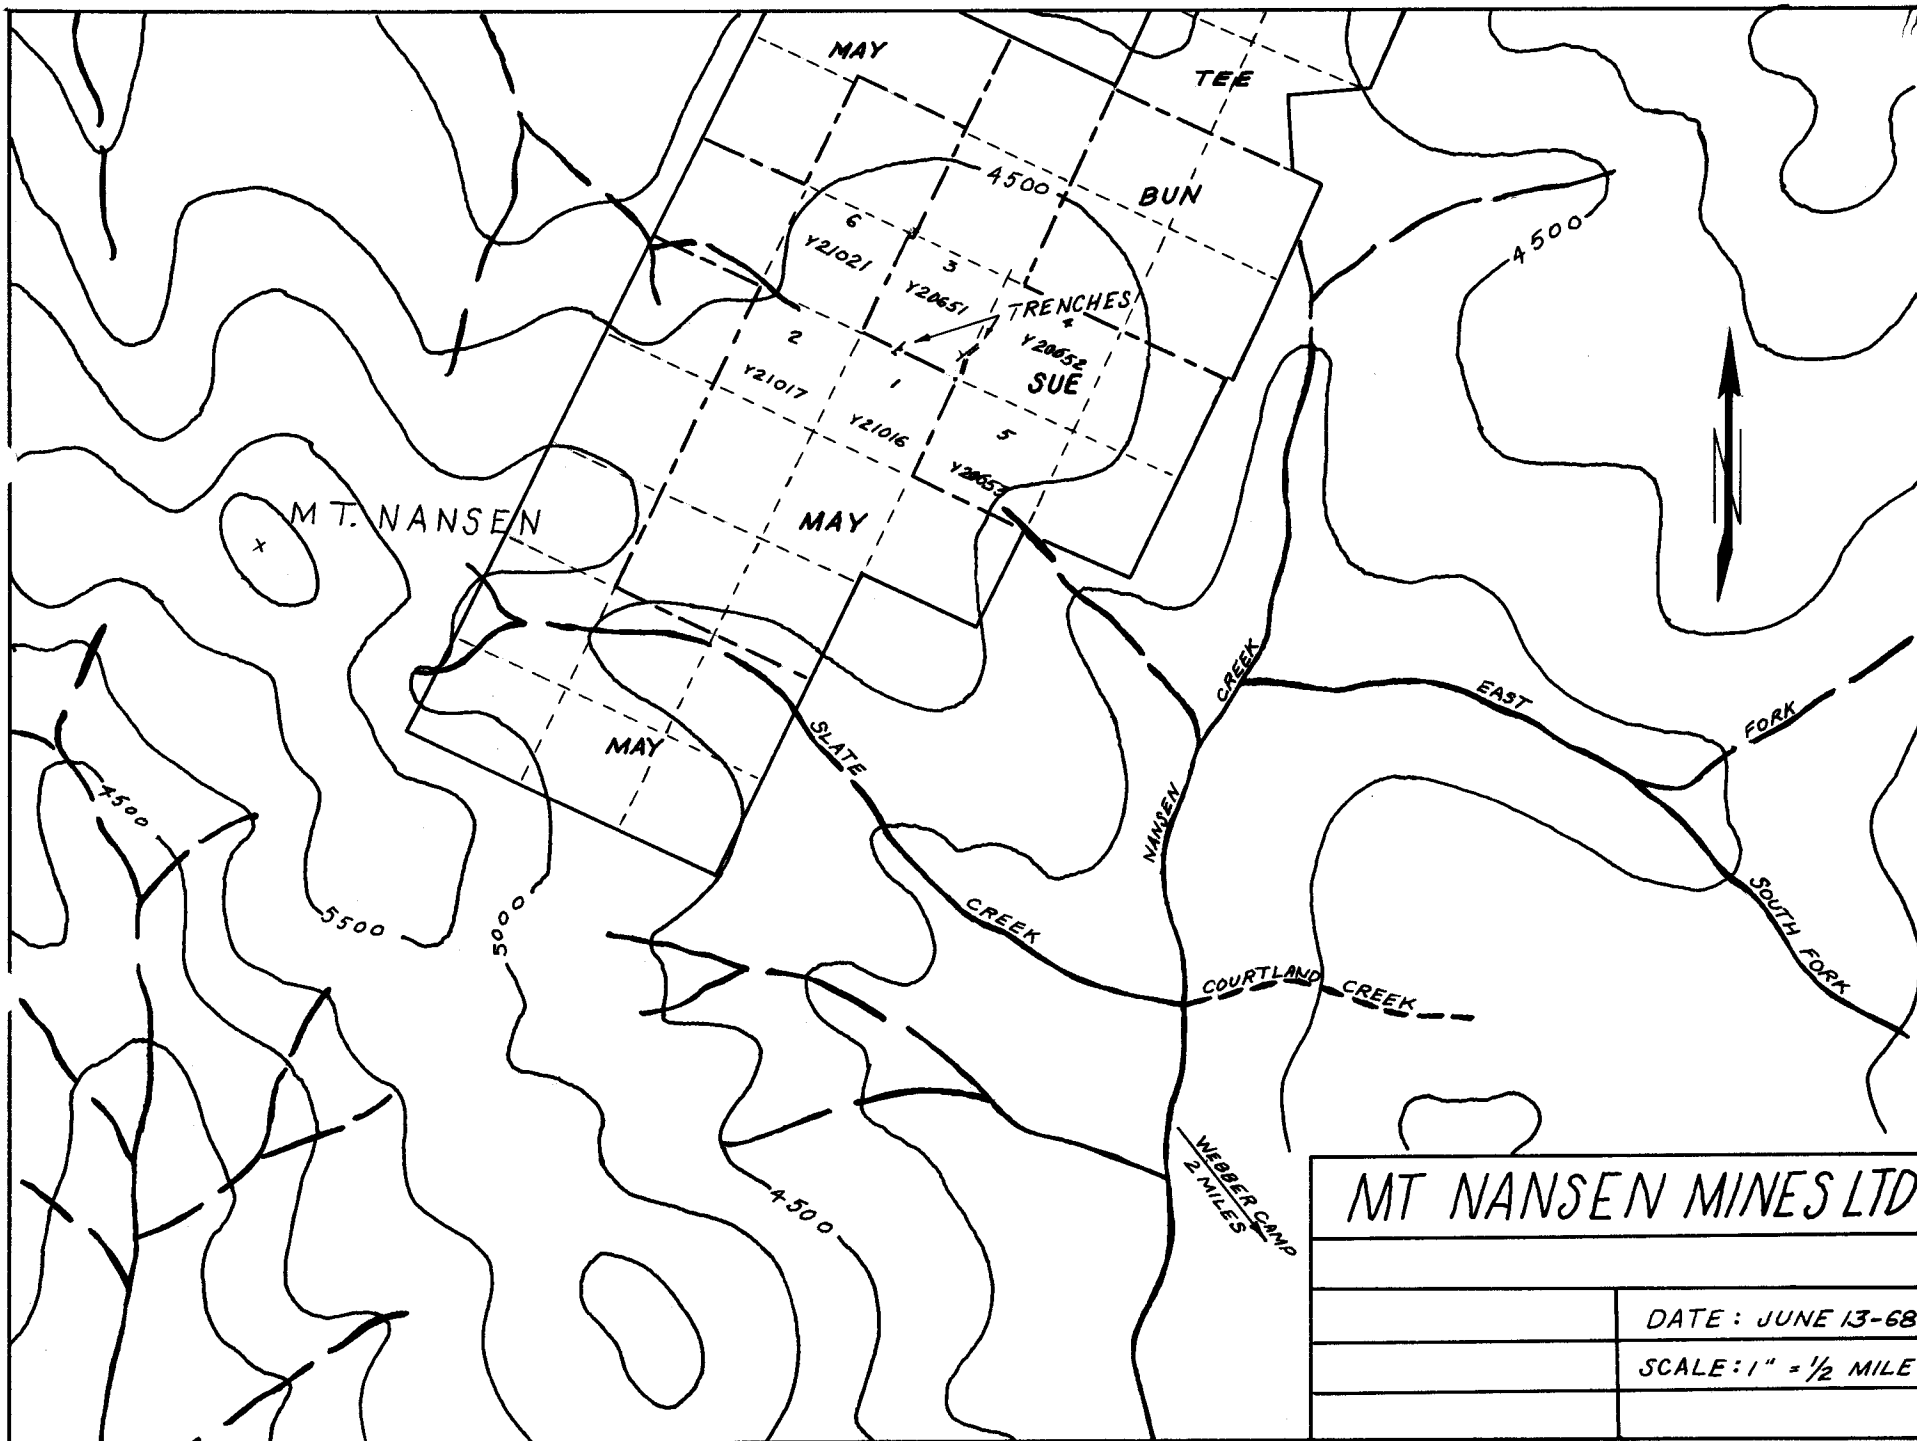
SCALE: 1" = 1/2 MILE

- Appendix:
1. Property map showing location of trenches, 1" = 1/2 mile
 2. Sketch map of trenches, 1" = 200'
