Assessment of Infill Site Suitability City of Whitehorse, Yukon

PRESENTED TO
City of Whitehorse

JUNE 5, 2017
ISSUED FOR USE
FILE: ENW.WENW03041-01

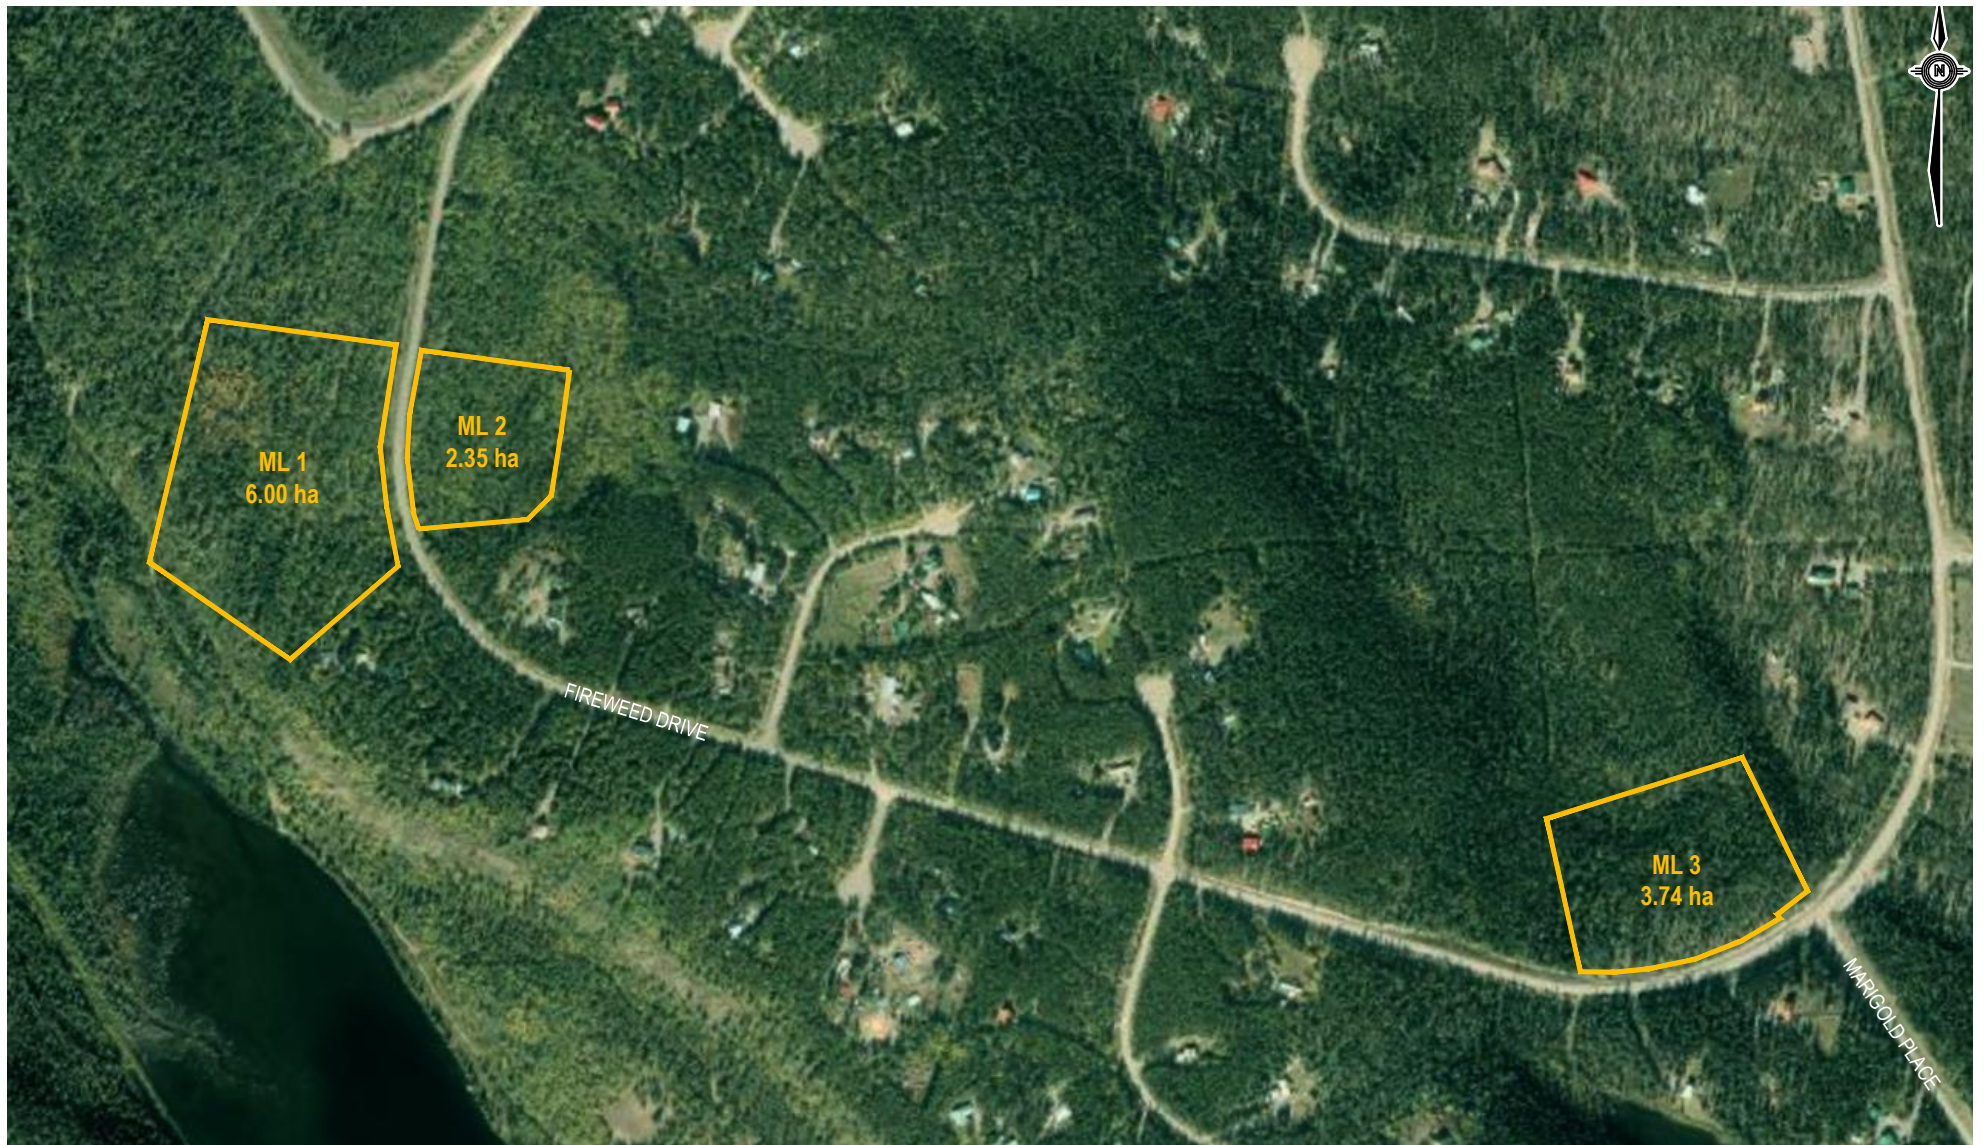
Figure 1a

- EXTENT OF INFILL AREAS

The Mary Lake assessment consists of three infill areas identified for the purpose of this assessment as ML1, ML2 and ML3. The size of each infill area is presented in Table 2-1 and infill area boundaries are presented on Figure 1a, appended to this report.
