DEMPSTER HIGHWAY

AIRPHOTO MATERIALS SEARCH

J. D. Mollard & Associates Ltd.
Sept. 71

DEMPSTER HIGHWAY
AIRPHOTO MATERIALS SEARCH
MILE 166 TO 275

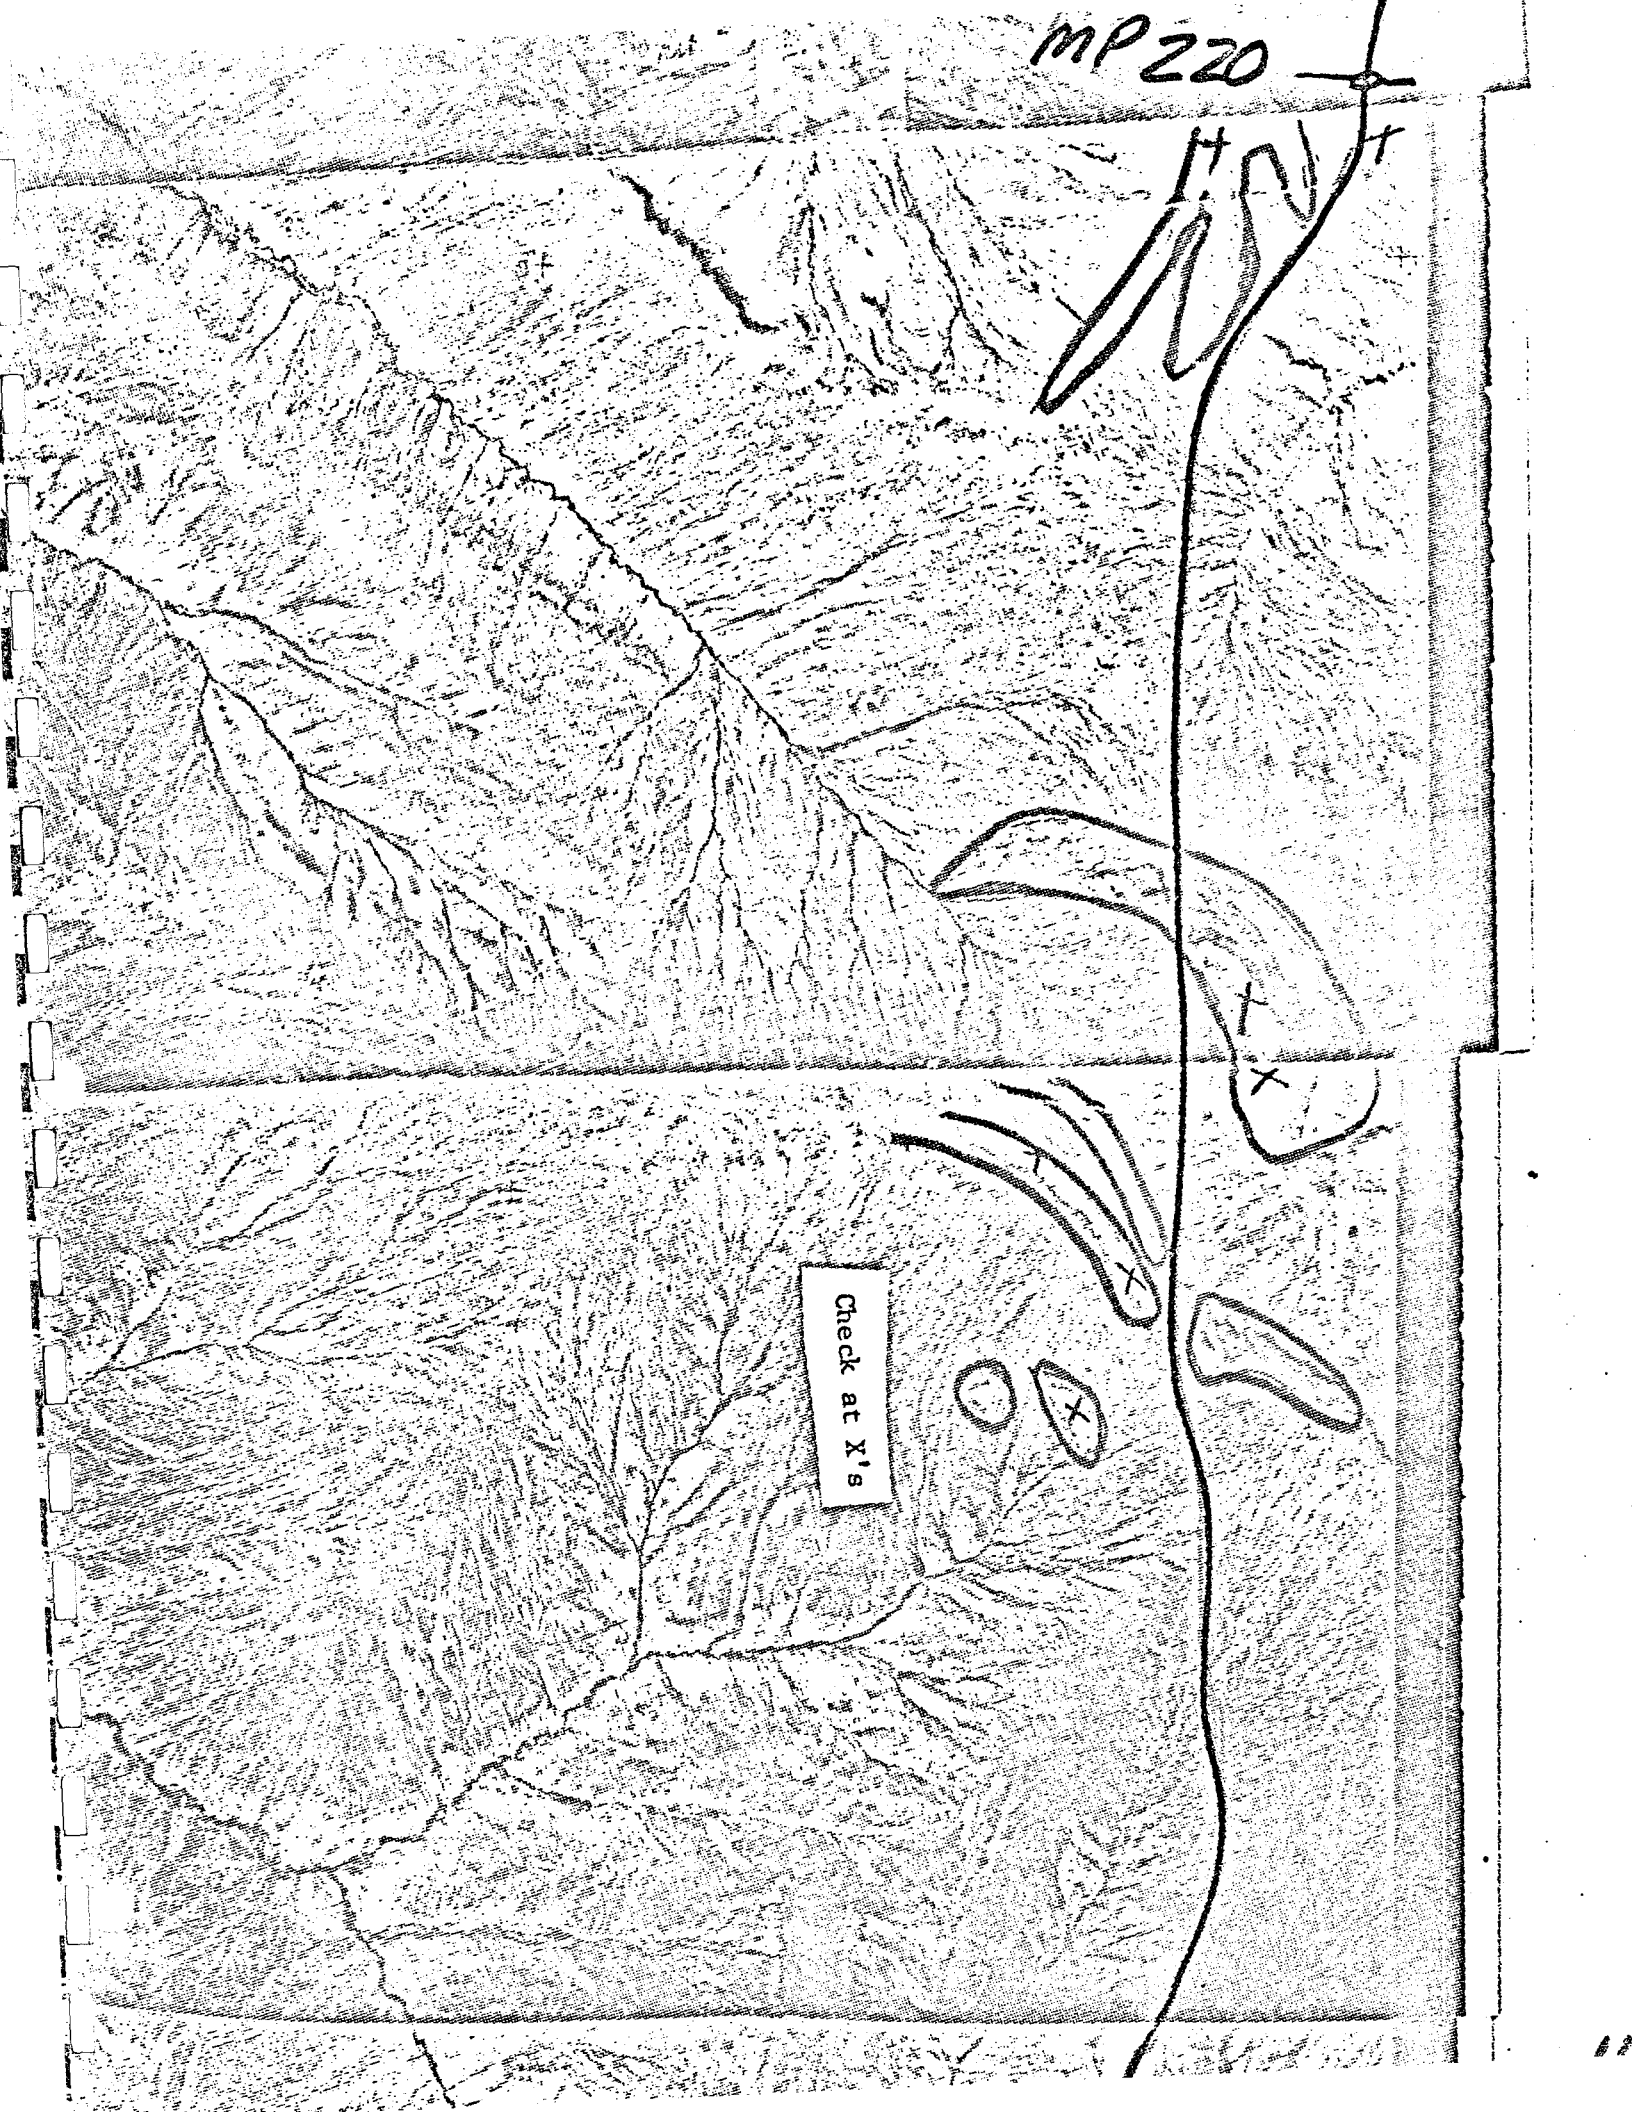
MP 220

Check at X's

Check depth and gradation
of exposed bars

Solifluction lobes,
terraces and sheets

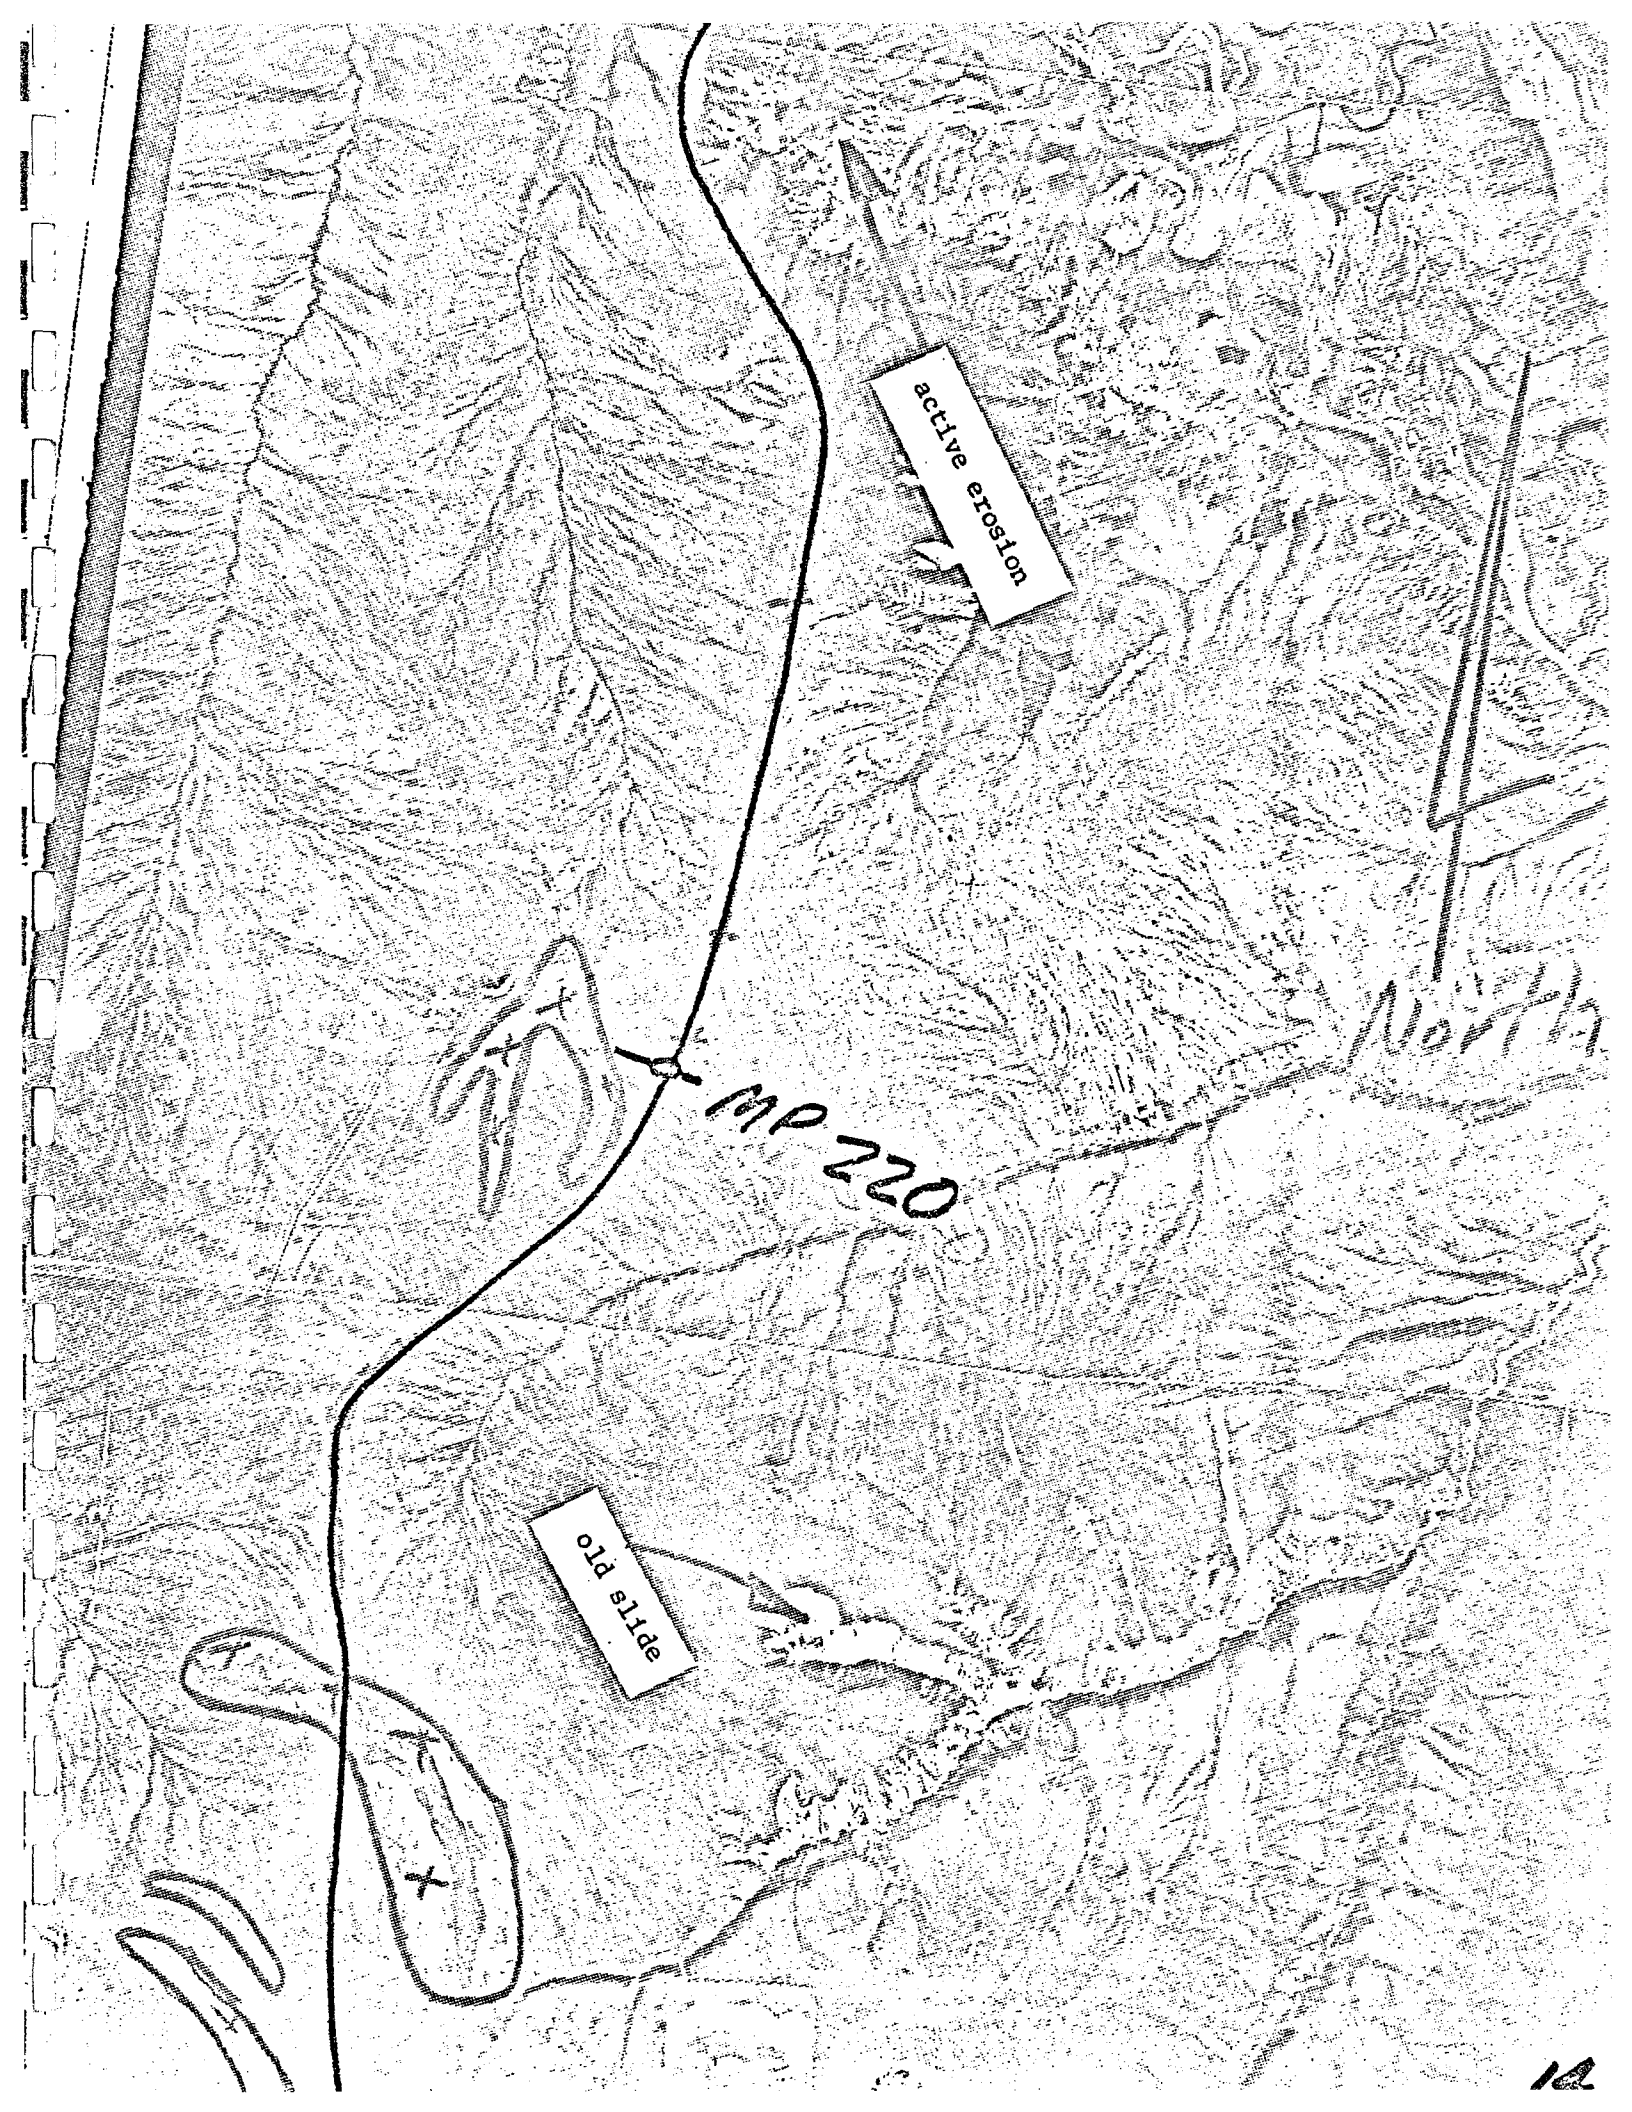
MP 220

active erosion

old slide

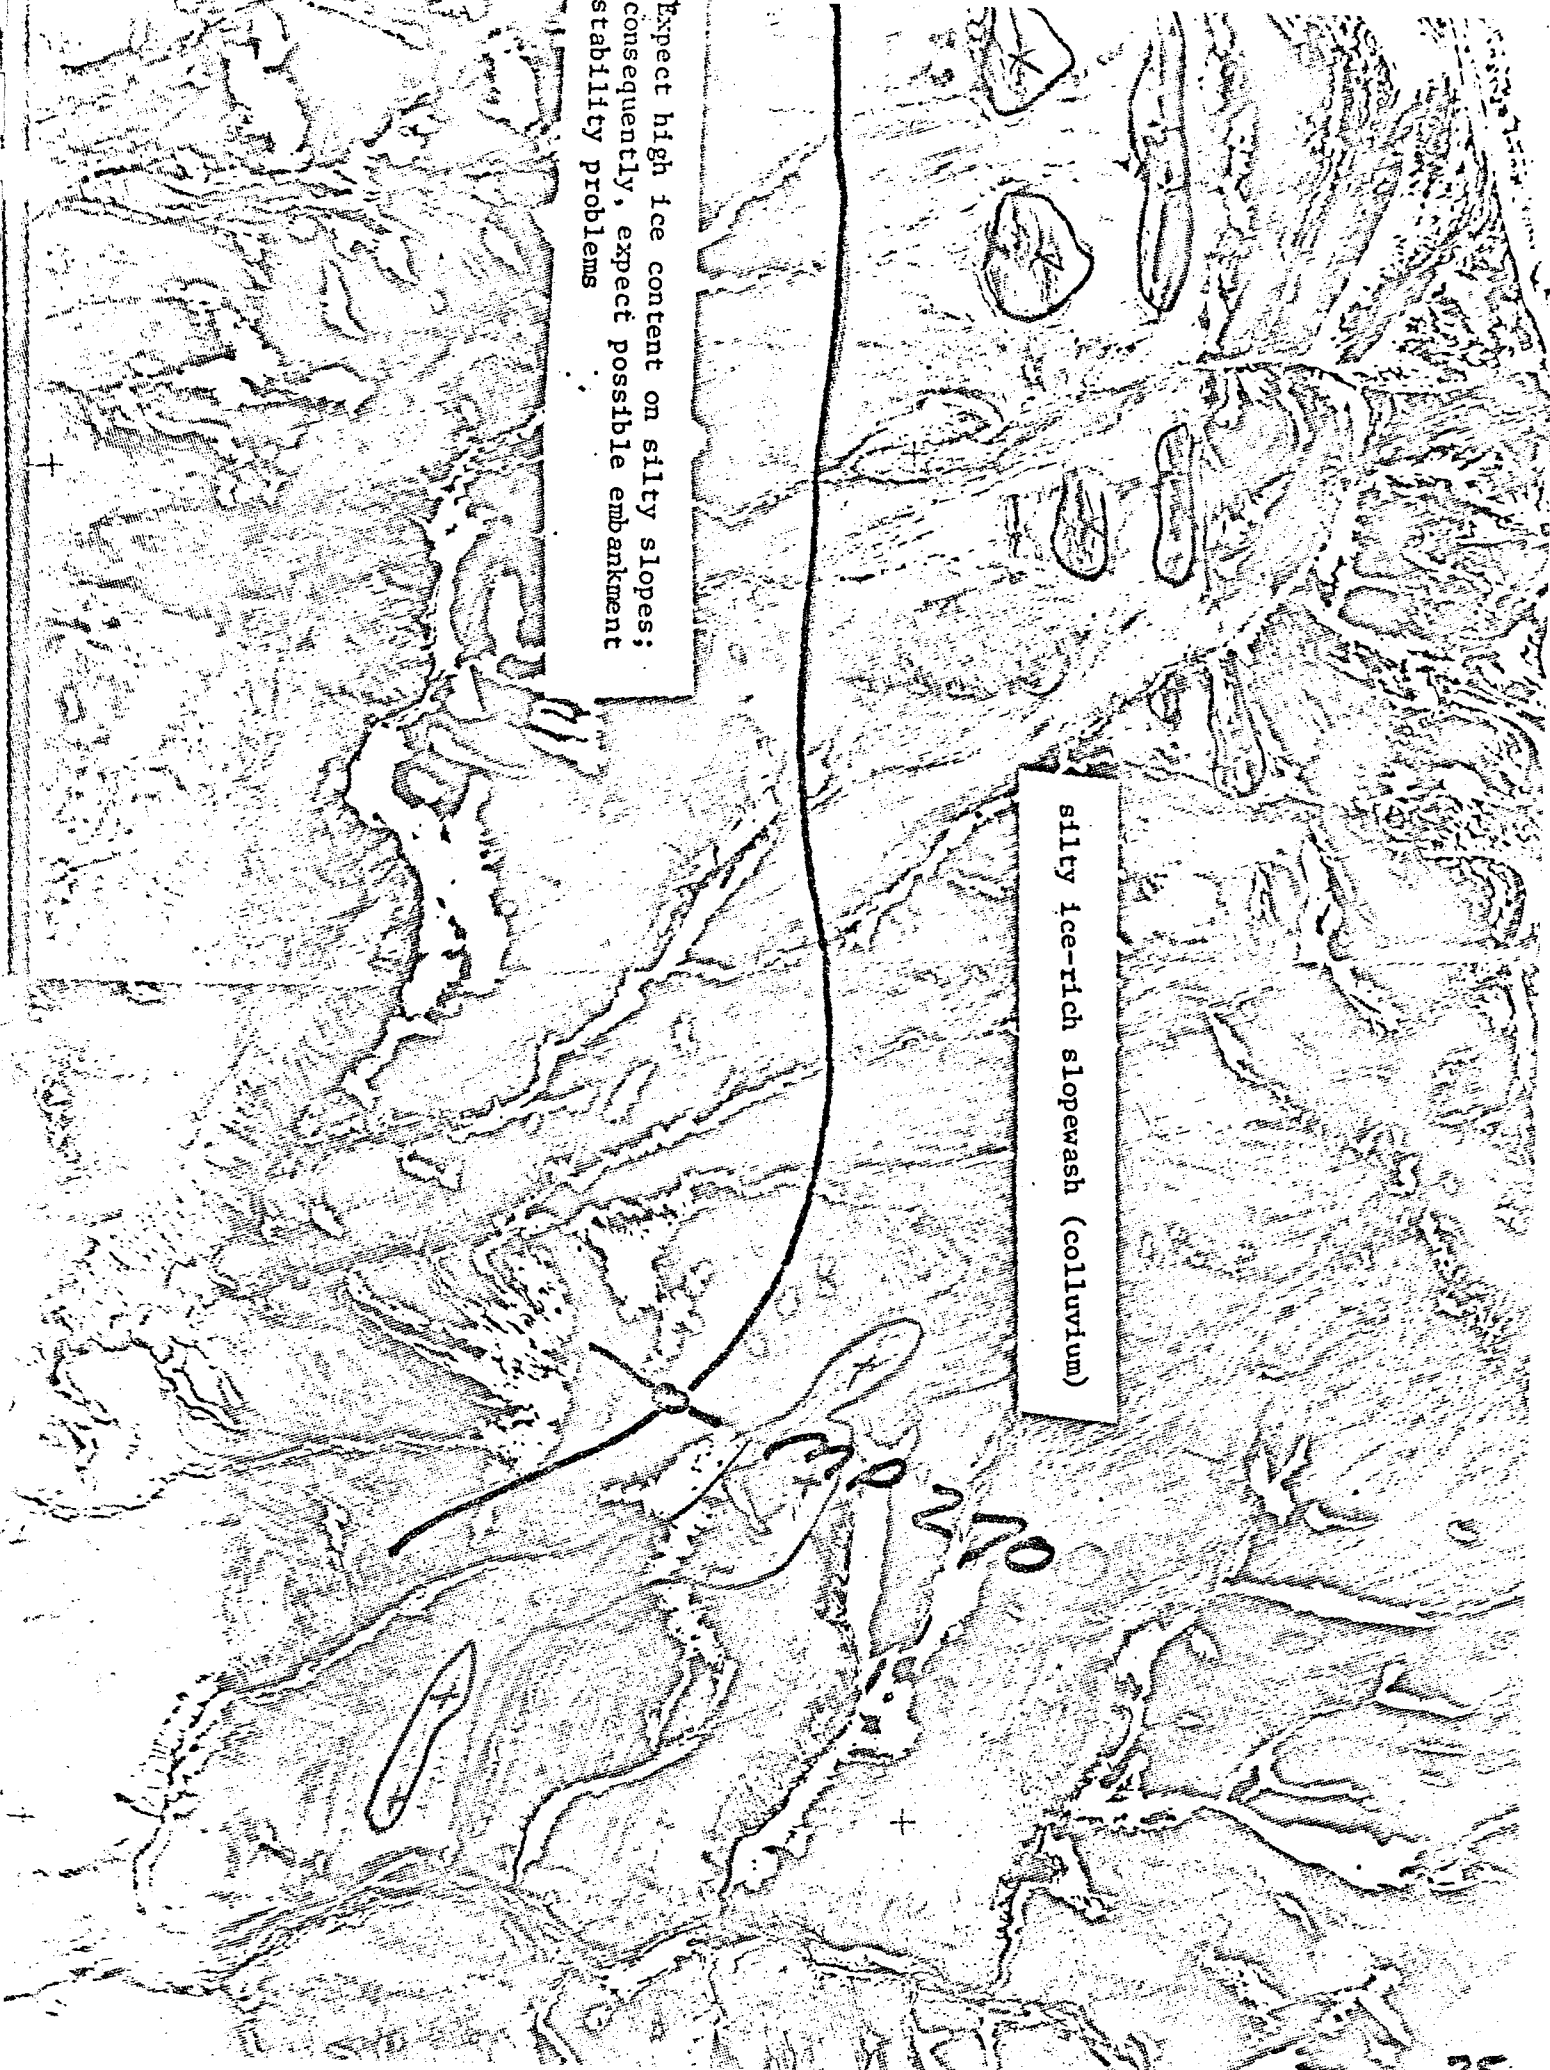
Expect high ice content on silty slopes; consequently, expect possible embankment stability problems

silty ice-rich slopewash (colluvium)

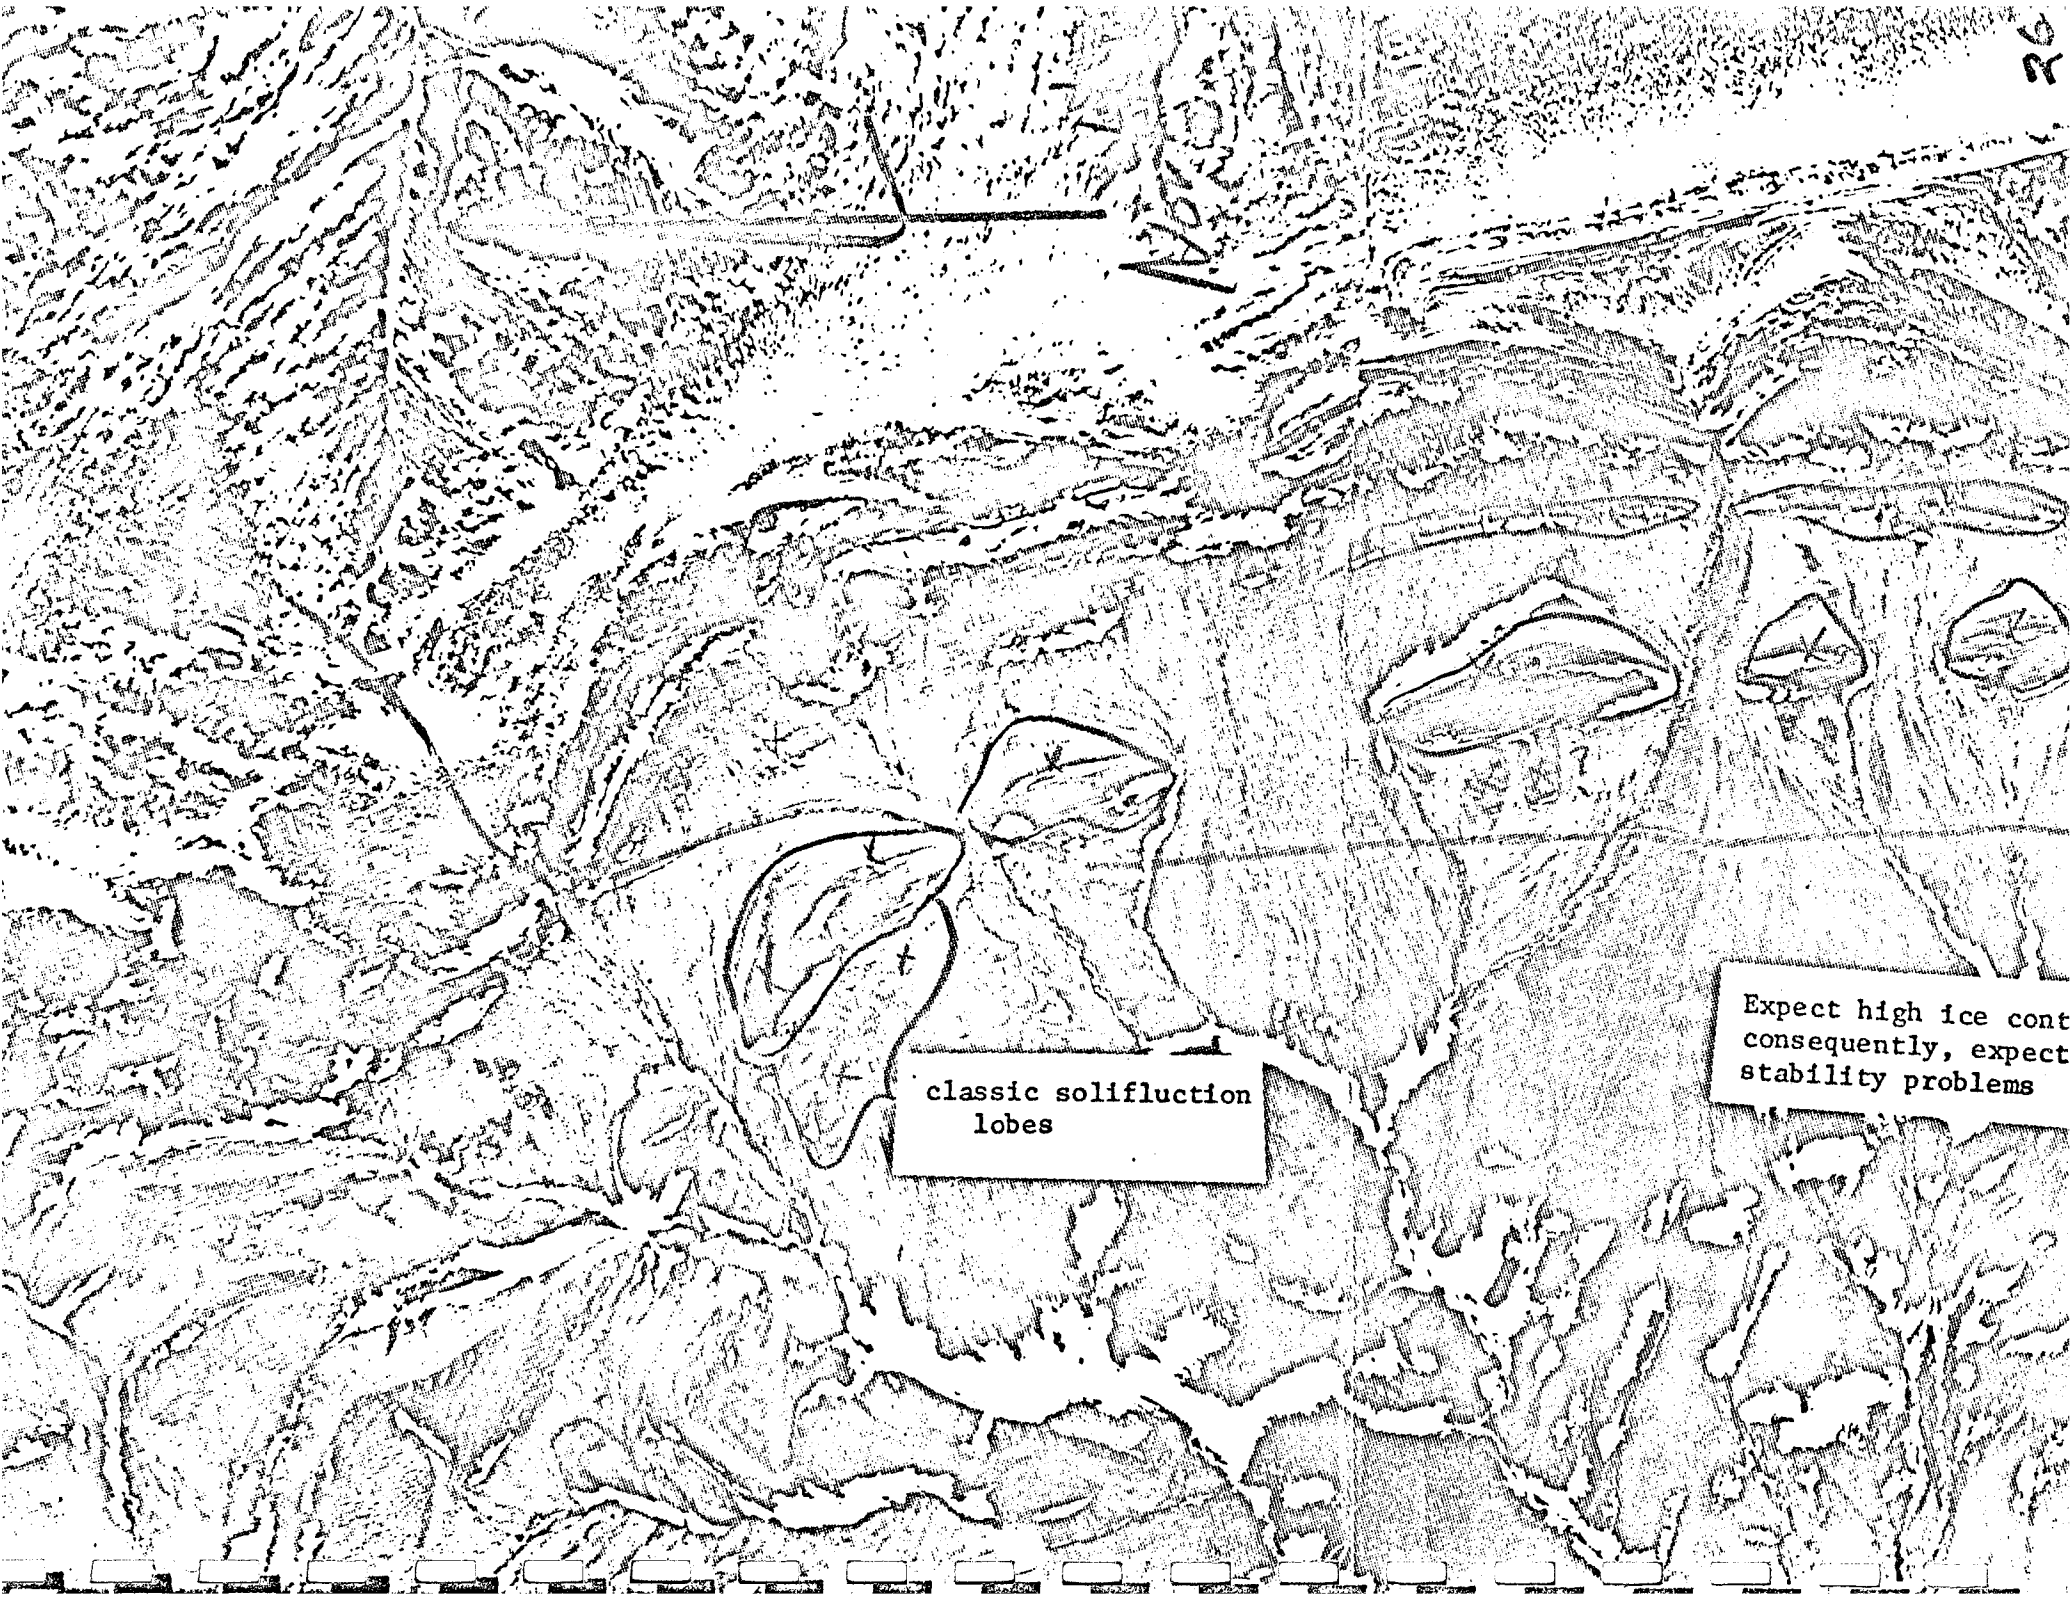
classic solifluction
lobes

Expect high ice cont
consequently, expect
stability problems
