SKETCH PLAN SHOWING
HORIZONTAL AND VERTICAL TIE
TO MURPHY ET AL WHITESTONE WELL
WHITESTONE AREA, Y.T.

DRILLING SUMMARY

MURPHY MESA B.P. SOUTH WHITESTONE Y.T. N58

MURPHY OIL COMPANY LTD.

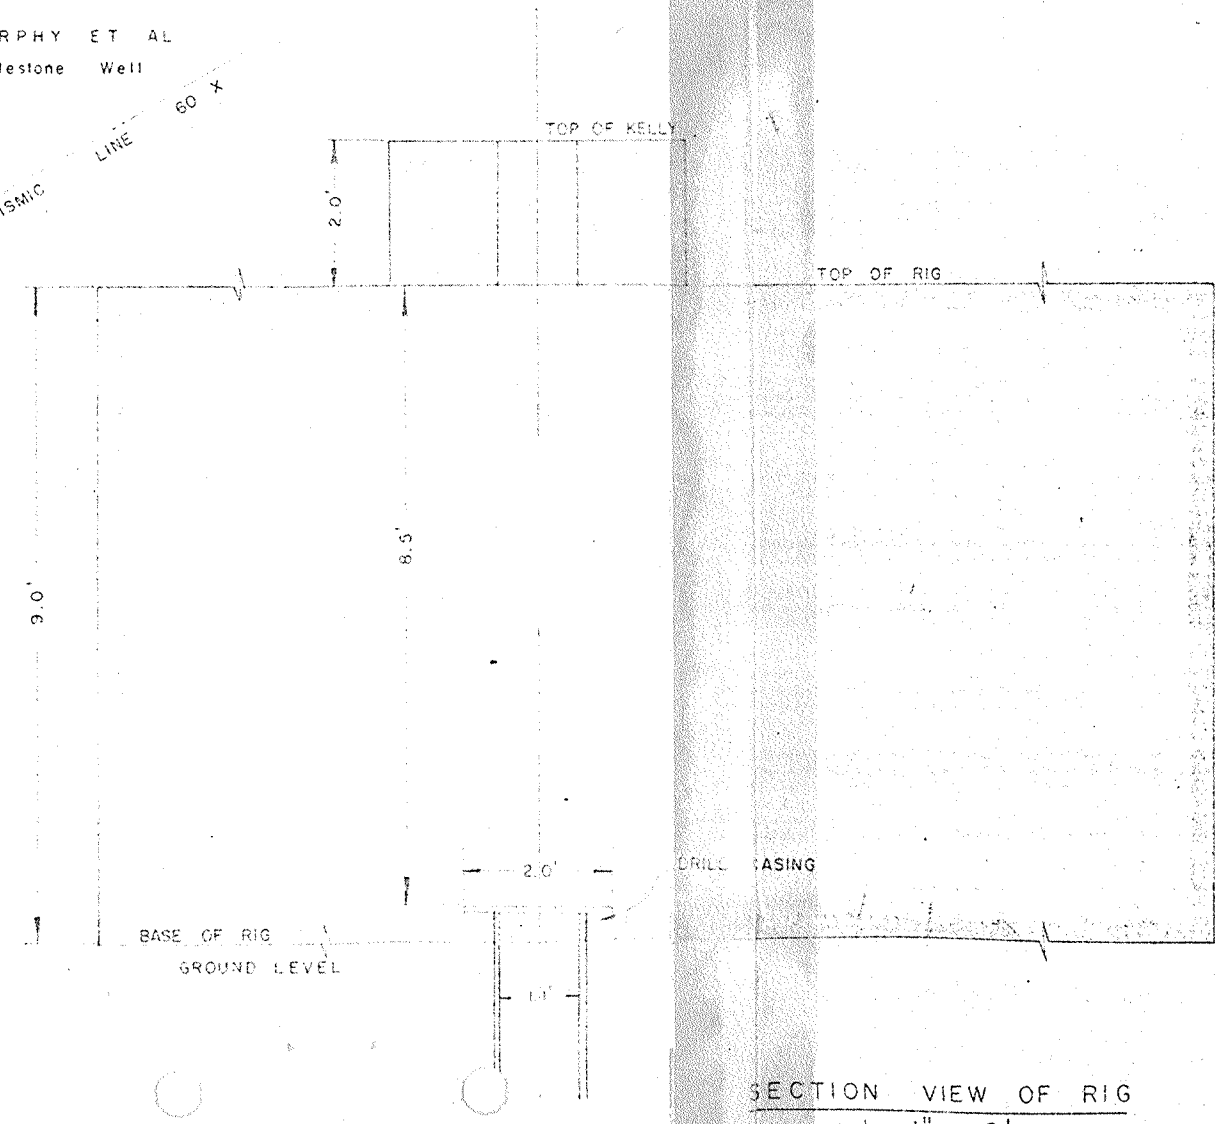
SECTION VIEW OF RIG
scale: 1" = 2'

ELEVATIONS

TOP OF KELLY	2917.6'
TOP OF RIG	2915.6'
DRILL CASING	2907.1'
BASE OF RIG	2906.6'
