DEVELOPMENT OF THE ZONE 2 WASTE DUMP

Submitted to the Yukon Territory Water Board

December, 1987

CURRAGH RESOURCES, INC.
117 Industrial Road
Whitehorse, Yukon

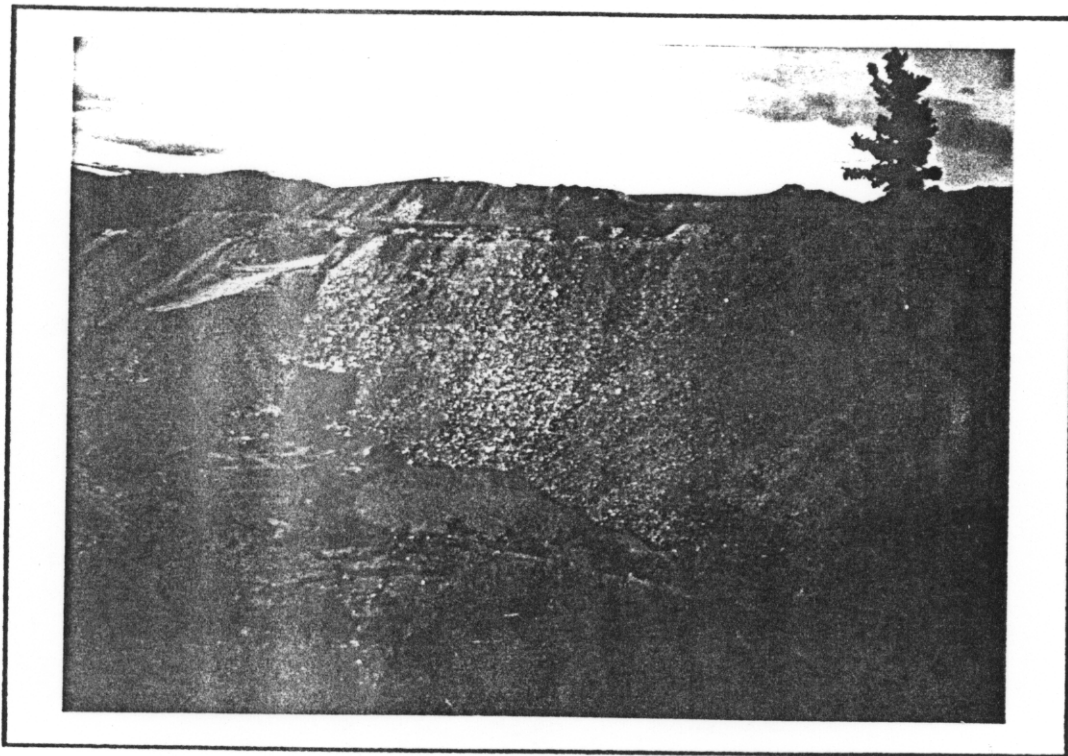
Zone 2 pit and dump, 9/87

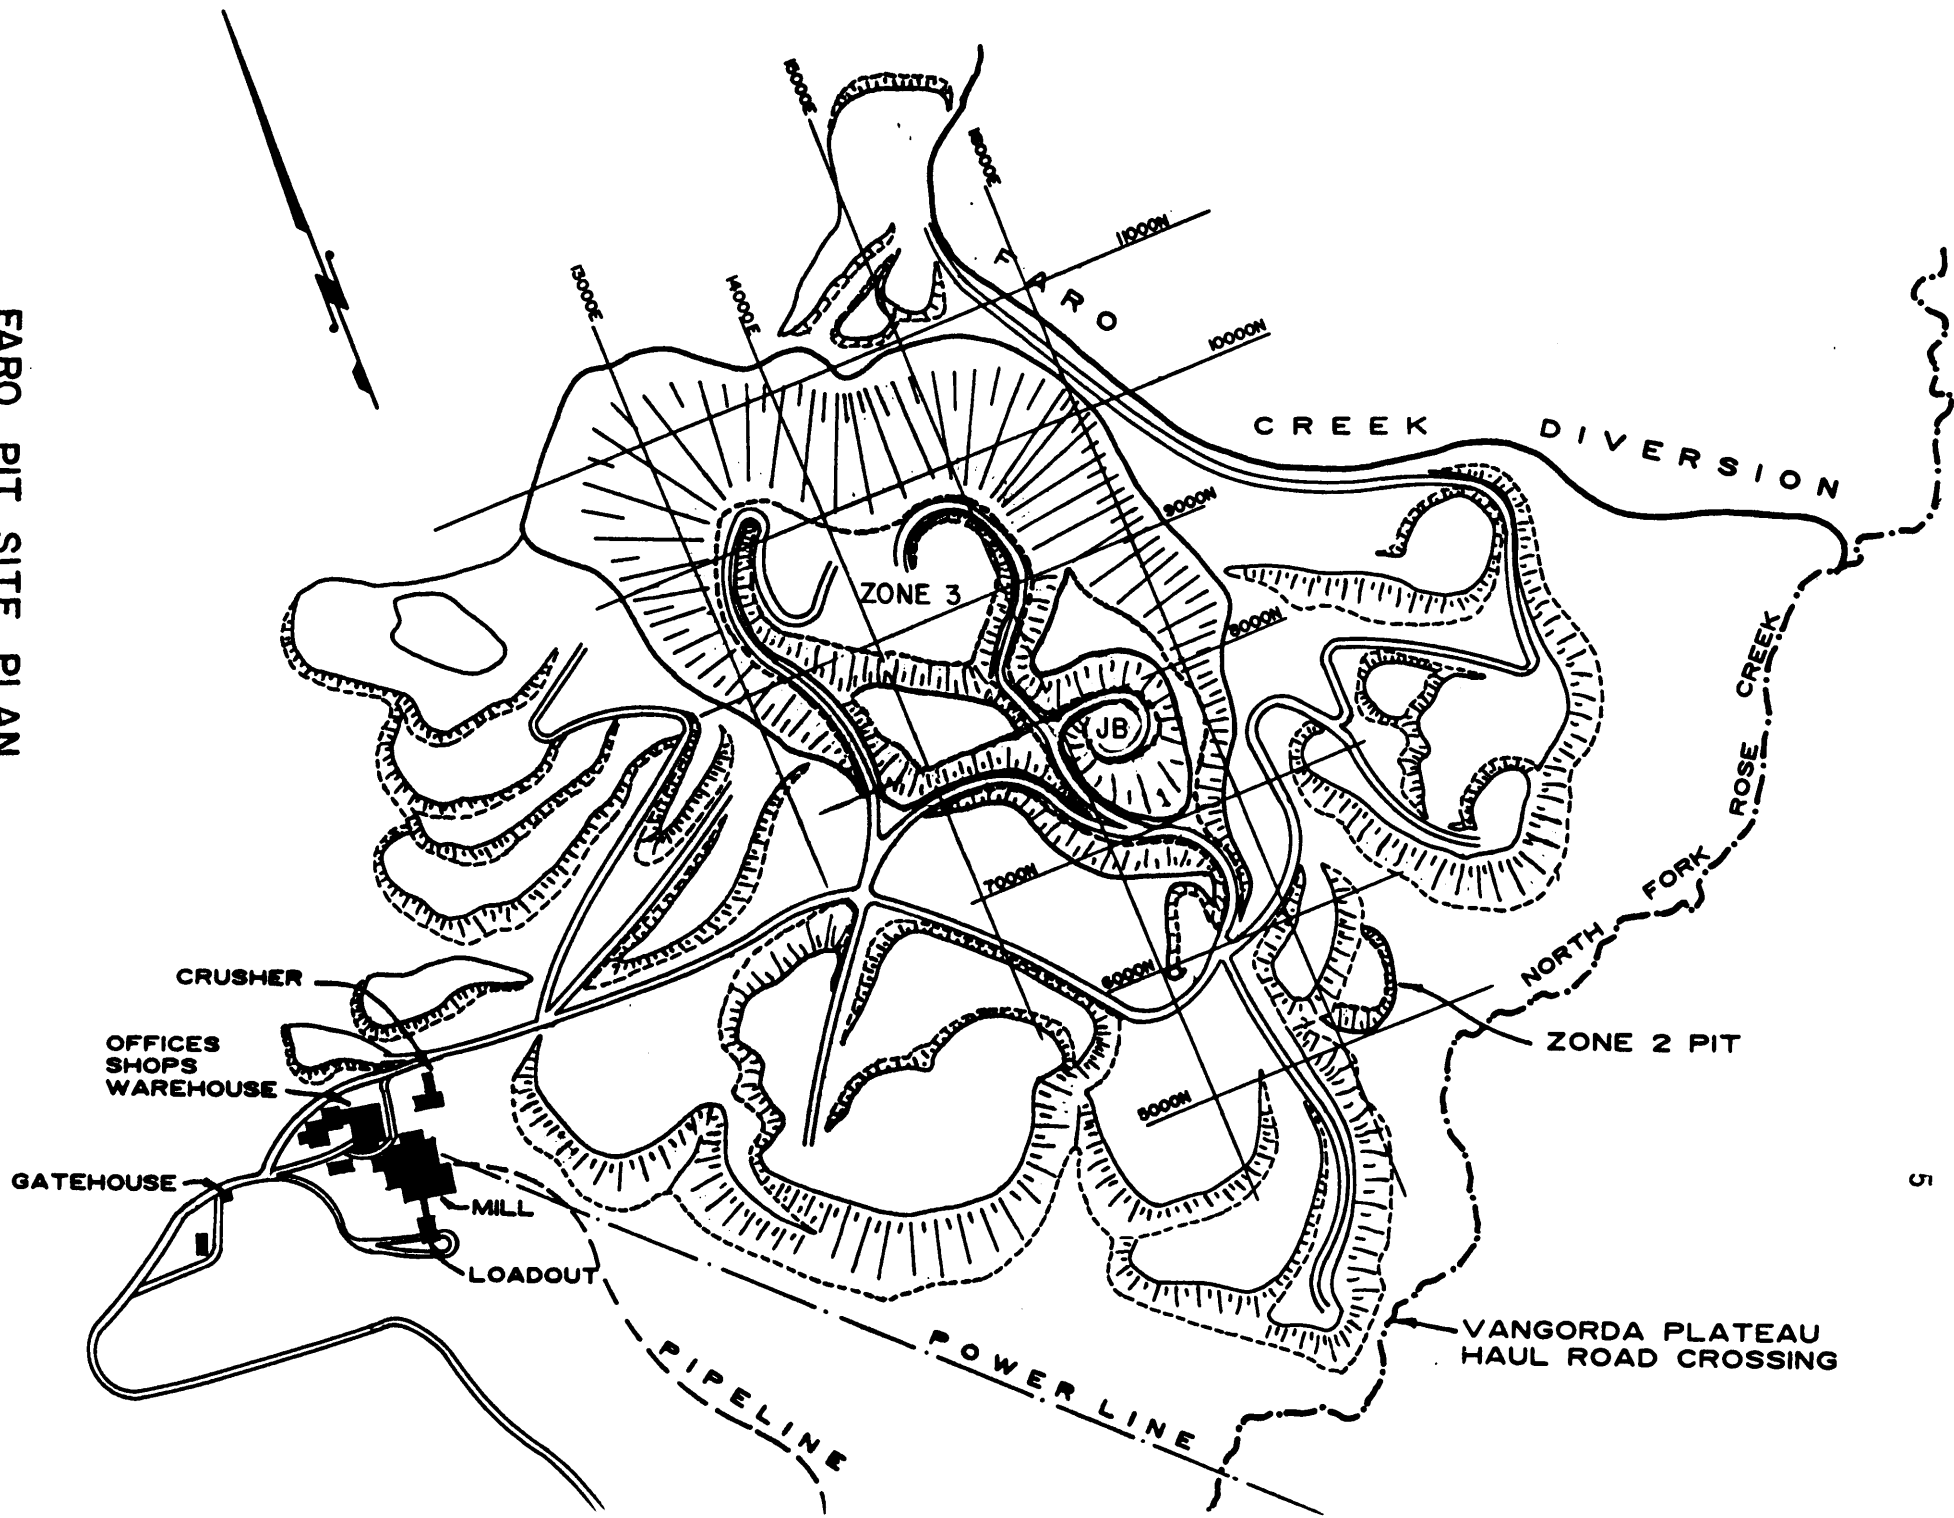
Fig. 1

FARO PIT SITE PLAN

This report's purpose is to provide details of the backfilling of the former Zone 2 pit . This area serves as the next major waste dump site and represents approximately eight million tonnes of dump capacity or 18 % of the dump capacity required through mine life. This dump area is of major importance as its proximity to the mine workings (Figure 1) significantly lowers haul truck cycle times compared to other dumping options.

The Zone 2 pit lies directly in front of the area to be developed. Failure to backfill the Zone Two pit would pre-empt use of this dump area. Alternate dump sites could be used, but at a greater haulage cost per tonne. Consideration would have to be given to moving the power line (Figure 1), developing dumps across the North Fork of Rose Creek or developing existing dumps to higher levels.

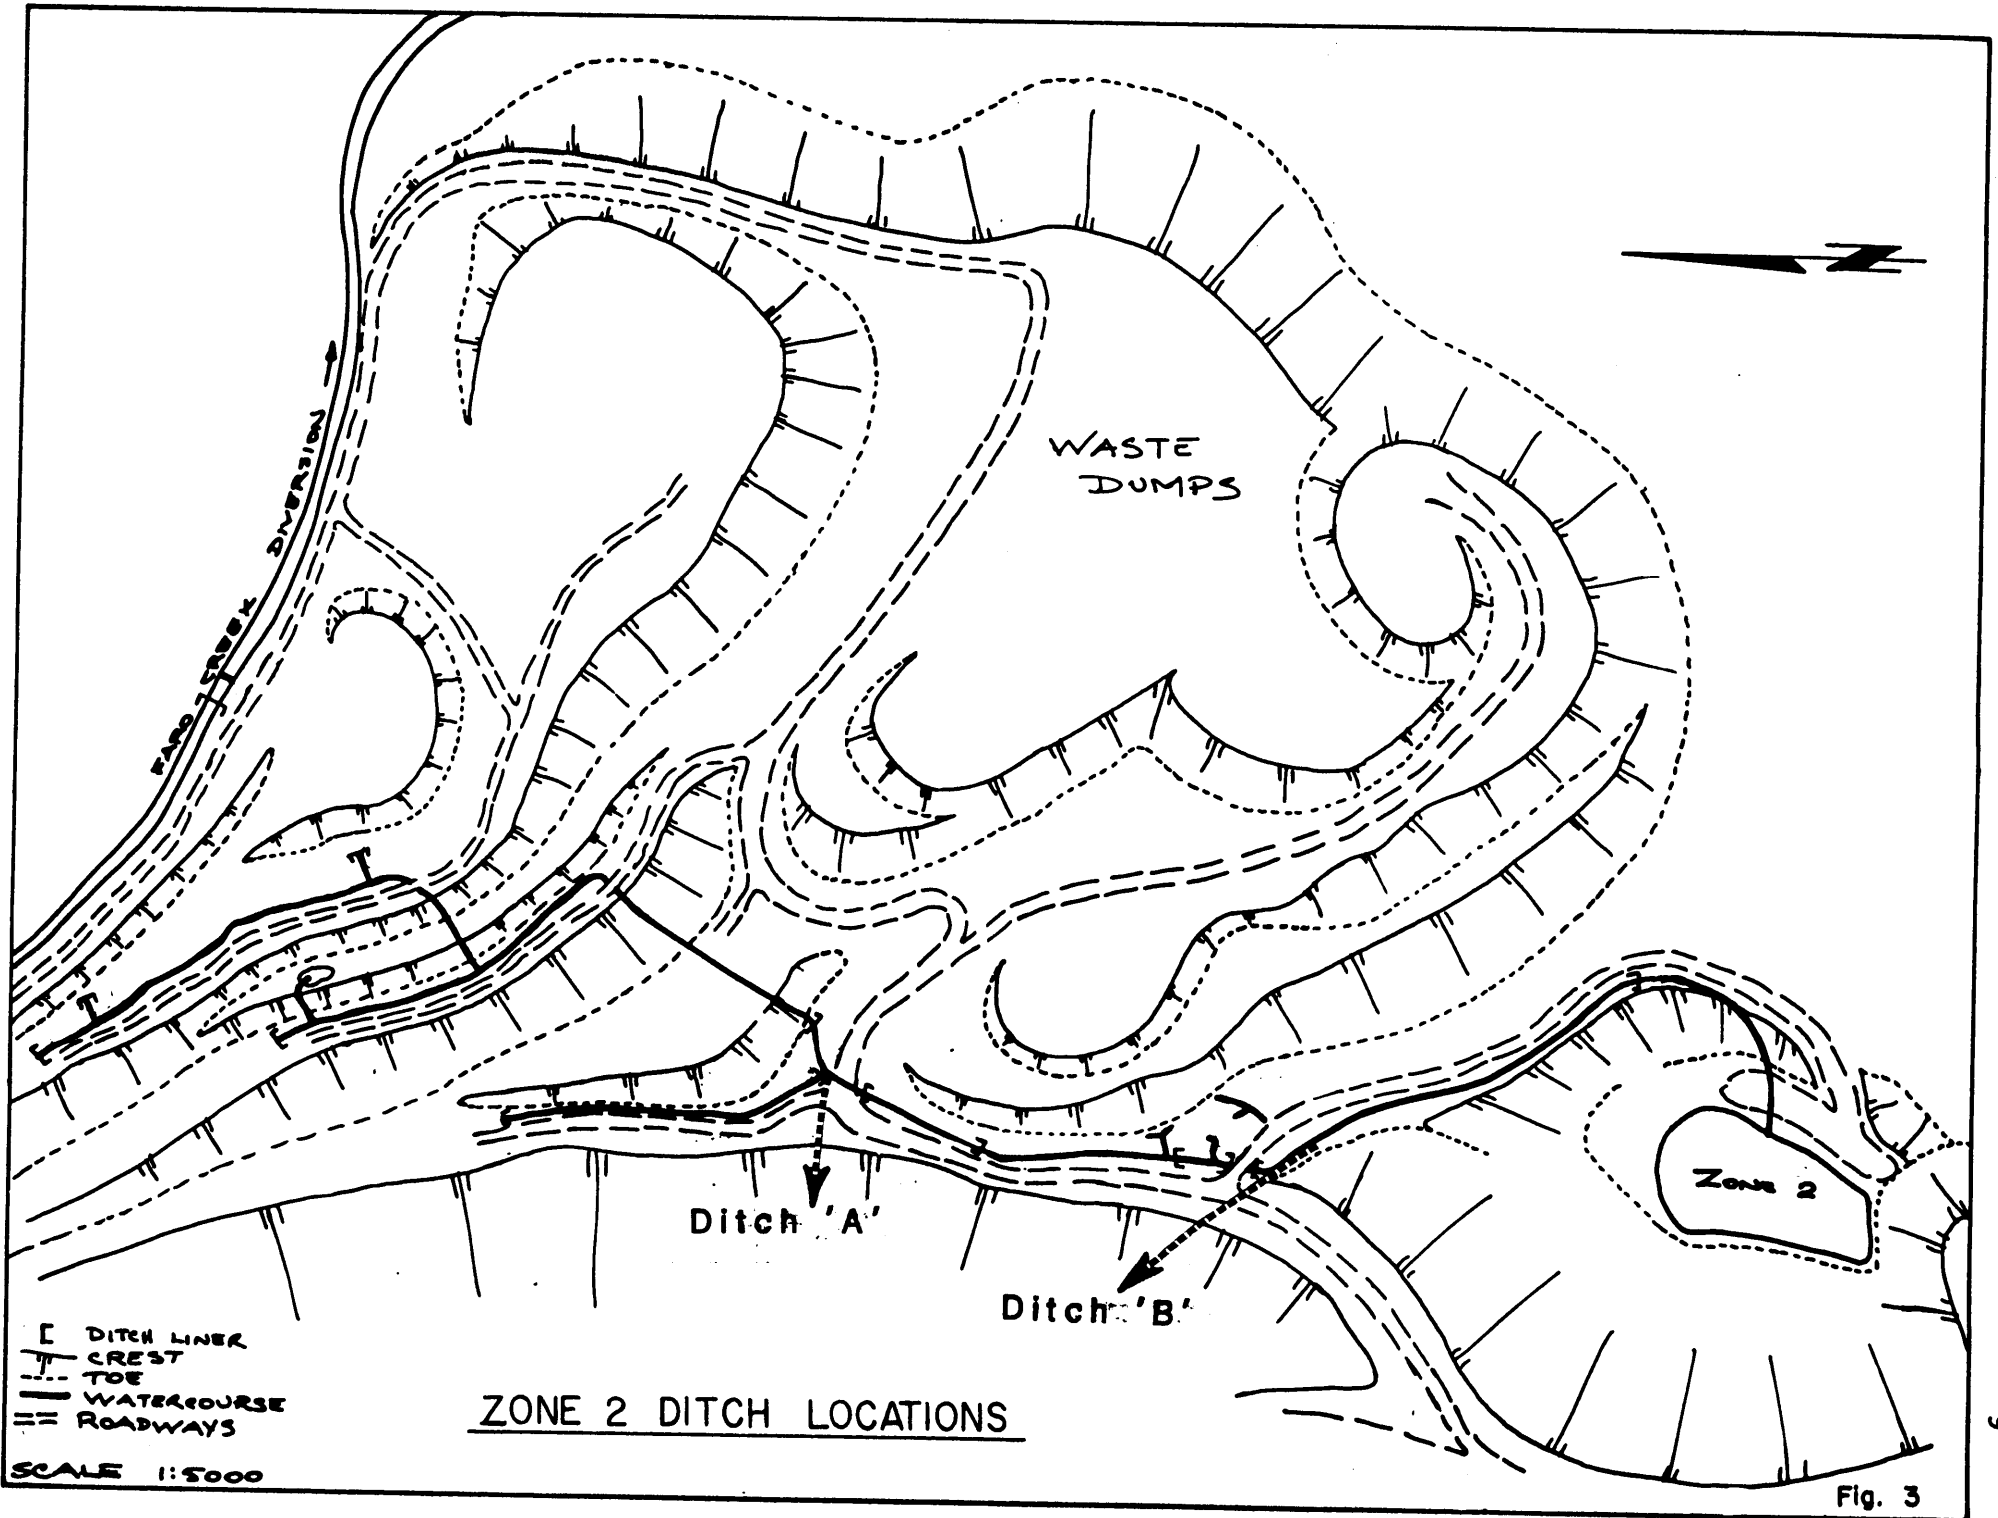
The diversion ditch (Ditch A, Figure 3) constructed during this stage is located at the 4030 foot bench in the main pit. It consists of an open, unlined ditch and it diverts all flow from the lined ditch system upstream of this point directly to the JB pit.

The surface inflow to Zone 2 from the lined ditch north of the pit will be intercepted and diverted into the JB pit, where an active sump is in place and is capable of handling the increased flow. Flow from the upper part of the ditch was intercepted during Stage One.

In late spring or summer, 1988, a permanent diversion ditch will be constructed to reduce surface and shallow subsurface flow to Zone 2 (Ditch B, Figure 3). This will consist of:

The diversion of the lined ditch system (Ditch A, Figure 3) and the installation of a surface and shallow subsurface seep collection ditch at the major seepage area (Ditch B, Figure 3) will eliminate much of the water currently flowing to Zone 2. Water currently being diverted from the main pit to Zone 2 will no longer enter the Zone 2 watershed. Water from the seepage

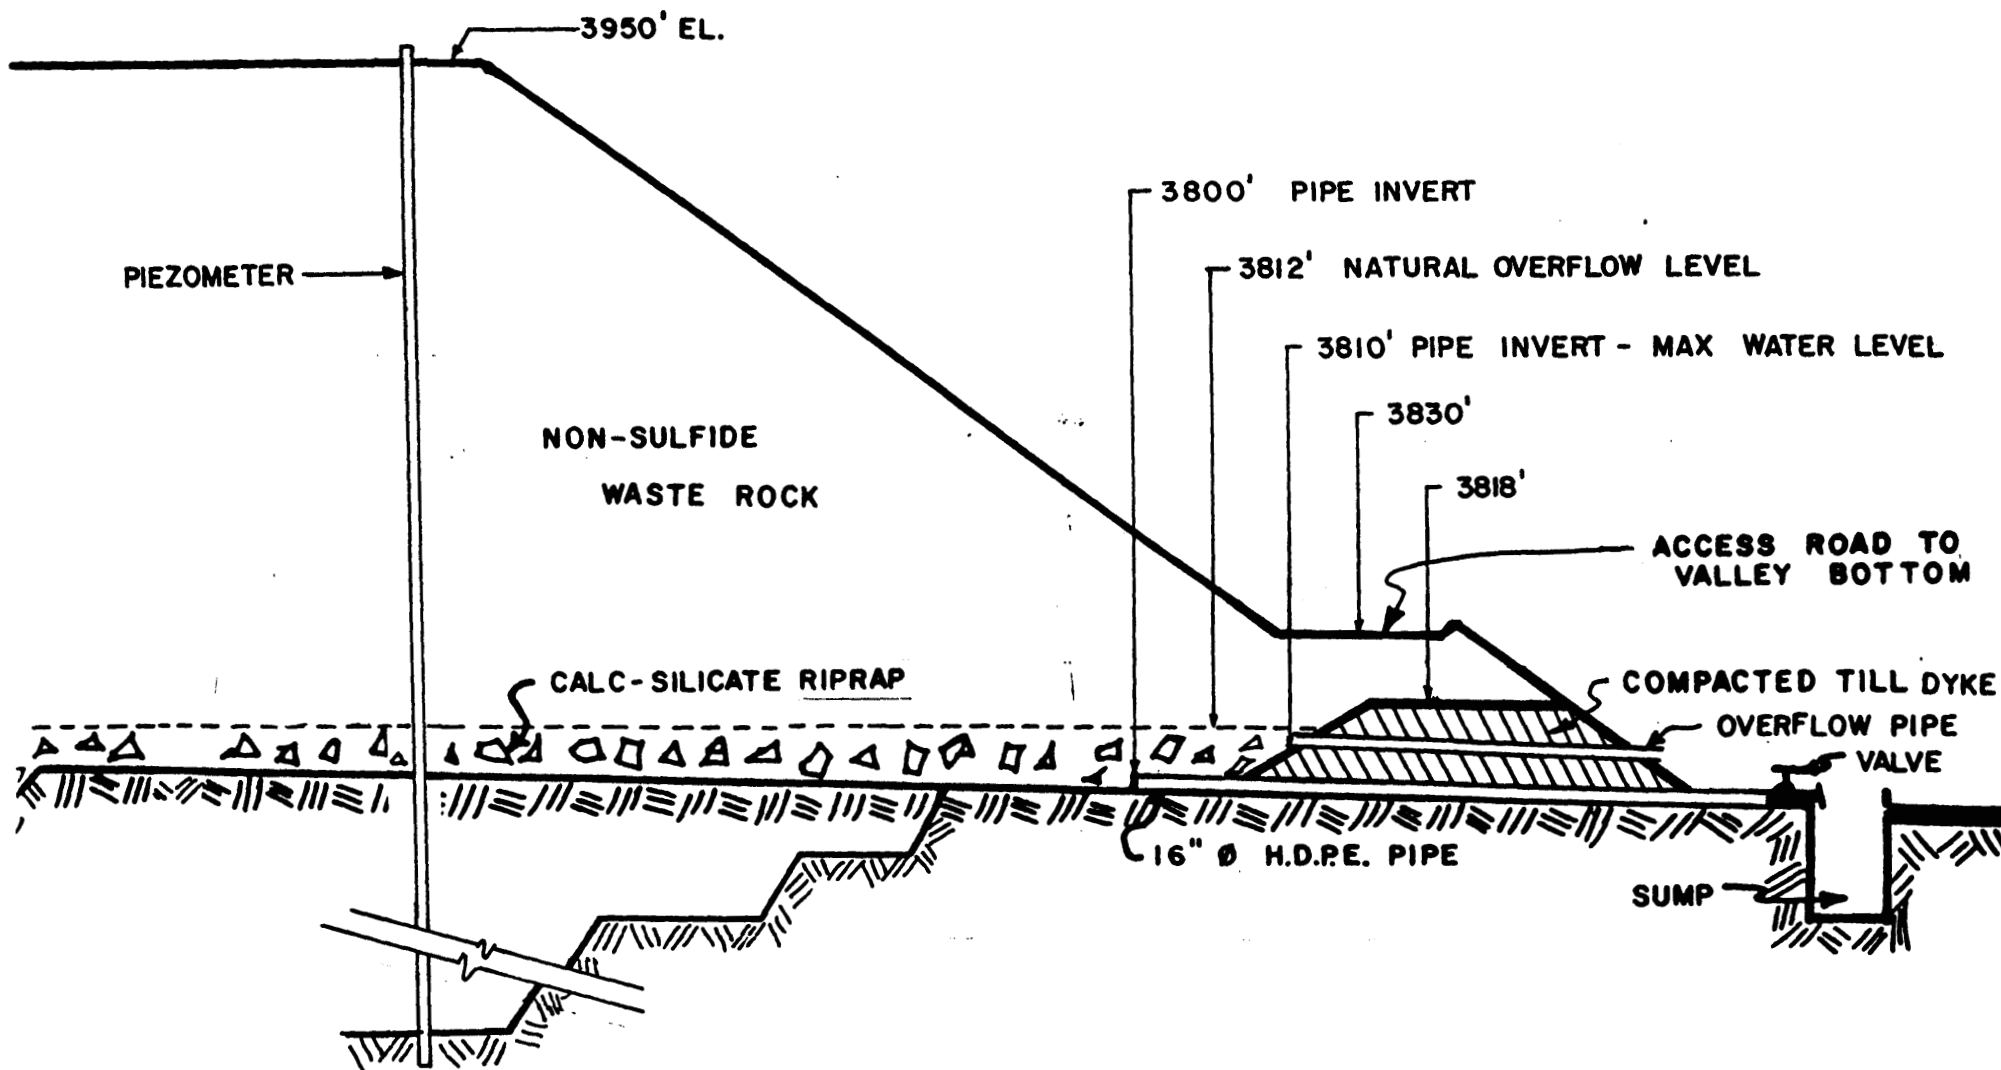
LONGITUDINAL SECTION THROUGH INTERNAL ROCK DRAIN.

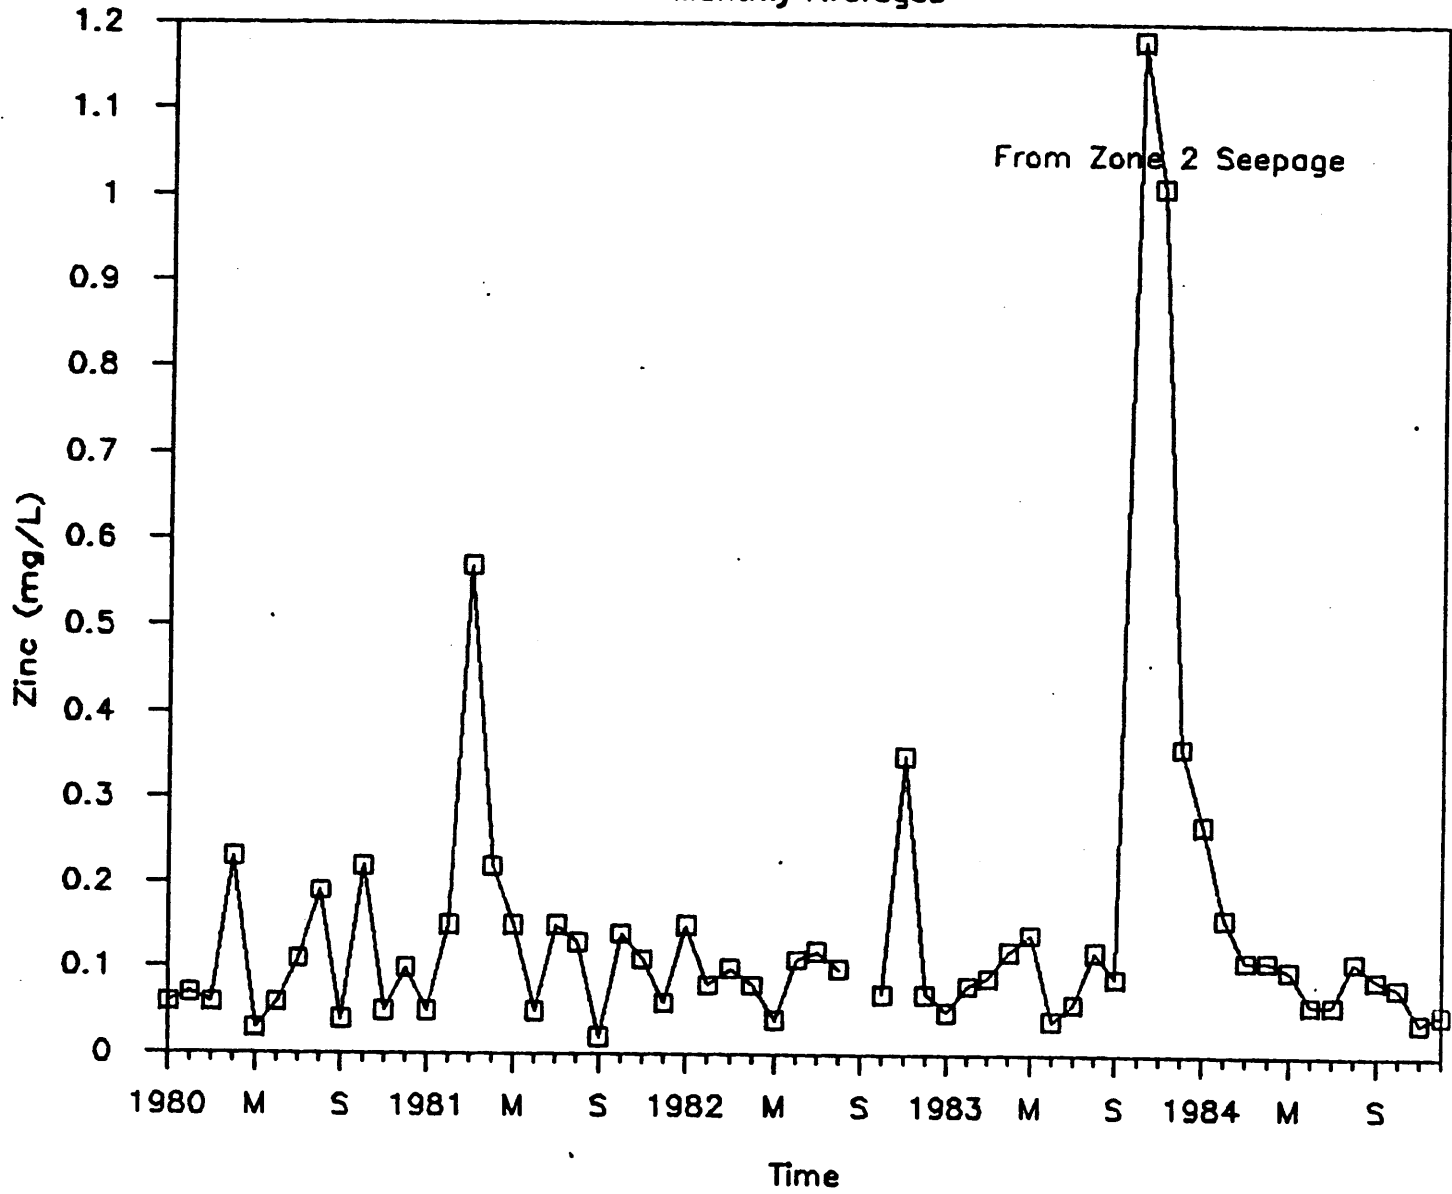
Fig. 5

ZINC LEVELS - North Fork of Rose Creek

Monthly Averages

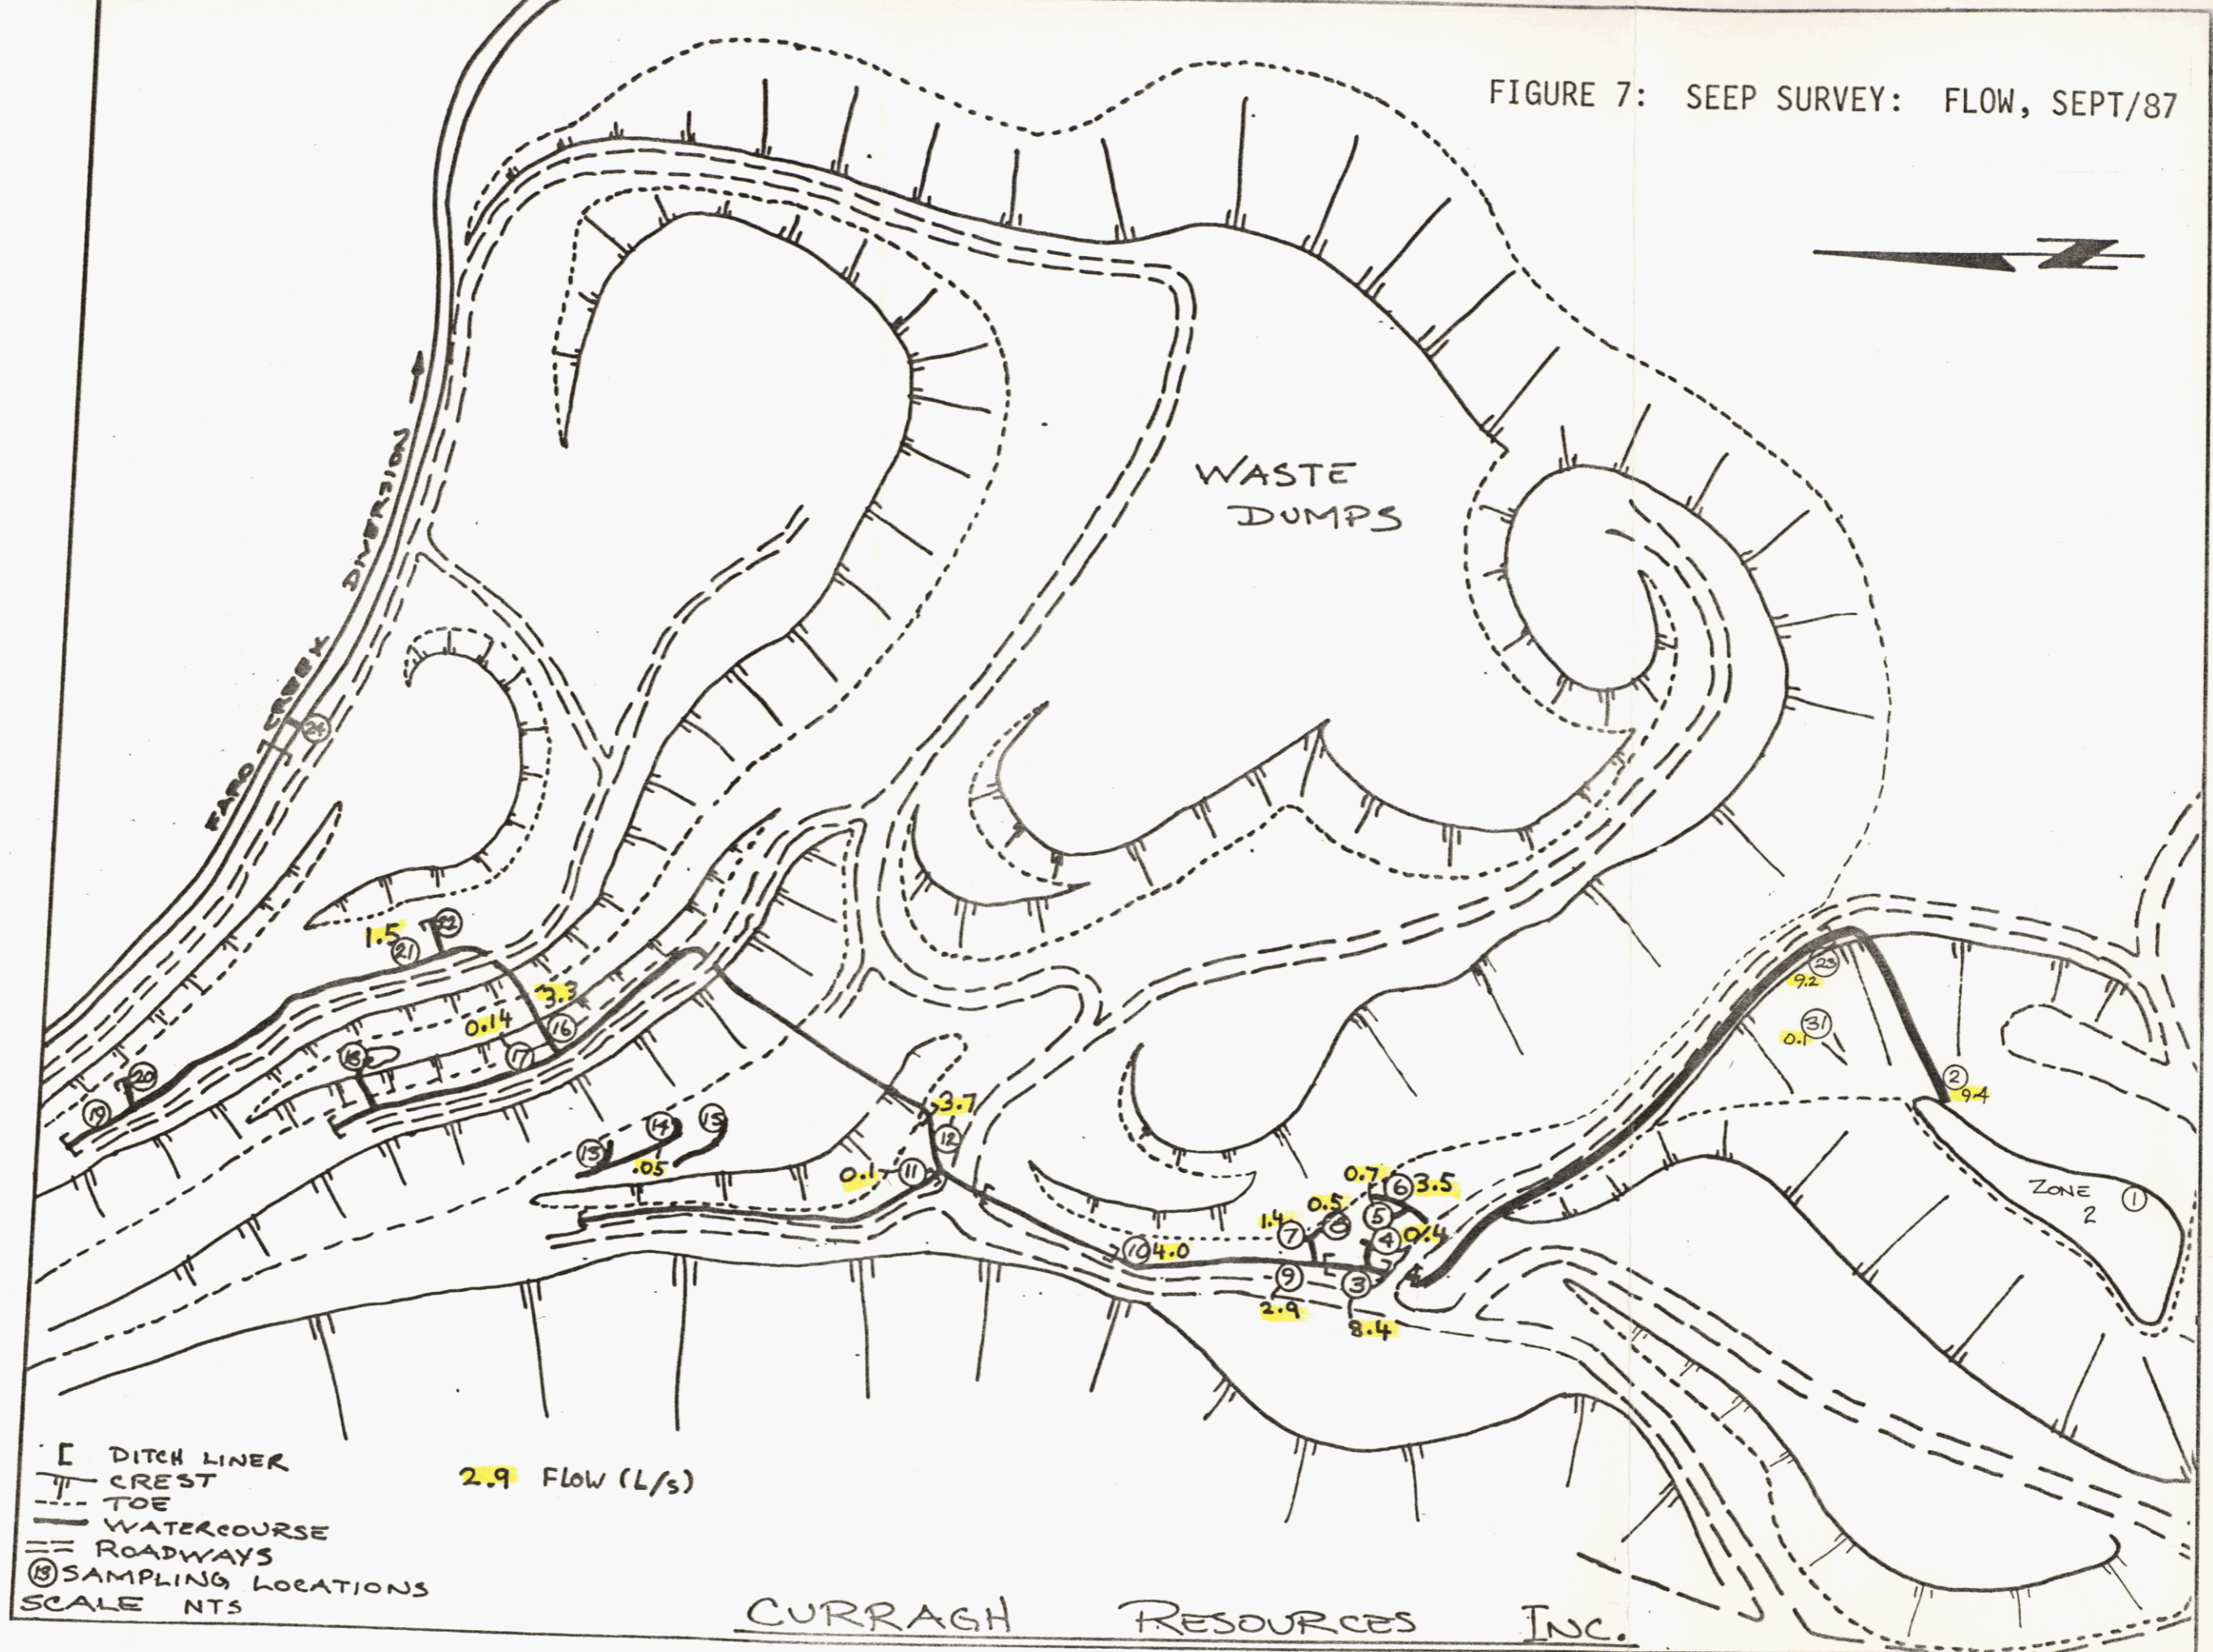
FIGURE 7: SEEP SURVEY: FLOW, SEPT/87

Results of laboratory and field testing are listed in Table 6. Zinc, copper and sulphate loads were calculated as the product of concentration and flow. It should be remembered that the accuracy of these values is limited by the approximate nature of flow values, particularly those arrived at by "estimation" (see Section 3.2.2.1). Flow measurements are shown on Figure 7 and Figures 8 and 9 show total zinc concentrations and zinc loads respectively.

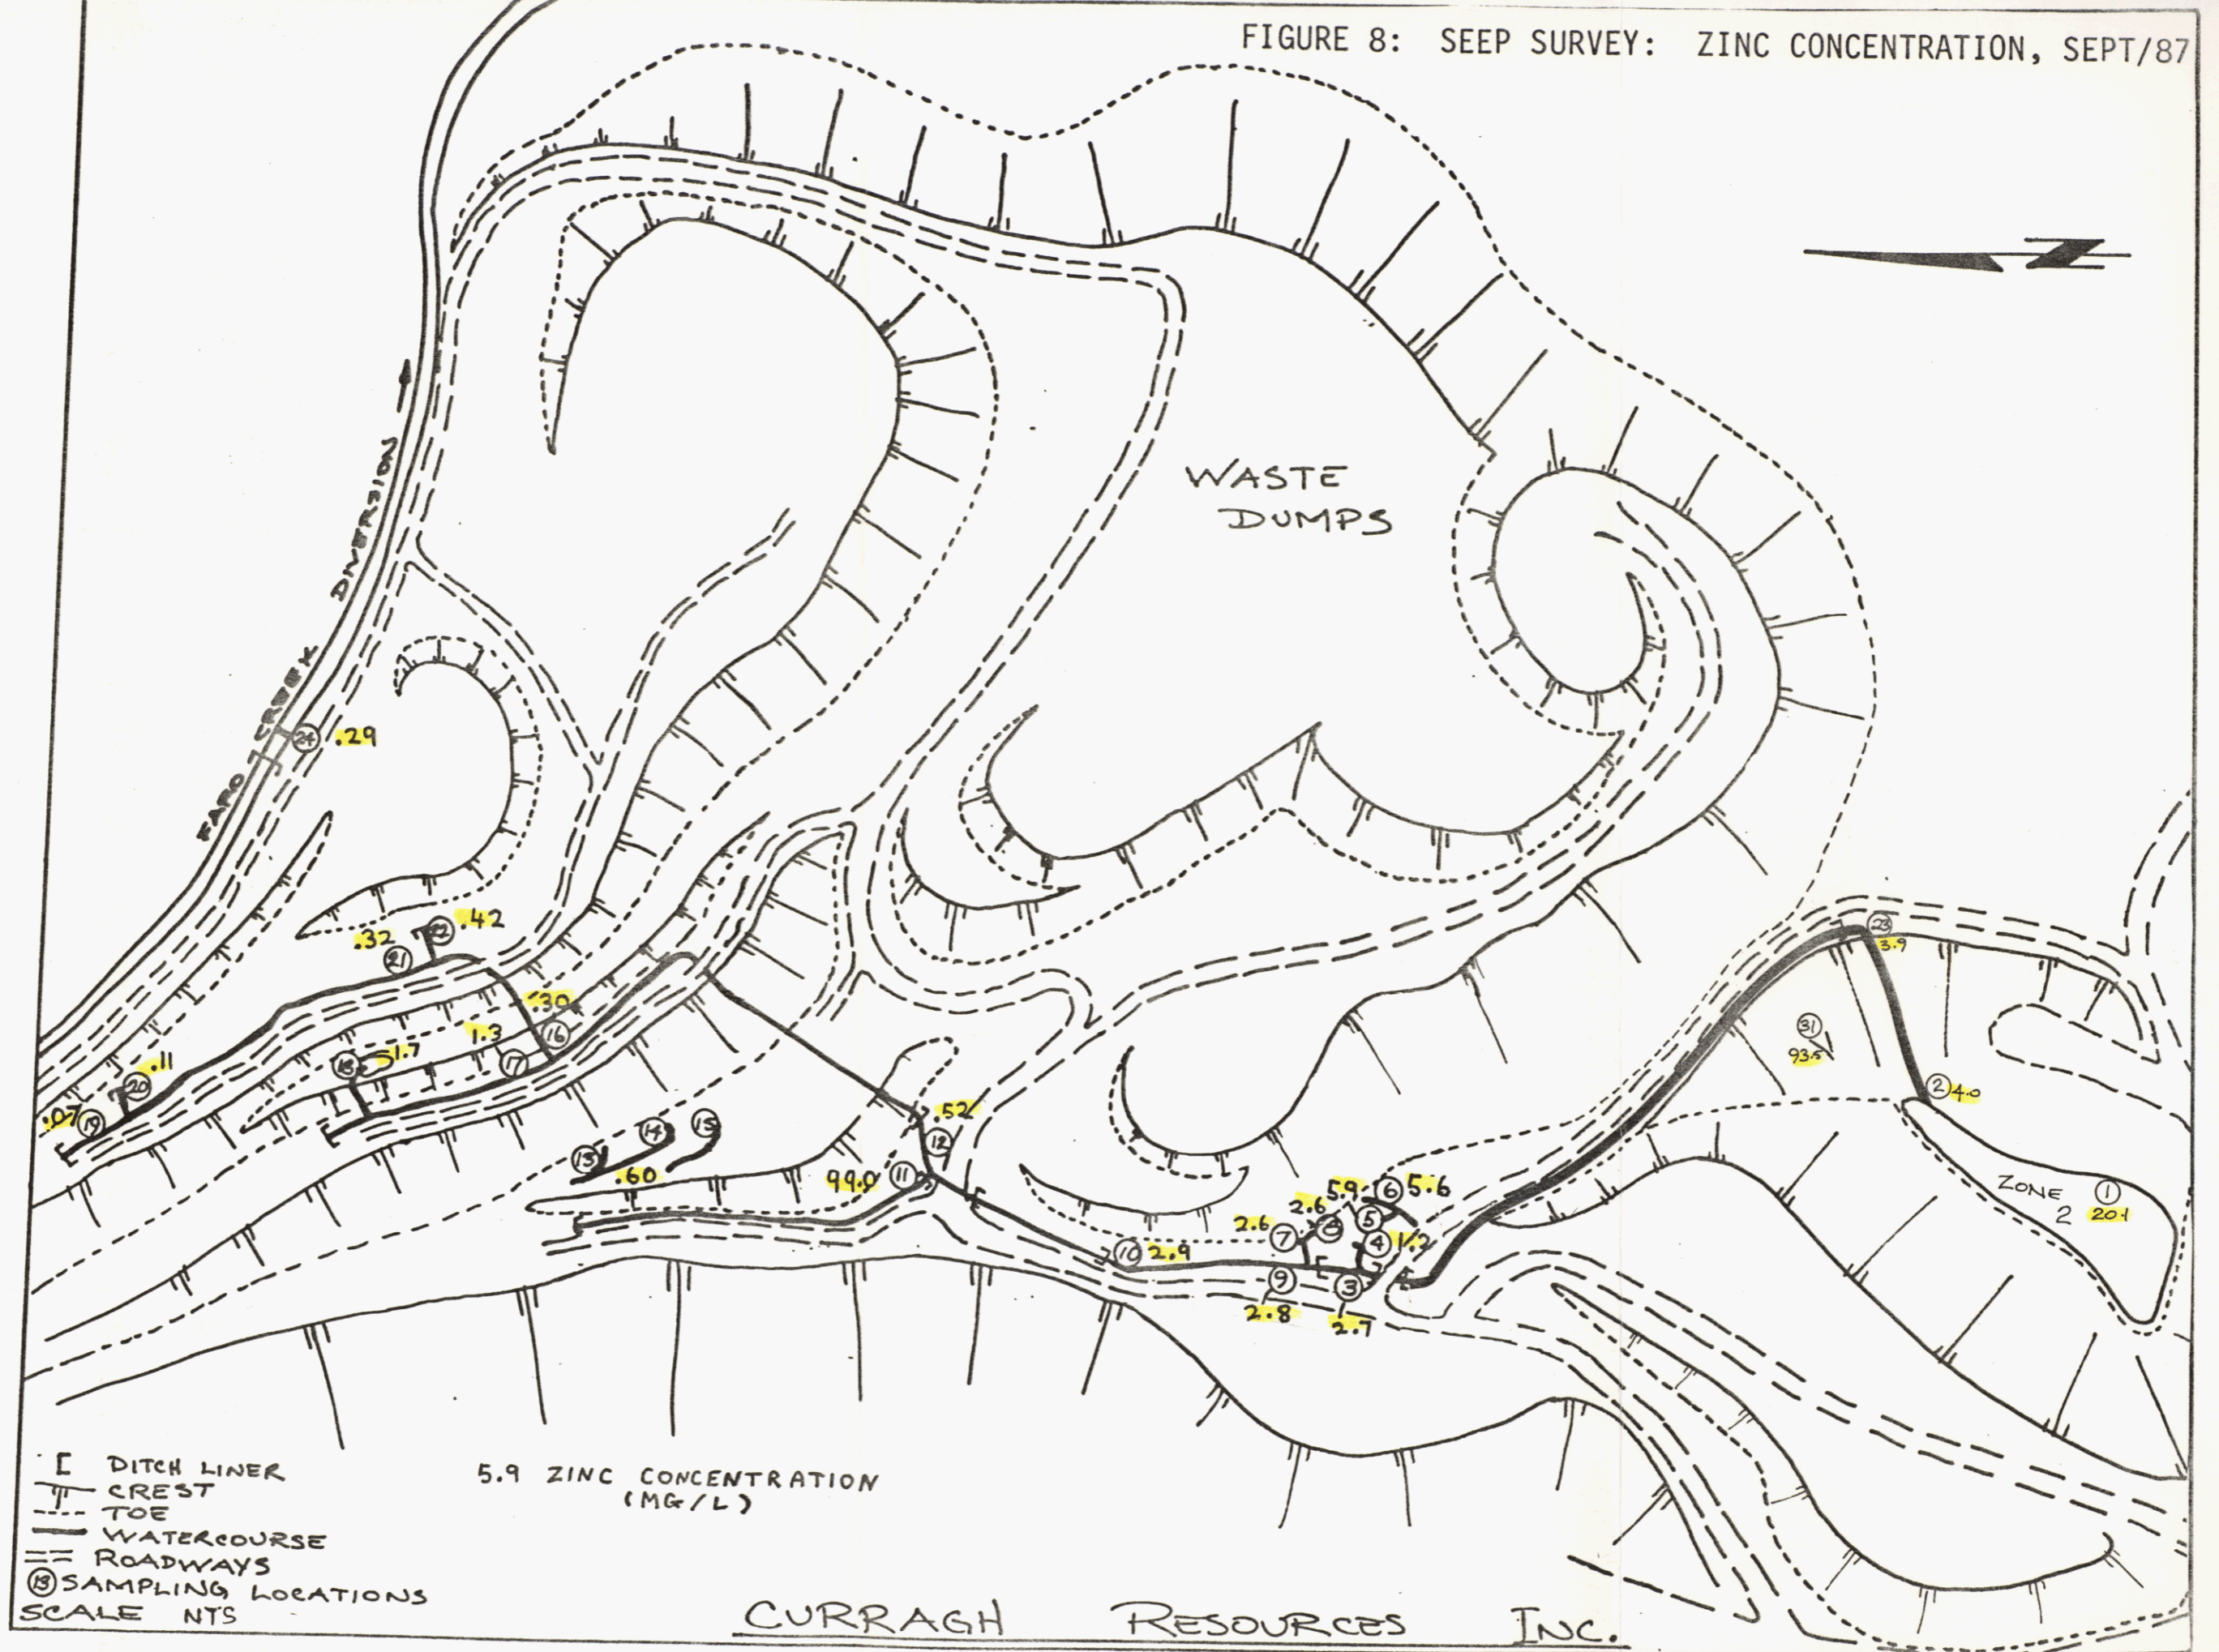
FIGURE 8: SEEP SURVEY: ZINC CONCENTRATION, SEPT/87

with very low pH, high zinc and copper. The zinc remained in solution but the copper was apparently removed from solution as the water was neutralized in the ditch. Major sources of zinc were the neutral seeps with high zinc from the old waste dumps northeast of Zone 2.

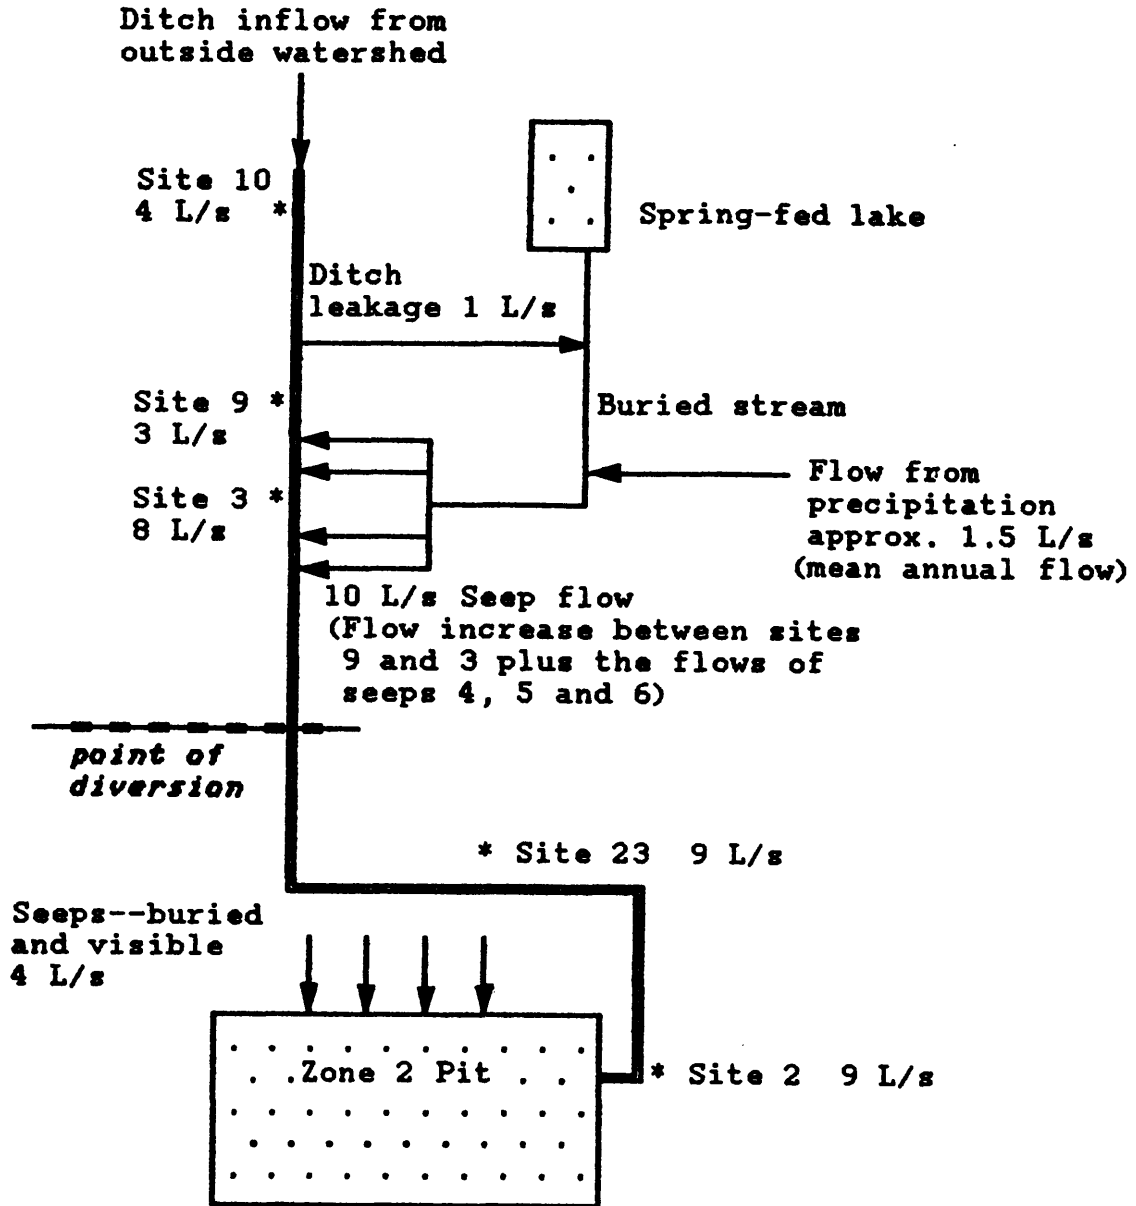
FIGURE 12: FLOW CONTRIBUTION TO ZONE 2 OF WATER THAT WILL BE DIVERTED

Estimates for late September, 1987

Figure 12 is a scheme of surface flow and seeps contributed to Zone 2 during the survey by water that will be diverted away from Zone 2 by the proposed ditches. At that time, this flow contributed to the pit at least 13 L/s of water. This does not include the shallow subsurface flow which will also be diverted. The component of this surface flow entering the pit through seeps along the northeast wall is estimated to be 4 L/s. The zinc load carried by this flow would depend on the type of rock the hidden seeps flow through. Given the prevalence of acid-generating material in this section of the pit wall (Figure 10), it is probable that some of these hidden seeps contained very high zinc loads. As indicated above, only 2 L/s of seeps equivalent in quality to seep 31 would result in the measured pit water concentration.

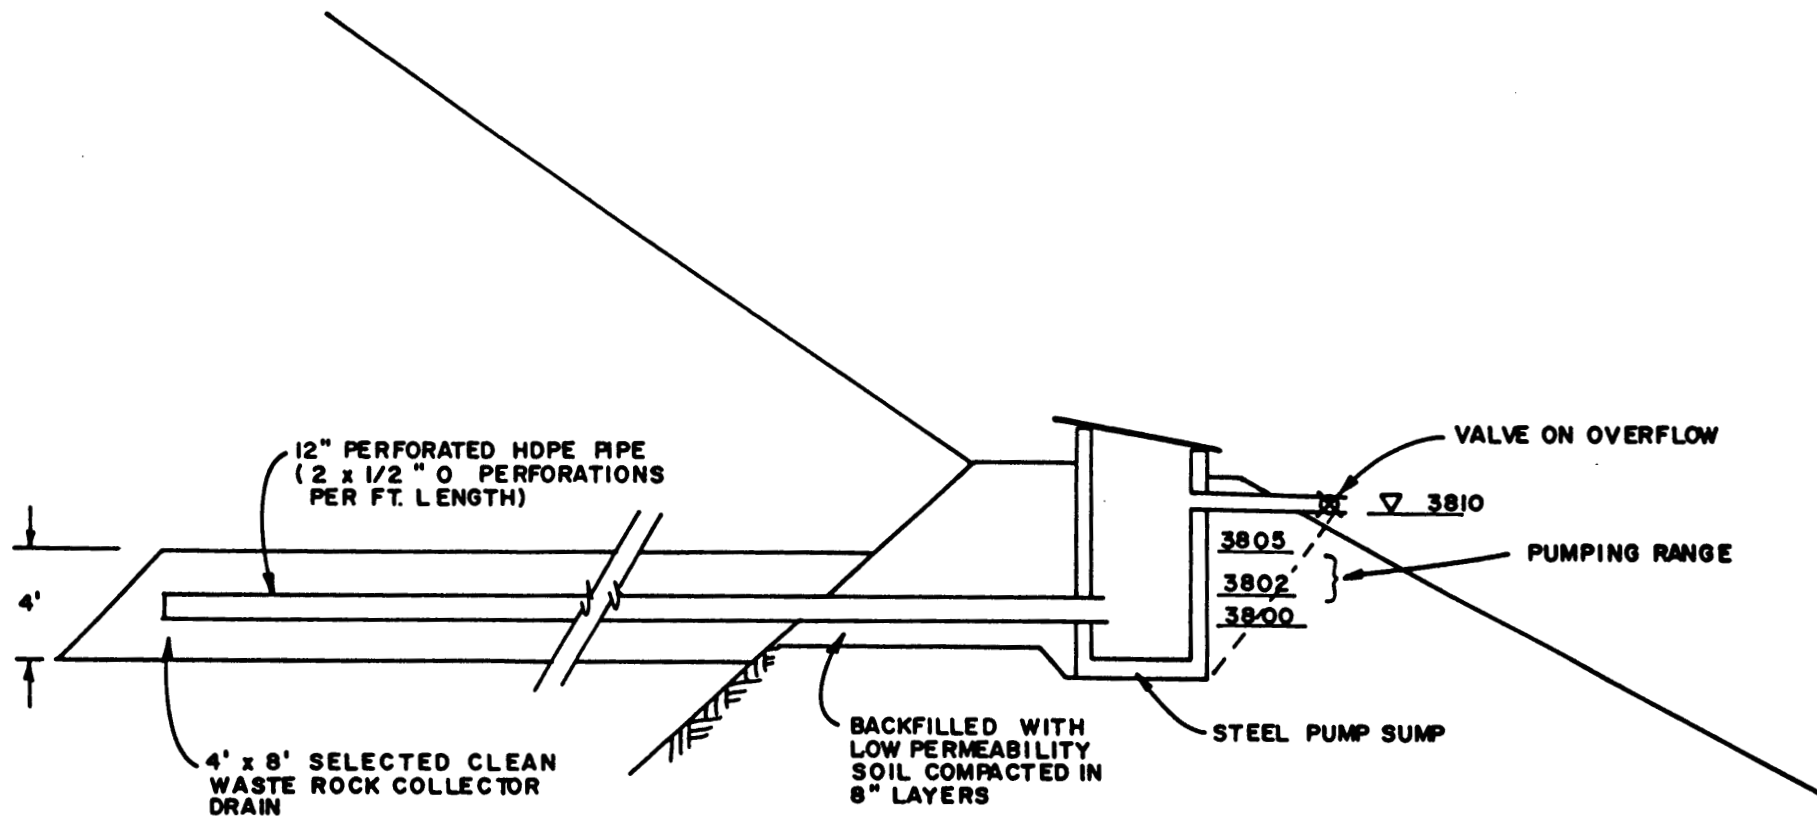
FIGURE 1 SECTION THROUGH ZONE TWO DEWATERING COLLECTOR

Until an overall abandonment plan is developed and successfully implemented it will be necessary to collect and treat drainage from the Zone Two pit. By installing a collector drain, as proposed, at a substantial depth below the discharge elevation of 3812 the seepage can be collected before it breaks through to the North Fork of Rose Creek valley. A collector layout as illustrated in Figure 1 is recommended. This arrangement allows the water in the pit to be maintained at least 10 ft. (3 m) below the mine observed discharge level. The level of the water in the pump sump will serve as a piezometer indicating the water levels in the pit.
