**INITIAL ENVIRONMENTAL EVALUATION**

**VANGORDA PLATEAU DEVELOPMENT**

**Stage One: 1987 Program**

**Curragh Resources Inc.**

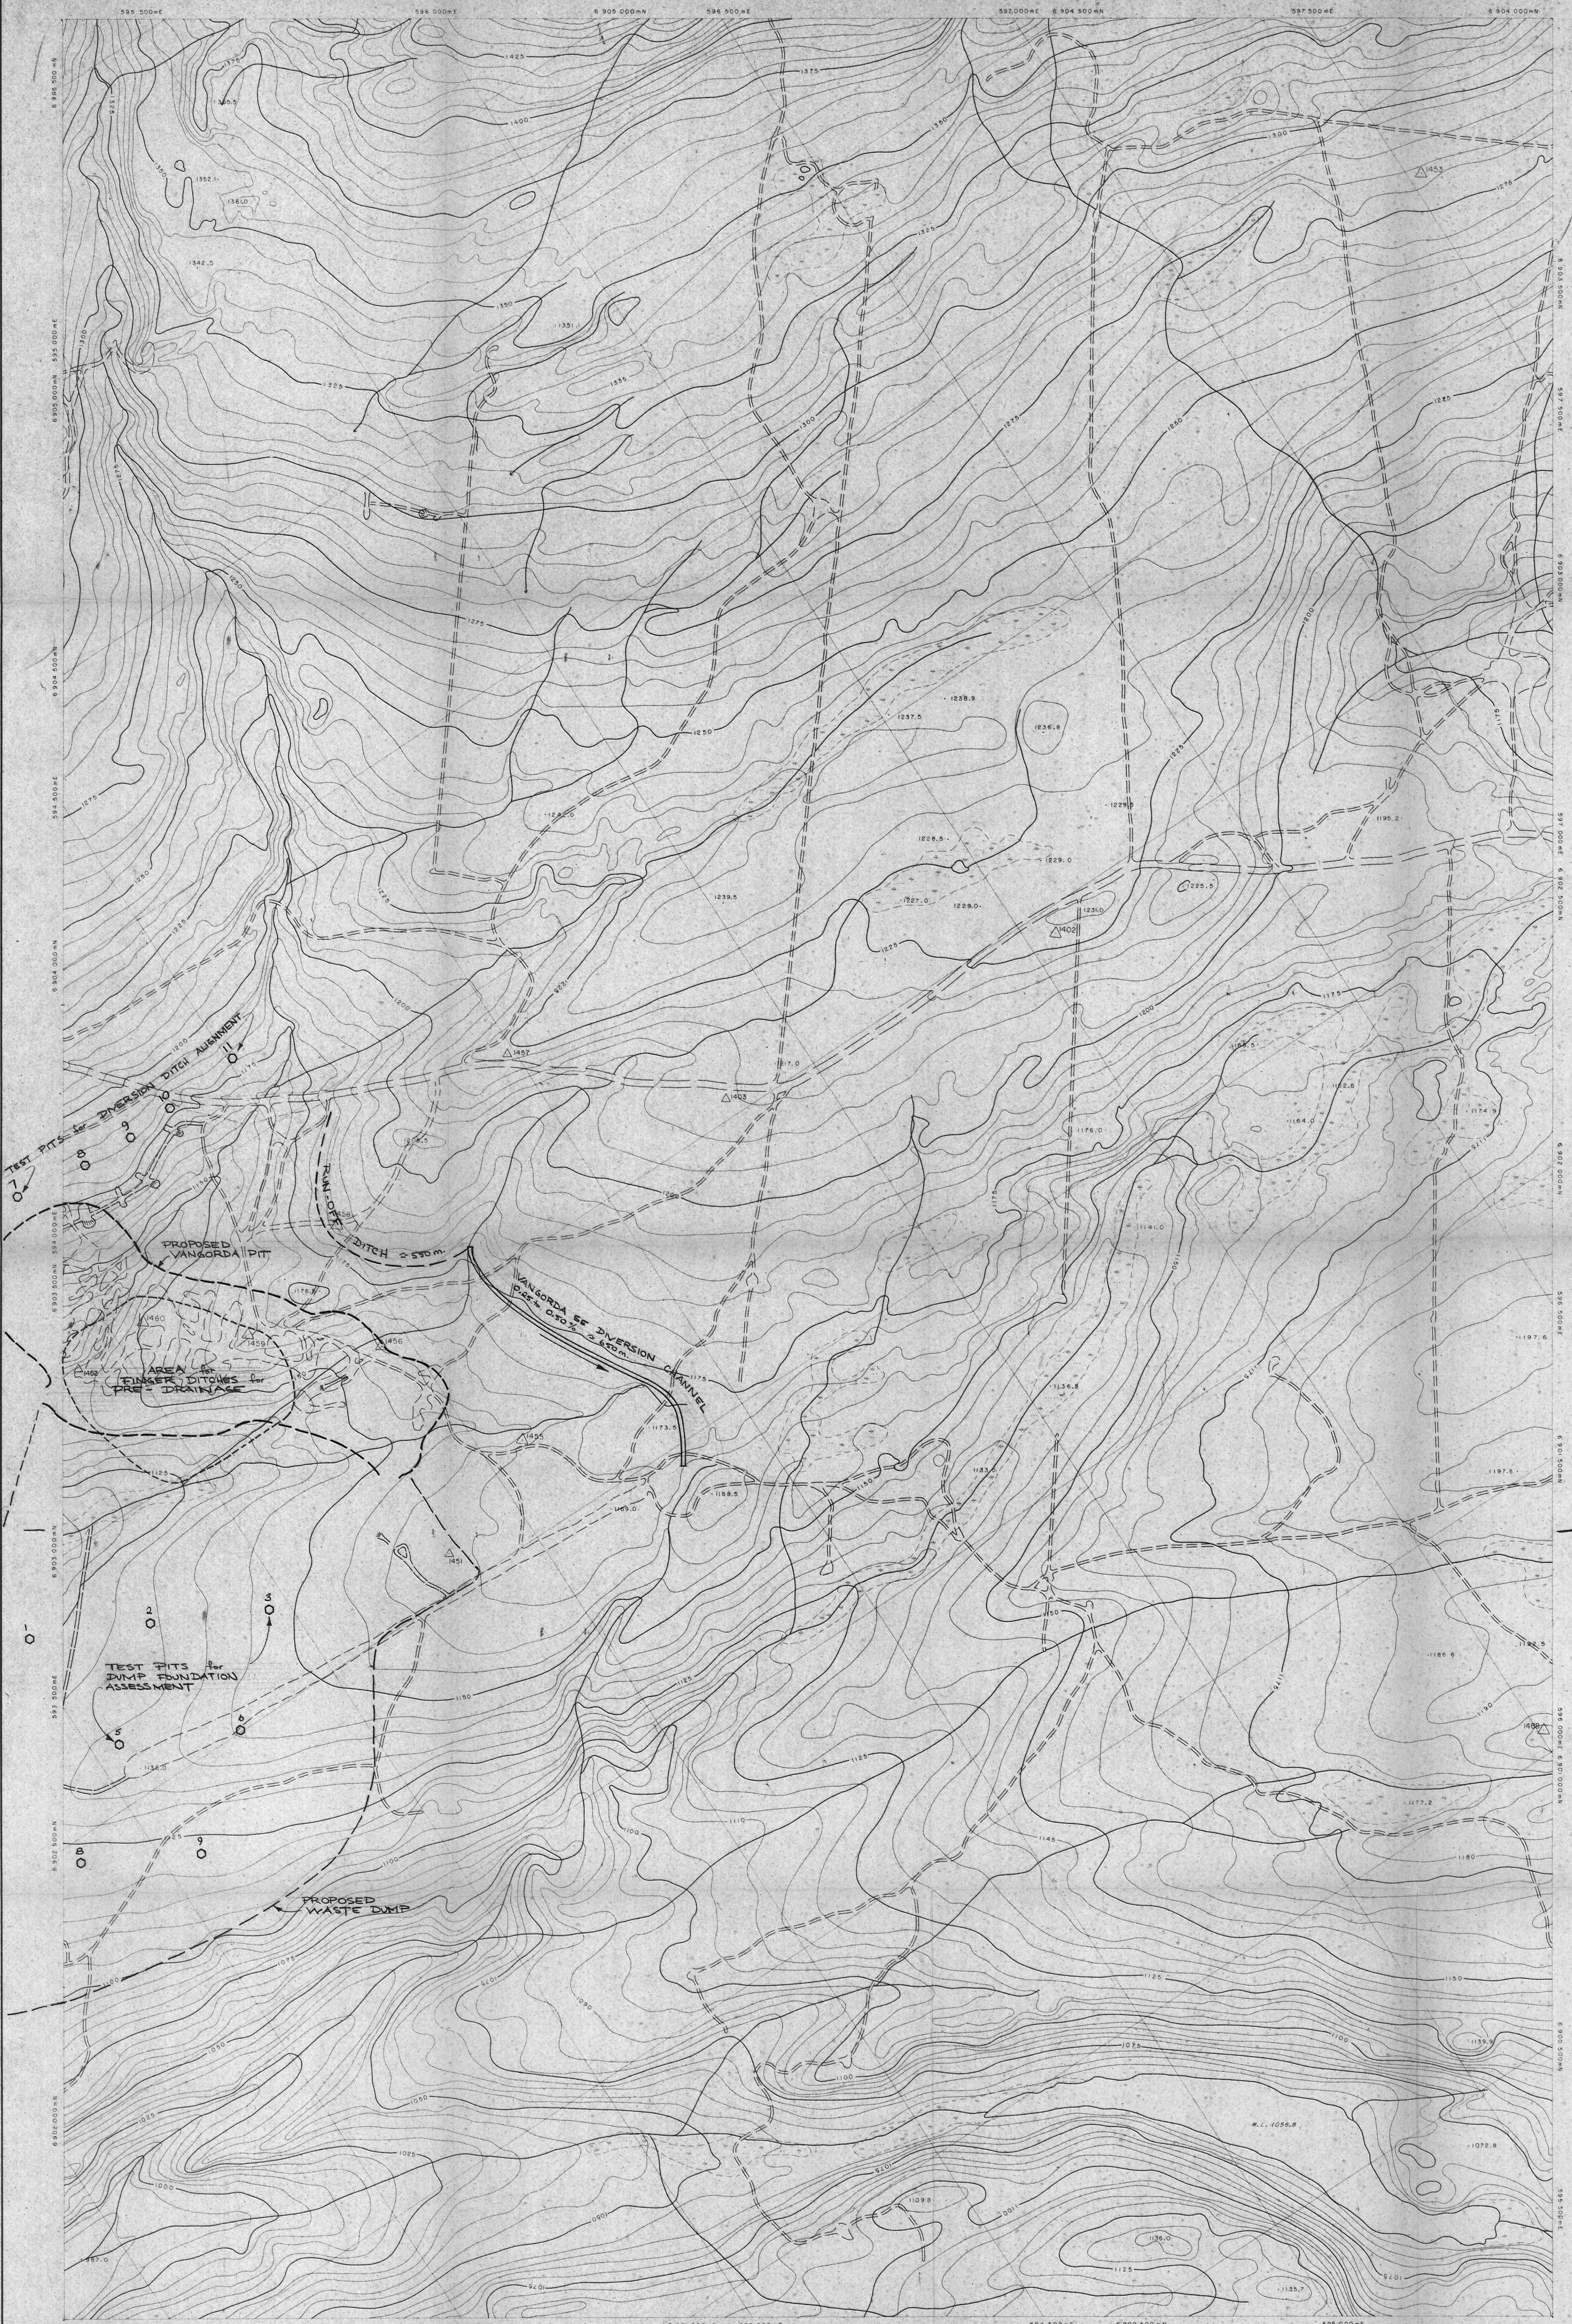
Figure 1b

Orthophoto map compiled from aerial photography taken in August, 1979 by North West Survey Corporation International Ltd.  
 Coordinates shown are U.T.M. coordinates based on Clarke's Spheroid of 1866 and are computed for Zone 8.  
 Elevations shown are Geodetic elevations based on the North American Datum, 1927.  
 Horizontal and vertical control survey was performed by Hosford, Impey, Welter & Associates Ltd. and North West Survey Corporation (Yukon) Ltd. in the summer of 1979 for Cyprus Anvil Mining Corporation and is included in a report of the same date.  
 Any conflict between contour numbers and planimetric detail is due to planimetric detail being added at a later date.

Figure 1a and 1b: Vangorda Plateau Development, 1987 Program (in map pockets)	
Figure 2: Doal Lake Soundings, August 21, 1987	
Figure 3: Vangorda Creek Flow, 1975-1977	
Figure 4: Water Quality Monitoring Sites

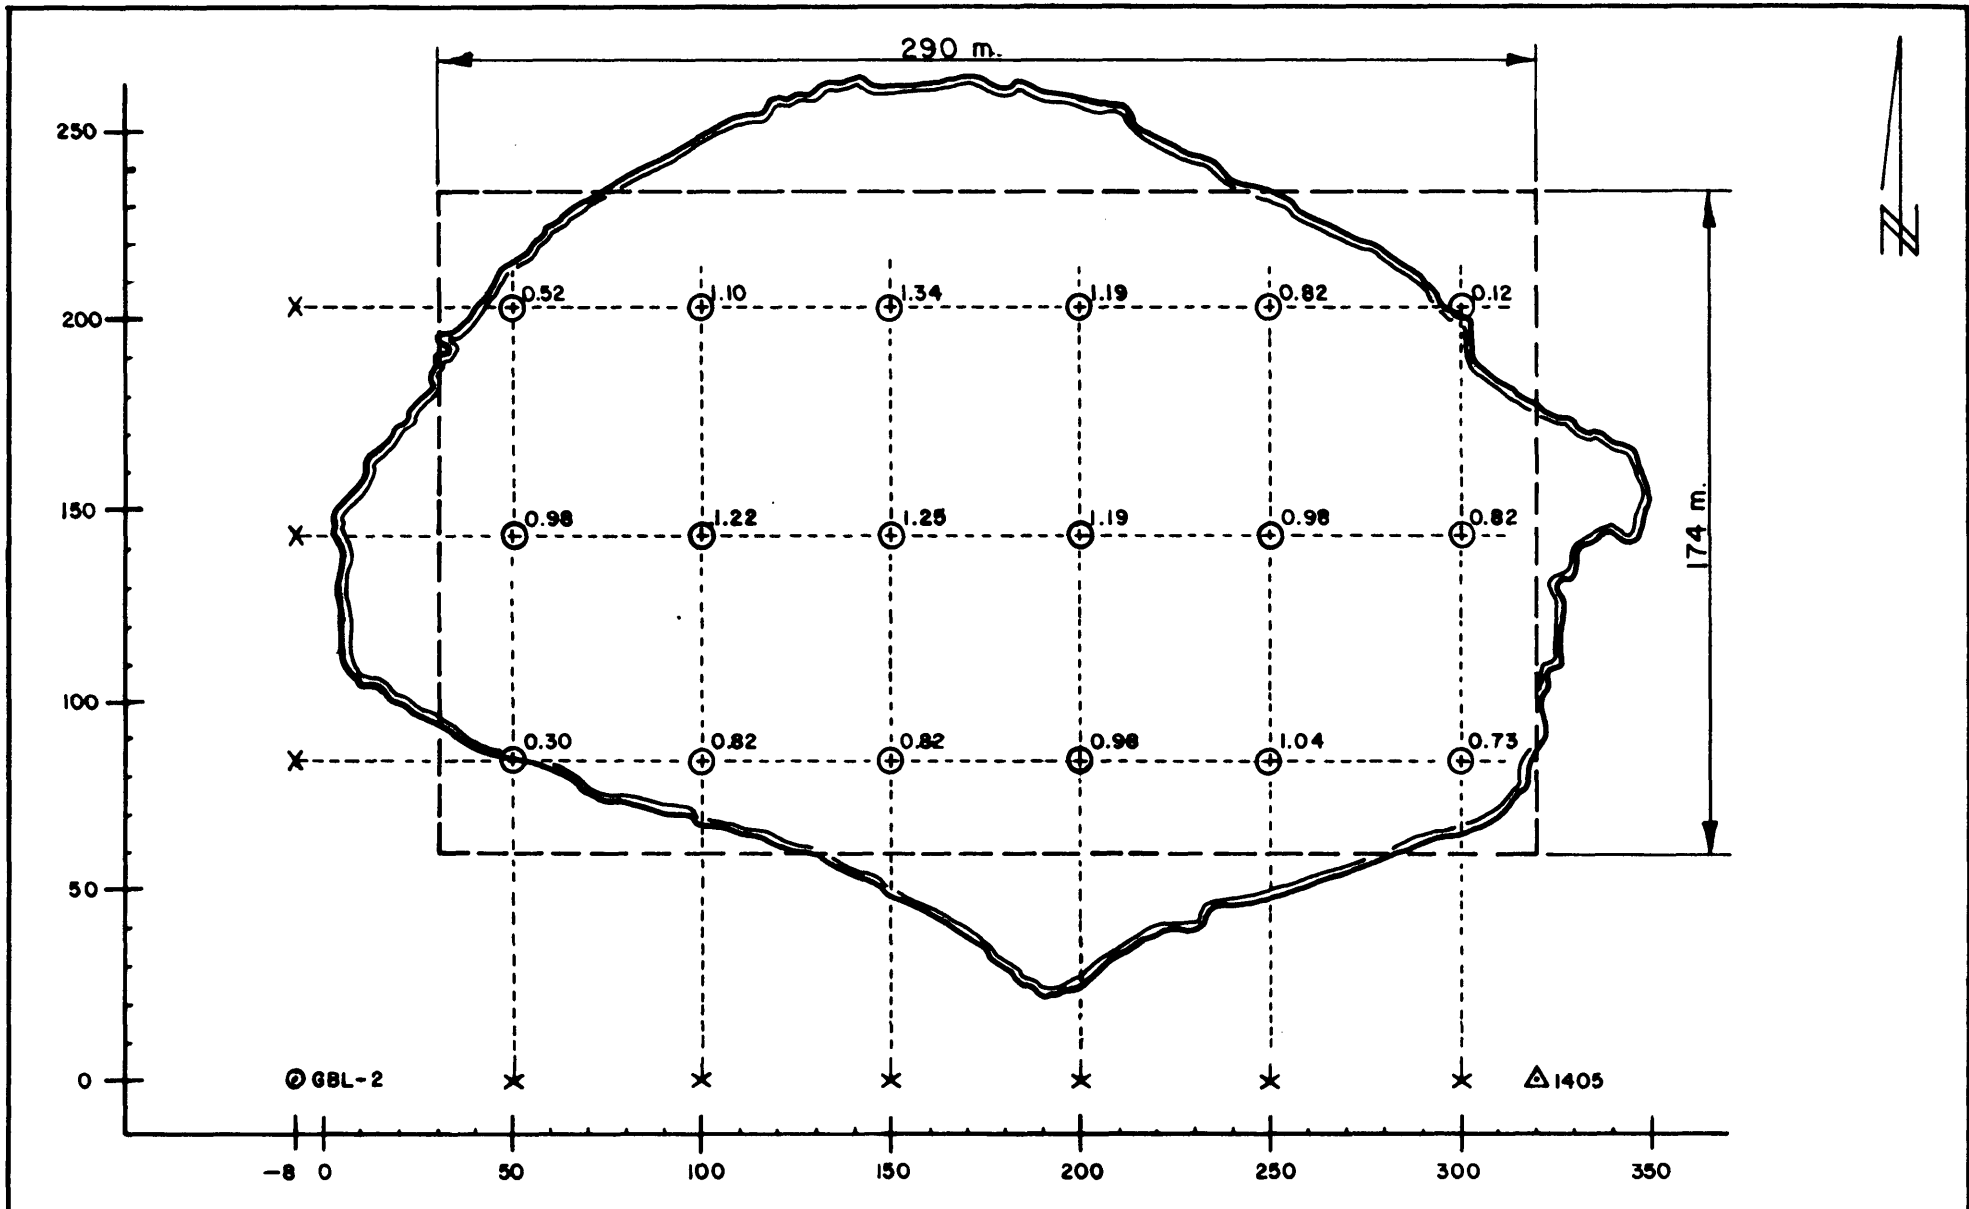
- ⊕ DEPTH STATION
- X GRID STATION
- LAKE PERIMETER from F-6-3 (E-3)
- - - AVERAGED OUTLINE

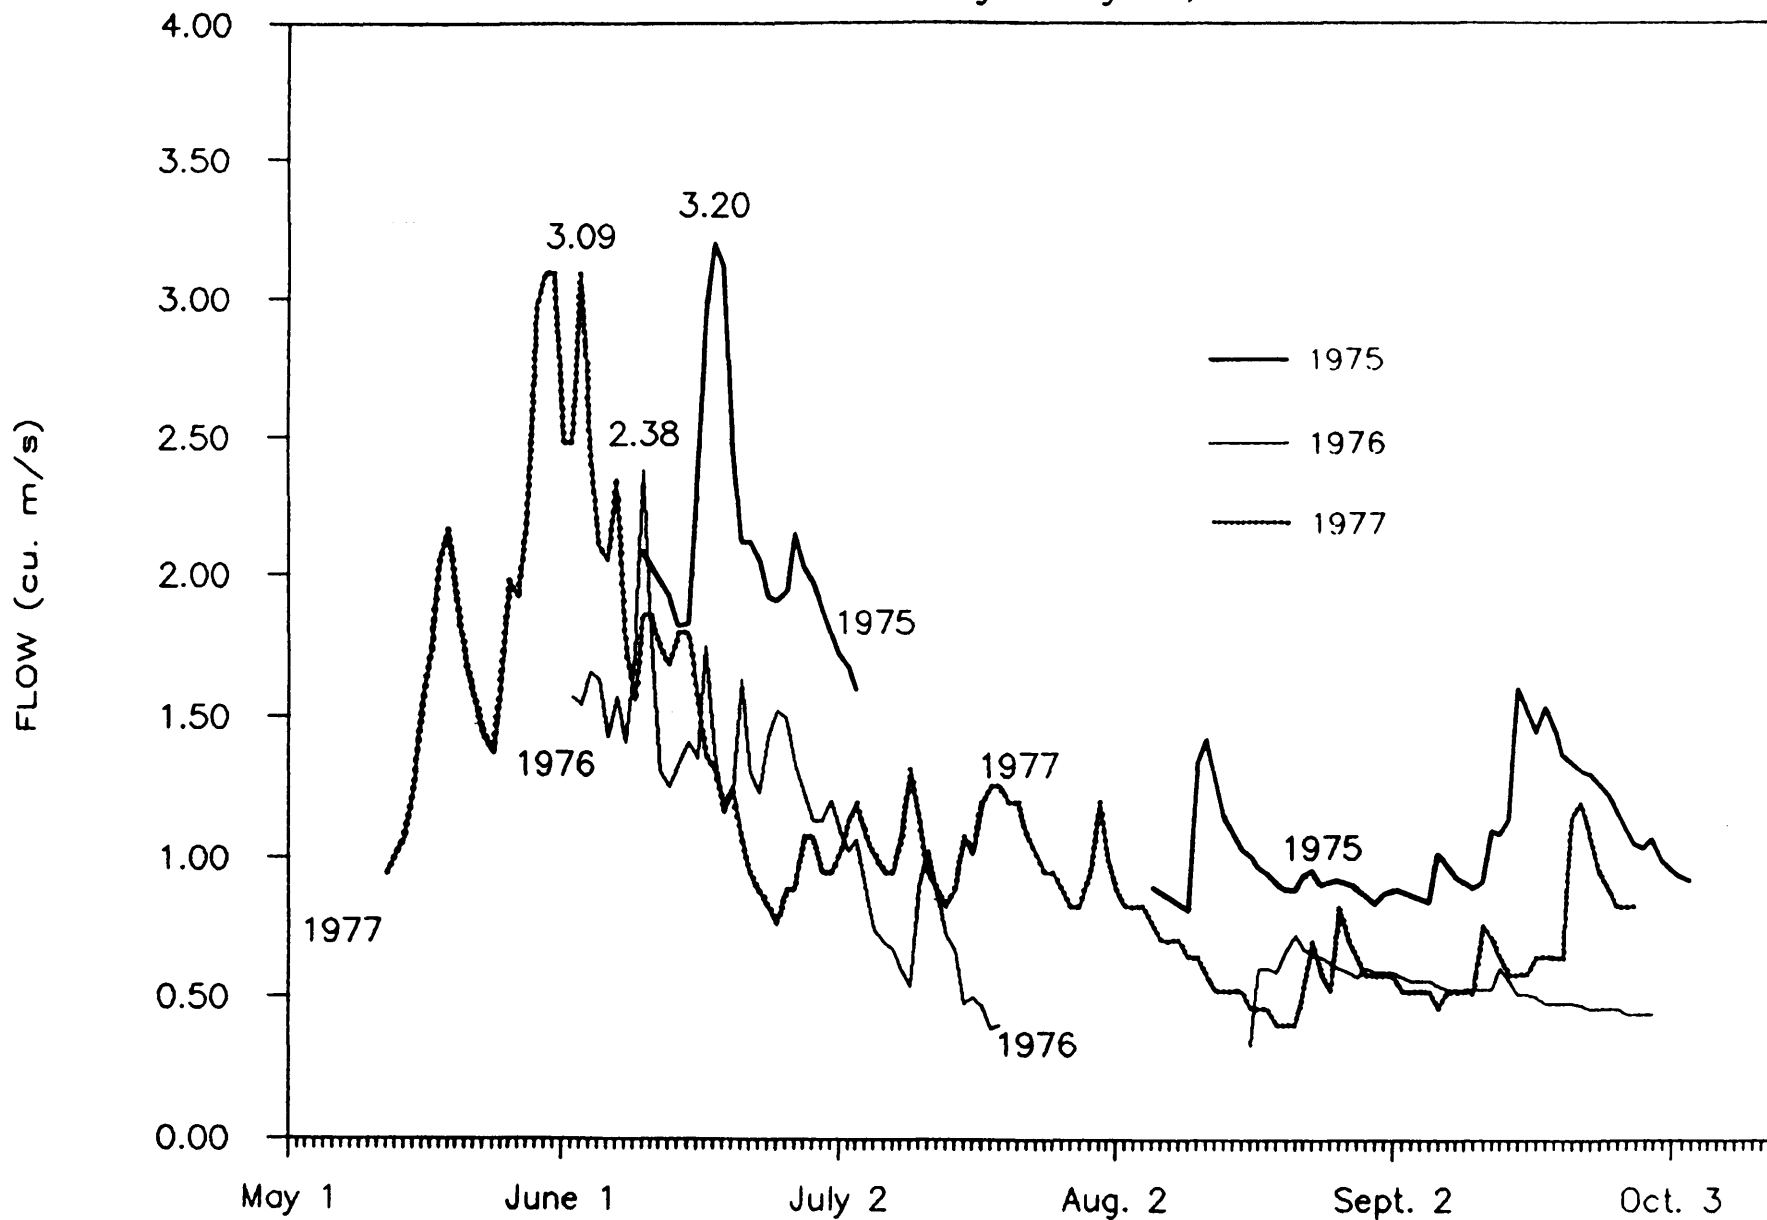
# VANGORDA CREEK FLOW 1975 - 1977

from Montreal Engineering Co., 1975 - 77

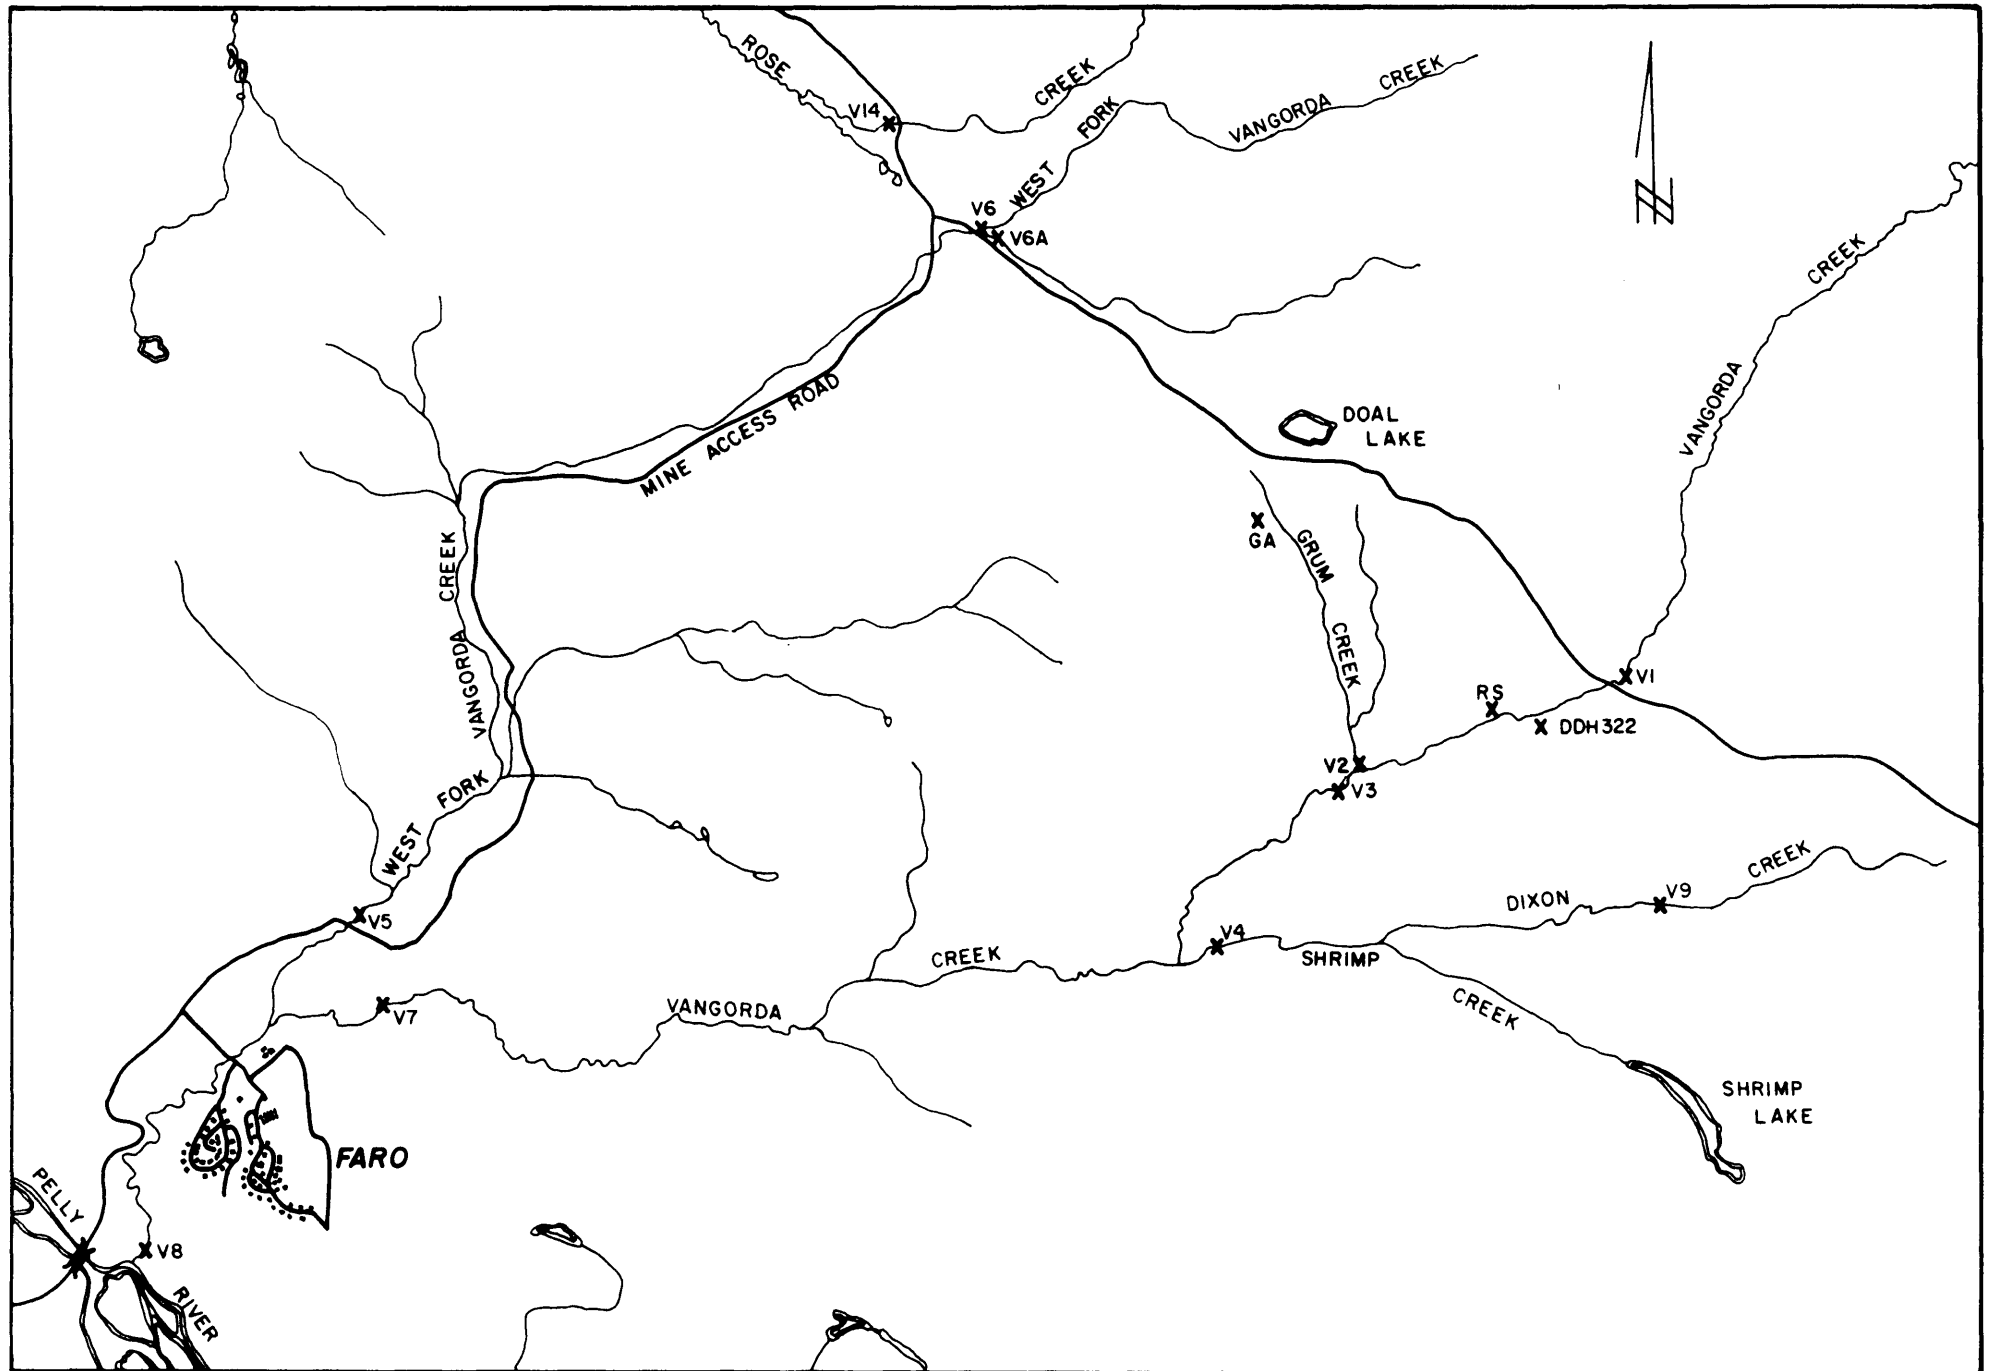
# WATER QUALITY MONITORING SITES

##### 4.2.1 Sites (see Figure 4 for locations)

- Doal Lake
- Near water sampling sites V1, V6, V7, and V8 (see Figure 4) and Vangorda Creek both upstream and downstream of the Faro town culvert.
- Side channels of the Pelly River at the mouth of Vangorda Creek and downstream of the Pelly River bridge.
