# **EBA Engineering Consultants Ltd.**

EBA File: 0201-10401

Subject: Hydrology Assessment - Dy Deposit Shaft  
Piezometer Installation  
Faro, Yukon

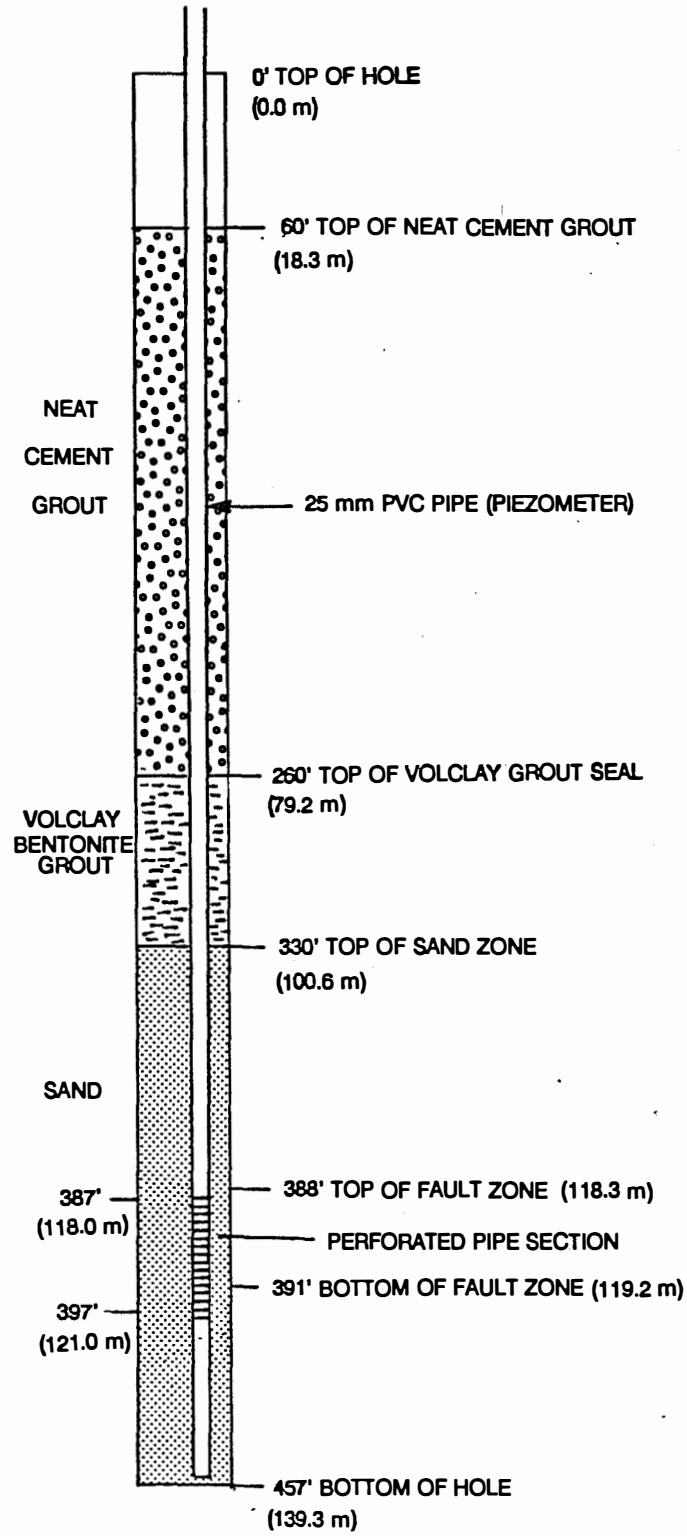
**FIGURE 1**

NOTE: 1. NOT TO SCALE  
 2. PIEZOMETER INSTALLED AT 45° ANGLE

**CONCEPTUAL DRAWING OF  
 PIEZOMETER CONSTRUCTION  
 FOR DY DEPOSIT  
 (PIEZOMETER NO: 10401-01)**

The construction of the piezometers consists of a single 25 mm PVC pipe installed to the bottom of the drillhole. The pipe was embedded in a sand layer that was poured into the drill hole and extends from the hole bottom to above the fault zone. Within this sand

section, the 25 mm pipe is perforated for a ten foot section within the fault zone. Above the sand section the drillhole has been filled with a bentonite grout and a neat cement grout. These grouts extend up to within one hundred feet of the ground surface. The dimensions of the various zones and sections of the piezometers and drillholes are shown in Figures 1, 2 and 3, attached.

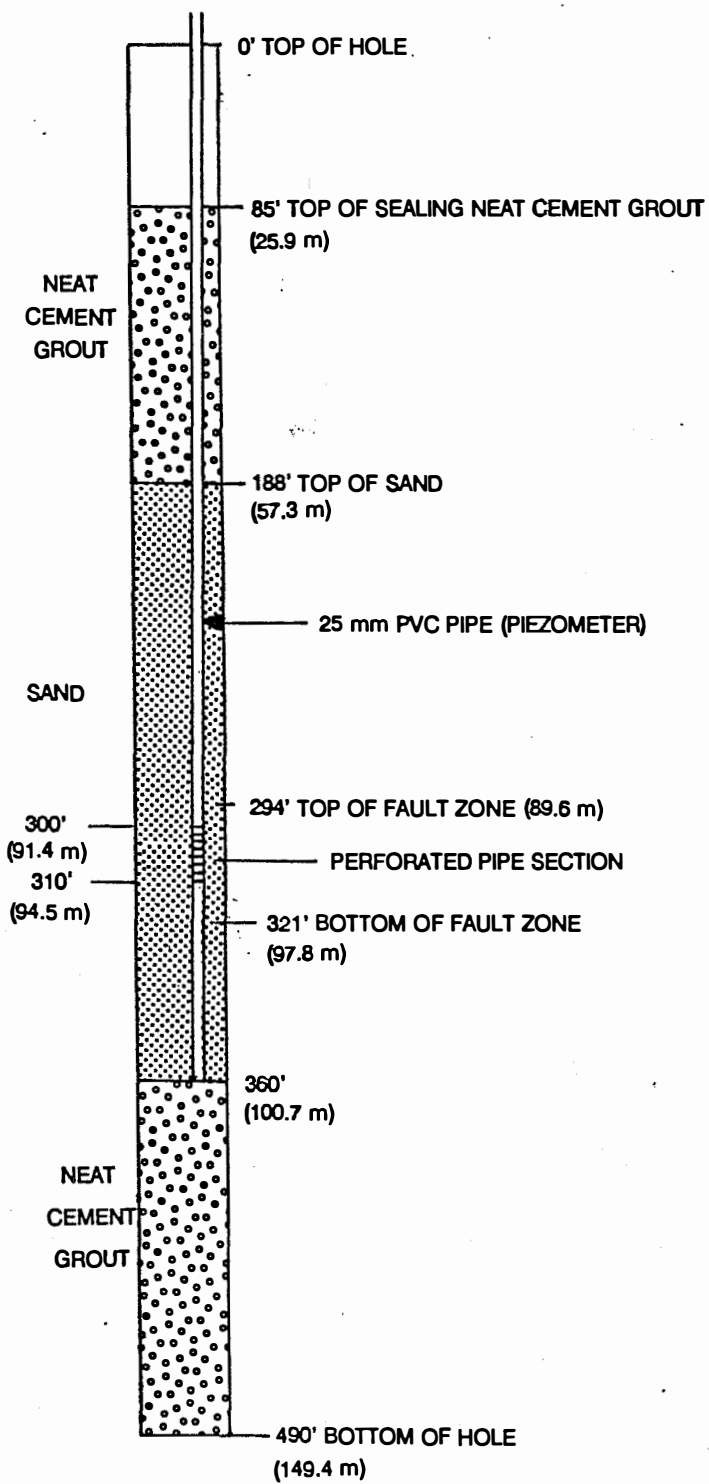
**FIGURE 2**

**CONCEPTUAL DRAWING OF  
PIEZOMETER CONSTRUCTION  
FOR DY DEPOSIT  
(PIEZOMETER NO: 10401-02)**

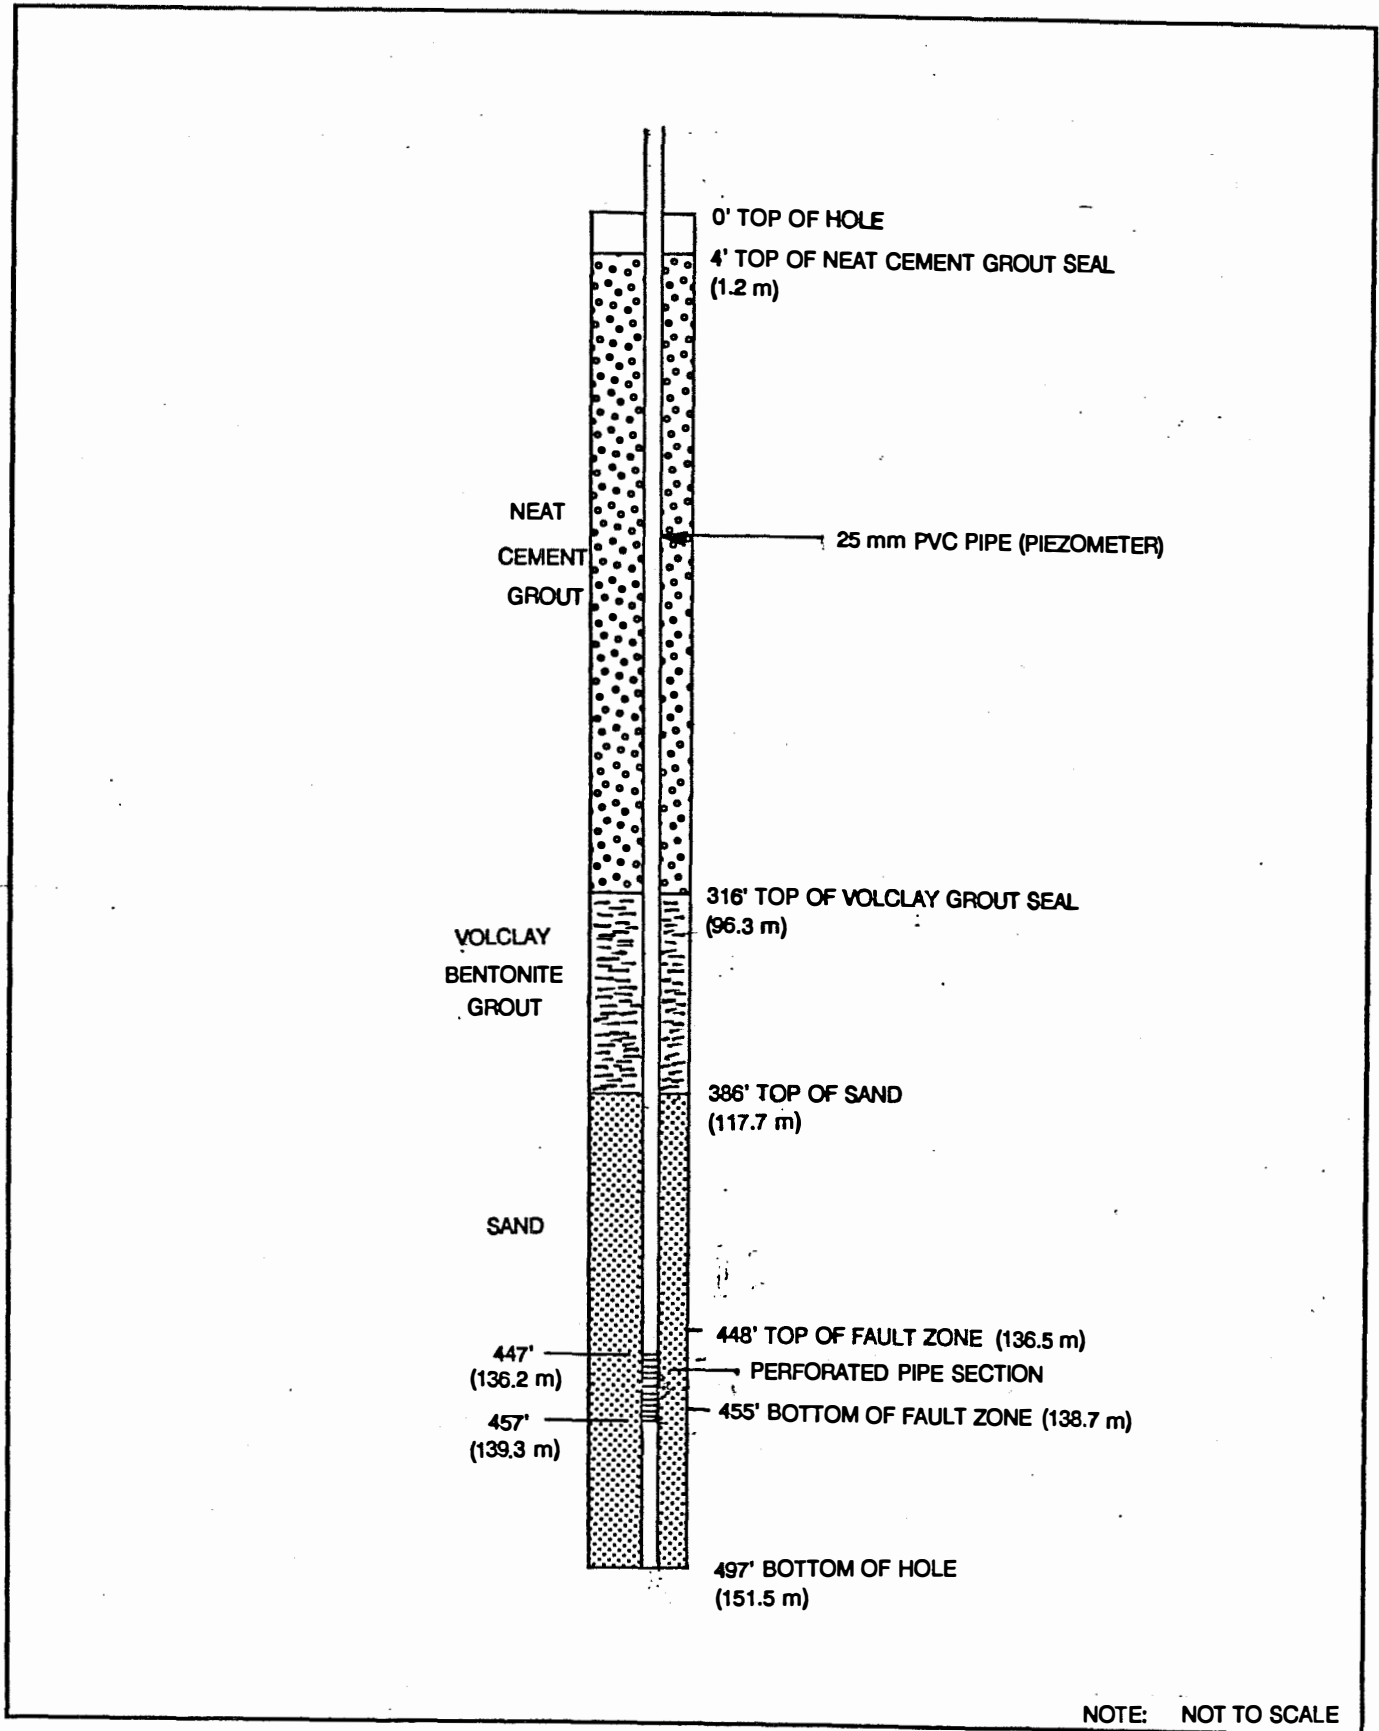
**FIGURE 3**

**CONCEPTUAL DRAWING OF  
PIEZOMETER CONSTRUCTION  
FOR DY DEPOSIT  
(PIEZOMETER NO: 10401-03)**
