HARDY ASSOCIATES (1978) LTD.

Re: Grum Deposit

Progress on work for the Grum deposit is summarized very briefly below. These results are preliminary and based on following assumptions and data:

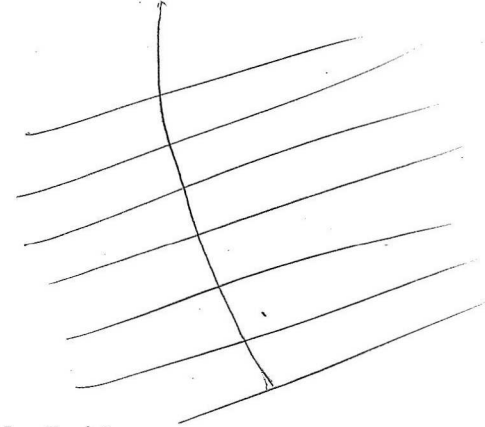
- eyeball
trace* {
- a) above 1203 m: 34° to 70° SW, steeper dips predominate
 - b) 1149 m - 1203 m: 50° to 60° SW
 - c) 1104 - 1149 m: 34° to 45° SW ↑
 - d) Faults in decline average:

266°/78° N
236°/89° N
80

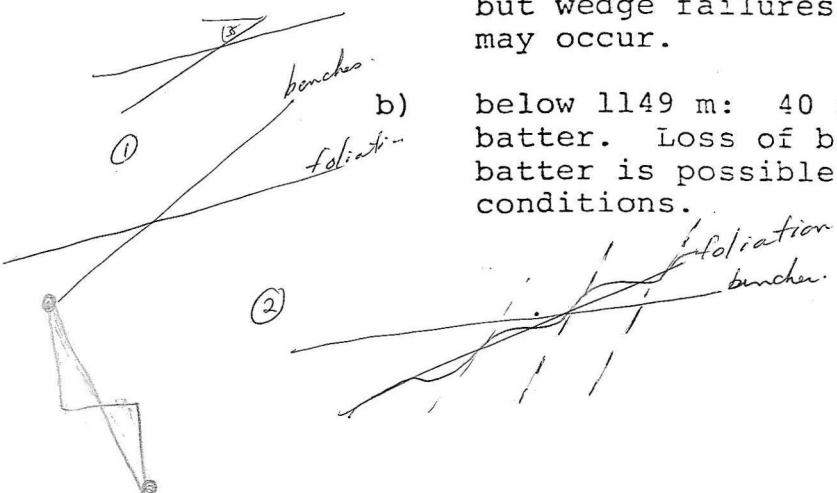
- a) above 1149 m: 40 ft benches can have batter angles 60 to 70°. 80 ft benches are possible but wedge failures back to a batter of 50° may occur.
- b) below 1149 m: 40 ft benches with 60 to 70° batter. Loss of bench edge back to 50 to 55° batter is possible under anything but dry conditions.
