Yukon Placer Database Operations Report

Field Name: Gatenby Mining, 1998-2003

Stream: Dominion: a tributary of Indian

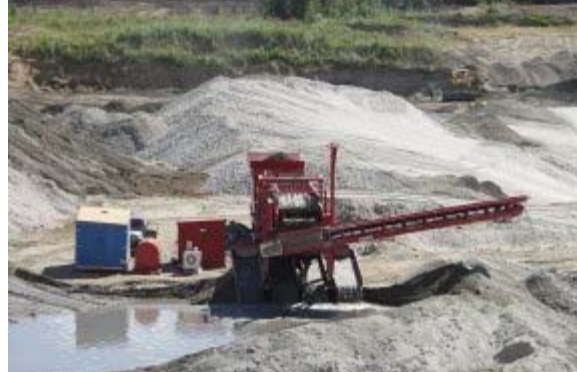
Title: Gatenby Mining Services, 1998-2002

Gatenby Mining Services sluice plant on Dominion Creek.

rubber-coated steel. The top deck had 1-inch holes and the bottom deck had ½ -inch holes. Coarse tailings left the plant and were stacked via another conveyor. Recovery was in vibrating trays. The processing rate was 150 loose yards per hour. Process water was supplied at a rate of 2500 igpm by an 8 by 10-inch Berkley pump powered by a Cummins engine. The operation was able to utilize ground water for sluicing. A recycle rate of up to 100% was accomplished with settling occurring in old mining blocks.
