# DAWSON RANGE DRAINAGES

SITES  
163-176

# NANSEN

## PLACER AREA

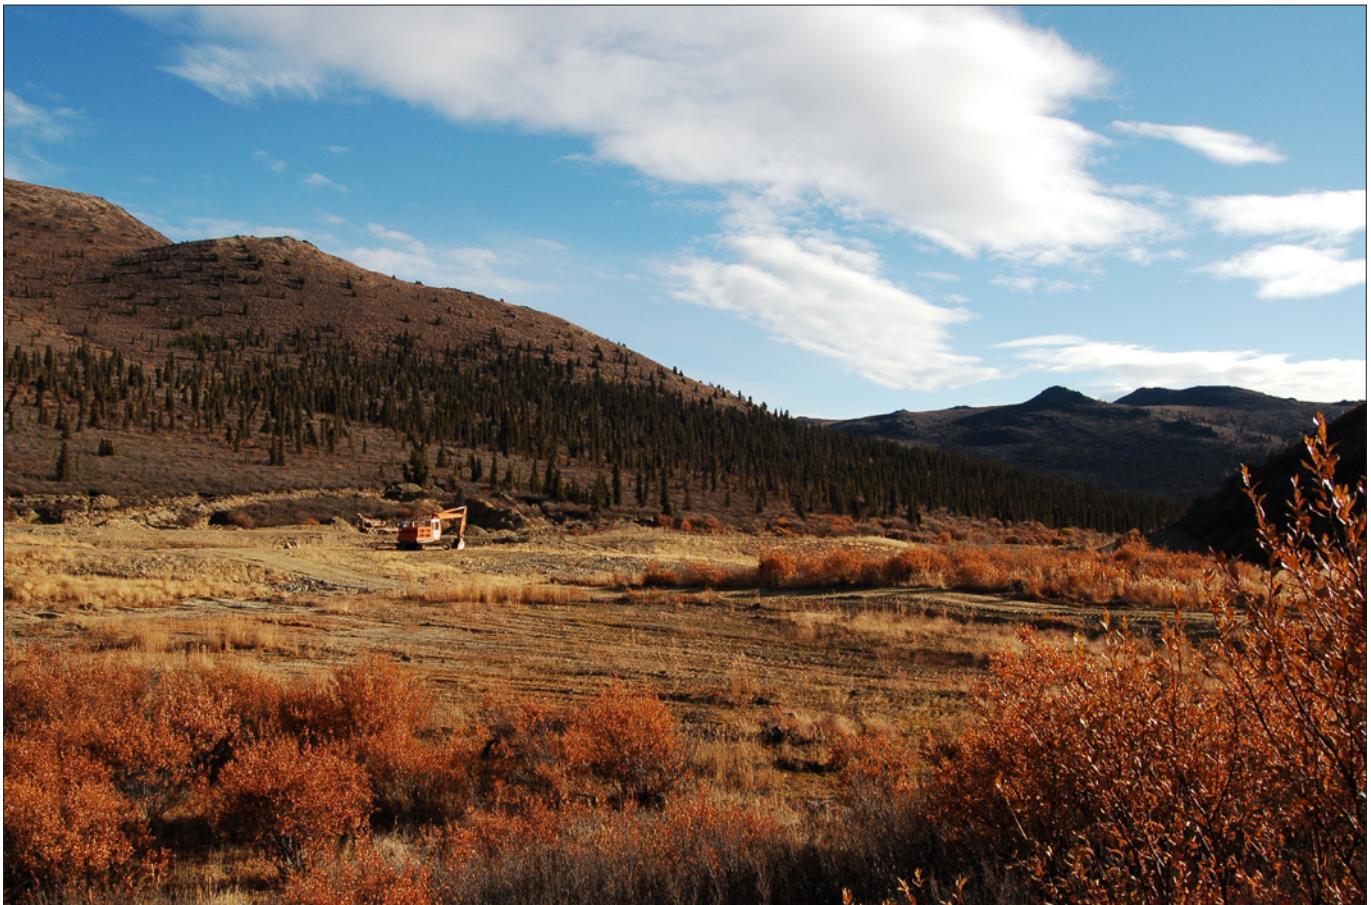
*John Trout's property on Victoria Creek showing reclamation in the foreground, Ennsley excavator and washplant in the background. Photo taken in 2006 after the ground was purchased by Lloyd Wade.*

**EQUIPMENT AND WATER TREATMENT** Equipment included a Caterpillar D8H with U-blade and ripper, a Caterpillar D7E with a straight blade and winch, an Insley 875 excavator with a ¾-cubic-yard bucket and a Caterpillar 966 loader with a 5-cubic-yard bucket. The wash plant consisted of a Simmons 4- by 8-foot screen deck classifying to minus 1 inch and

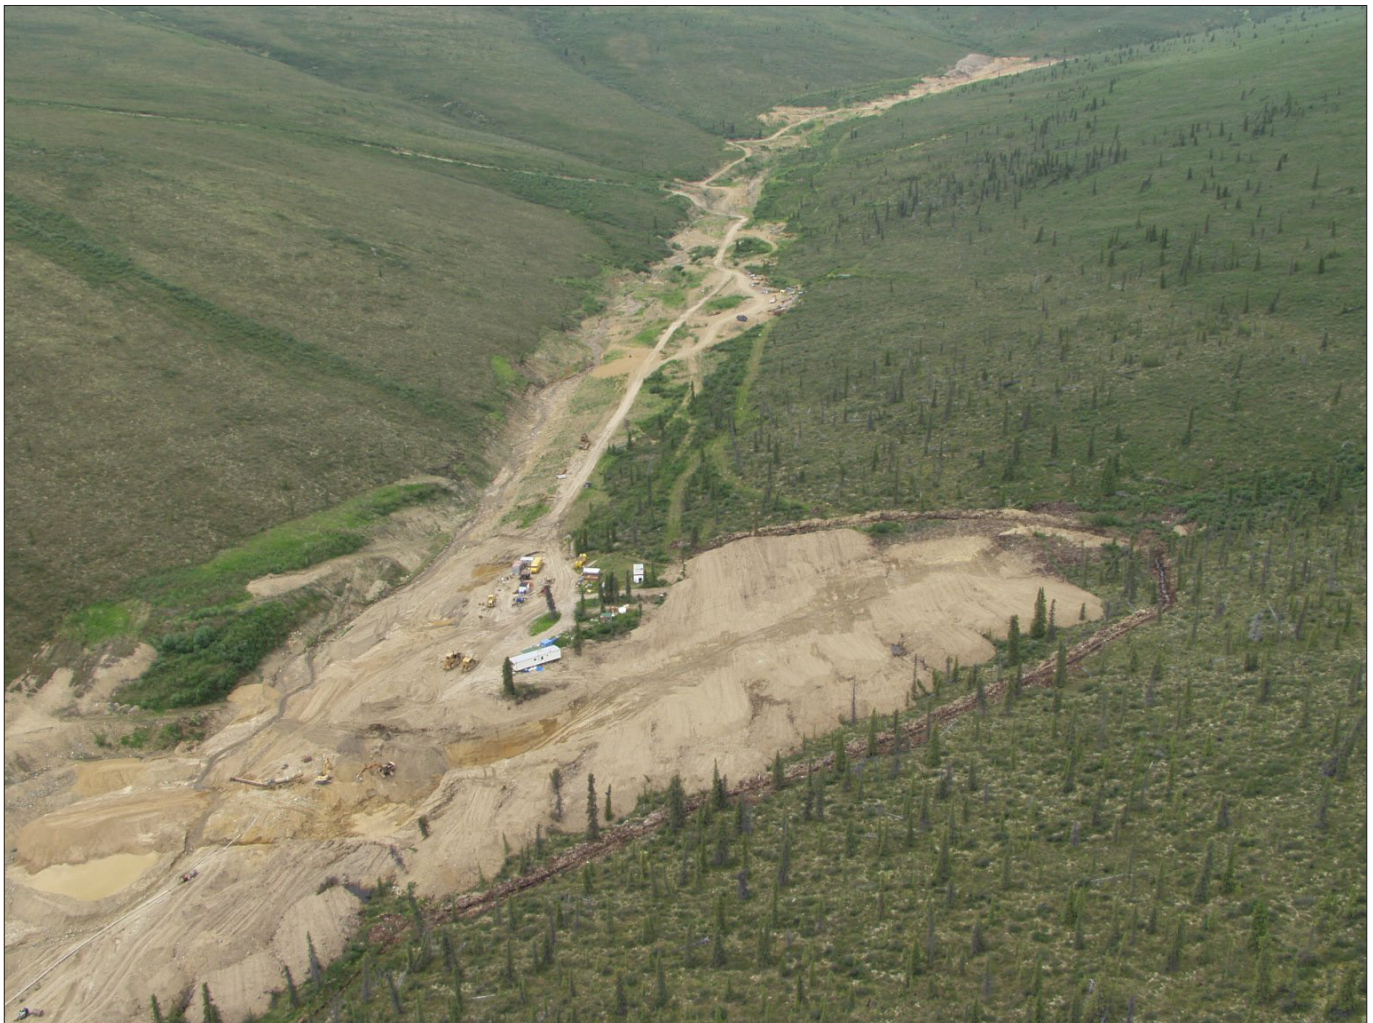
*Aerial view of Bill Trerice's operation on Back Creek, 2003.*

**WORK HISTORY AND MINING CUTS** Bill Trerice began mining here in 1999, and mined until 2005. In 2003, a crew of two miners worked a single 9-hour shift daily to process two cuts: one 100 by 150 feet (30 x 45 m) and one 50 by 150 feet (15 x 45 m). The operation concentrated approximately 100 feet (30 m) from the valley centre on the left limit, near the confluence of an unnamed side pup. In 2004, the same crew worked a daily 8-hour shift to mine a cut 130 by 200 feet (40 x 60 m). In 2005, a crew of three miners worked a daily 9-hour shift to mine one cut 150 by 450 feet (45 x 140 m).

**EQUIPMENT AND WATER TREATMENT** In 2003 and 2004, a Komatsu D355A bulldozer with U-blade and ripper and a Caterpillar D8H with U-blade and ripper were used for stripping, while a Komatsu 220 excavator with a  $\frac{3}{4}$ -cubic-yard bucket was used to feed the wash plant. A Case 125B excavator with a  $\frac{3}{4}$ -cubic-yard bucket was used for ditching and stockpiling pay. Mr. Trerice also had a churn drill on the site for testing. The wash plant consisted of a 4- by 26-foot Beaver trommel, supplied with 1200 igpm by a Monarch 6-inch pump powered by a 30 hp electric motor. The processing rate was 35 loose cubic yards per hour. Effluent was settled in-stream and recycled. Due to low water supply, only 300 hours were spent sluicing in 2004. In 2005, the Komatsu D355A bulldozer was used for stripping while a Komatsu WA250 loader was used for hauling overburden, moving pay to the wash plant and feeding the wash plant. The Komatsu 220 excavator was used for ditching and stockpiling and the Caterpillar D8H was used for stockpiling. The same wash plant was used but the processing rate was reduced to 30 loose cubic yards per hour. Effluent was settled in-stream and

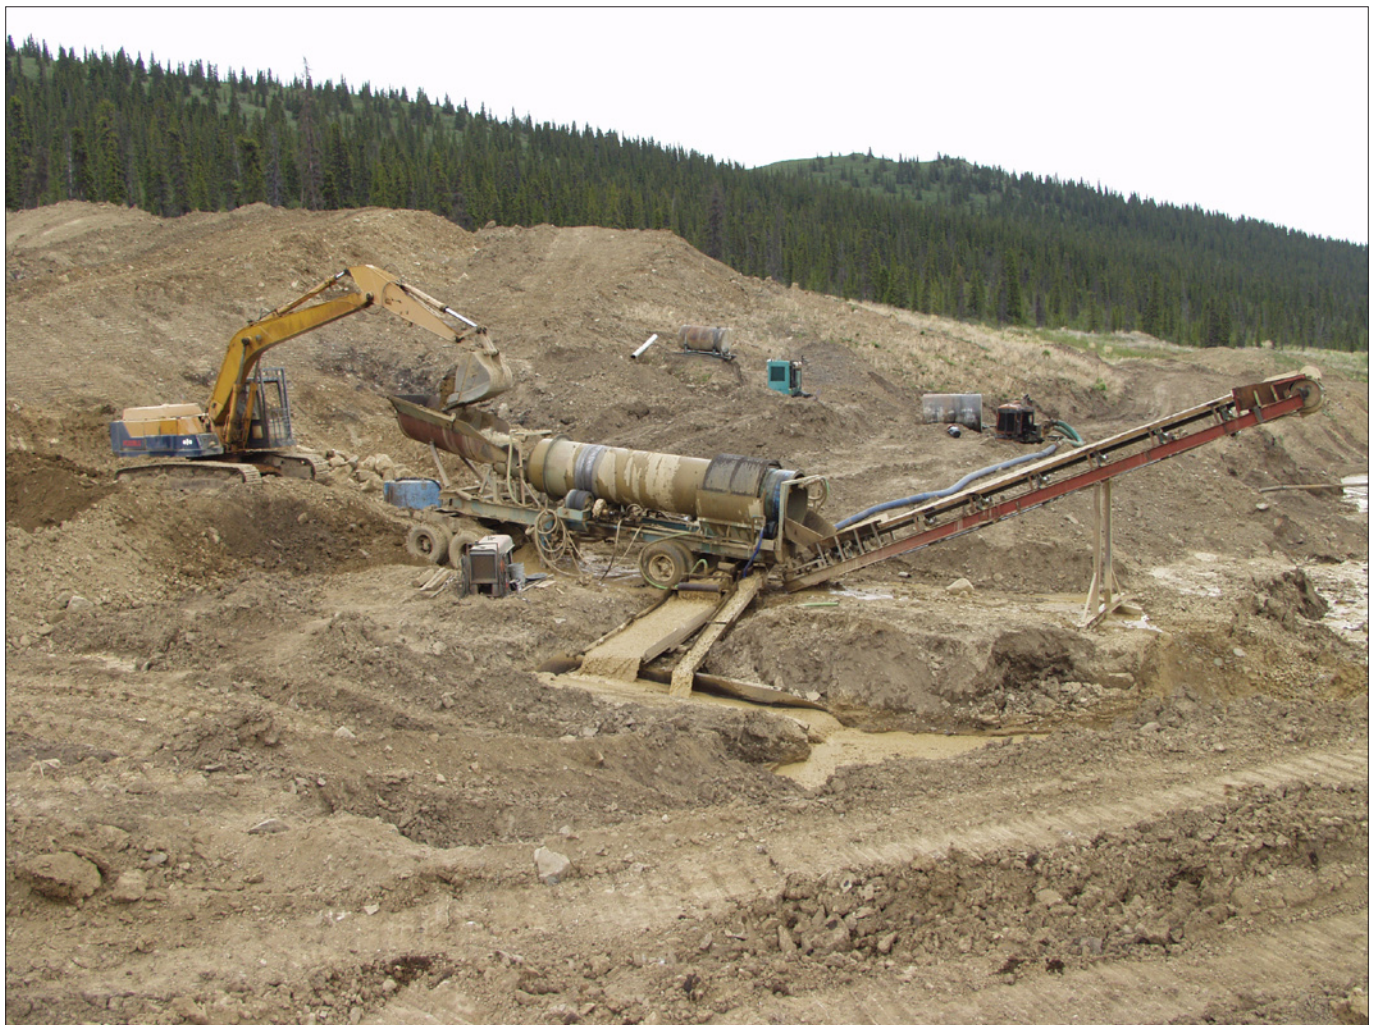
*Bill Terrice sluicing on Back Creek, 2004.*

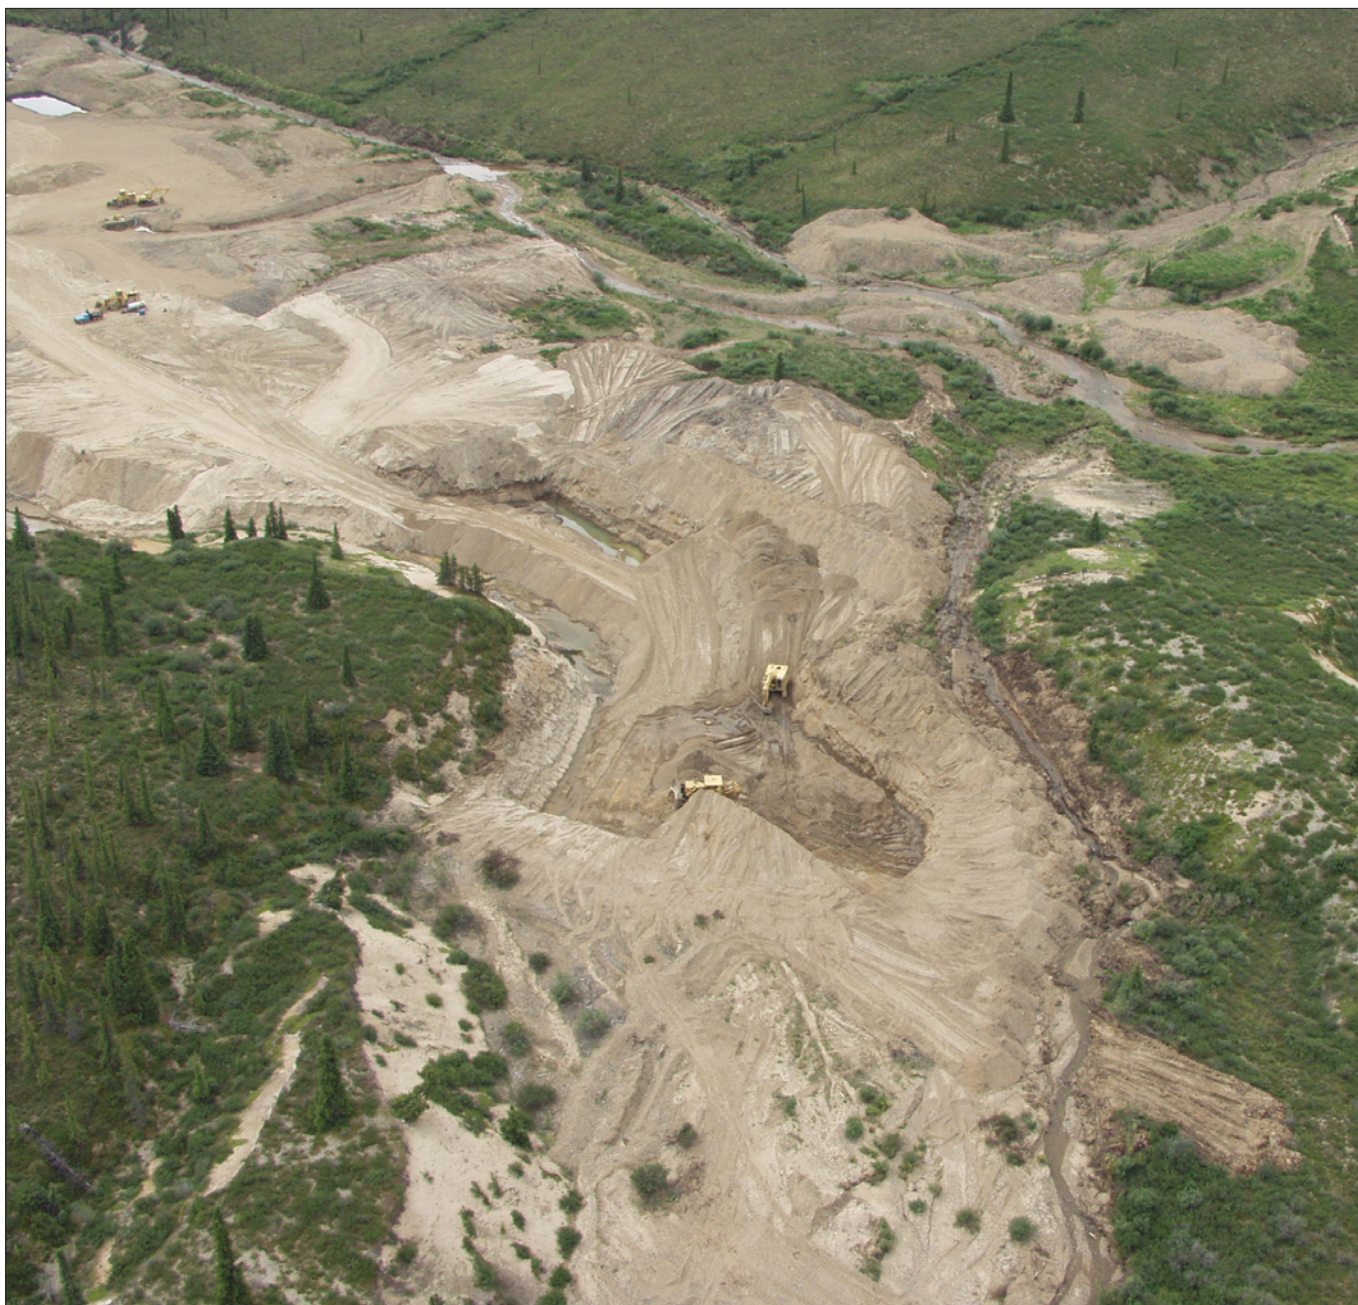
*Johnson Exploration mining on Nansen Creek at the mouth of Discovery, 2003.*

**LOCATION** The property was located on the left limit of Nansen Creek, between just downstream of the mouth of Dolly Creek and just upstream of the mouth of Discovery Creek.

**EQUIPMENT AND WATER TREATMENT** Equipment consisted of a Caterpillar D9H for stripping, stacking pay and reclamation; a Caterpillar 235 excavator for stripping, establishing drainage and stacking pay; a Caterpillar 988B loader for stripping, hauling pay and tailings; a Caterpillar 980C loader for stripping, hauling pay and tailings; and a Caterpillar 966D loader for hauling pay and tailings. The wash plant consisted of a 16-foot belt feeder which fed pay to a 7-foot-diameter by 40-foot-long trommel which classified to minus 1 inch. The two 26-foot sluice runs, each had 10 feet of live bottom riffles followed by 16 feet of 2½-inch expanded metal screens. Water was supplied from Nansen Creek and pumped by a 4- by 4-inch Cummins-powered pump at 800 igpm, enough to process 100 loose cubic yards per hour. Effluent was treated in two large ponds and discharged back to Nansen Creek. Clean-ups were done with an IRD Duplex clean-up jig with two 12- by 12-inch cells, and final concentration was done with a magnet and gold wheel.

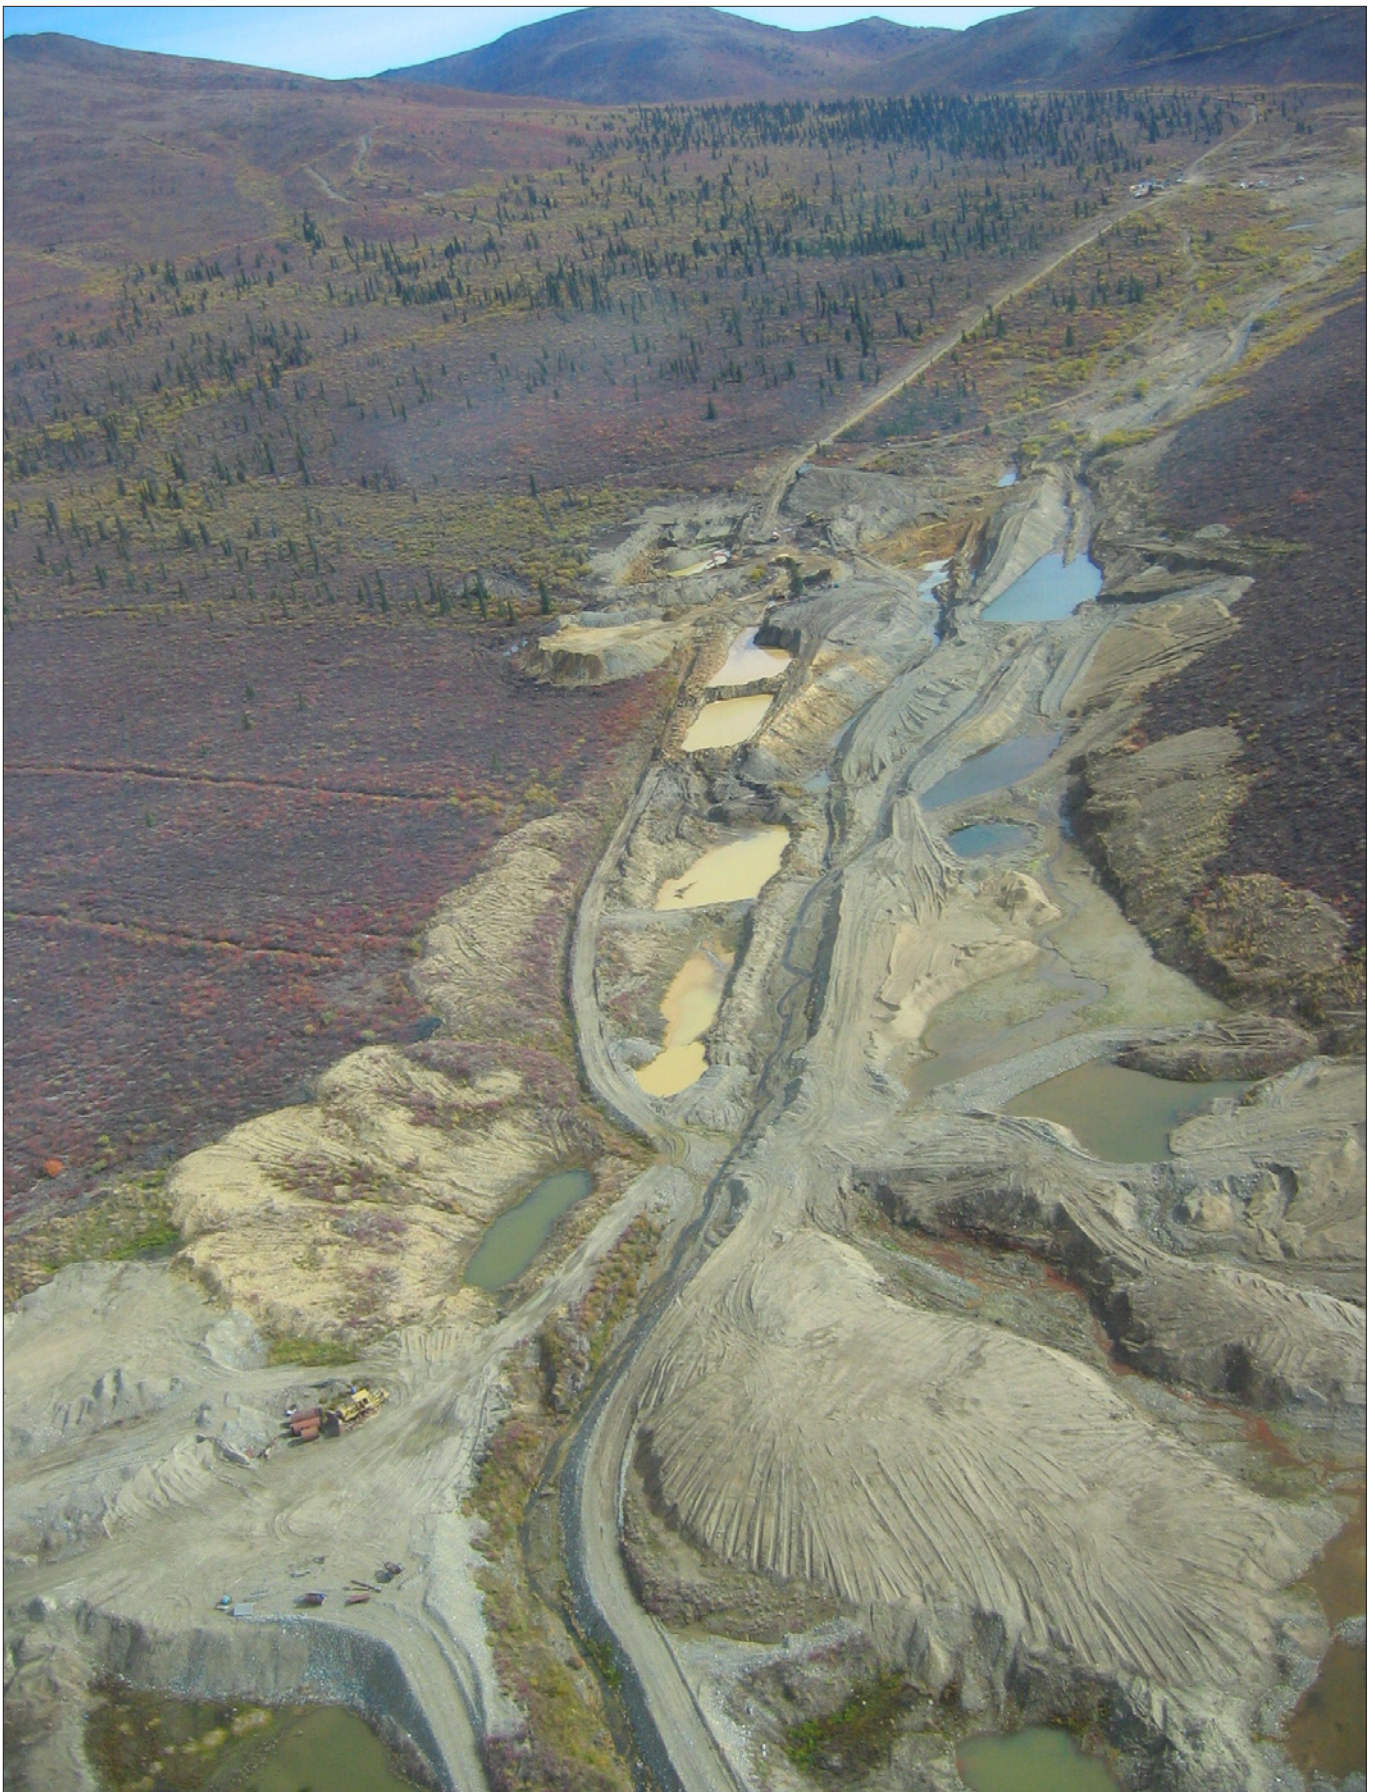
*38421 Yukon Inc. mining on the East Fork of Nansen Creek, 2005; view looking northwest.*

**EQUIPMENT AND WATER TREATMENT** Equipment consisted of a Case 125B excavator for stripping and testing, and a Hough 100 loader for stripping.

**SURFICIAL GEOLOGY AND STRATIGRAPHY** From 2 to 3 feet (0.6 to 0.9 m) of black muck was exposed overlying a thin gravel. Bedrock was not reached.
