Yukon Placer Database Operations Report

Field Name: Tic Exploration Ltd./Dendys, 1992-2003

Stream: Gladstone: a tributary of Kluane Lake

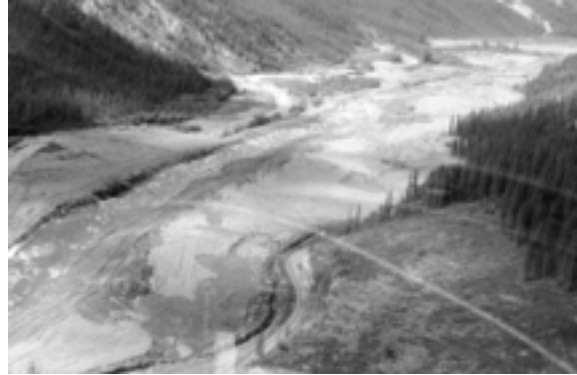
Title: Al Dendy's Tic Exploration, 1999

The Robert E. Leckie Award for Outstanding Placer Mining Reclamation Practices was presented to Al Dendys Tic Exploration in 1999.

Immediately following work in any given area, the tailings were levelled, recontoured and covered with fine material stockpiled during preparation of the mining cut. To date, this is the finest example of progressive placer mining restoration work in the Whitehorse Mining District.
