Physical Land Development Constraints Mapping

Whitehorse City Limits Portion of the
Kwanlin Dün Traditional Territory, Yukon

Palmer Project #
2211201

Prepared For
Kwanlin Dün First Nation

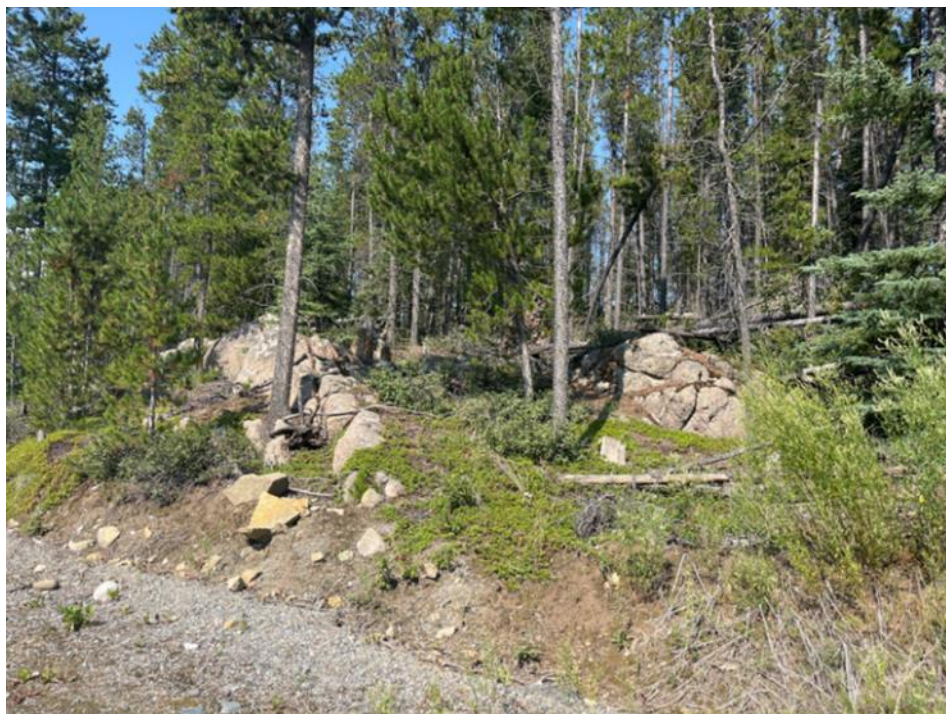
Photograph 1. High bedrock constraint. Area is outcrop dominant.

Exposed or shallow bedrock was identified as a constraint primarily due to the complexity it can introduce for land development (e.g., Photographs 1 and 2, Appendix C). Extensive bedrock outcrop or shallow bedrock in a map unit may increase construction costs through the need for blasting or other means of bedrock removal to achieve desired grade and/or install underground utilities. Bedrock is considered a constraint that can be fully overcome through increased development costs. Bedrock was generally identified as a constraint within the uplands along the western edge of the study area, and along the eastern edge of the study area near Grey Mountain.

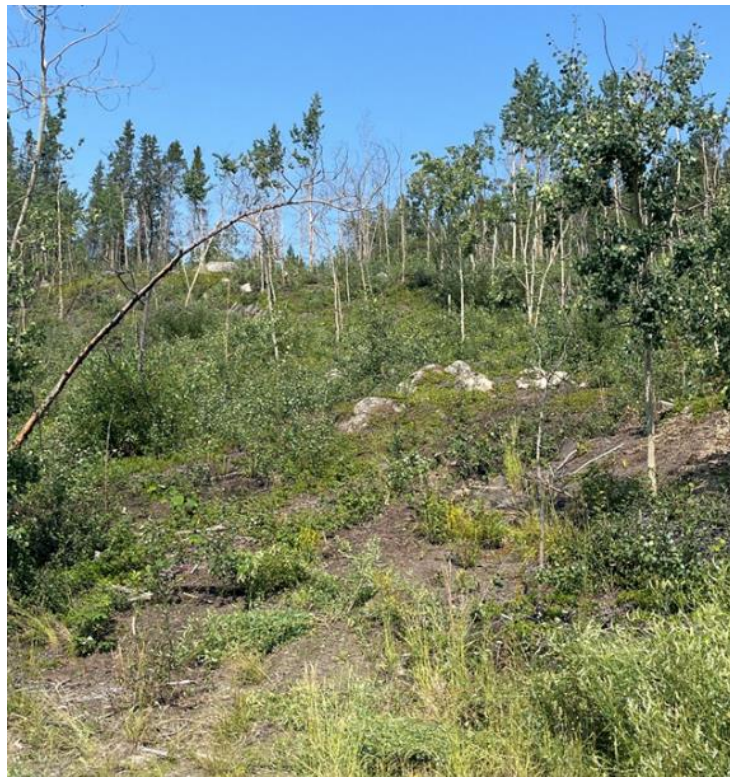
Photograph 2. Moderate bedrock constraint. Outcrop occupies less than 1/3 of the area.

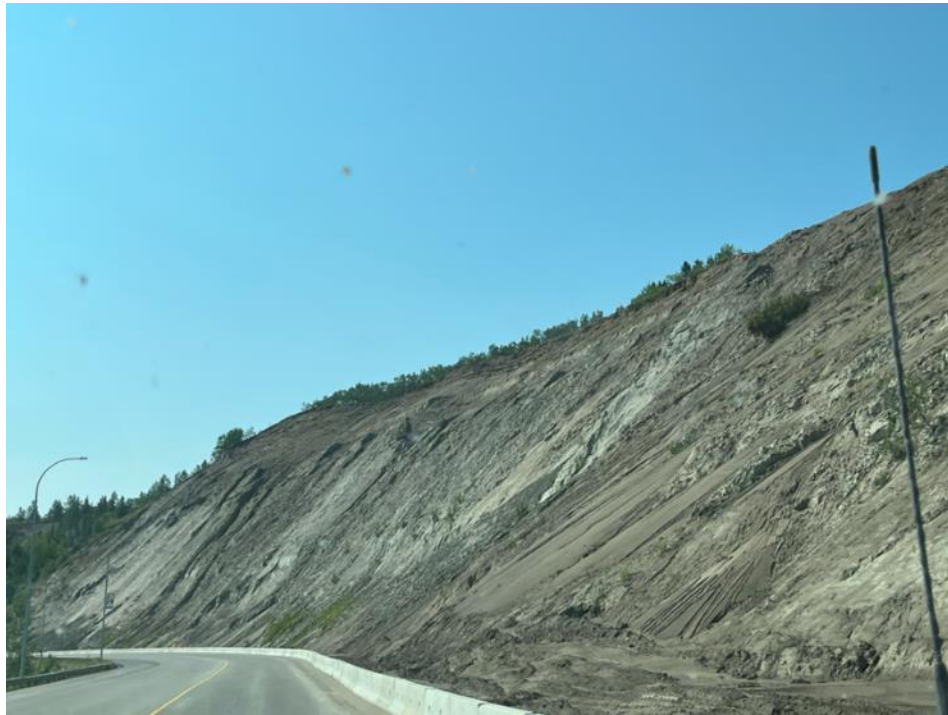
Photograph 3. High erosion constraint. Steep slope with visible sloughing.

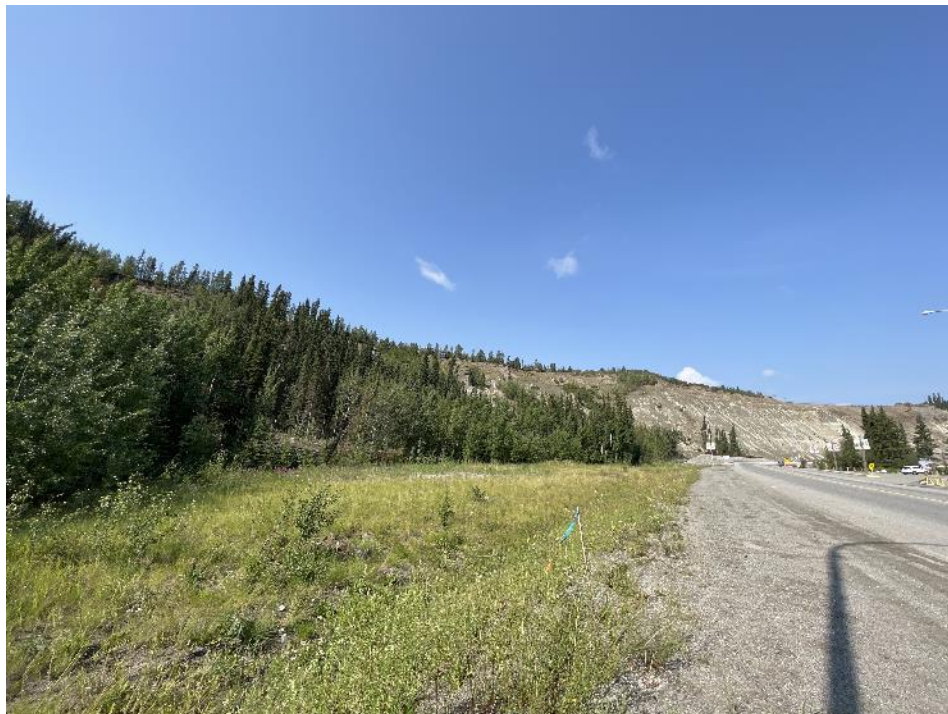
Photograph 4. Erosion area, showing transition from moderate (left foreground) to high (right background) constraint with a transition from stabilizing vegetation to a lack of vegetation, respectively.

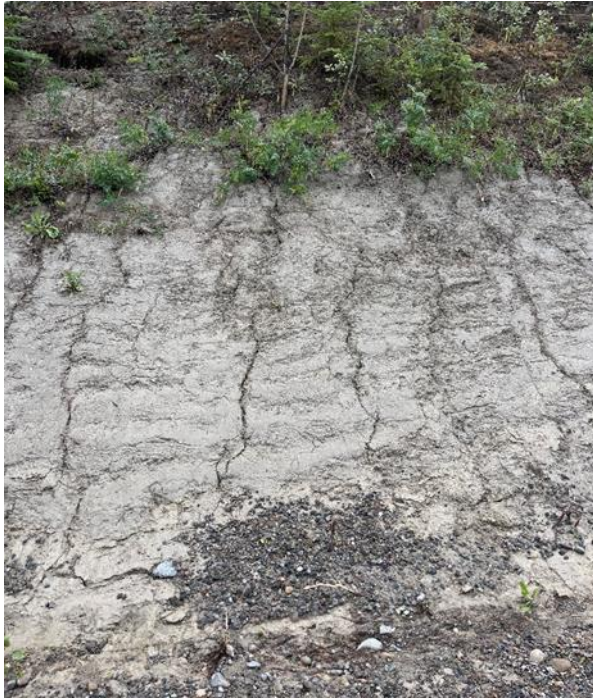
Photograph 5. Low soil constraint, clay-rich material.

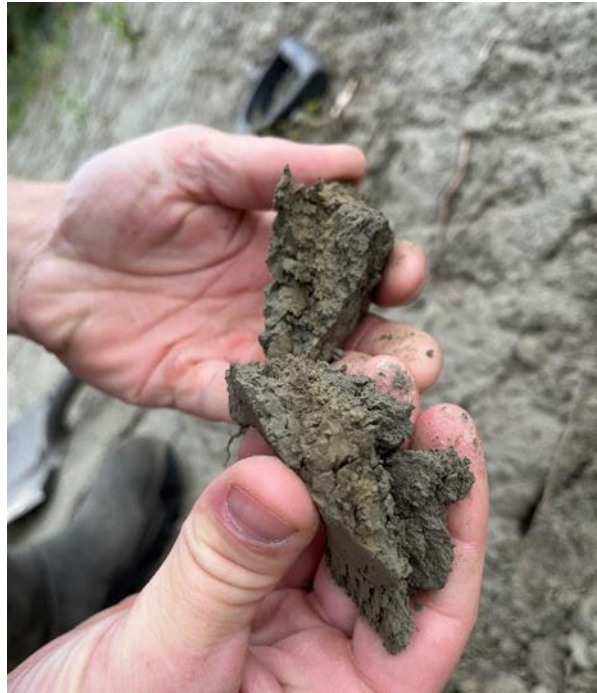
Photograph 6. Low soil constraint, clay-rich material.

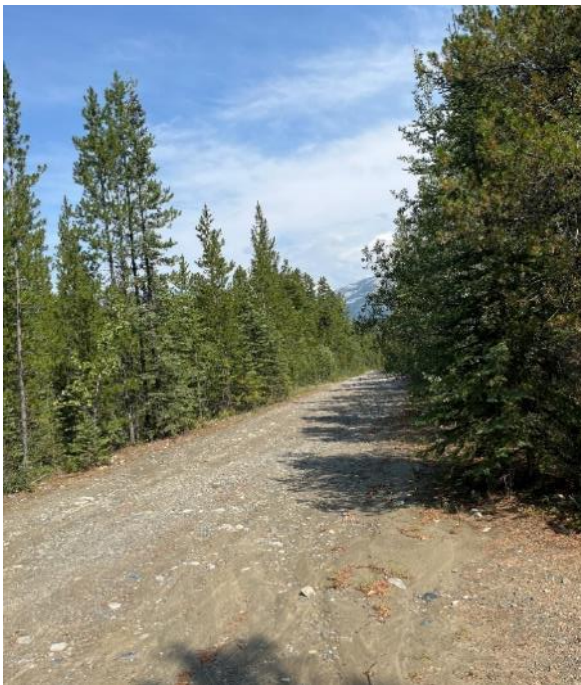
Photograph 7. Low topographic constraint, average slope gradient 10-20%.

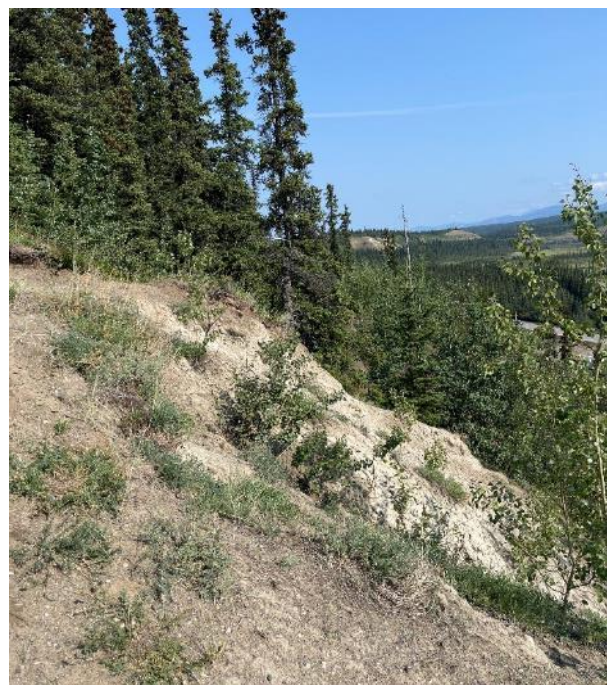
Photograph 8. High topographic constraint, average slope gradient >30%.

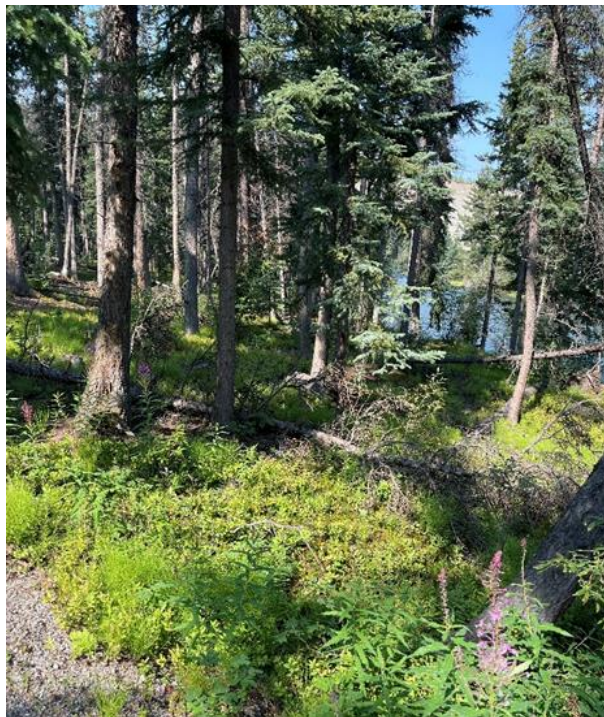
Photograph 9. Moderate floodplain recurrence constraint area, adjacent to and slightly elevated above Yukon River.

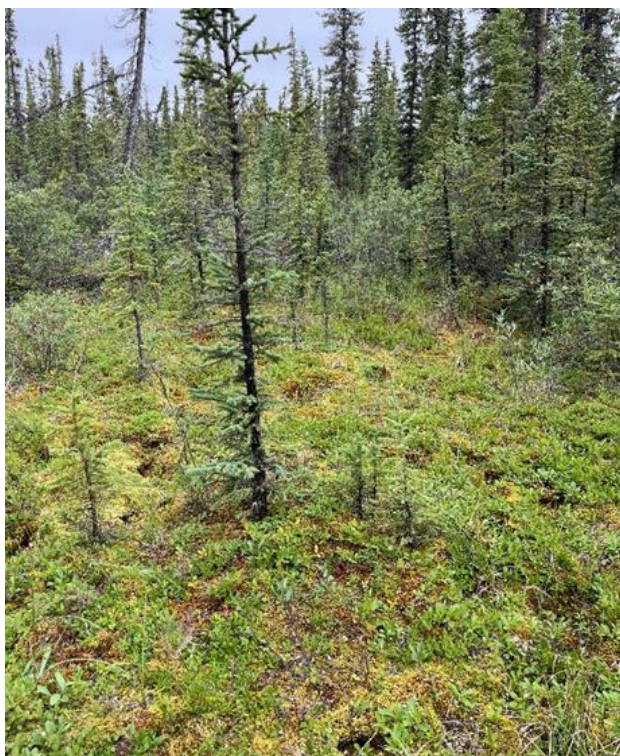
Photograph 10. High permafrost constraint. Organic-covered, undulating, suspected ice-rich ground.

Permafrost constraints identify areas underlain by perennally frozen ground. Permafrost can increase the cost of construction. Thawing ice-rich permafrost can require ongoing maintenance and pose hazards. Land development typically results in localized thaw of underlying permafrost. Map units interpreted to be underlain by ice-rich permafrost are classified as highly constrained due to the potential for differential ground settlement (thermokarst) and are best avoided. Units underlain by permafrost with low ice content are classified as moderately constrained and may require additional design, construction and/or maintenance costs to support development. Permafrost constraints are uncommon within the study area. Map units with permafrost constraints are most commonly found at higher elevations along the western border of the study area, particularly on northerly aspects with concave slope morphology, but may be found scattered throughout the study area where organic cover has insulated and preserved underlying permafrost (e.g., Photograph 10, Appendix C).

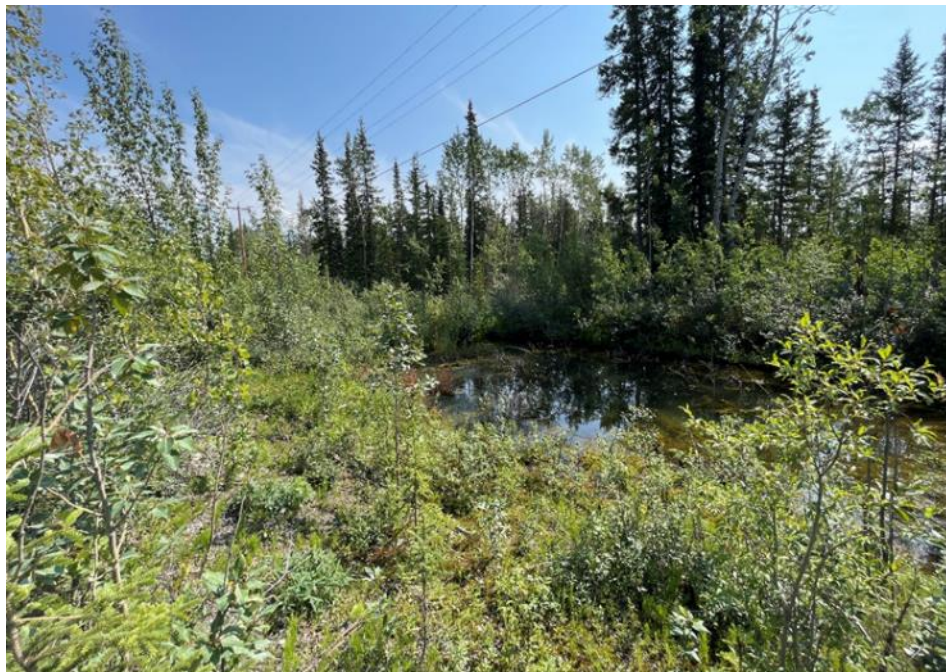
Photograph 11. High water table depth constraint. Localized surface ponding.

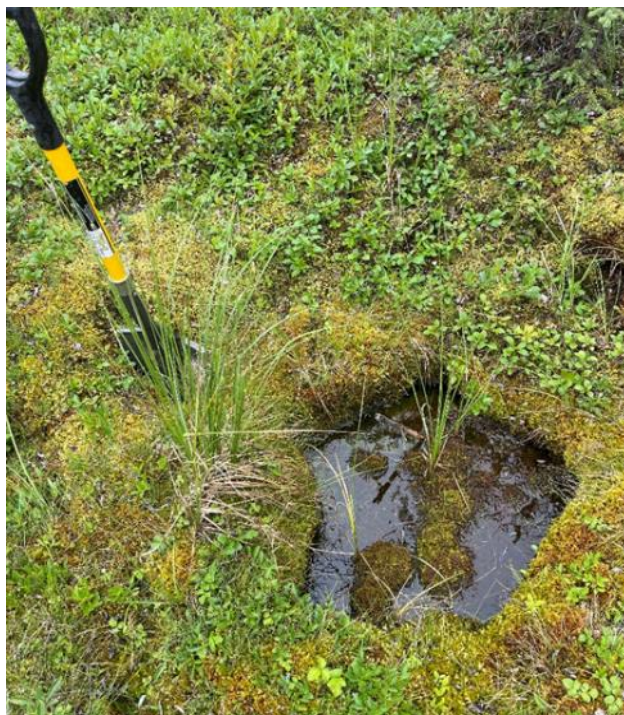
Photograph 12. High water table depth constraint. Water is present at surface.

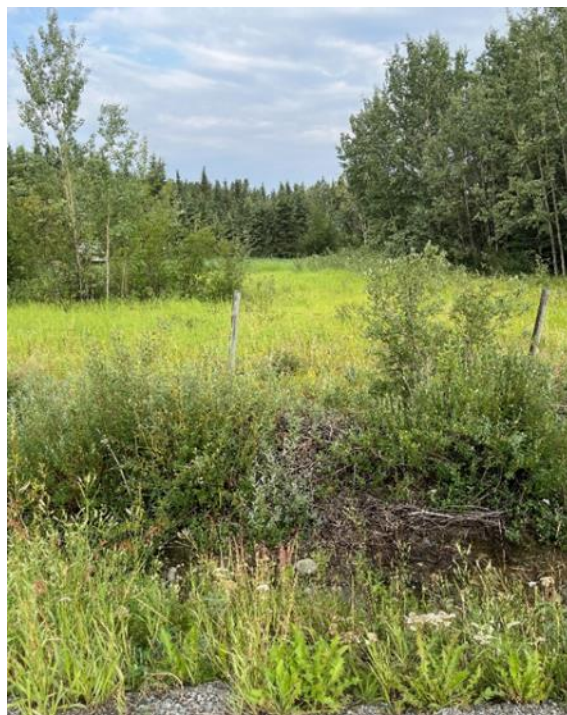
Photograph 13. Moderate water table depth constraint. Water table is <1 m from surface.
