GEOTECHNICAL INVESTIGATIONS
OF CONSTRUCTION MATERIALS
KM 139 TO 243, DEMPSTER HIGHWAY, YUKON

YUKON COMMUNITY AND TRANSPORTATION SERVICES

OCTOBER 1986

KLOHN LEONOFF
CONSULTING ENGINEERS

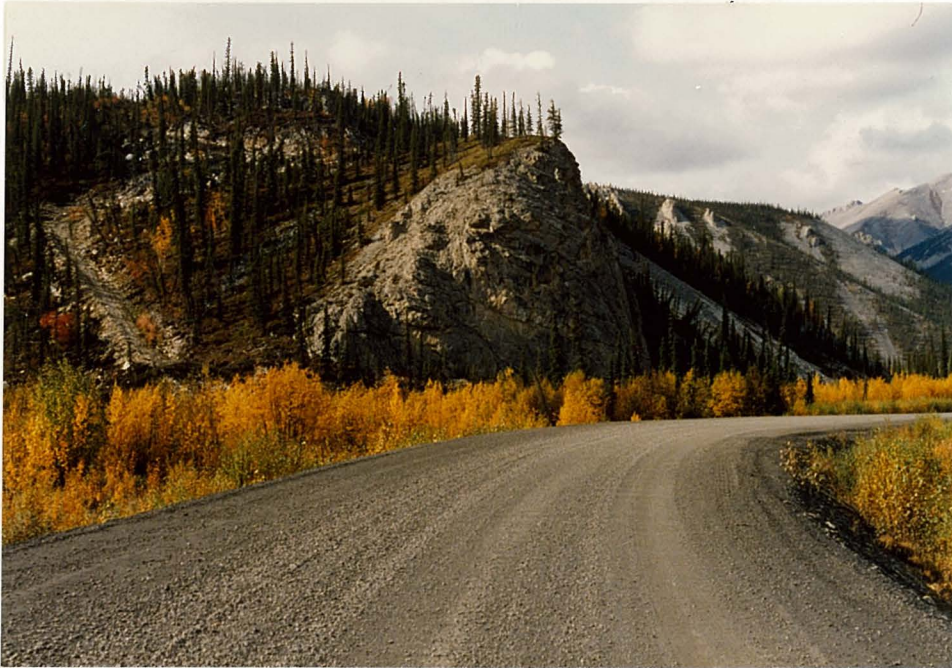
SITE RF 194.9

Rock Description

Limestone

Site RF 194.9 comprises a dark grey, carbonaceous, fine grained, slightly weathered limestone. The Uniaxial Compressive Strength has been estimated at 175 mPa. Substantial recrystallization has occurred along fracture surfaces accounting for the lower strengths. The formation is medium to thickly bedded and is expected to generate rock blocks 700 mm and larger.

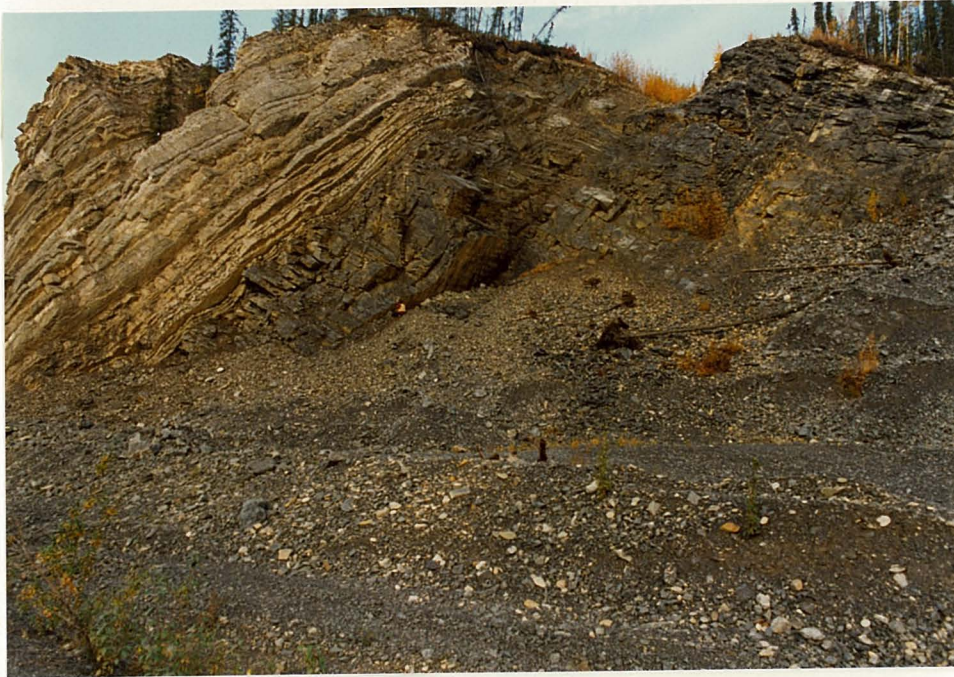
SITE RF 210.8

Rock Description

- dark grey
- carbonaceous
- fine grained
- surface staining
- strong
- moderately weathered
- thinly bedded
- point load index 11 mPa
