Subject: Desktop Geotechnical Evaluation, Slope Assessment, and Detailed Berm Design
Block 338, Fifth and Rogers Street Property
Whitehorse, YT

Tetra Tech EBA Inc. (Tetra Tech EBA) was retained by the Government of Yukon, Energy, Mines and Resources, Sustainable Resources Division (YG) to complete a desktop geotechnical evaluation and provide geotechnical recommendations for the design and construction of foundations for the proposed development of Block 338 located at Fifth and Rogers Street, Whitehorse, YT (the Property). The scope of work also included a site-specific slope and terrain assessment, and detailed berm design.

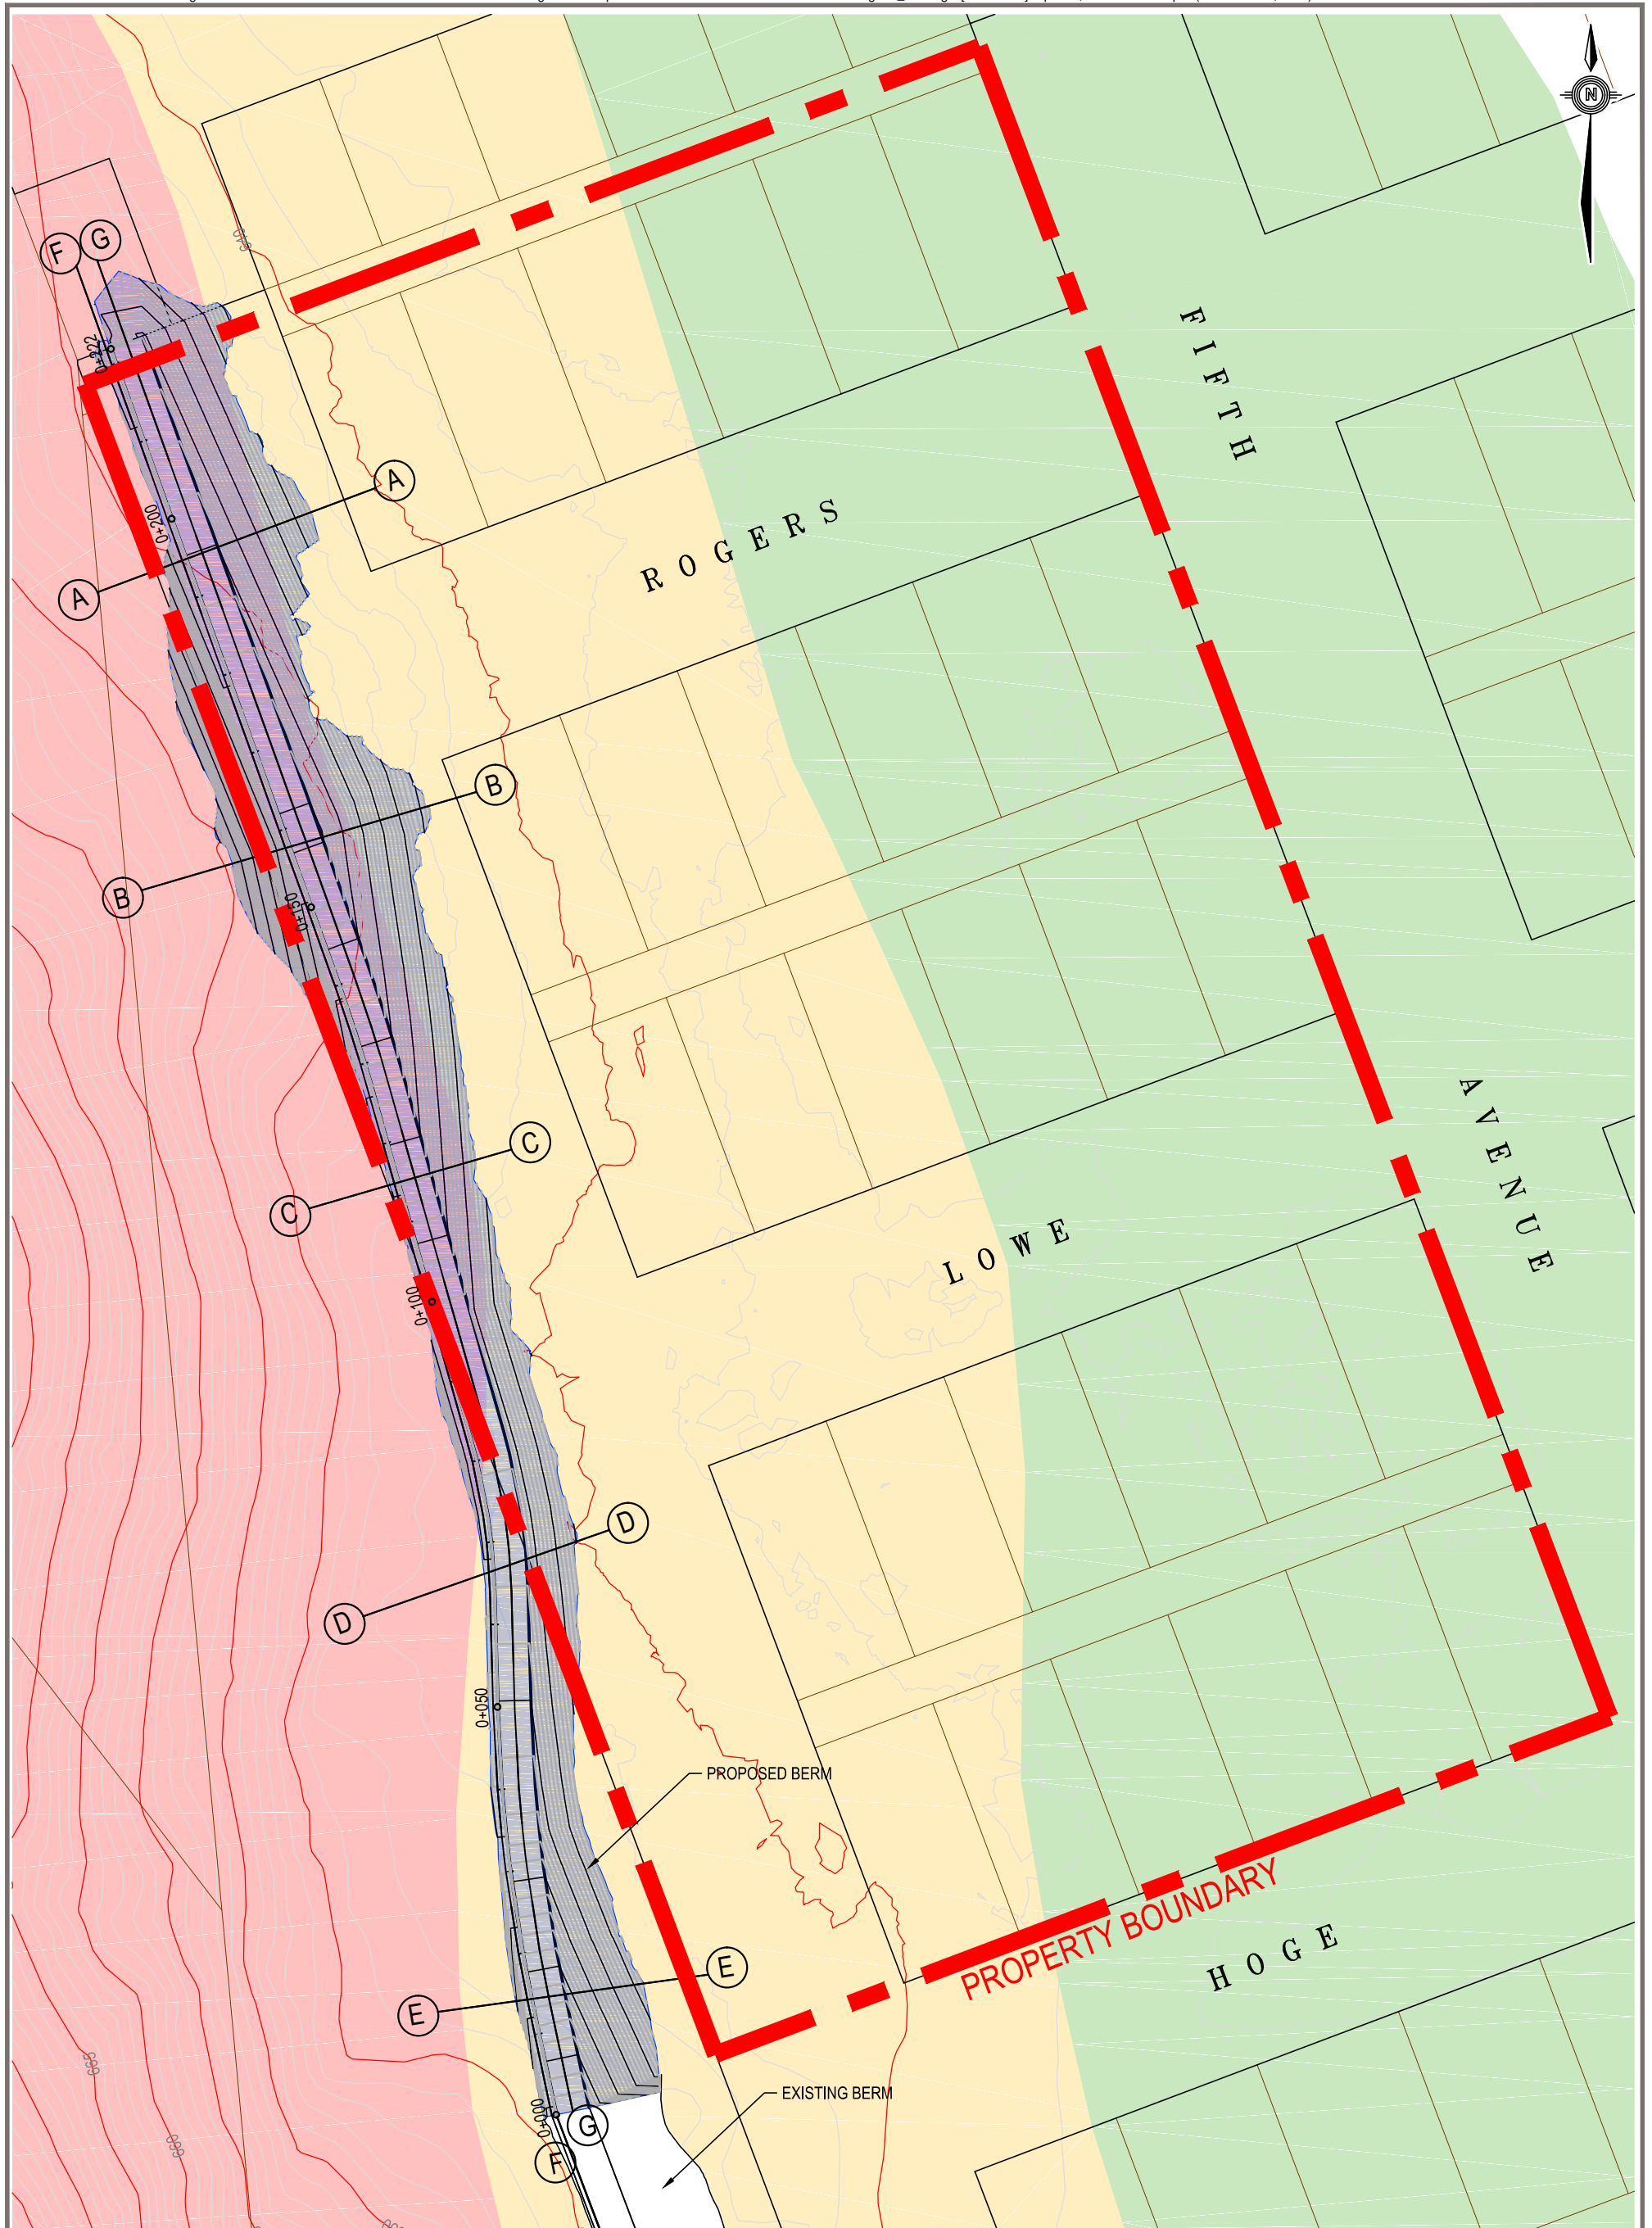
The table below summarizes the subsurface conditions based on historical boreholes and testpits completed in close proximity to the Property. The locations of these boreholes and testpits are shown on Figure 1. It should be noted that there were additional logs utilized during the desktop study, however, not all are shown below in Table 1.

- - MINOR CONTOURS (1.0 m)
- - MAJOR CONTOURS (5.0 m)
- - LOT LINE
- - - - - PROPERTY BOUNDARY
- - OTHER SURFACE FEATURES
- ⊕ - BOREHOLE LOCATION
- ⊕ - TESTPIT LOCATION
- - HIGH HAZARD AREA
- - MODERATE HAZARD AREA
- - LOW HAZARD AREA

Construction of a berm, as recommended in Tetra Tech EBA’s Downtown South Terrain Stability Assessments report (April 2012) has been accepted by the City of Whitehorse to apply to all affected development properties in the area. It will reduce risk from upslope mass movement processes at the subject property. Construction began in 2015 along the St. Elias property, and is expected to continue north through the subject site. The included drawings and design are based on the St. Elias property berm design drawings and topography survey data provided by YG. Prior to commencement of construction, a detailed survey should be undertaken to verify location and alignment for proposed containment berm, as recommended in the 2012 report. Refer to Figure 1 and Figure 3 for the containment berm site plan and typical details, respectively.

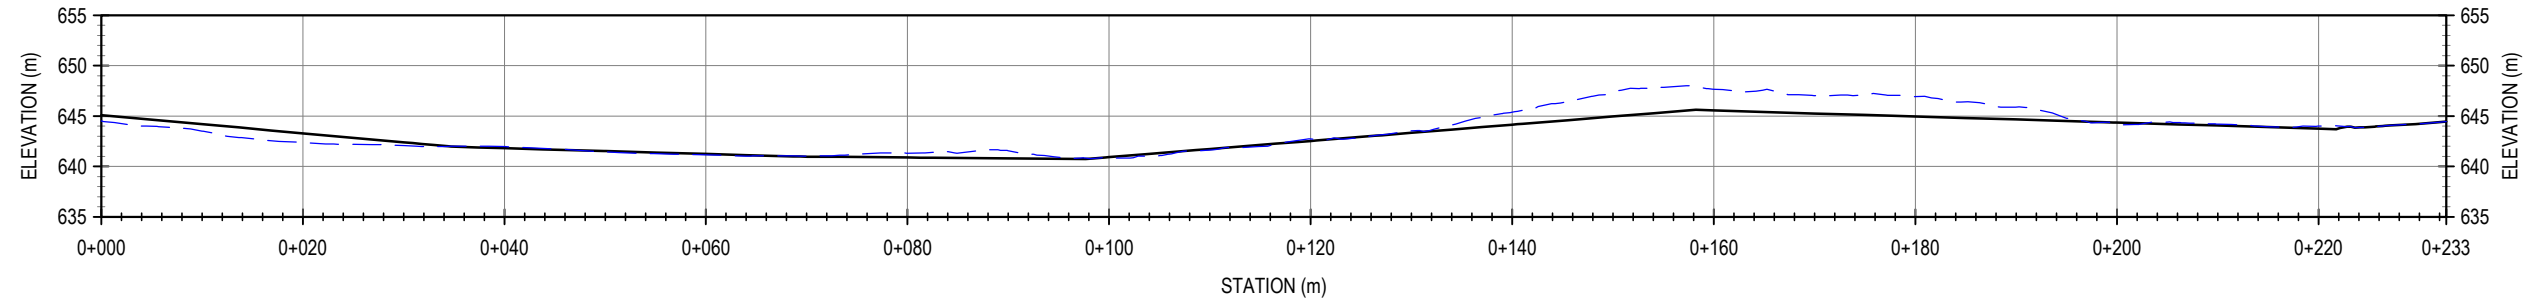
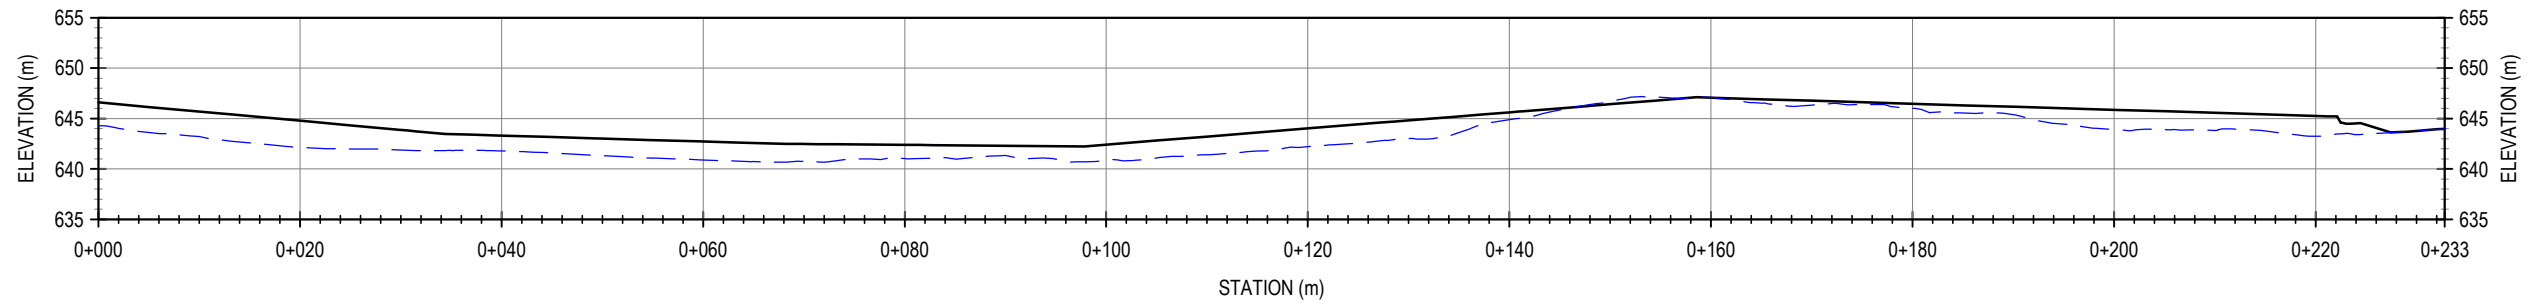
Figure 2

Ditch Profile

Crest Profile

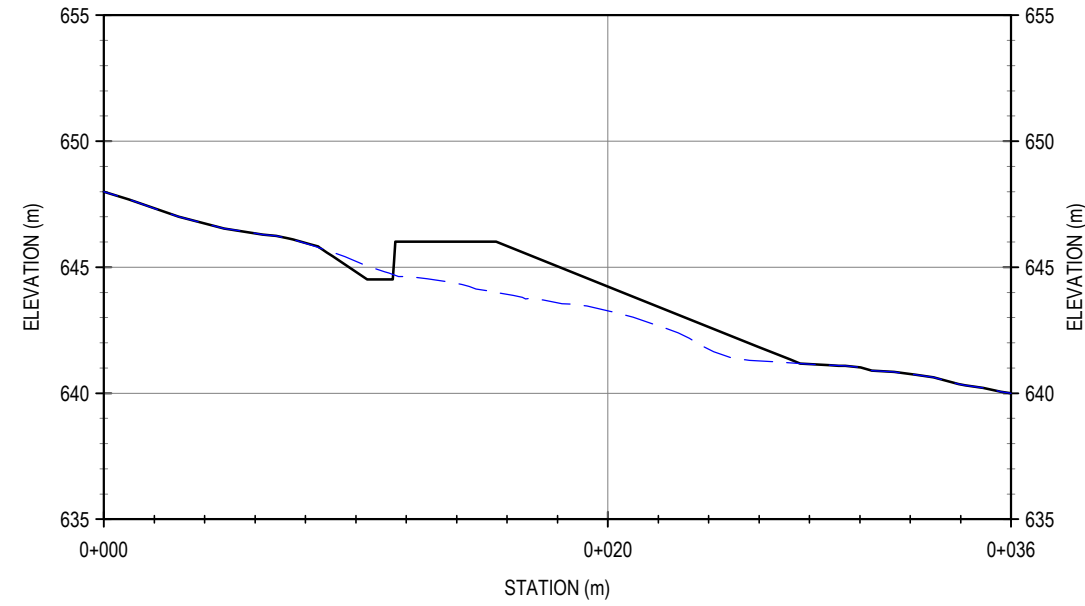
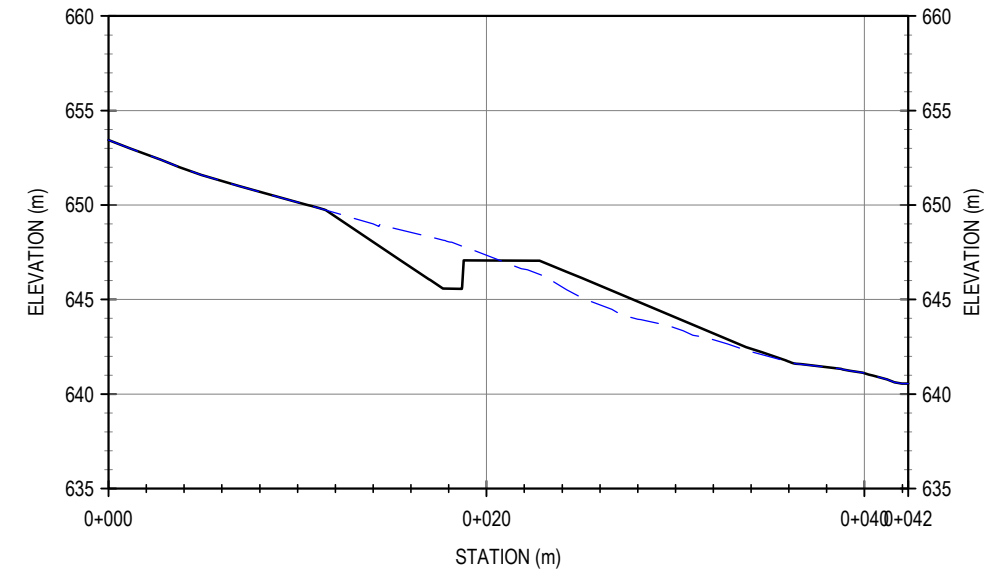
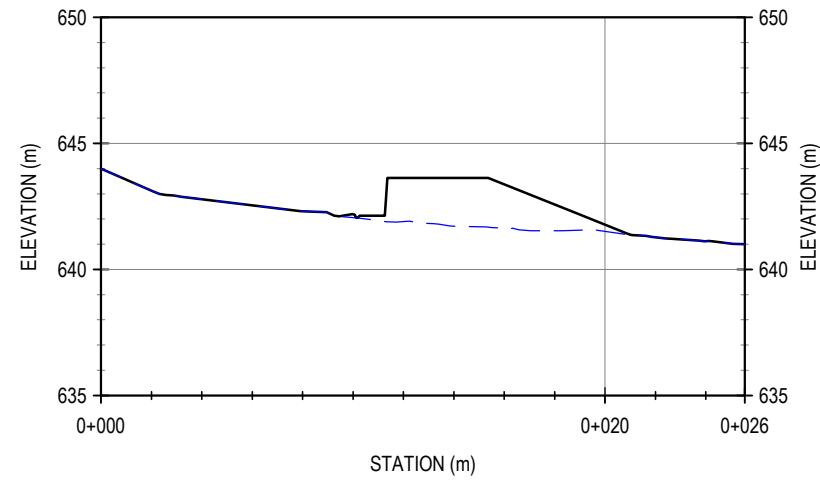
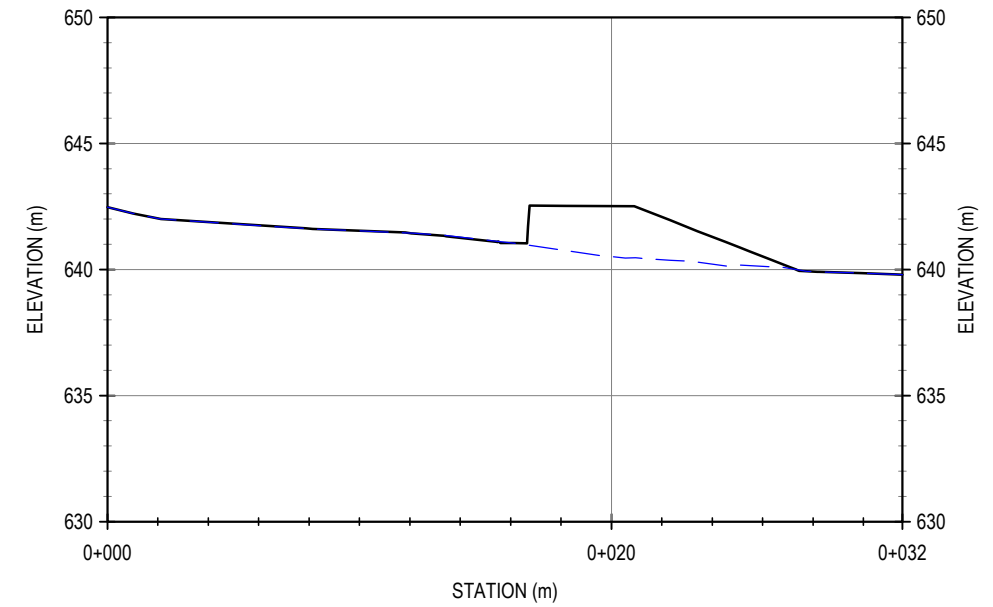
Figure 3

A-A

B-B

C-C

D-D

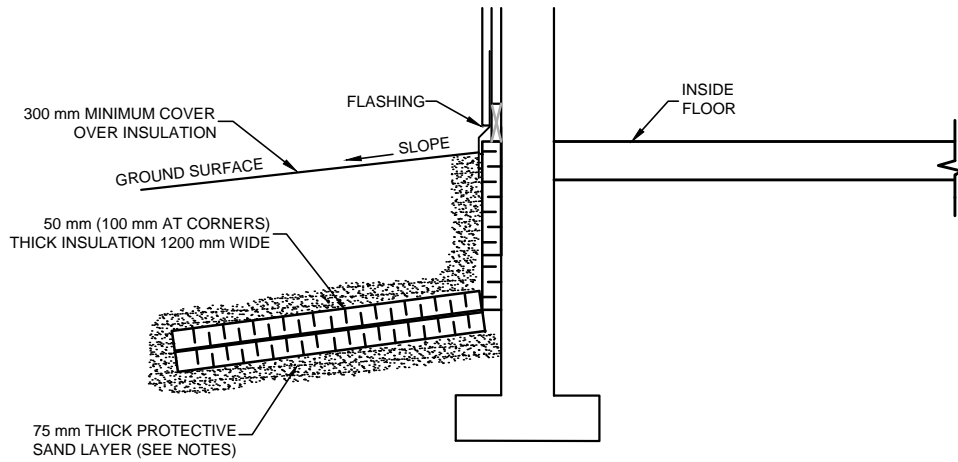
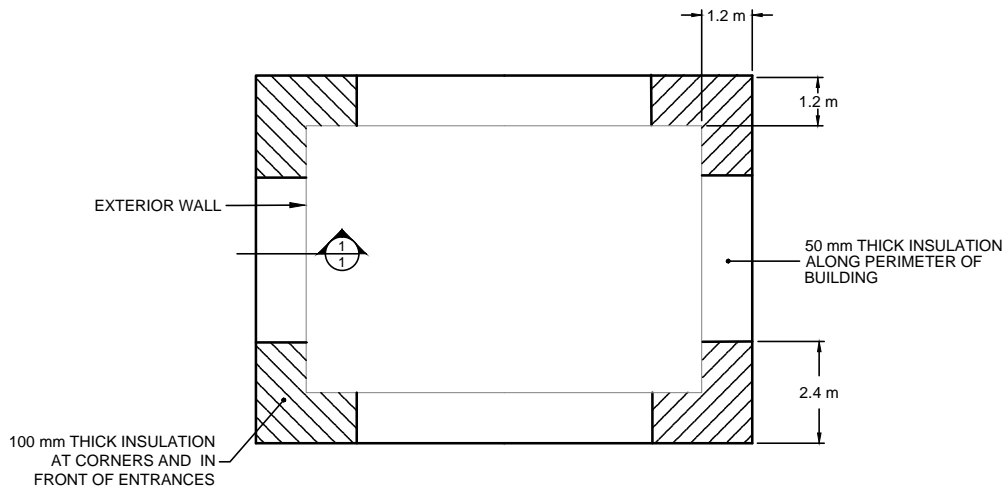
Figure 5

1 SECTION - MONOLITHIC SLAB
1 N.T.S.

1 SECTION - STRIP FOOTING
1 N.T.S.

PLAN
N.T.S.

1. THE INSULATION (DOW CHEMICAL HI SERIES STYROFOAM OR POLYURETHANE OR APPROVED EQUIVALENT) SHOULD BE MOISTURE RESISTANT AND SUITABLE FOR BURIAL UNDER VEHICULAR TRAFFIC AREAS.
2. A MINIMUM BEDDING THICKNESS OF 75 mm OF FINE TO MEDIUM GRAINED SAND SHOULD BE PLACED ABOVE AND BELOW THE INSULATION FOR PROTECTION.
3. THIS PLAN IS NOT TO SCALE

- Because the base of the subexcavation may be expected to terminate in frost susceptible material (SILT) insulation must be installed around the perimeter of the building to protect the subgrade soils from potential frost heave movement. Typical insulation details are shown schematically on Figure 2. Alternatively, insulation can be omitted if the depth of subexcavation is extended to the lesser of 2.4 m or into non-frost-susceptible material (which should be confirmed by a qualified geotechnical engineer);

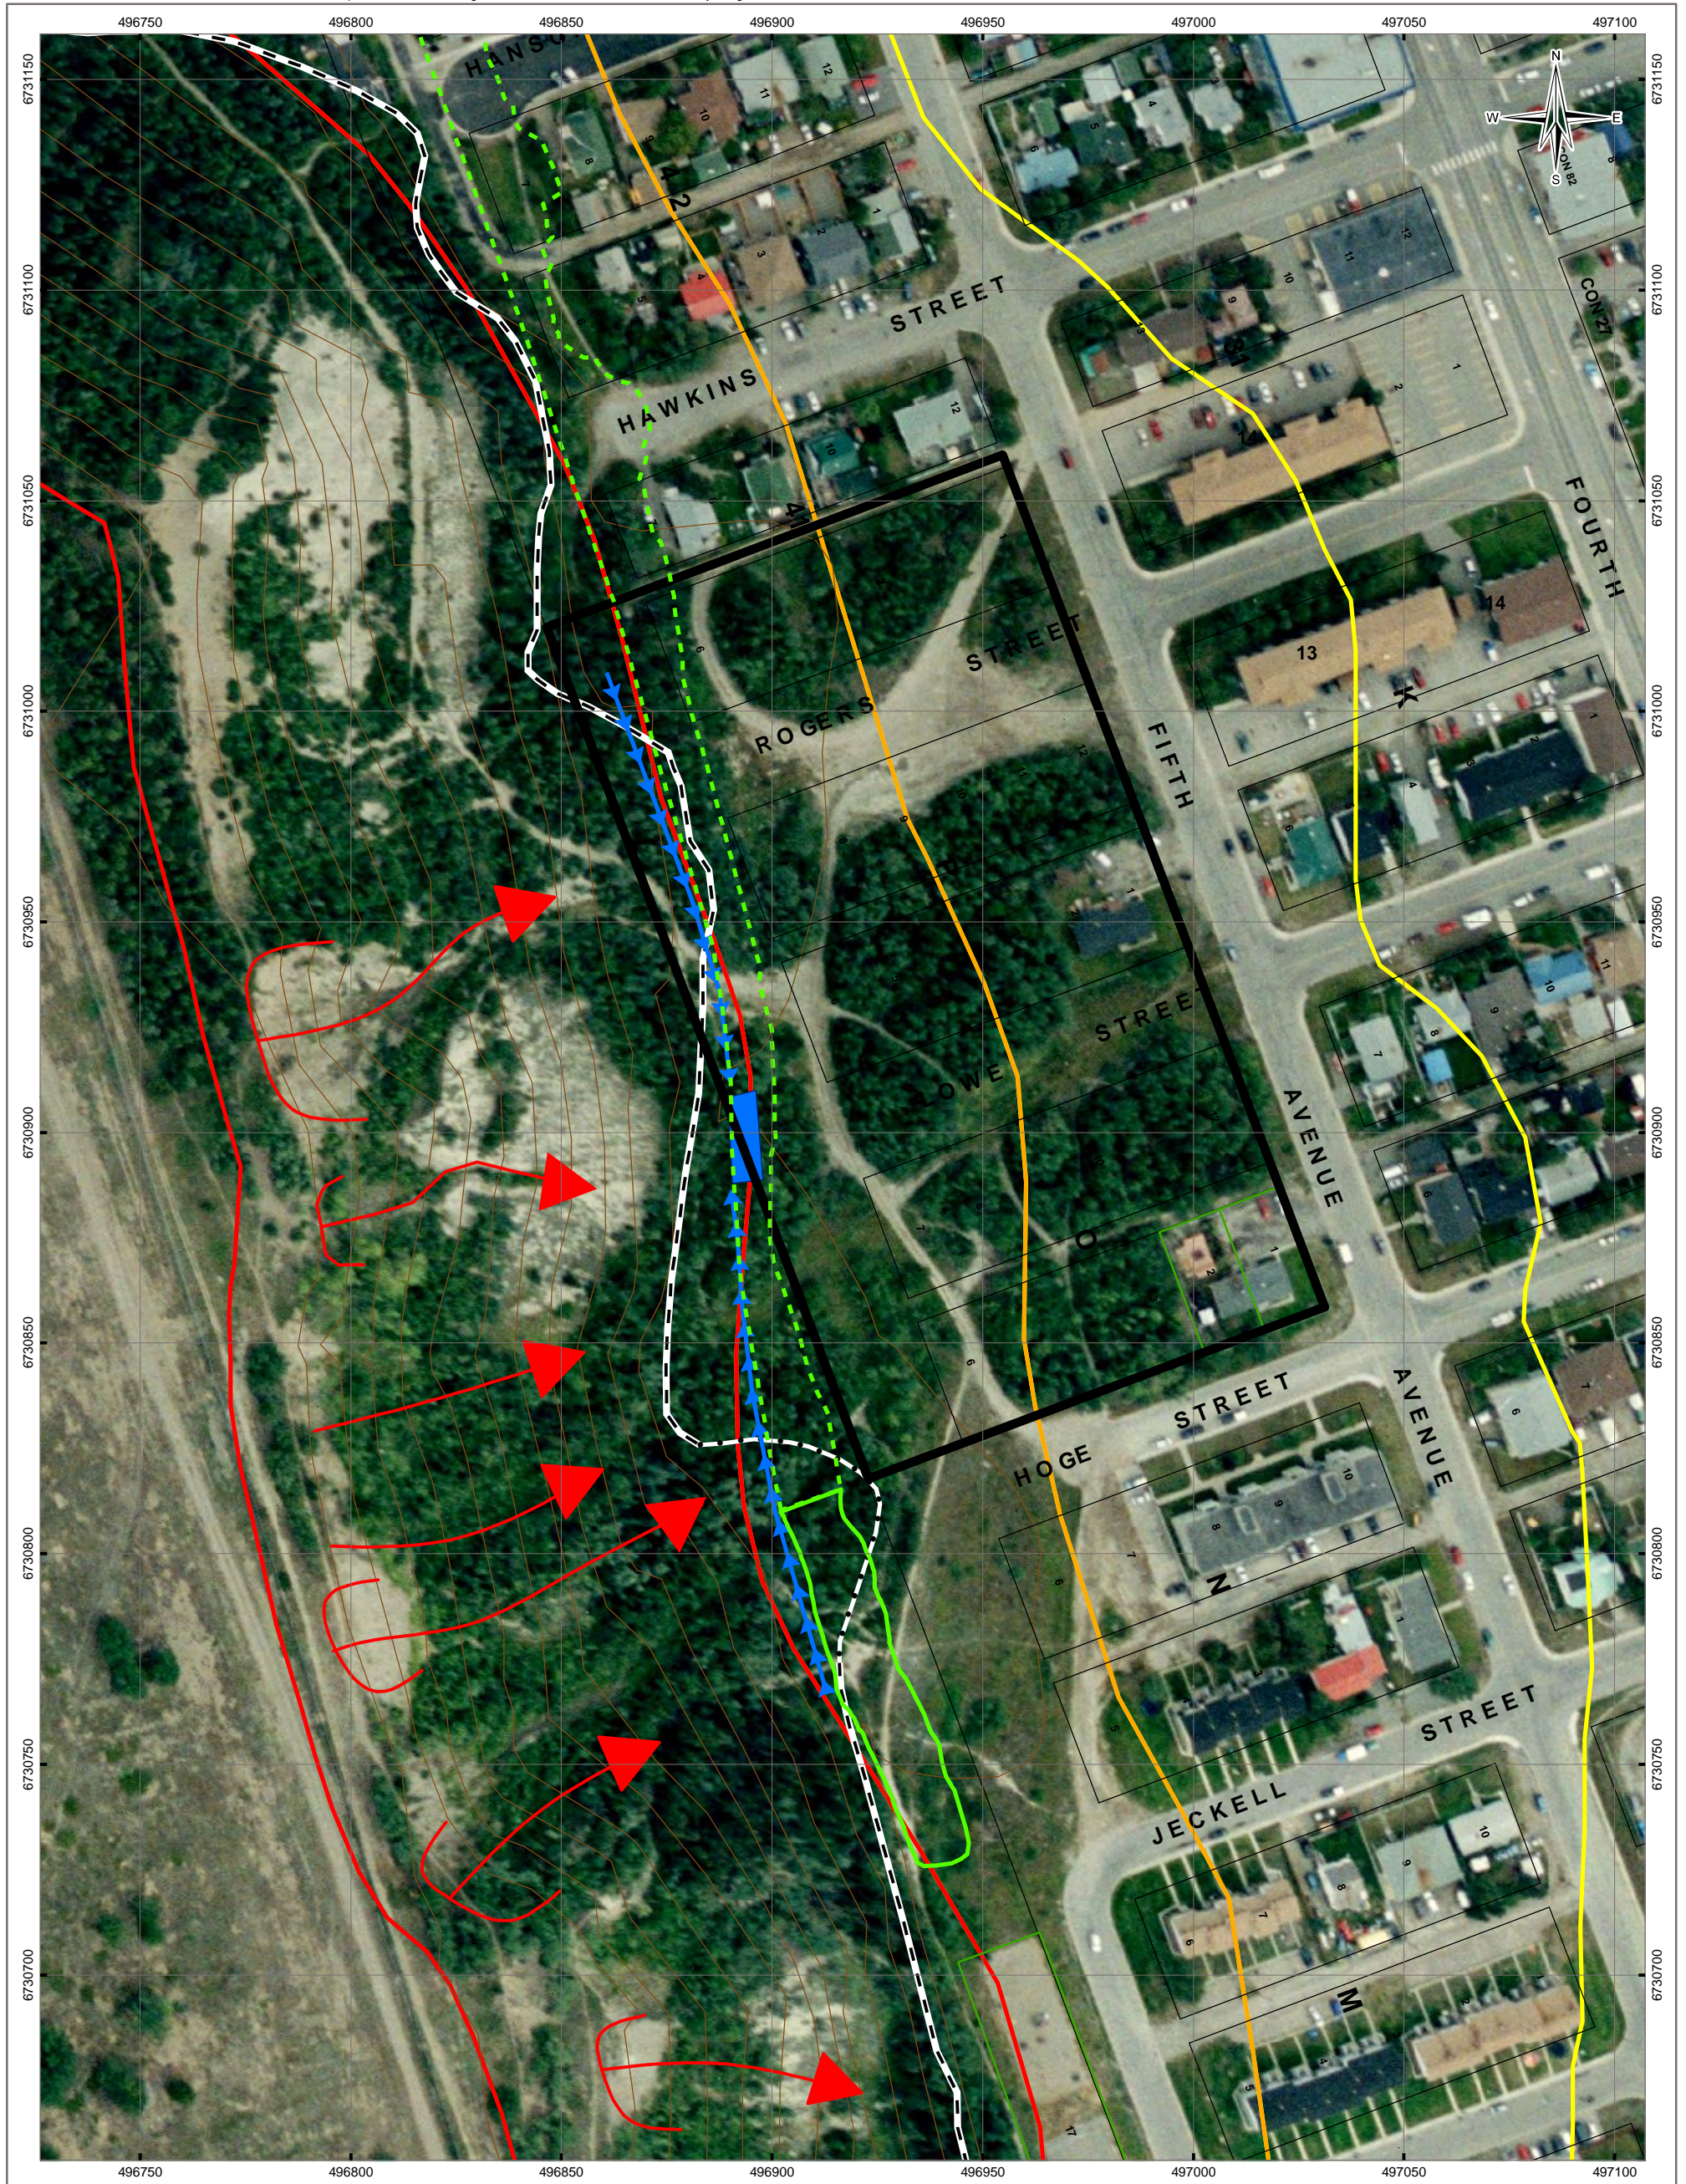
Figure 1 Site Plan

- YG Proposed Site Area
 - Constructed Berm
 - Proposed Berm
 - DTS Park Area
 - Mass Movement - Active
 - Contour (5 m)
 - Toe of Escarpment
 - Toe of Escarpment - Gradual Slope Change
 - Collection Ditch Flow Direction
 - Potential Location of Silt Collection / Settling Reservoir
- Geohazard Rating**
- High Hazard
 - Moderate Hazard
 - Low Hazard

To reduce the hazard of upslope mass movement processes at this site, a continuous berm should be constructed near the lower slopes of the escarpment to control and reduce the consequence of mudslides and deposition from high suspended sediment flows. Construction of this berm was a key recommendation in a report completed by EBA for the City of Whitehorse in April 2012. The new berm is required to divert and collect sediment transported from the erosional processes initiating on the escarpment in the south downtown area. Once in place, the berm will reduce the geohazard east (downslope) of the berm to Low Hazard. Most of the berm centreline is located within 20 m inside of the western boundary of the subject property (Figure 1).

Construction of a berm, as recommended in EBA's Downtown South Terrain Stability Assessments report (April 2012) and shown on Figure 1, has been accepted by the City to apply to all affected development properties in the area. It will reduce the risk from upslope mass movement processes at the subject property.

The centreline location of the recommended berm (Figure 1) is mostly within the western extent of Block 338. Development of residential buildings can be facilitated once a suitable berm has been constructed to City standards.
