REPORT 160636/1

**VANGORDA PLATEAU DEVELOPMENT
AS-BUILT CONSTRUCTION REPORT FOR
LITTLE CREEK DAM**

STEFFEN ROBERTSON AND KIRSTEN (B.C.) INC.

MAY 1991

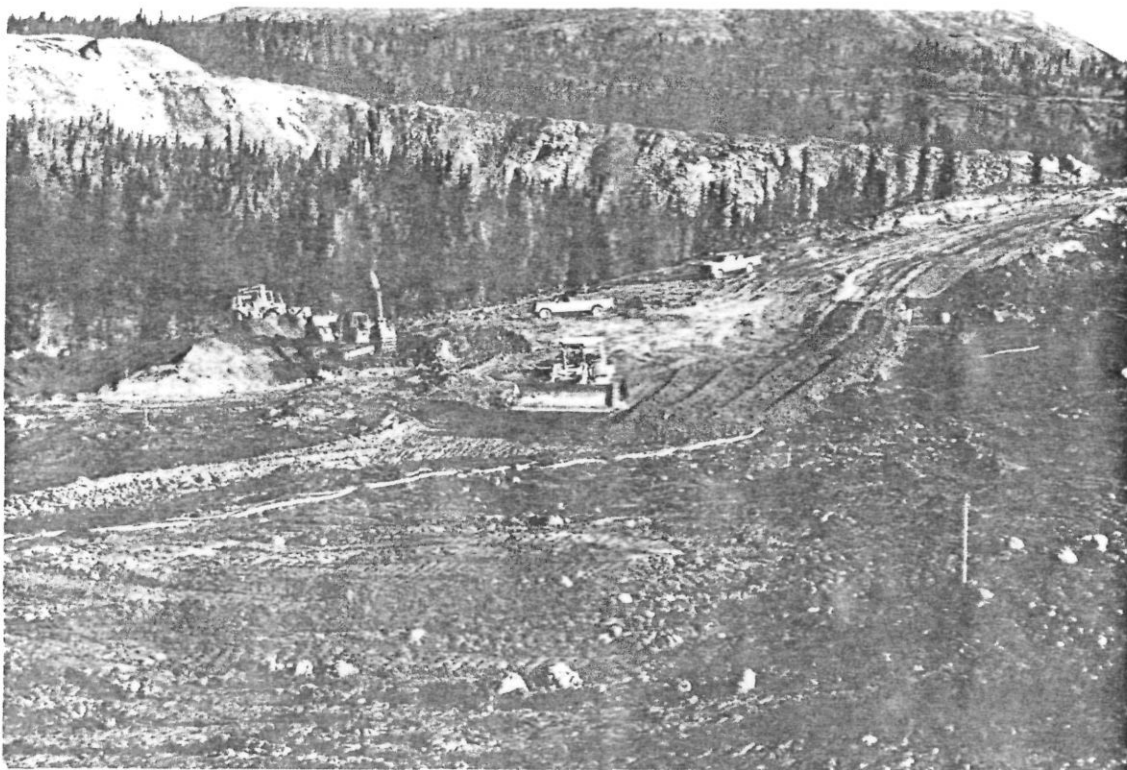
PLATE 2:

Sept. 13/90. Opposite view to Plate 1, from the south abutment of the dam. Excavation of the cutoff by the backhoe is underway and the area in valley bottom between the cutoff trench and the upstream toe of the dam is being covered with till from the stripping of Vangorda open pit.

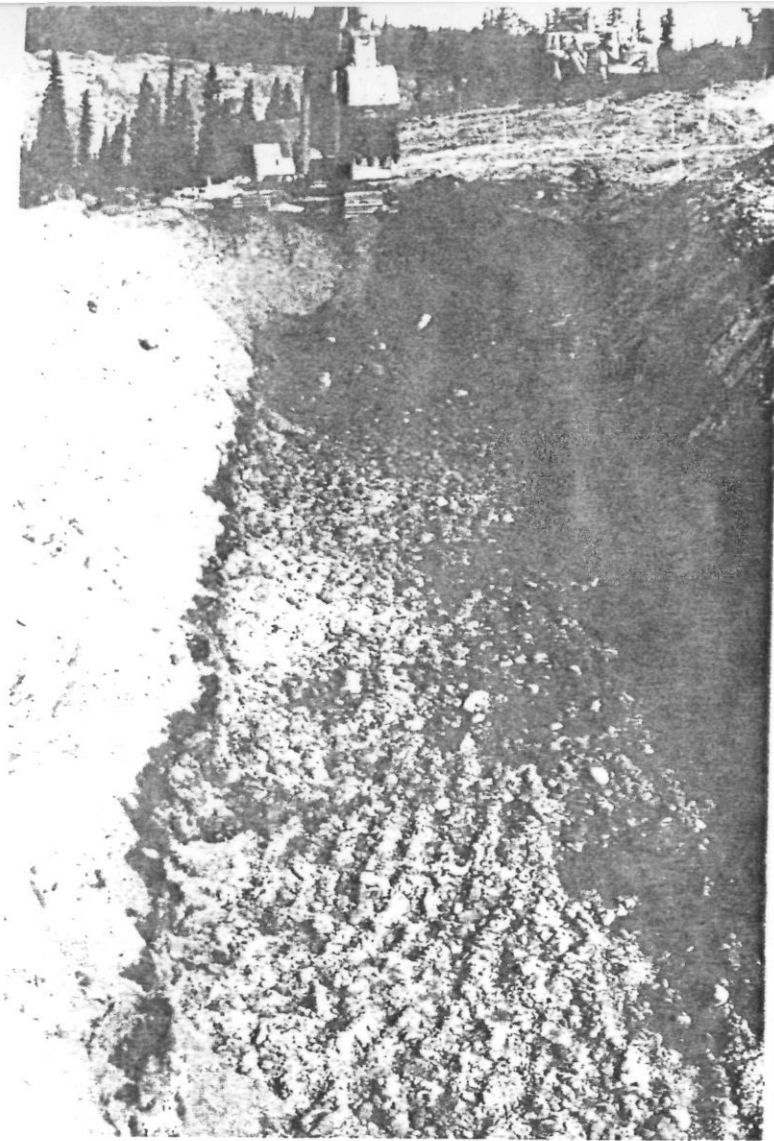
PLATE 3:

Sept. 13/90. Northward view of completed cutoff trench between Sta. 0+180 (in foreground) and Sta. 0+210. Brown sand and gravel overlies olive till which, in turn, overlies grey till. Groundwater is evident near the base of the sand and gravel.

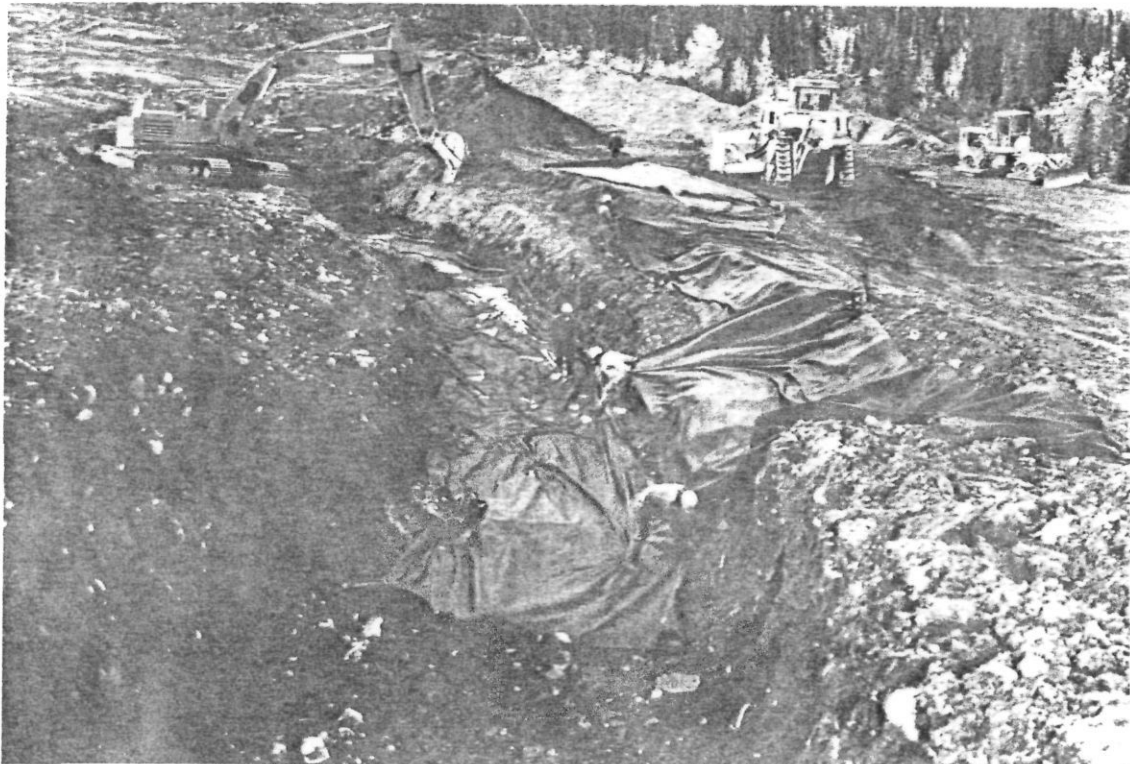
PLATE 4:

Sept. 14/90. Excavation of the cutoff trench between Sta. 0+180 and 0+235 is complete and filter fabric is being placed on the base and against the downstream face of the trench.

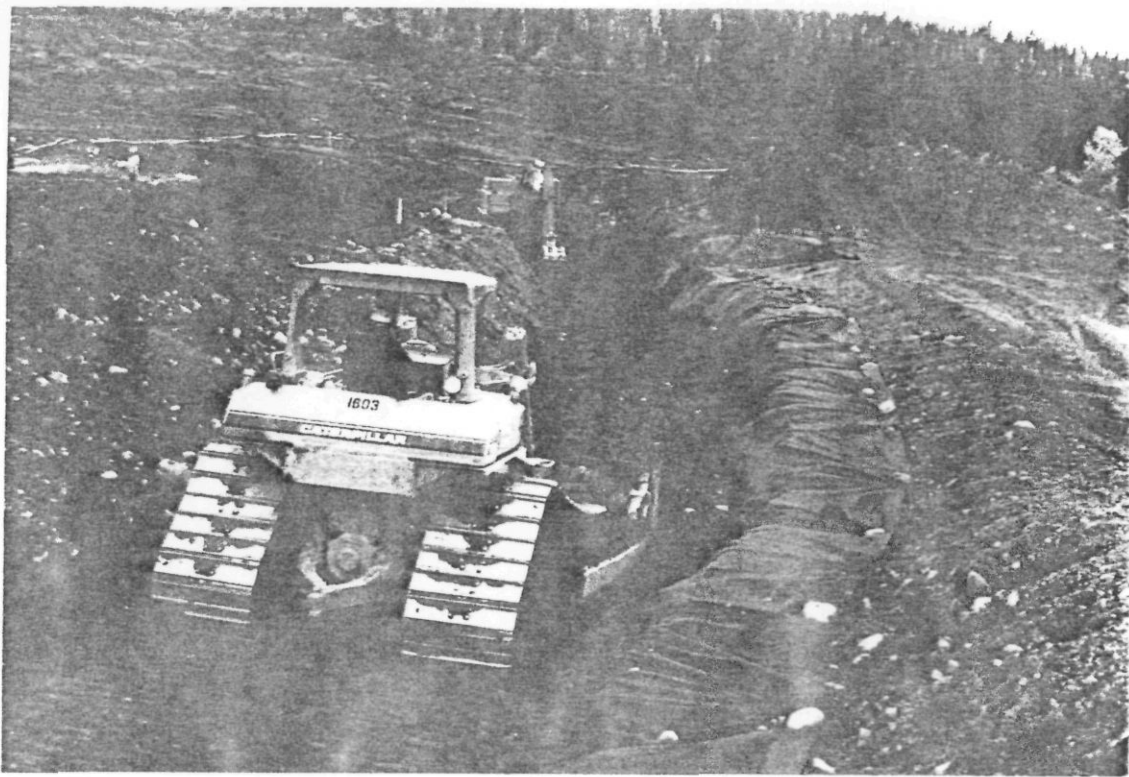
PLATE 5:
Sept. 14/90. The cutoff trench is then backfilled in thin lifts which are placed initially by the backhoe and then tracked down with a dozer in preparation for compaction.

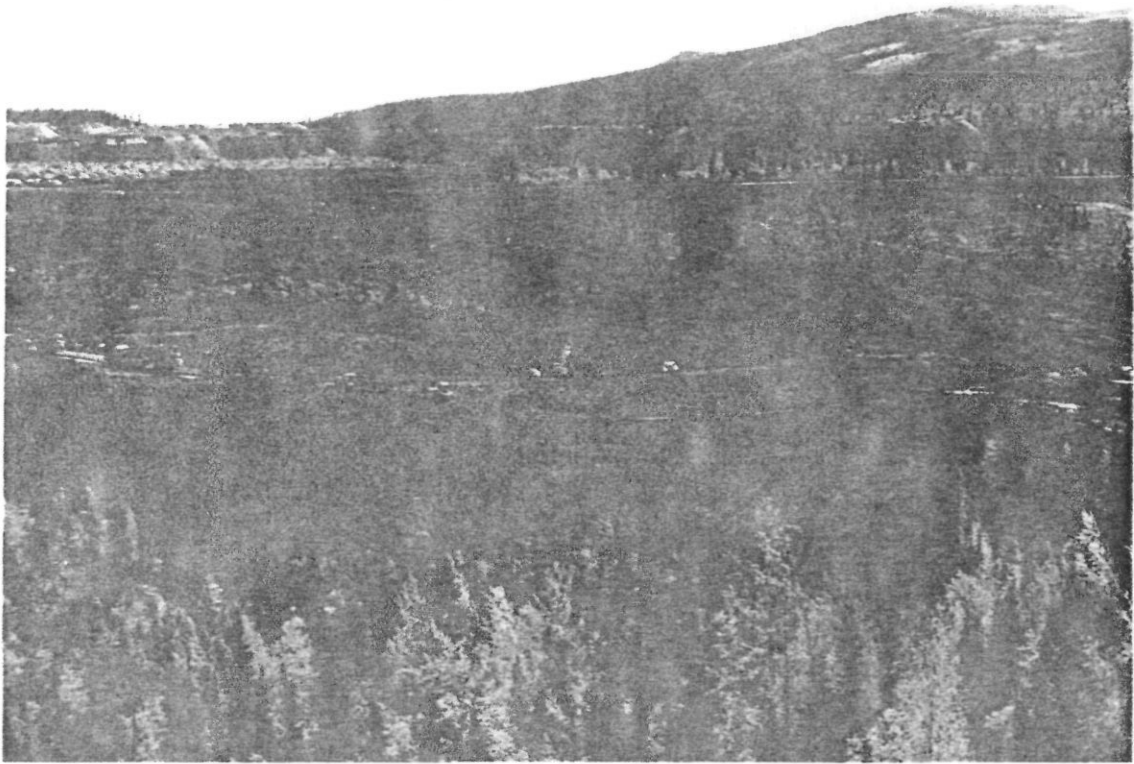
PLATE 7:

Sept. 15/90. View from the main haul road showing the scrapers hauling till. The brownish zone in the foreground of the footprint is the local sand and gravel which has been redistributed to develop part of the blanket drain and the downstream toe of the dam.

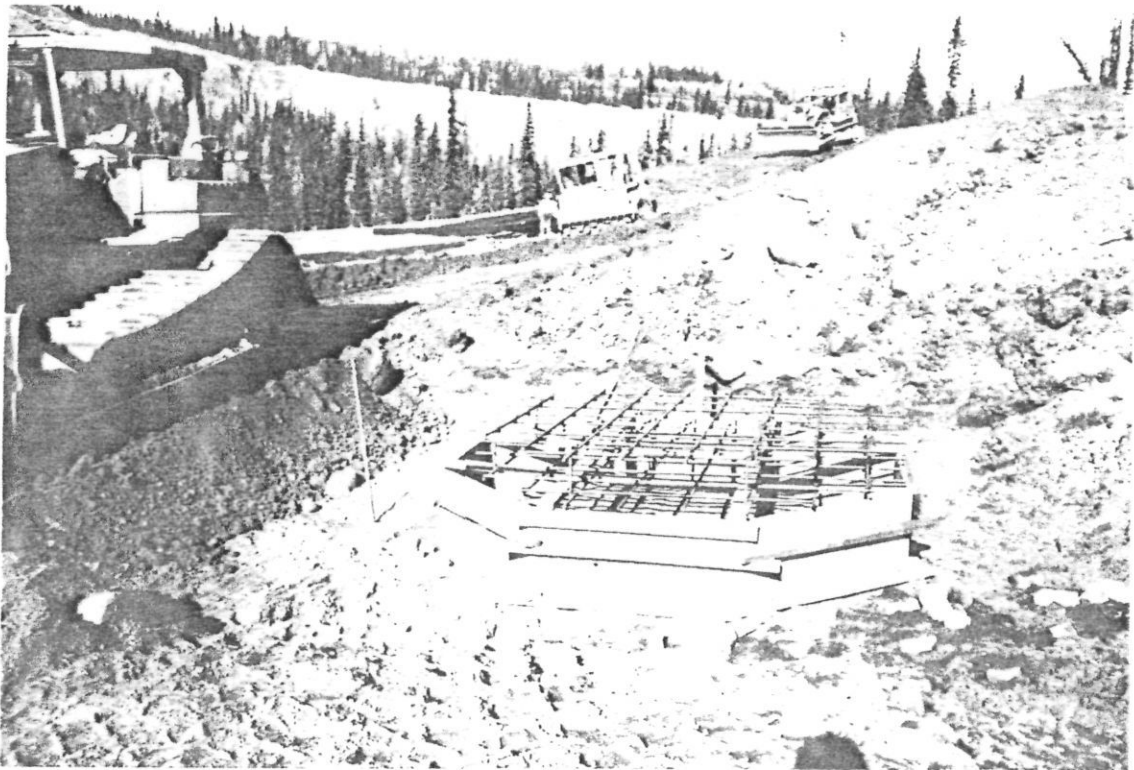
PLATE 8:

Sept. 17/90. Formwork for the base of the wet well in place on in situ sand and gravel. In background, filter fabric is partially in place over the blanket drain on the north side of the valley.

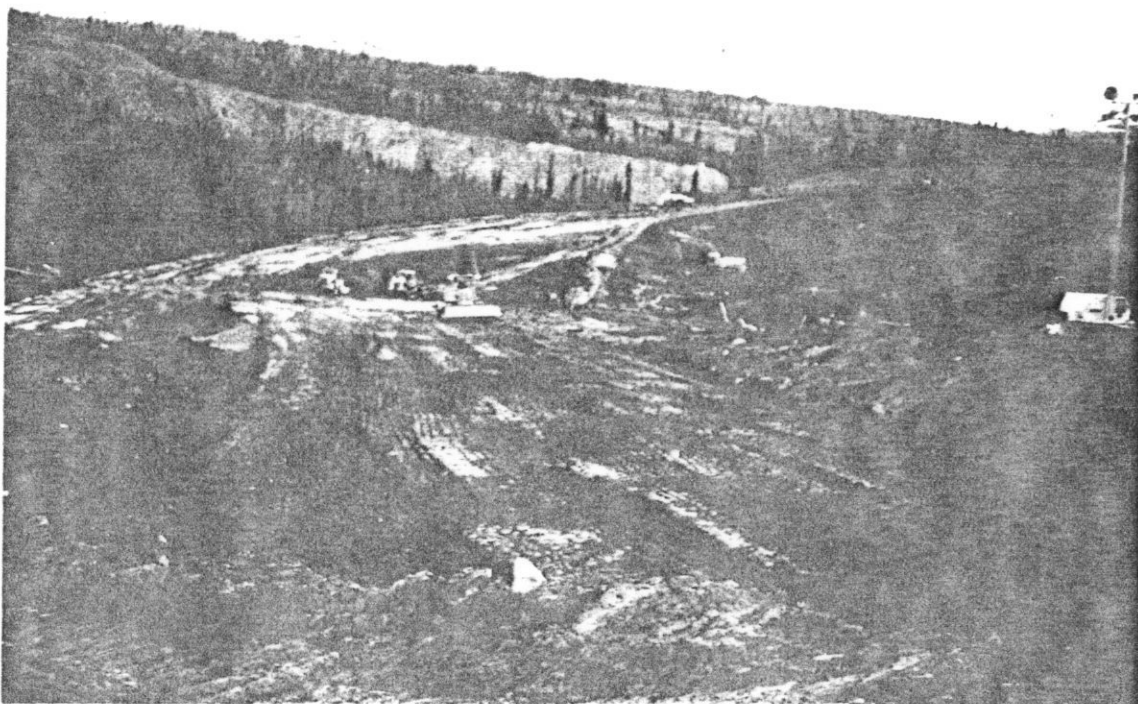
PLATE 10:

Sept. 30/90. Backfilling in thin compacted lifts of the area between Sta. 0+020 and 0+070 where the zone of permafrost was excavated.

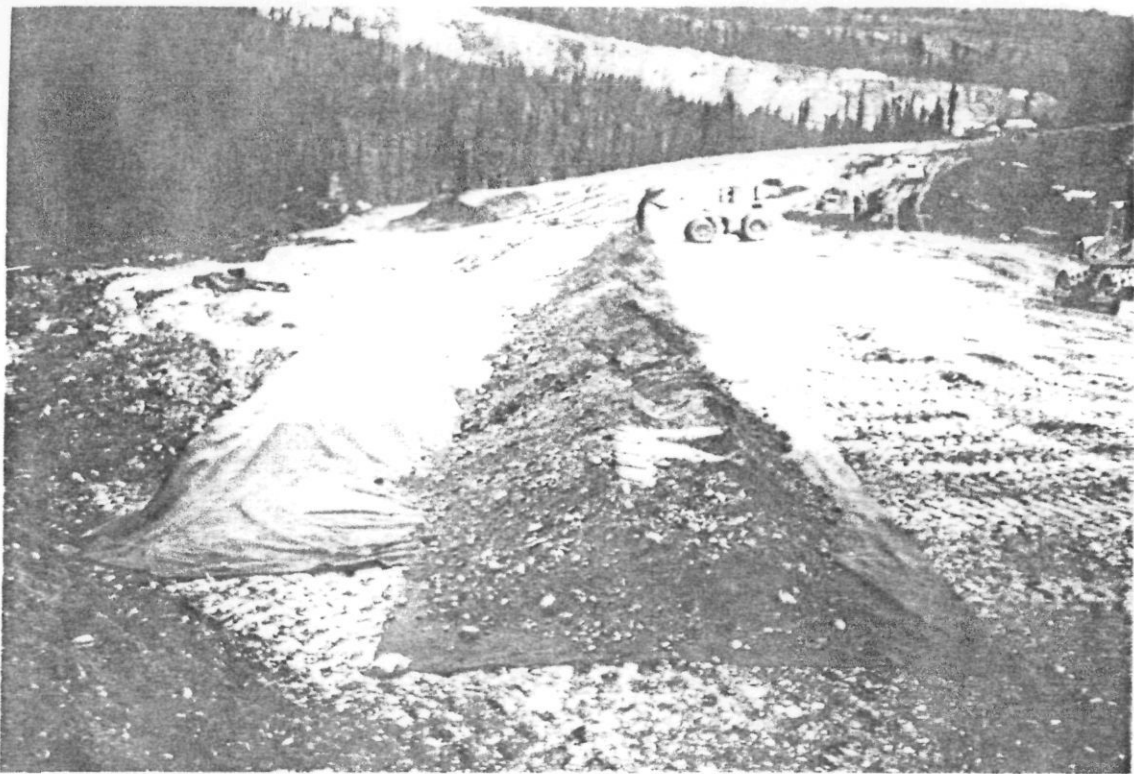
PLATE 11:
Oct. 1/90. View northwards from Sta. 0+040 at the construction of finger drain "L1."

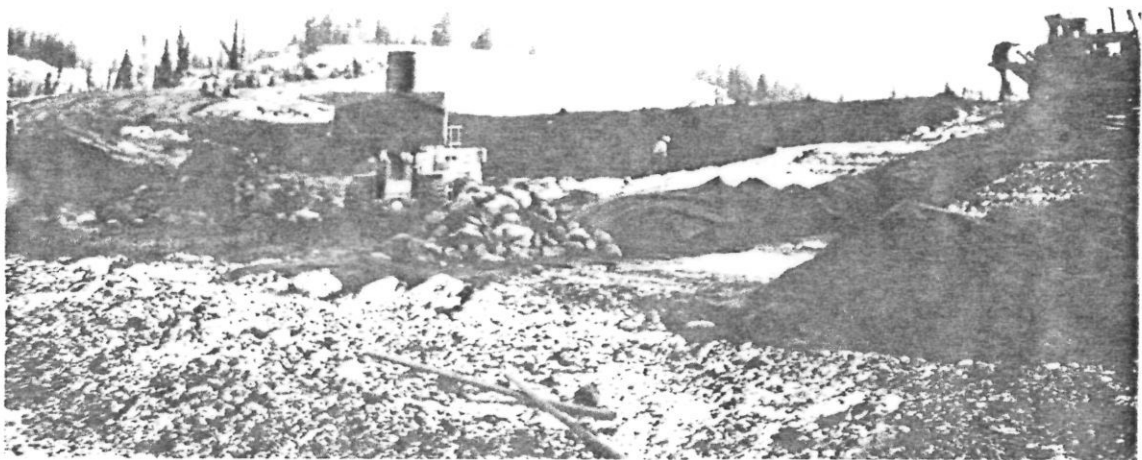
PLATE 12:
Oct. 3/90. Covering finger drains "T1" and "T2" with filter fabric and constructing the rock drain at the end of "T1."

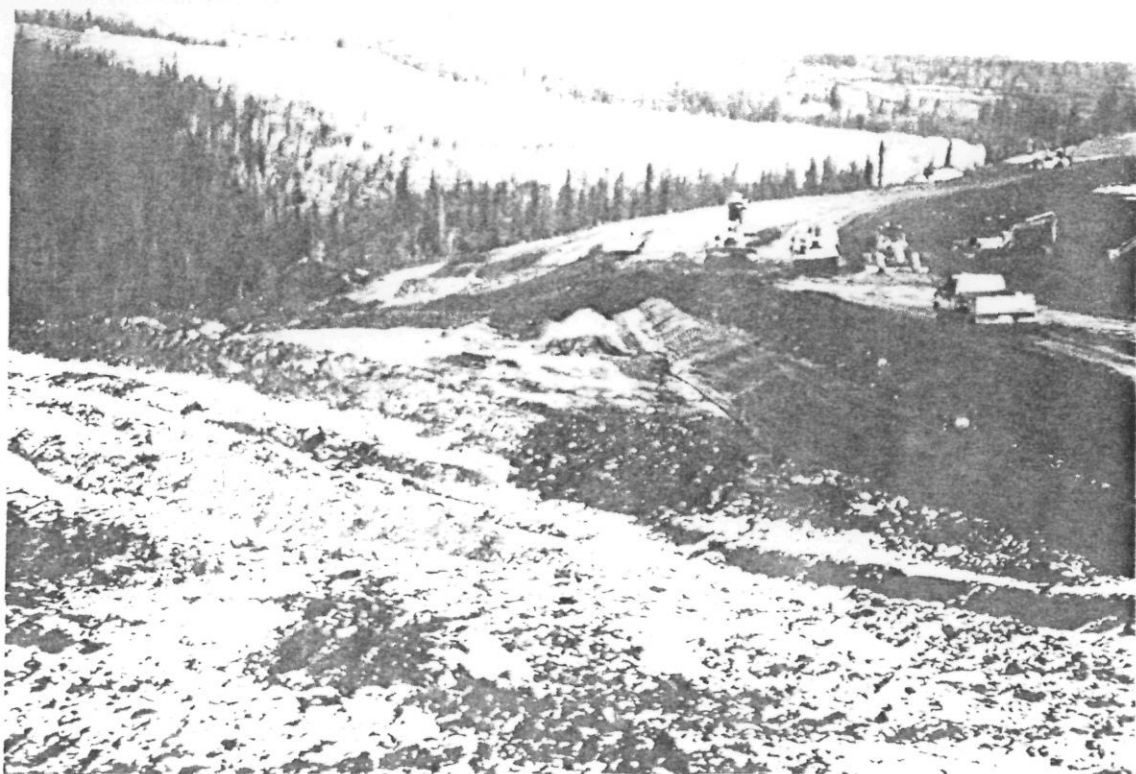
PLATE 13:

Oct. 3/90. Placement of till over top of the finger drains on the south side of the dam footprint.

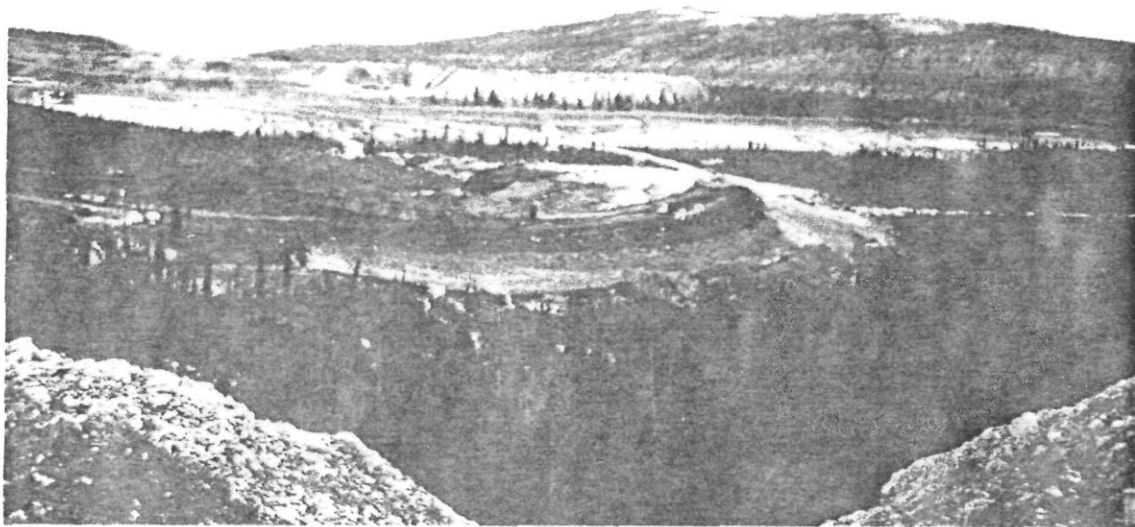
PLATE 14:

Oct. 8/90. View from the main haul road. Crest of the dam is at Elev. 1112.
