**CURRAGH RESOURCES LTD.**

**Rose Creek Fisheries Study**

**Interim Report - May 1987**

**P.A. HARDER & ASSOCIATES LTD.**

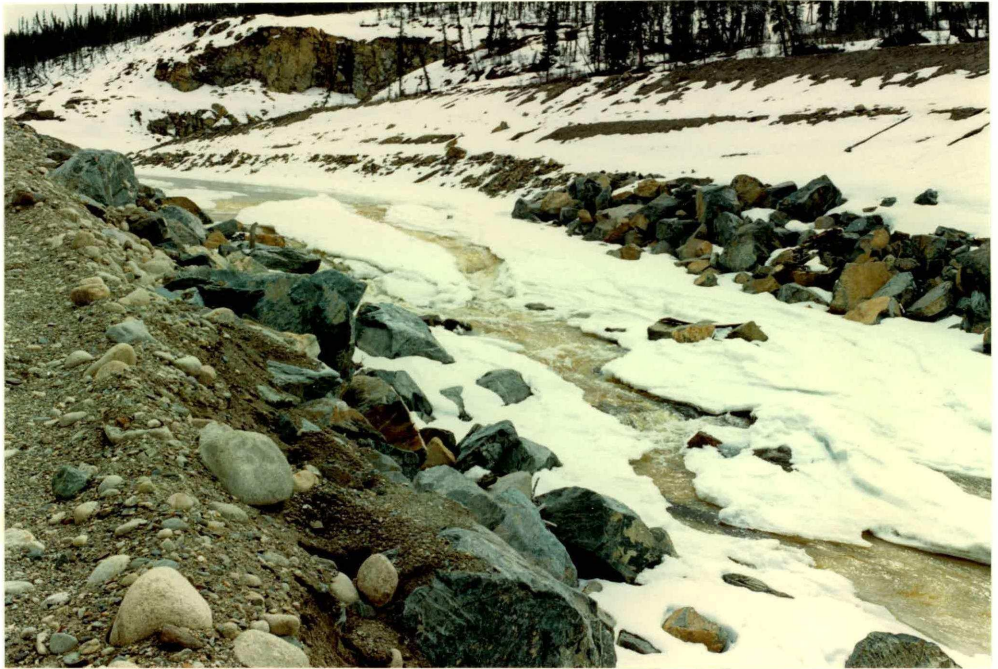
Plate 3. Upper Extent of Rose Creek Diversion Channel.

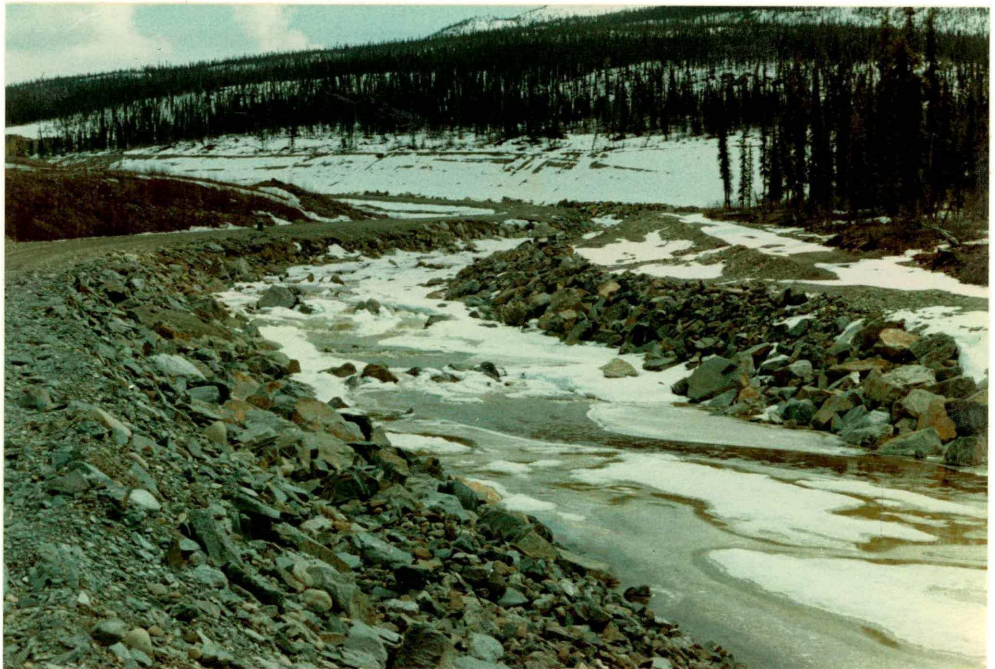
Plate 4. Mid-section of Rose Creek Diversion Channel.

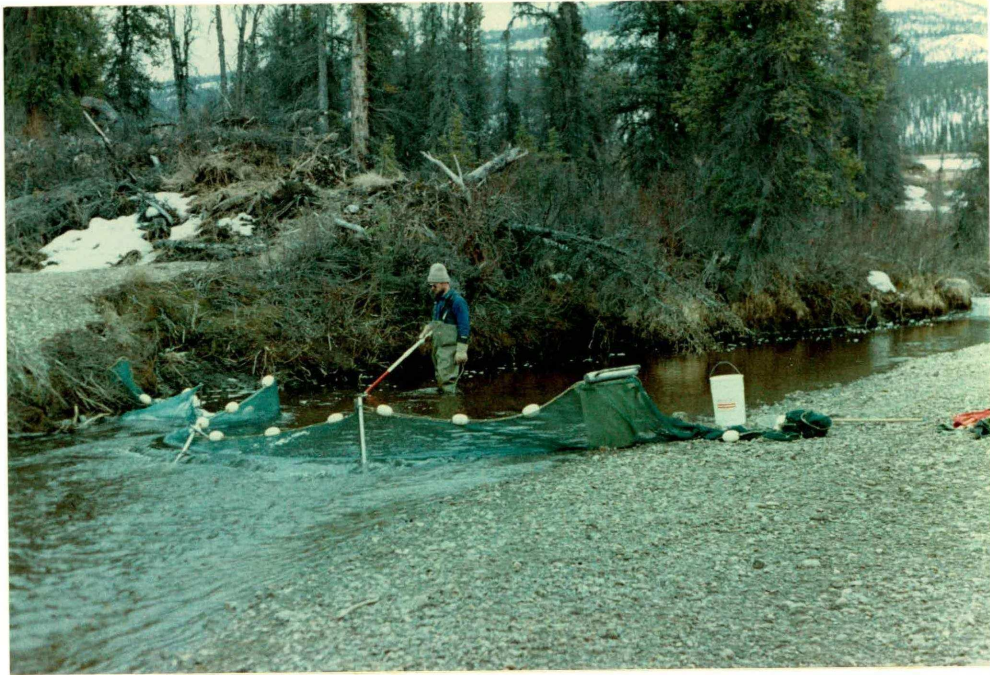
Plate 5. Lower Rose Creek below Diversion Channel and above Tailings Effluent. Sample Site No. 3.

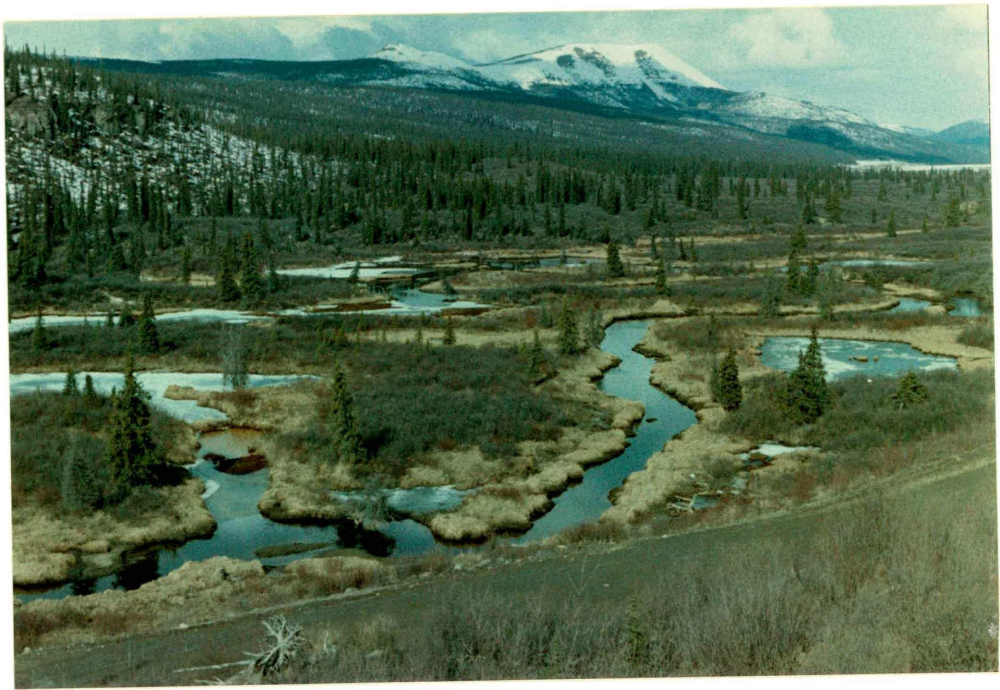
Plate 7. South Fork of Rose Creek below Reservoir; Note Low Gradient and Extensive Beaver Ponding.

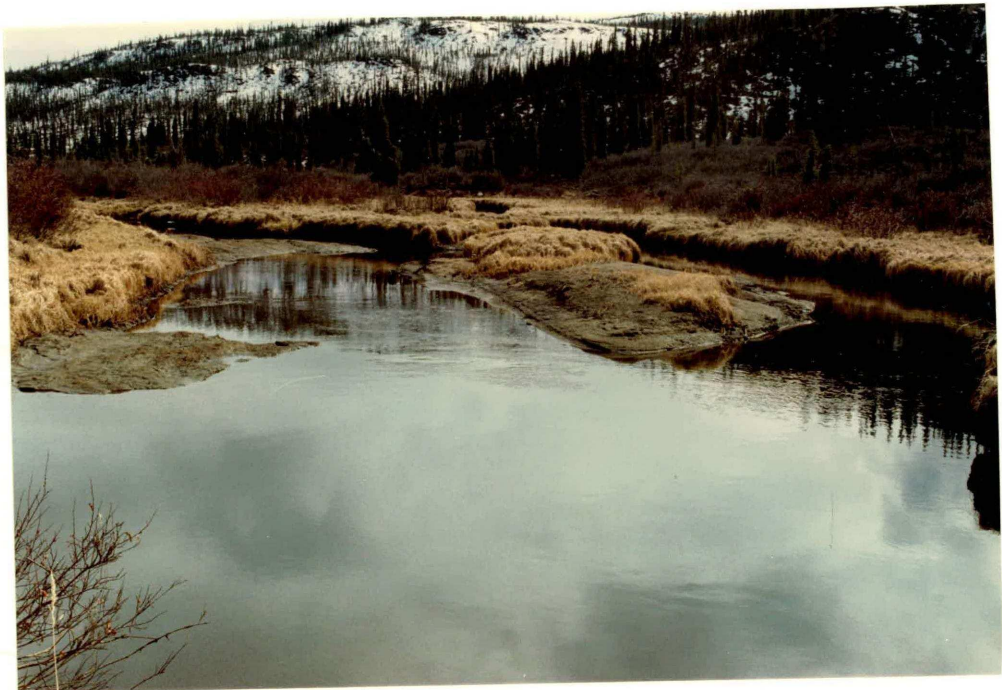
Plate 8. Typical Low Gradient Section of the South Fork below Beaver Pond Area. (0.5% Grade with Silt Substrate).

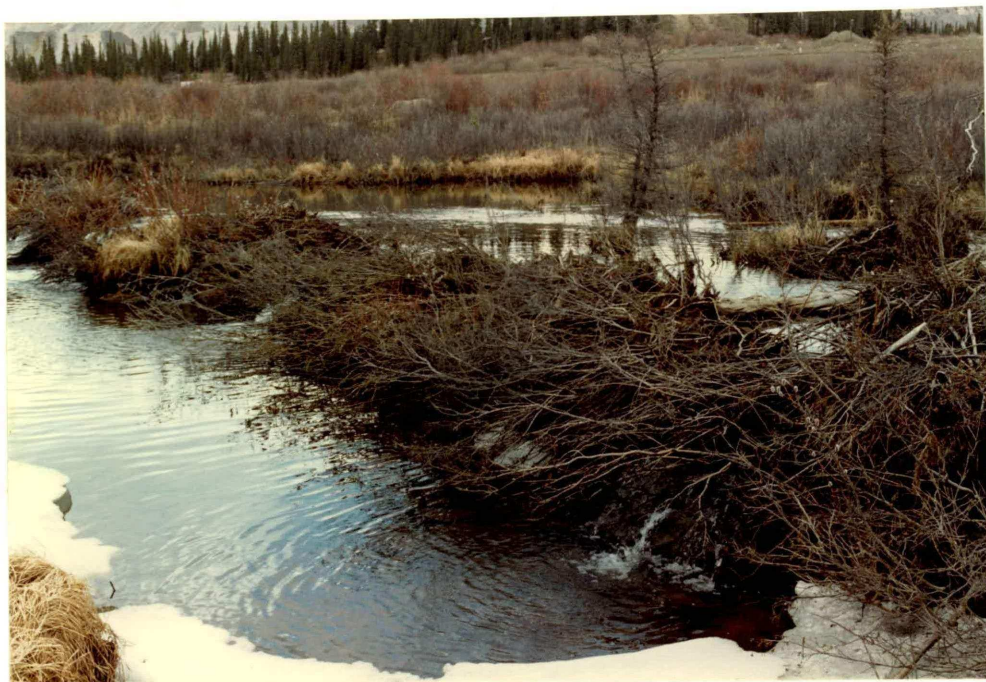
Plate 9. Beaver Dam in Mid-section of the South Fork. This is a Point of Difficult Fish Passage.

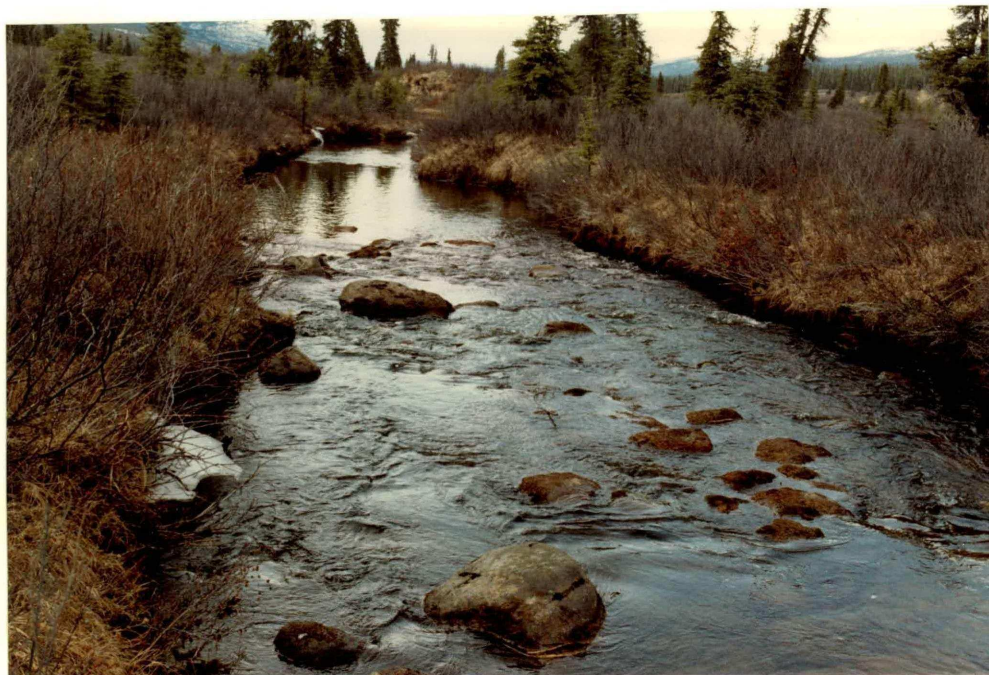
Plate 10. Shallow Riffle Section Approximately 150 m Downstream of Beaver Dam (Plate 9).

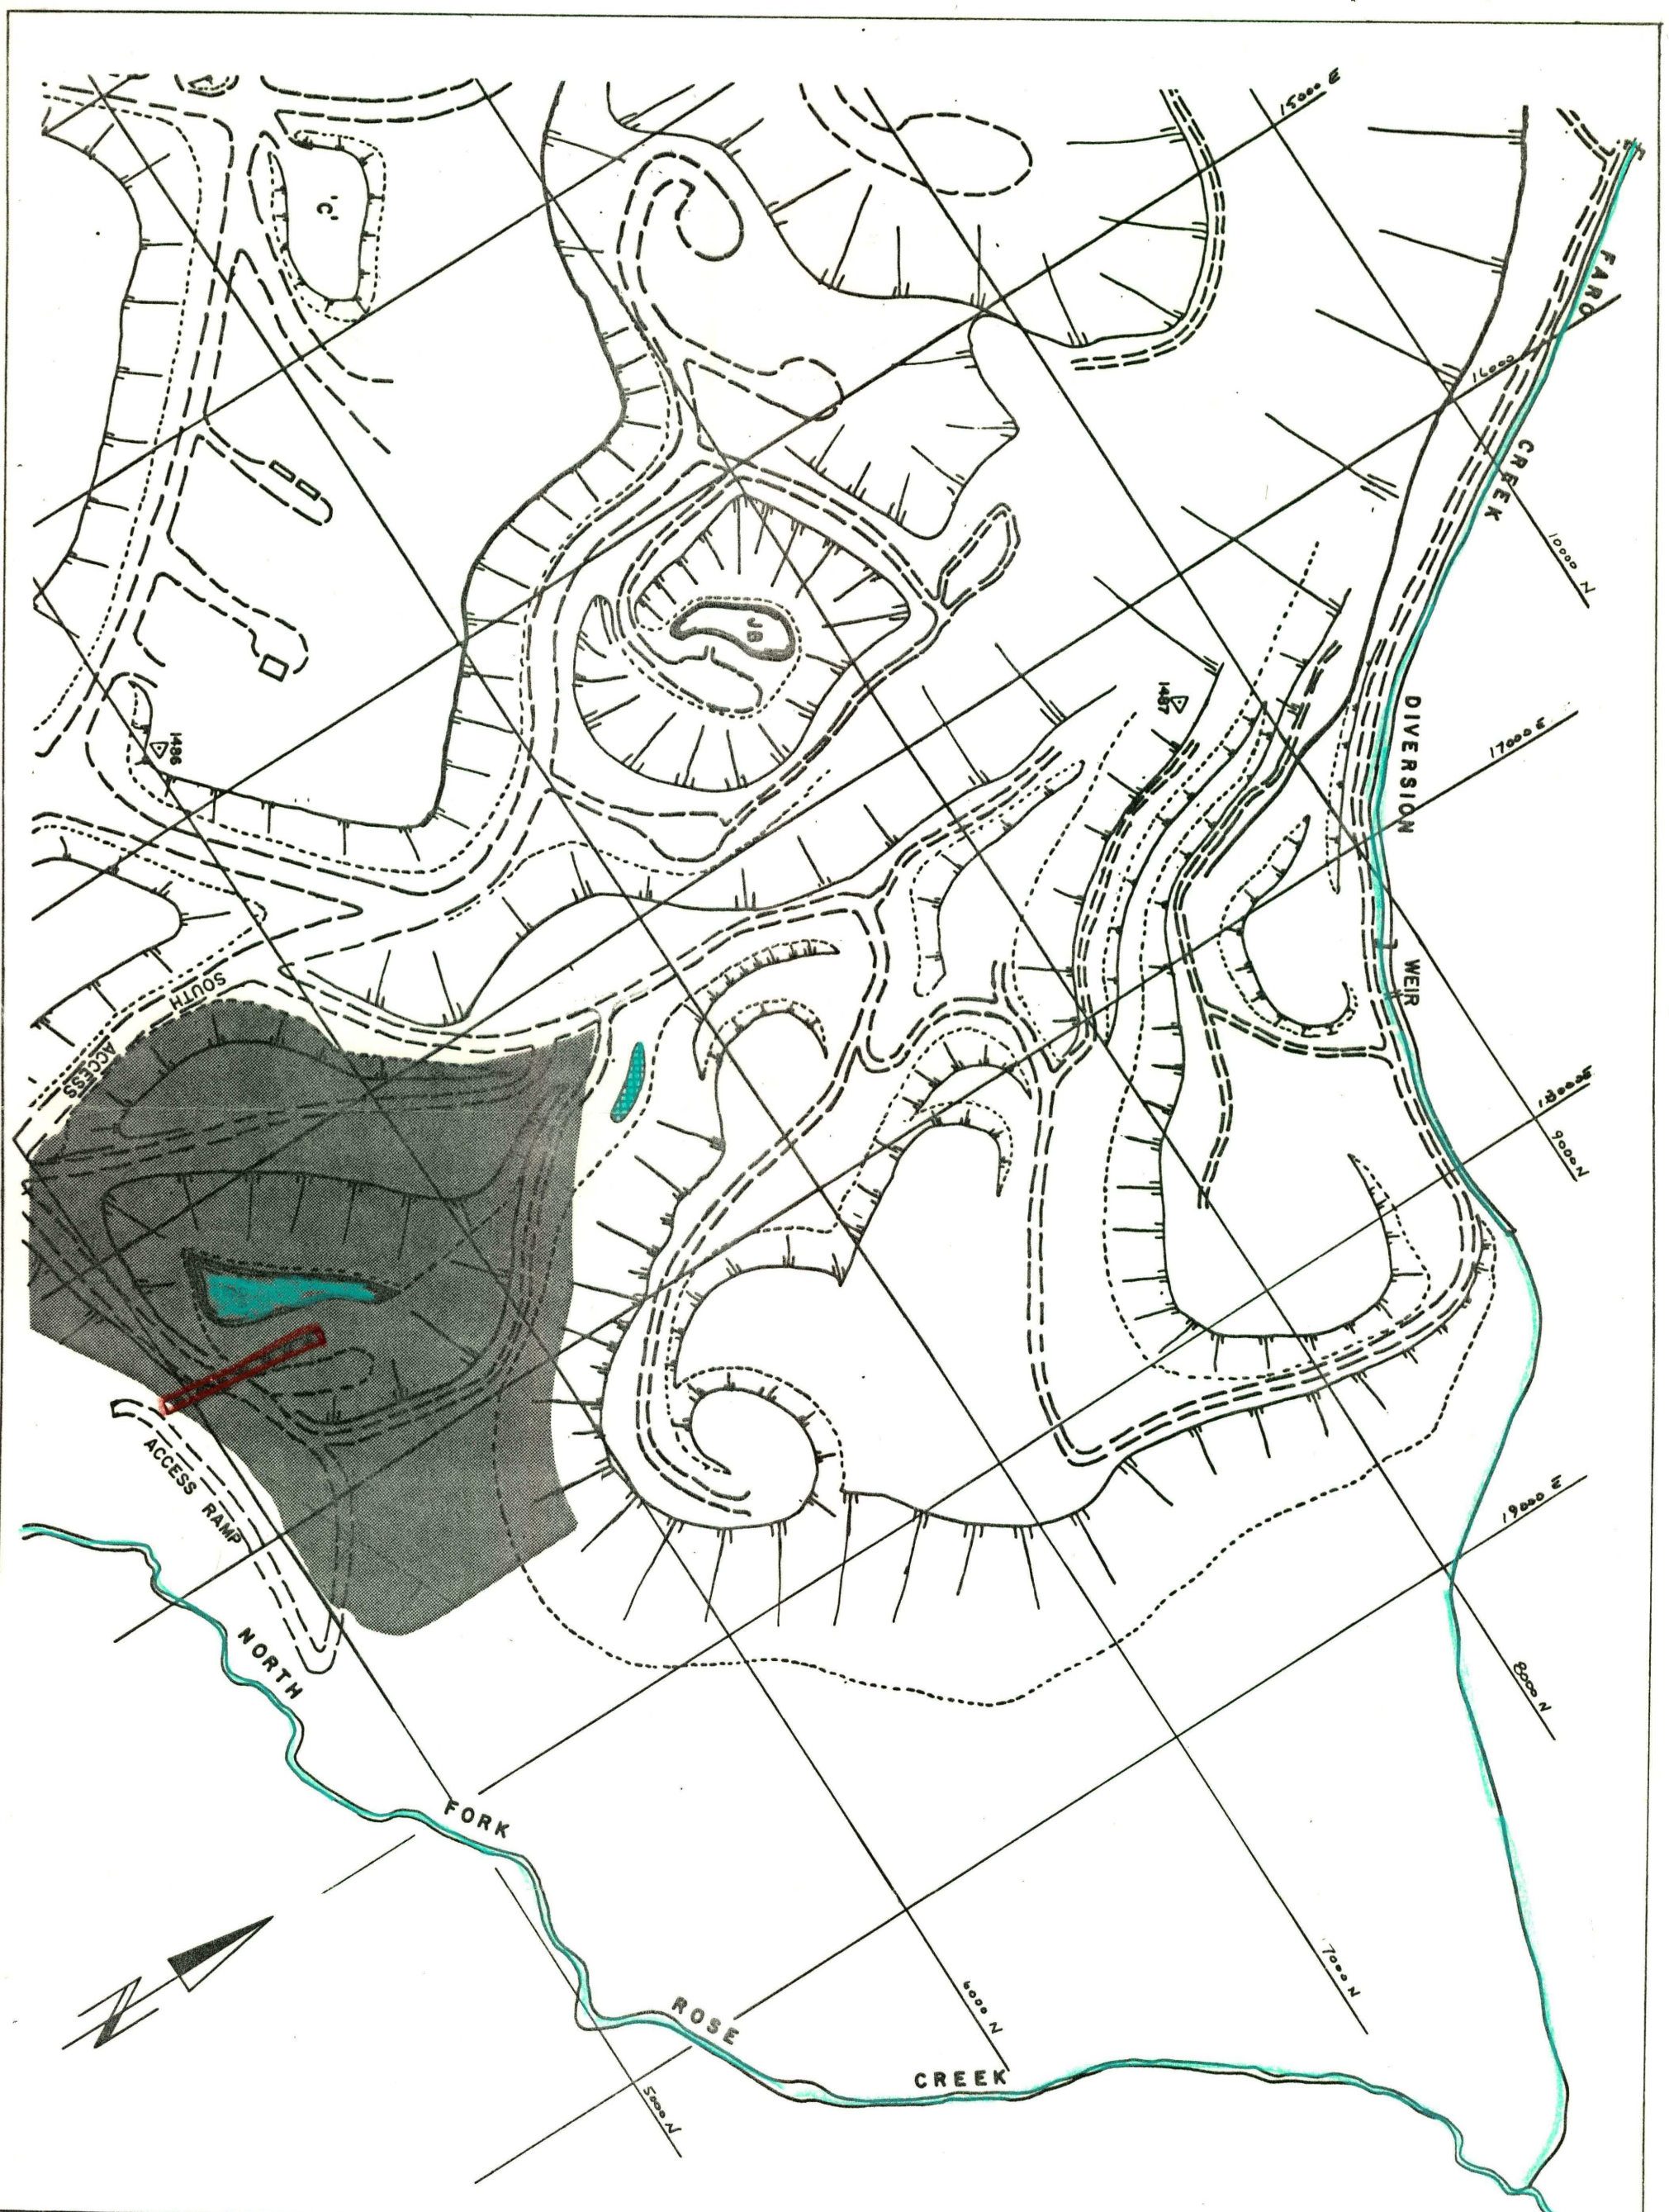
CURRAGH RESOURCES INC.  
ZONE 2 WASTE DUMP

The final stage will be the development of the waste dump itself to the ultimate design limits (Figure 2).

Construction of an access ramp to the 3710 foot elevation (Figure 2) requires approximately 34,000 loose m<sup>3</sup> of material cut from the existing crest of the Zone 2 waste dump as well as approximately 23,000 loose m<sup>3</sup> of additional fill. This material is non sulphide-bearing rock, calc-silicate transitional to phyllite. Ramp design is constrained by the dump limit on the west to a 21 m width. With berm allowance, this restricts the ramp to single truck hauling. The ramp grade is -10% and follows on top of the old perimeter access into the Zone 2 pit. The ramp will provide access to the discharge point of the internal drain as well as accessing a source of gravel for the pit operation.
