TABLE 5 DATA FOR SPECIFIC WATER QUALITY PARAMETERS UPSTREAM OF THE FRESHWATER POND IN ROSE CREEK

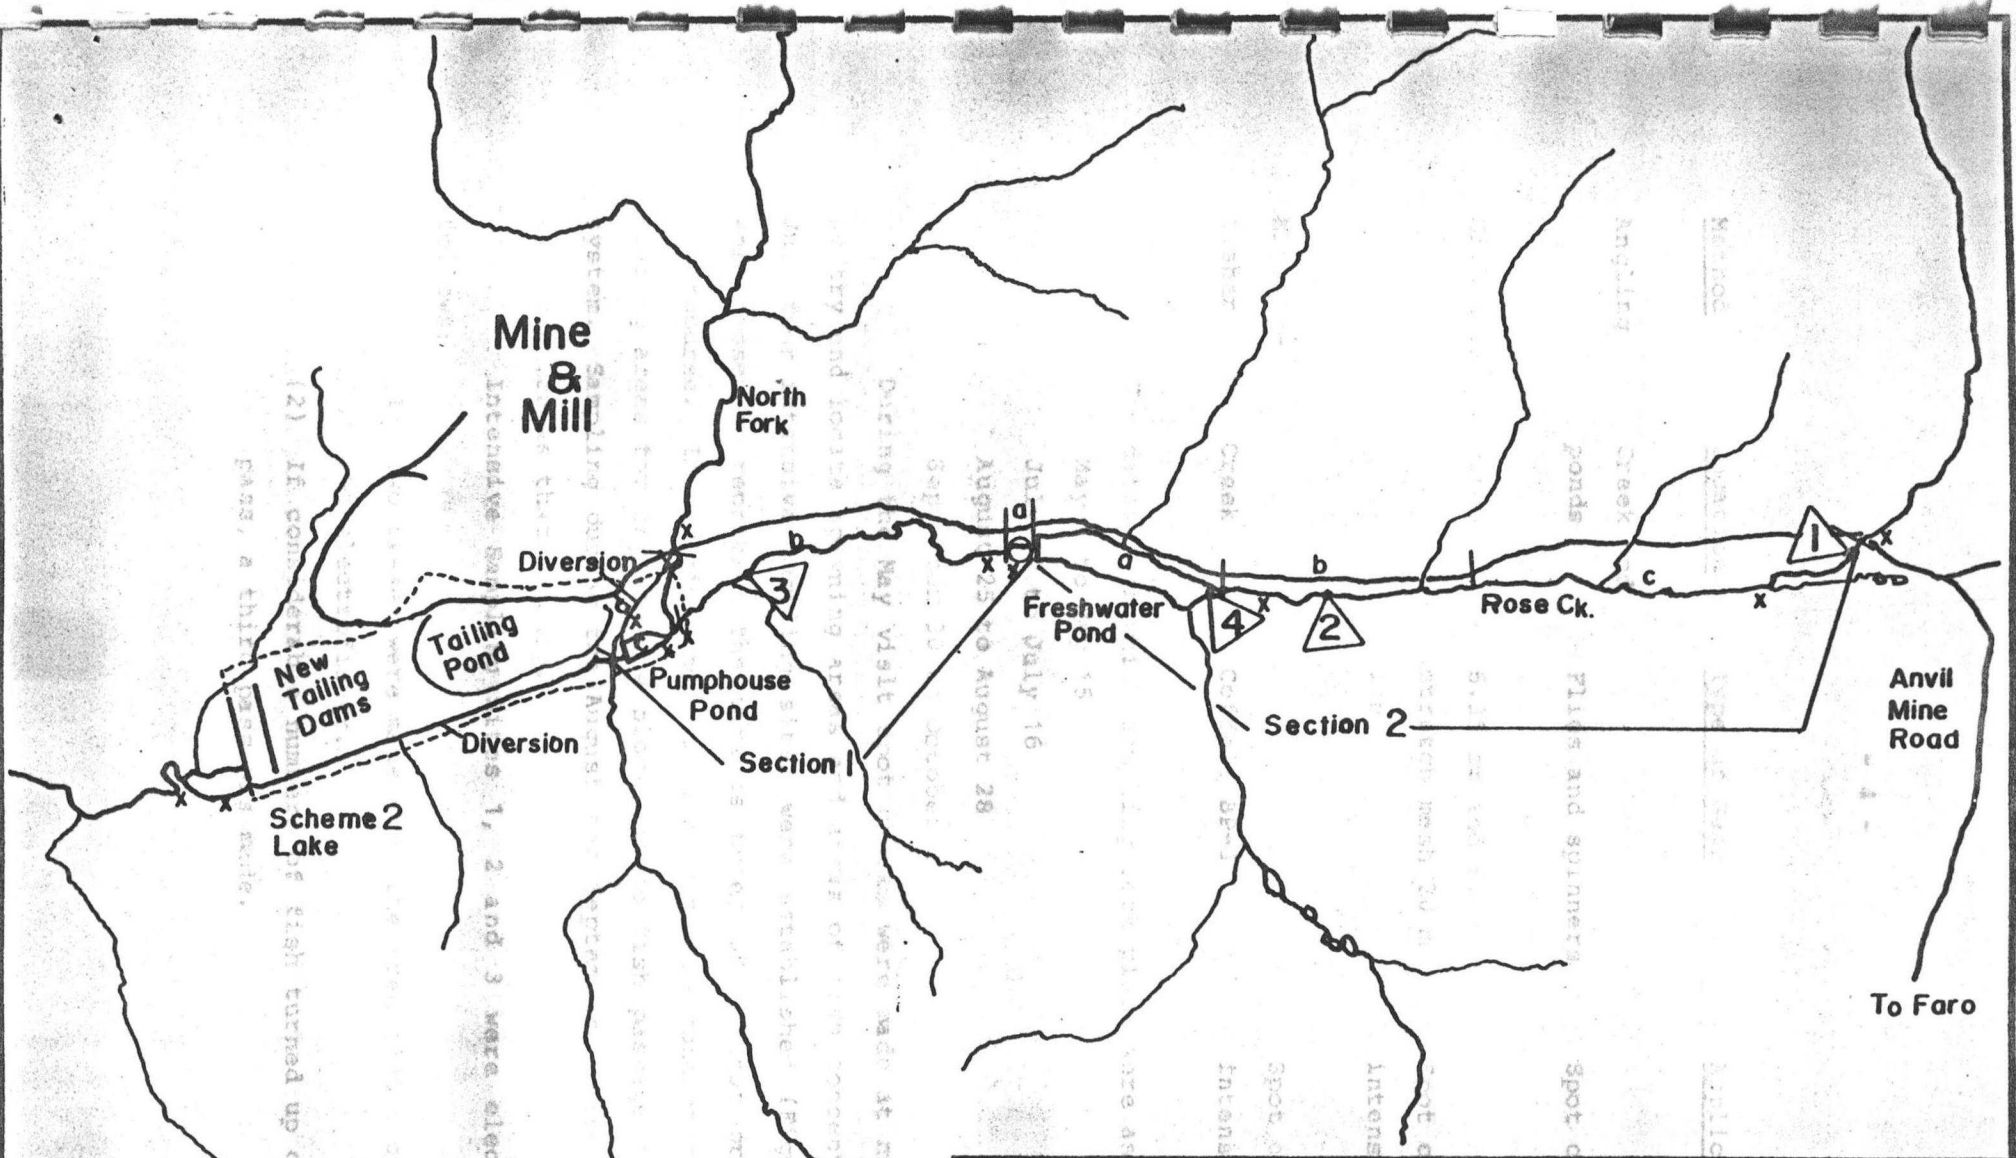
**FIGURE 1. Details of study area.**

- - Beaver Dam
- △ - Intensive Sampling
- |a| --- - Habitat Boundary
- x - Spot Check
