Seep Flows (L/s) September 24-26

Seep Zinc levels (extractable) June 18/87

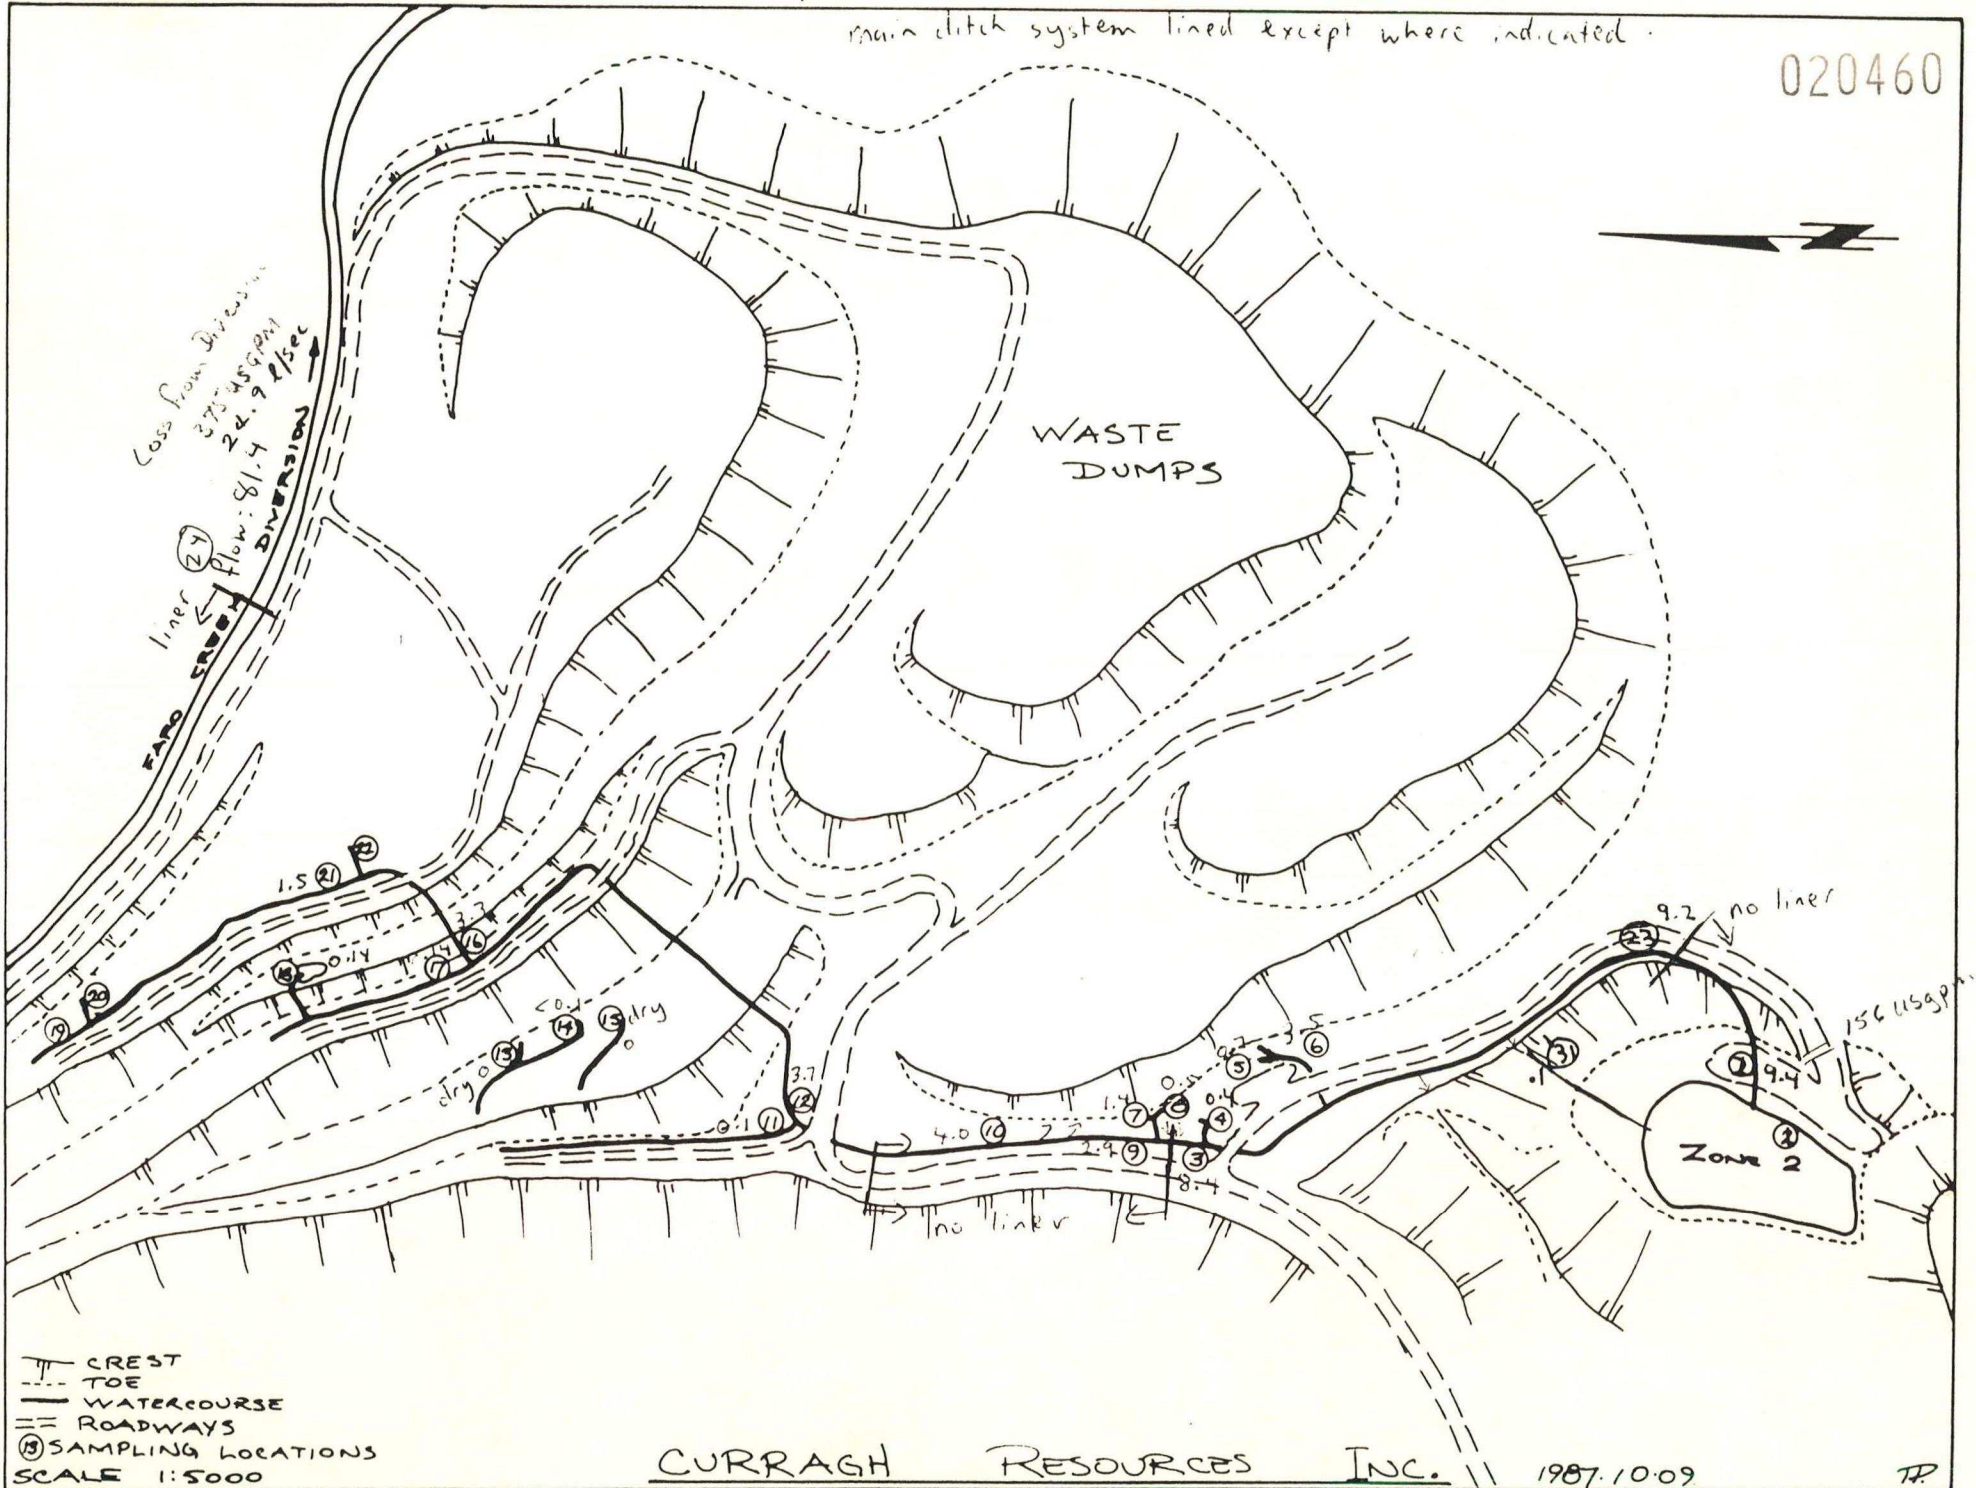
FIGURE 4

main ditch system lined except where indicated.

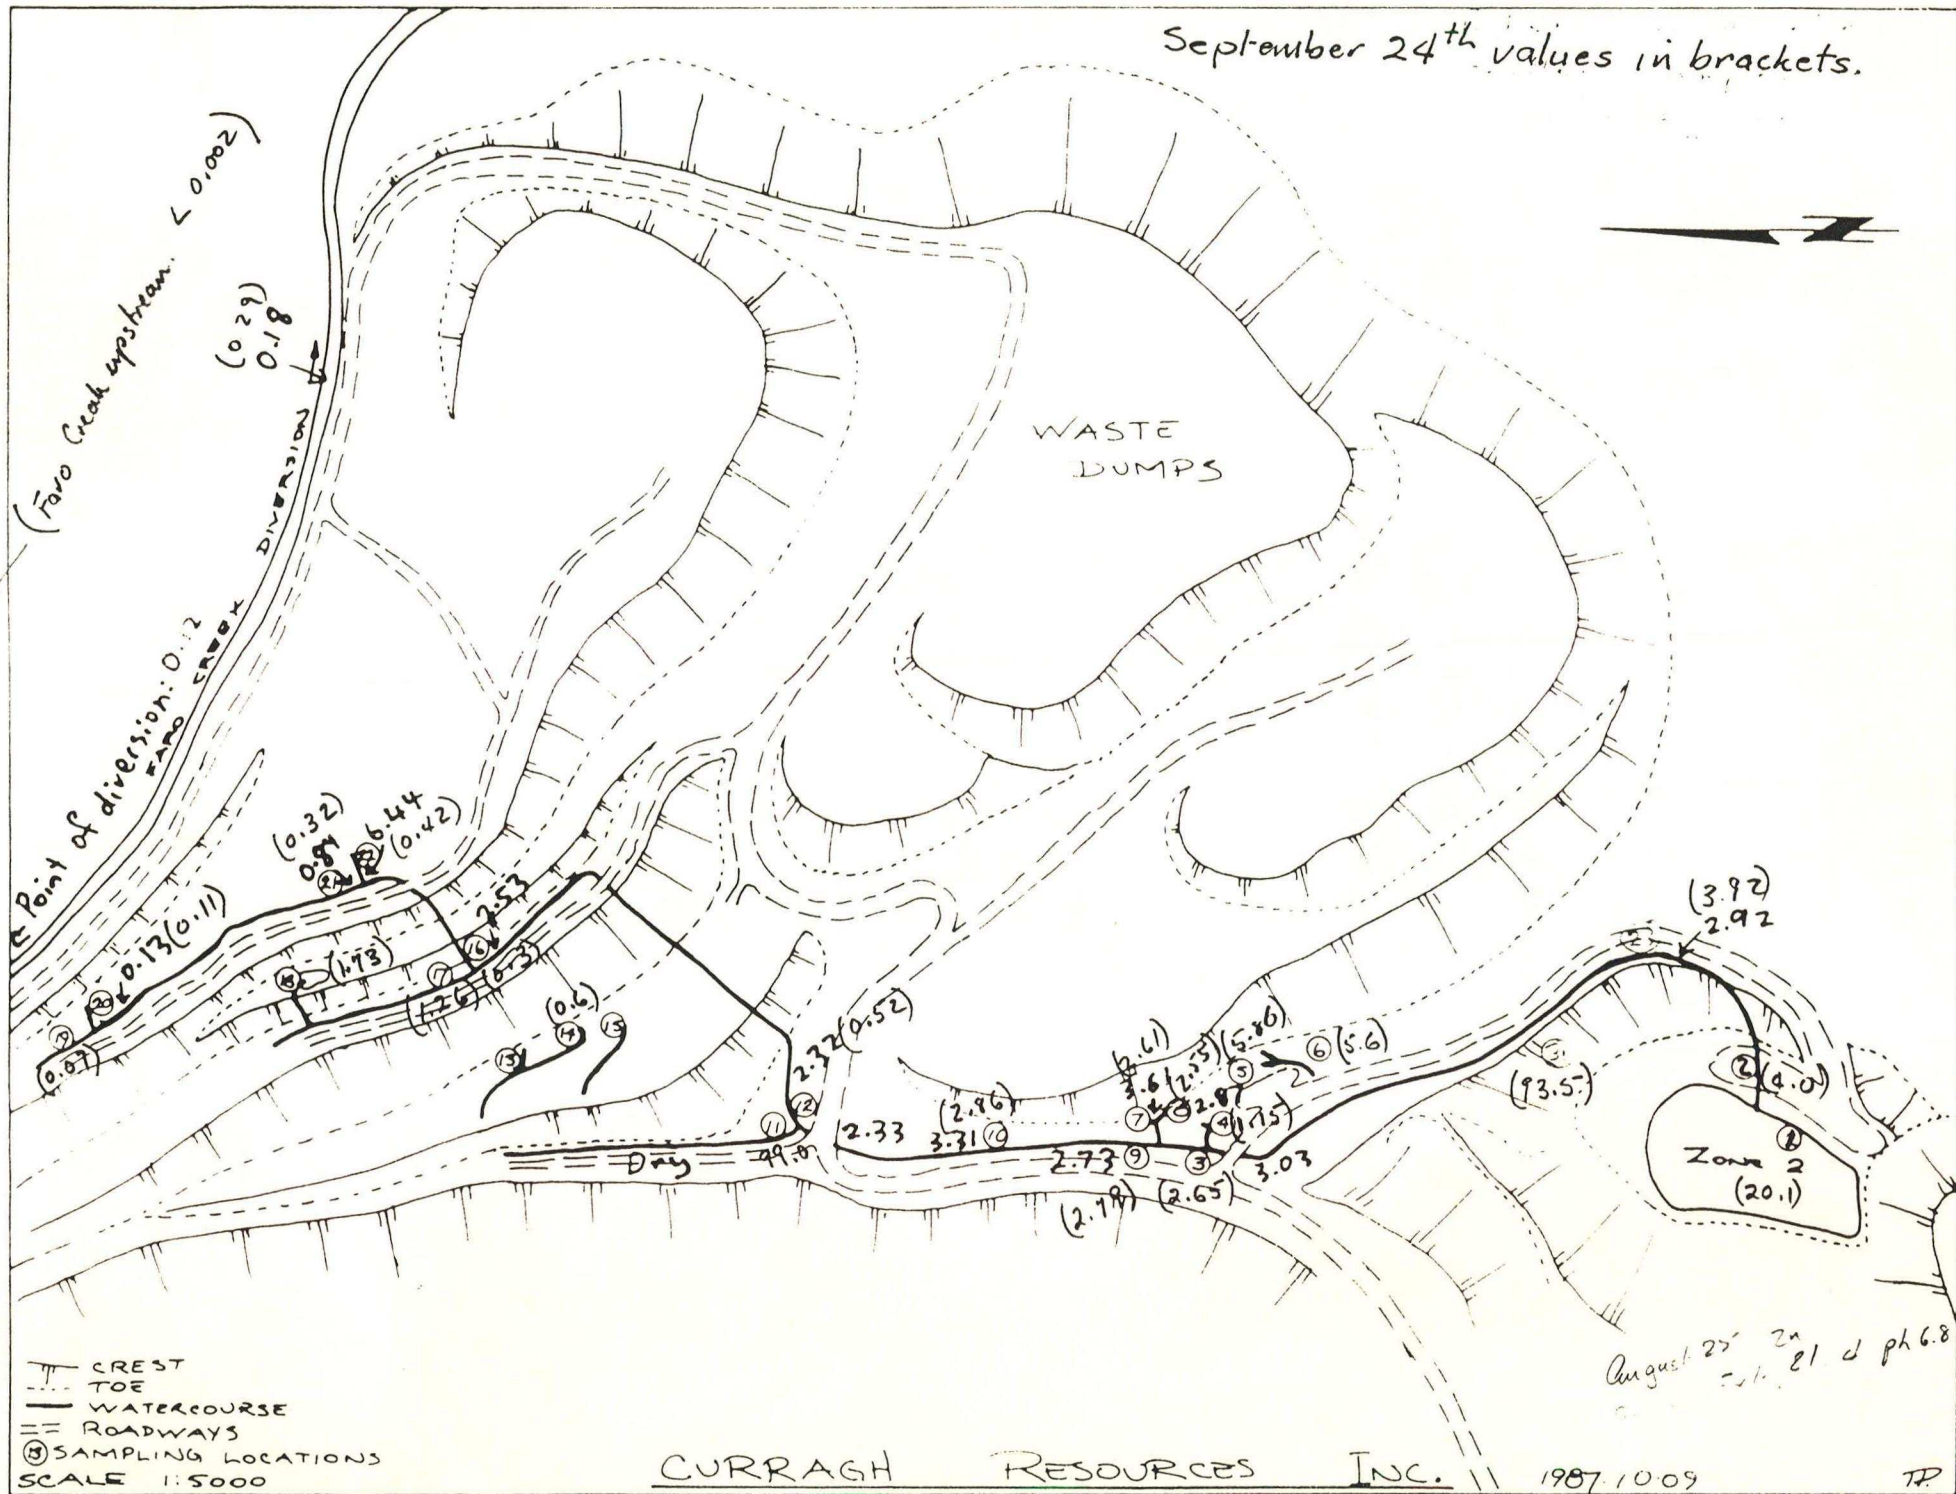
FIGURE 2

September 24th values in brackets.

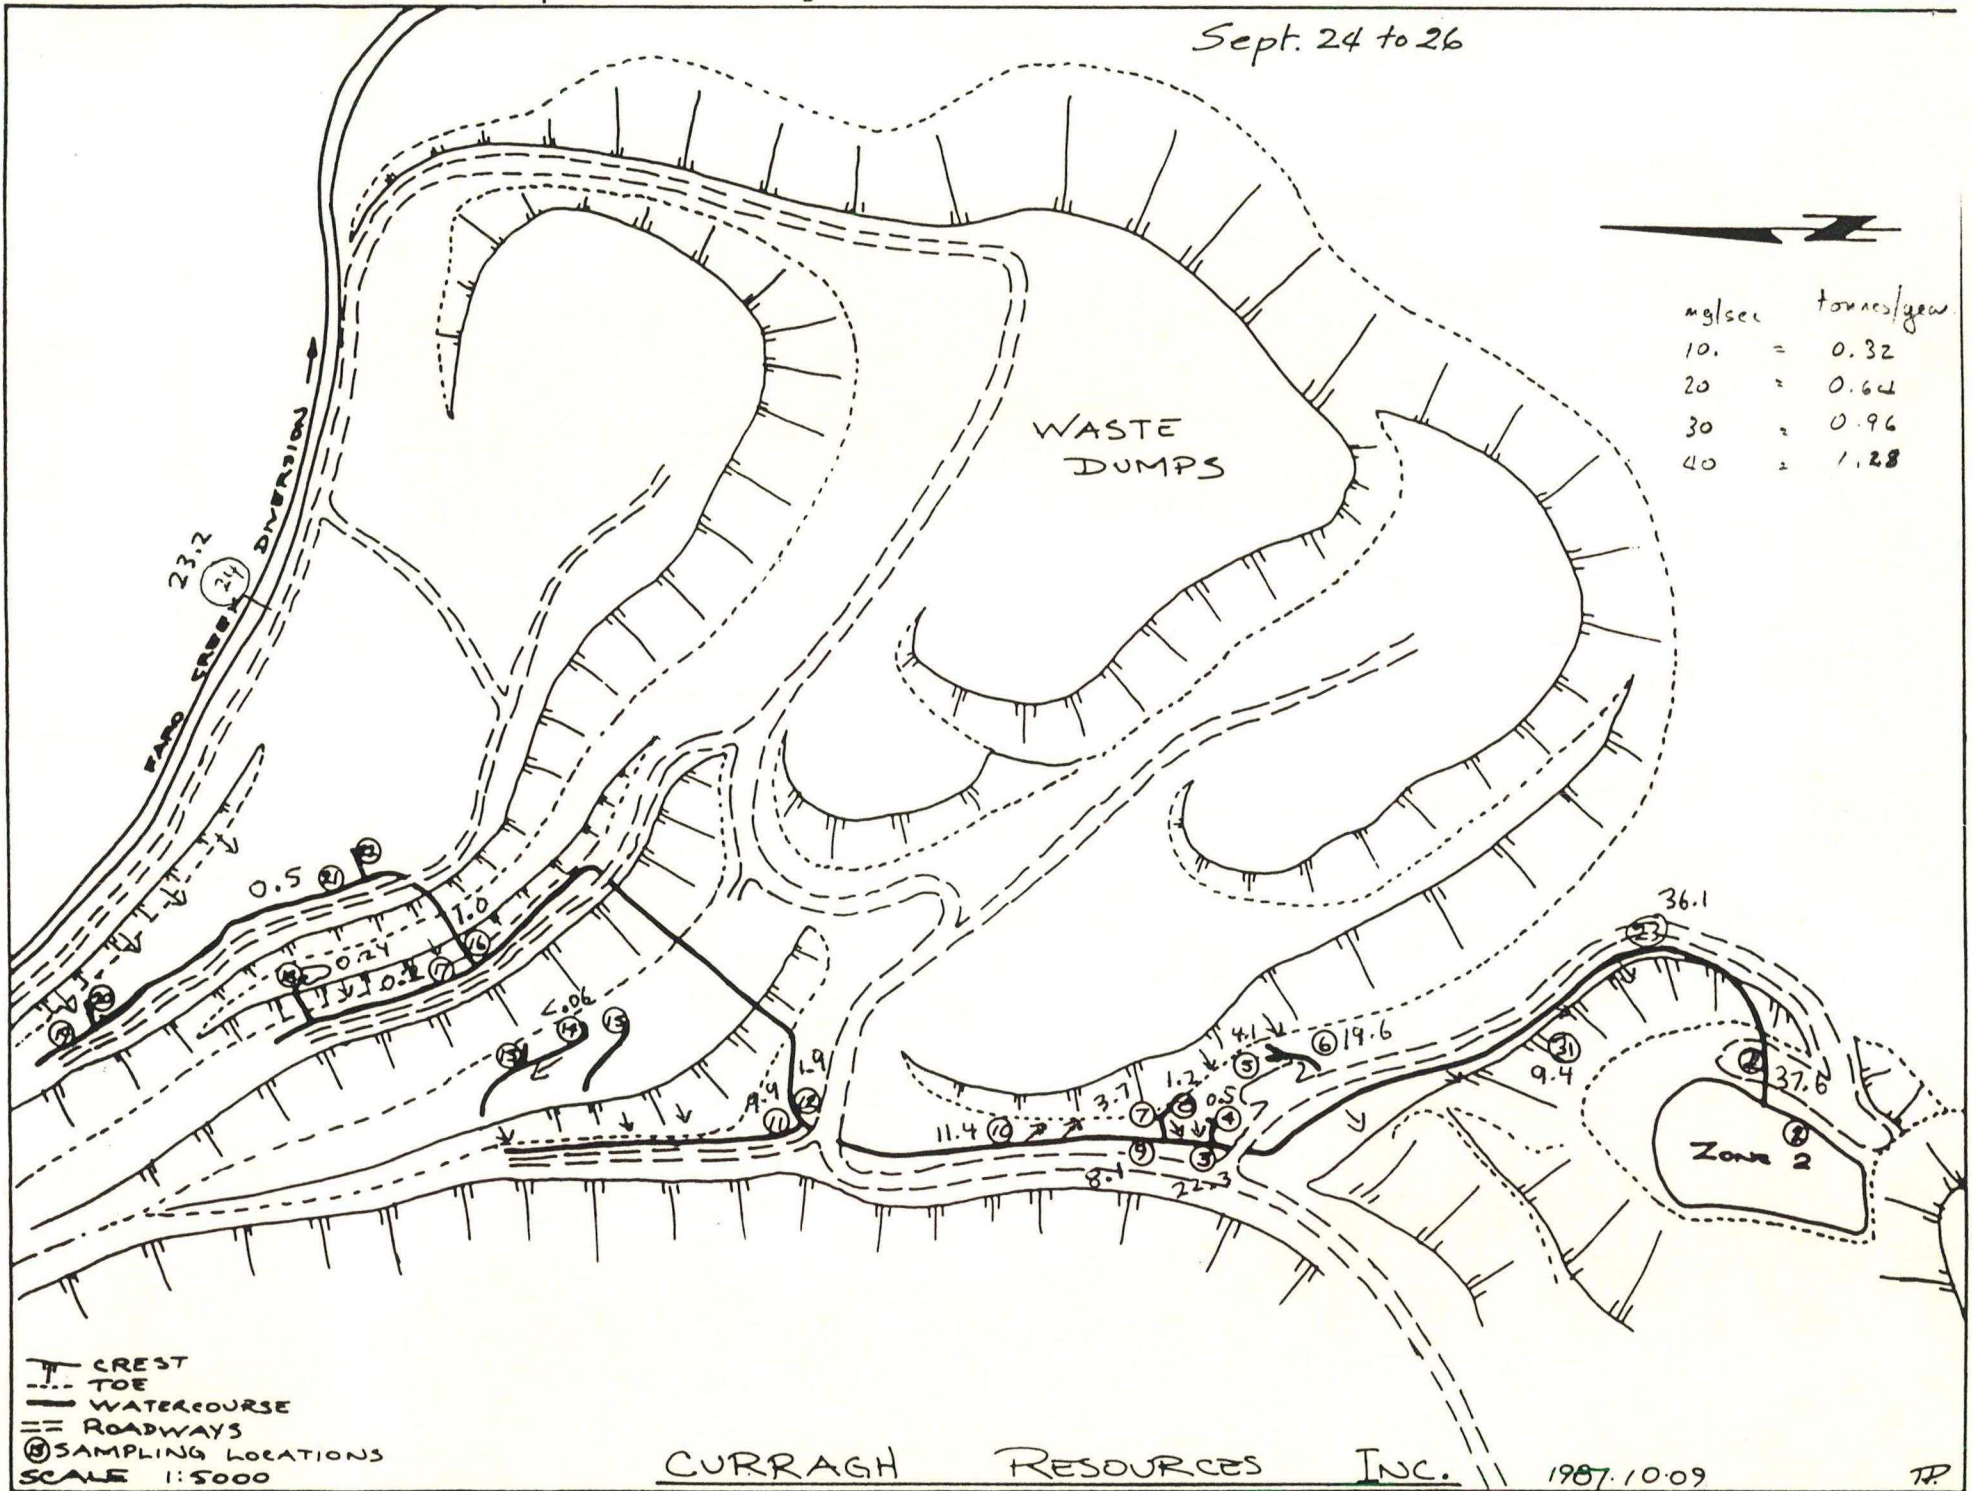
FIGURE 3

Seep Zinc loadings mg/s → direction of observed flows.

Sept. 24 to 26

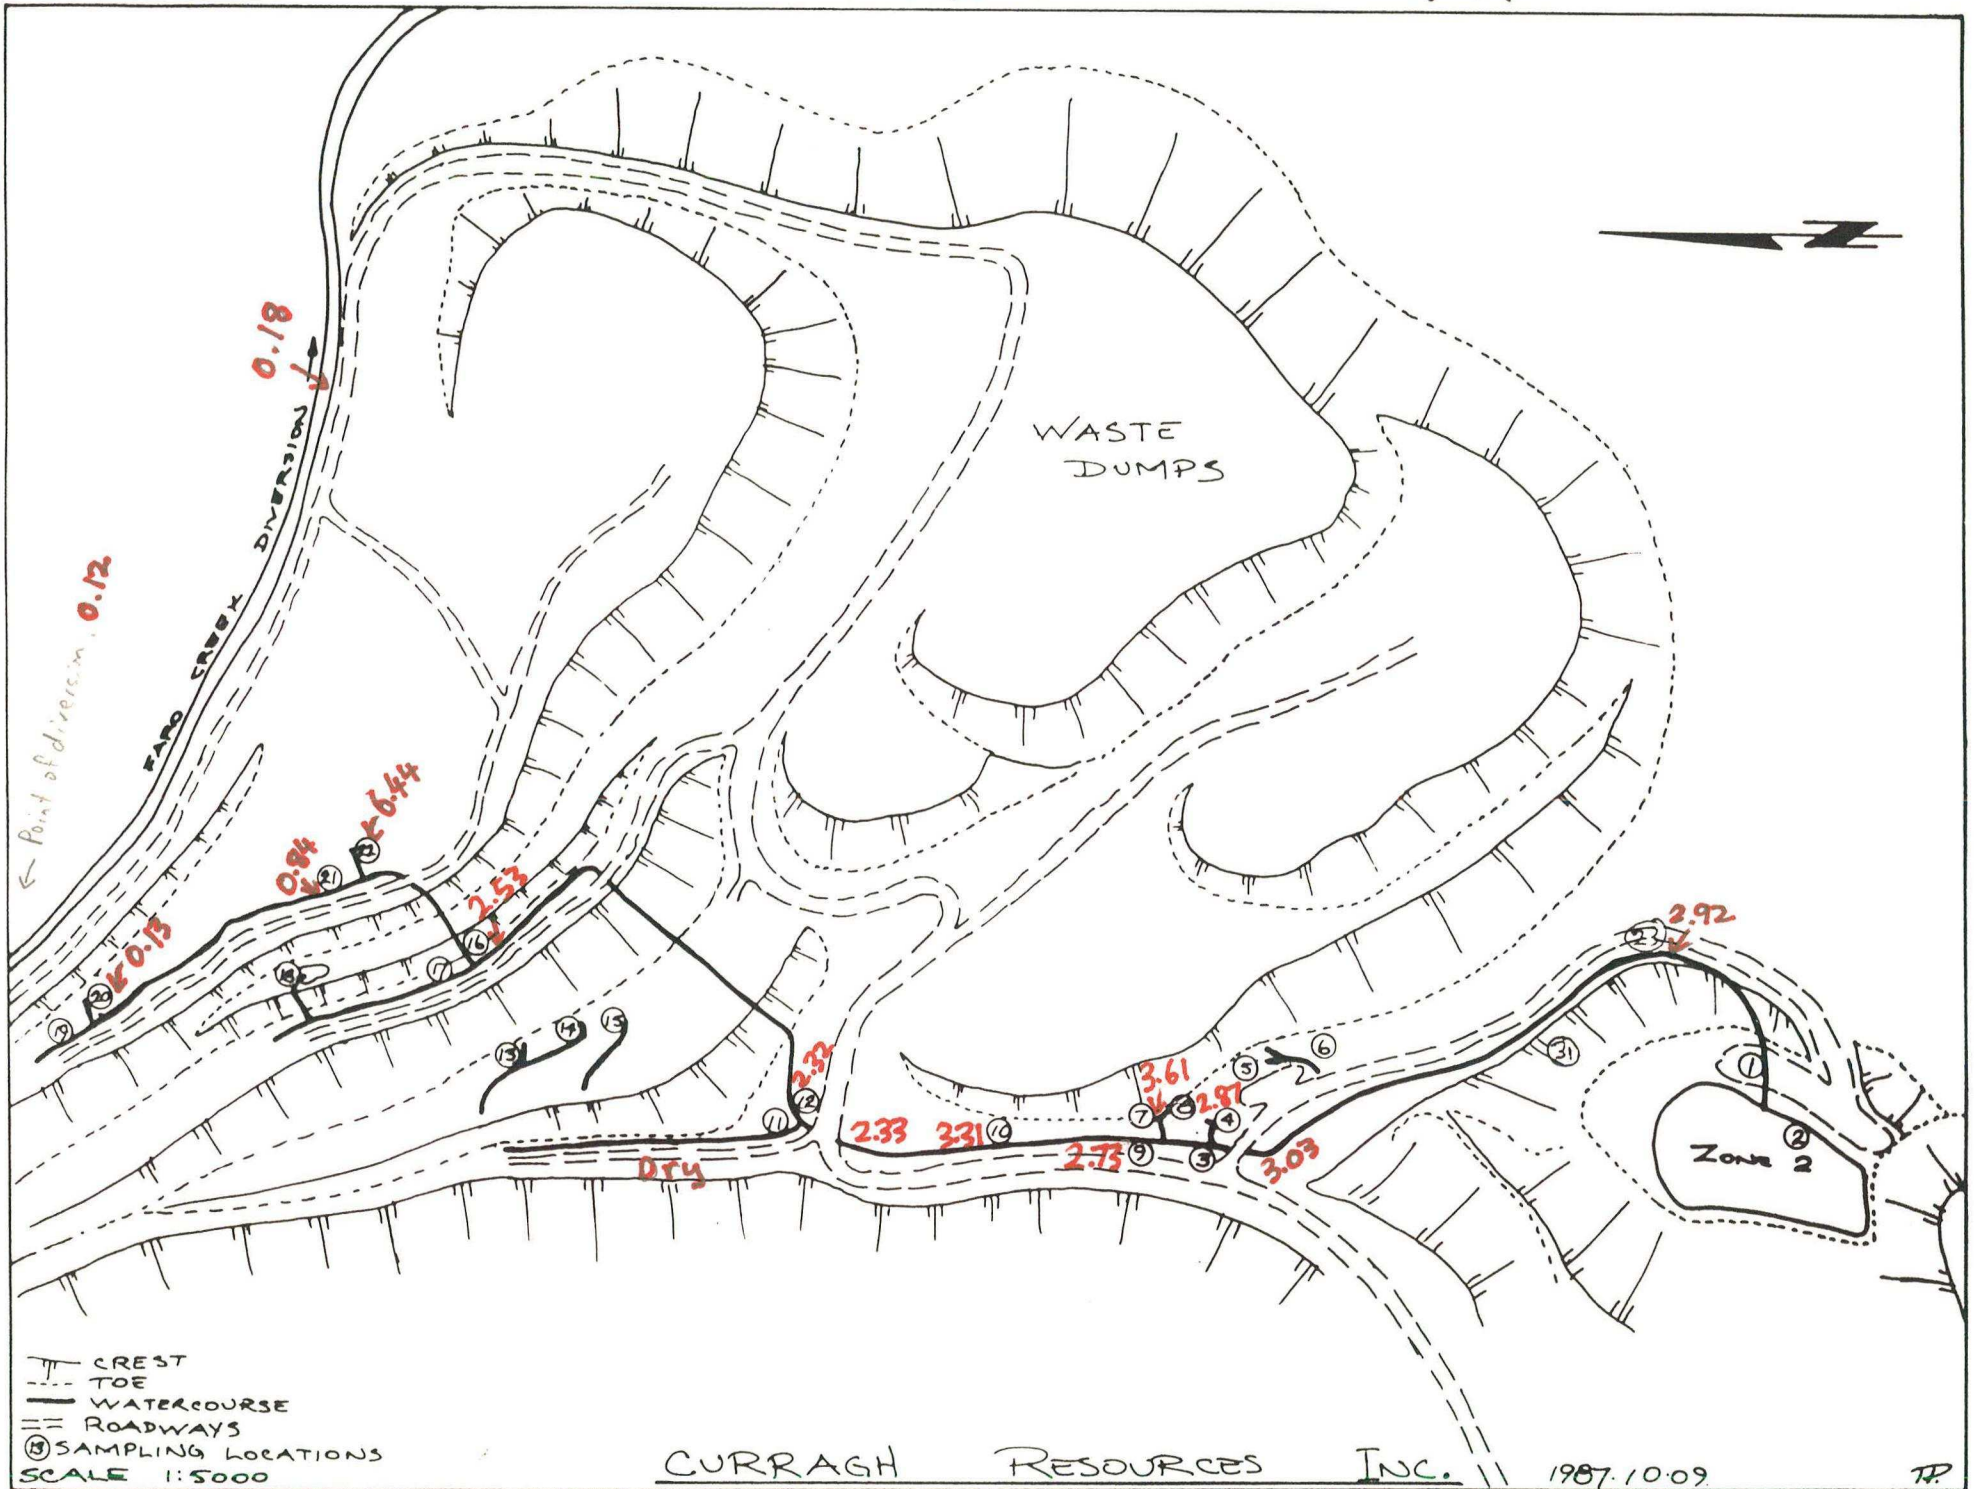
Zinc levels (extractable) June 18/87
