Geologic Hazard Rankings Village of Mayo, Yukon (1:20 000 scale)

This map accompanies the report "Mayo Landscape Hazards: Geological Mapping for Climate Change Adaptation Planning" released in 2011 by the Northern Climate Exchange, Yukon Research Centre, Yukon College. For copies of the report or additional information, please visit yukoncollege.yk.ca/research.

GEOLOGIC HAZARD RANKINGS
VILLAGE OF MAYO, YUKON
parts of NTS 105M/12

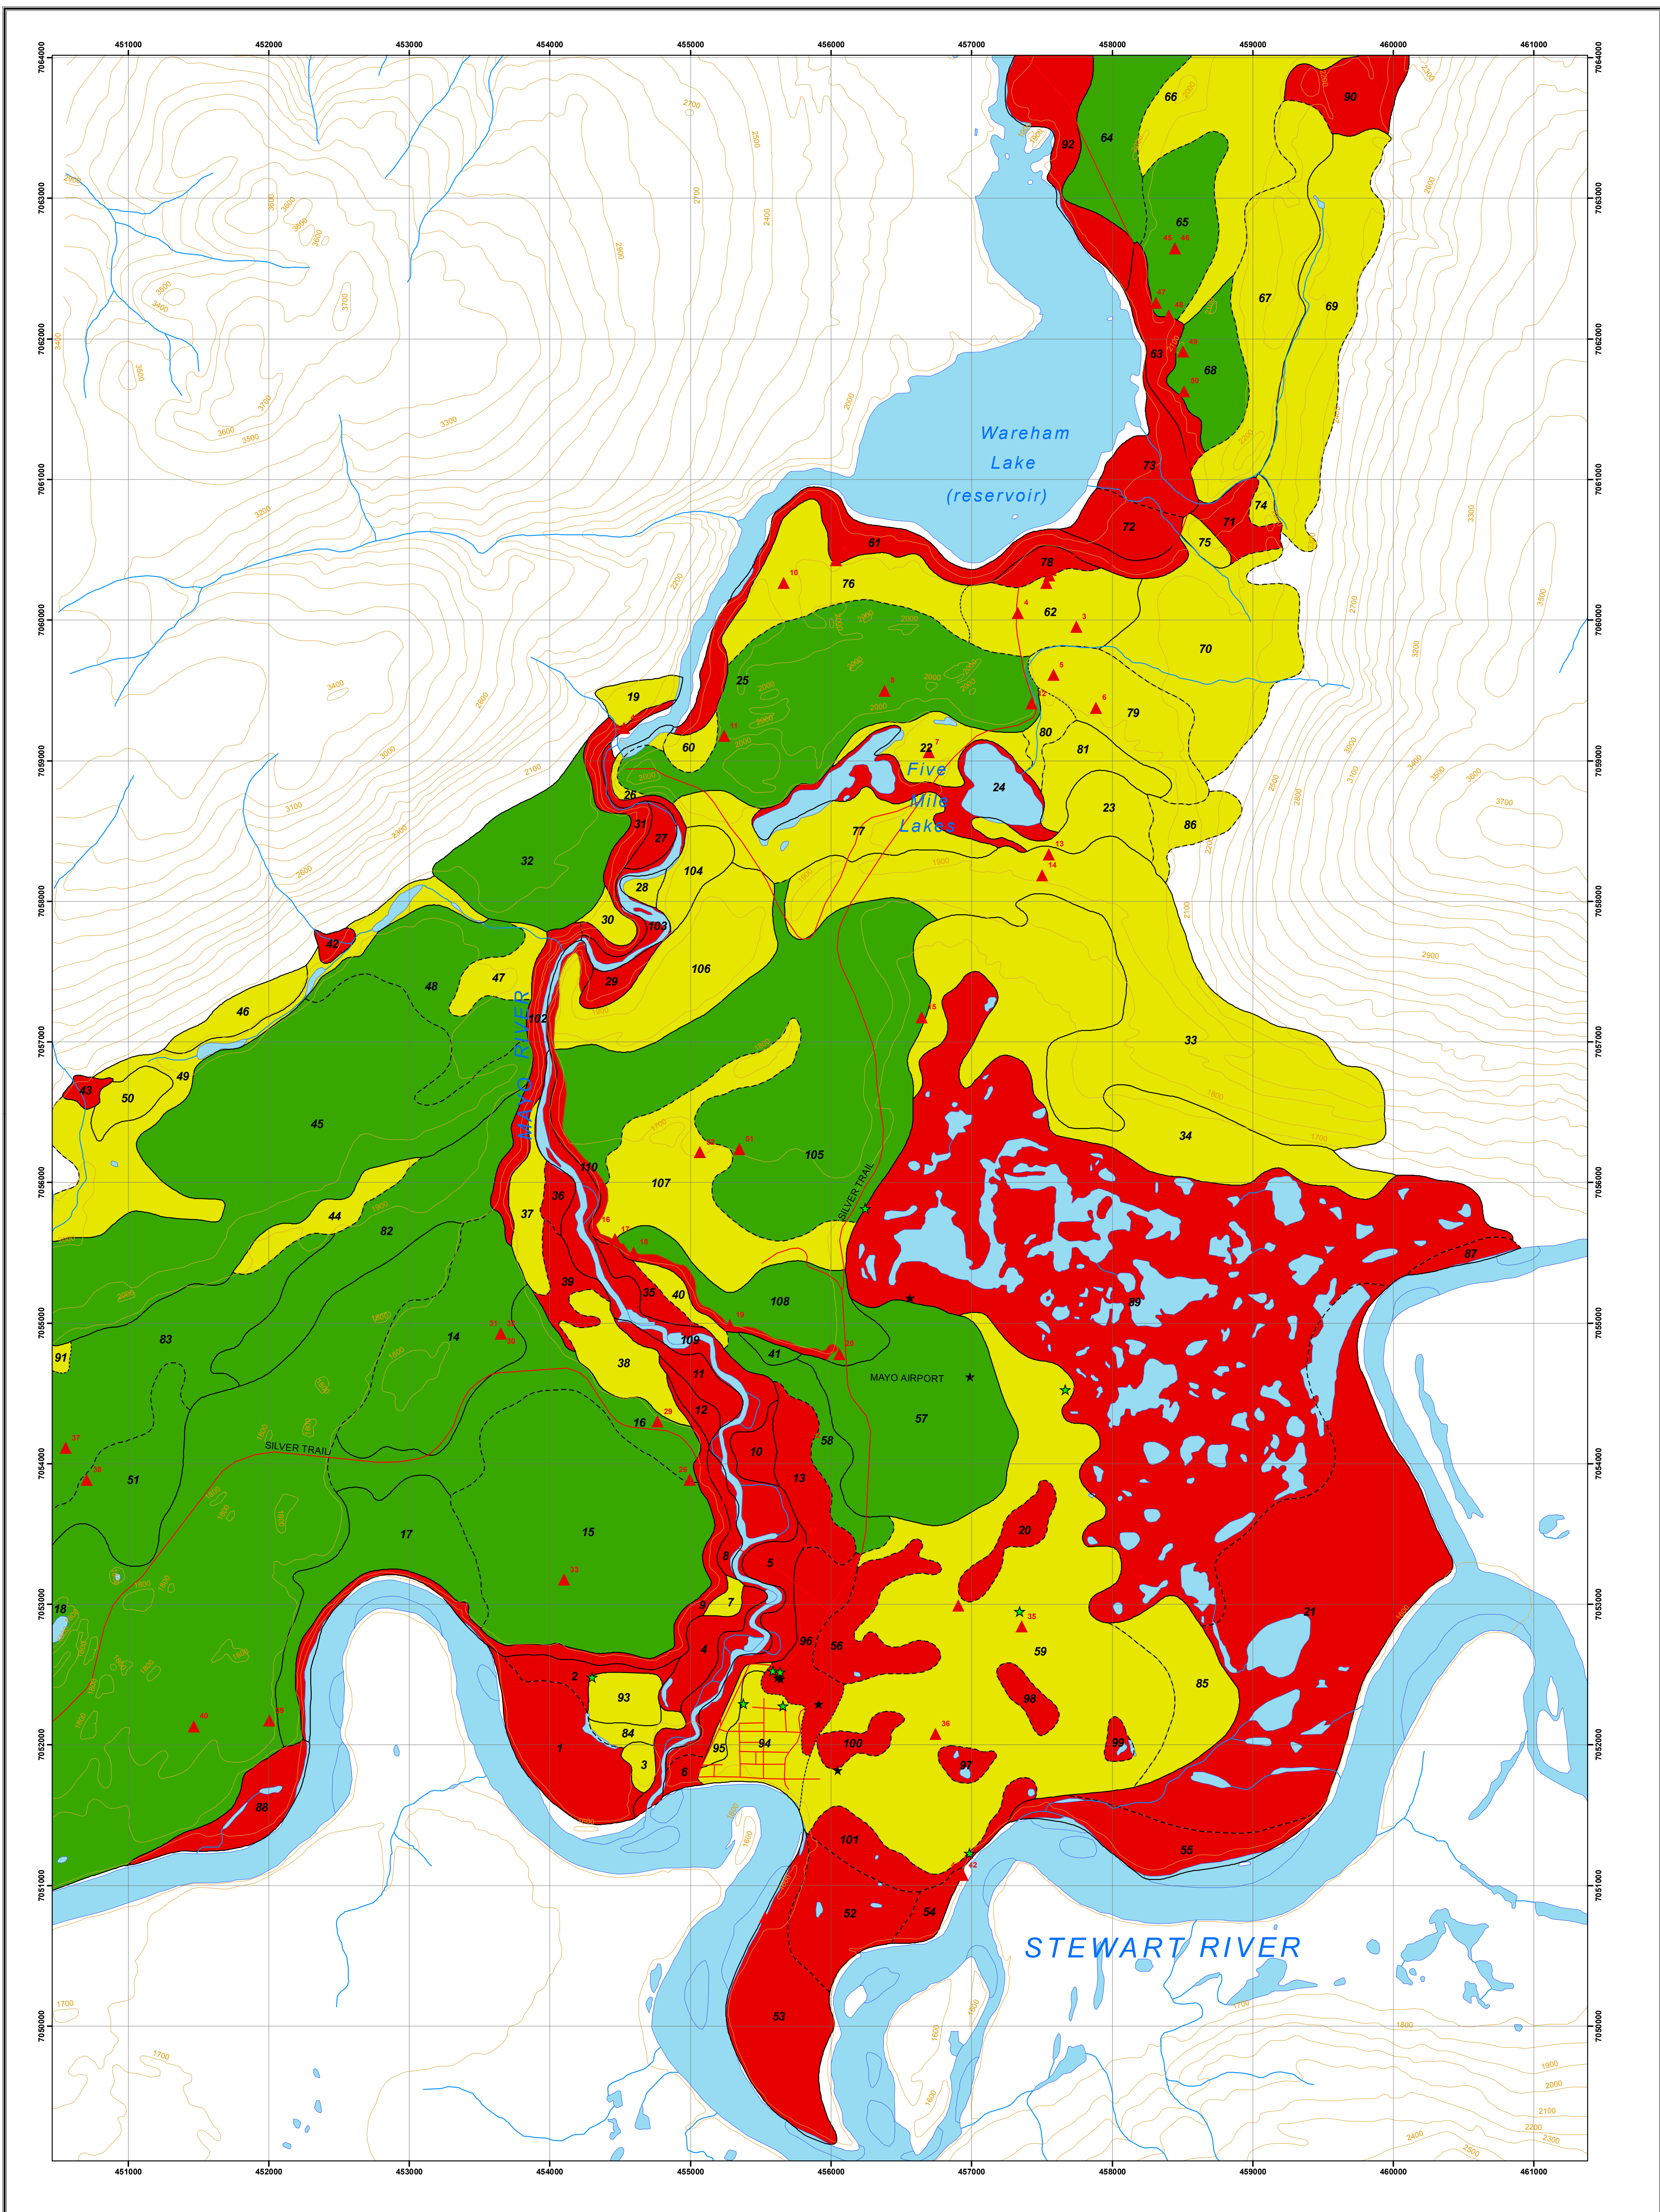
The potential environmental changes identified in the preceding sections of this report can be used to identify current and future landscape hazards in the Mayo region. The combined properties of surficial material type, landform shape, slope, aspect, hydrological regime, climate regime, and permafrost conditions have been used to arrive at a set of hazard "rankings" that can be used to assess the potential stability of landscape units around the Village of Mayo.

Based on processes acting on distinct geological units, a hazard ranking of low, medium, or high has been assigned to each geological unit in the hazard map area. Rankings are qualitatively assigned to reflect the following conditions:

- **Low: Stable landform.** Unlikely to be affected by mass movement, thermokarst, subsidence, bank erosion, flooding or instability. These landforms typically consist of gravel or sand, are well drained and have shallow to moderate slopes. Low hazard landforms may contain little to no permafrost and are above the floodplain of the Stewart or Mayo rivers. Landforms with low rankings are unlikely to become unstable under predicted changes in climate.

- **Medium: Moderately stable landform.** Unlikely to be affected by mass movement, thermokarst, subsidence, bank erosion, flooding or instability. These landforms typically consist of gravel, sand, glacial diamicton or colluvial materials. They are well to moderately drained and have shallow to steep slopes. Medium hazard landforms may have moderate amounts of permafrost and may occur within an area of shallow groundwater. Landforms containing permafrost may be susceptible to ground subsidence which could be accelerated by thermal erosion in areas of shallow groundwater. Permafrost thaw may also cause slope instability in some landforms. Medium hazard landforms are likely to become either more or less stable under predicted changes in climate.

- **High: Unstable landform.** Likely to be affected by mass movement, thermokarst, subsidence, bank erosion, flooding or instability. These landforms typically consist of glacial diamicton, colluvium, glaciolacustrine, lacustrine and fluvial deposits. They are generally moderately to poorly drained and have shallow to steep slopes. High hazard landforms may have a significant thickness of permafrost containing high ice contents, be prone to gravity-induced erosion, and occur within the floodplain of the Stewart or Mayo rivers. High hazard landforms are likely to become either more or less stable under predicted changes in climate.

It is important to note that hazard rankings are based on general observations of surface materials, drainage, slope angle, vegetation and the presence of permafrost landforms; limited subsurface information was provided by Direct Current resistivity profiling, shallow drilling and probing of permafrost, and textural analyses. This has resulted in a projected risk ranking that will require geotechnical and/or engineering analyses to quantify.

In classifying polygons, we have taken a precautionary approach and applied a category of higher risk where we are not confident in lower categories. However, every polygon will contain zones of lower and higher risk than the overall polygon classification. It is for this reason that this map should serve only as an initial guide for planning purposes. Any development will still require detailed site investigations.
