# Dawson City Landscape Hazards

Geoscience Mapping for Climate  
Change Adaptation Planning

**Northern Climate ExChange**  
YUKON RESEARCH CENTRE • Yukon College

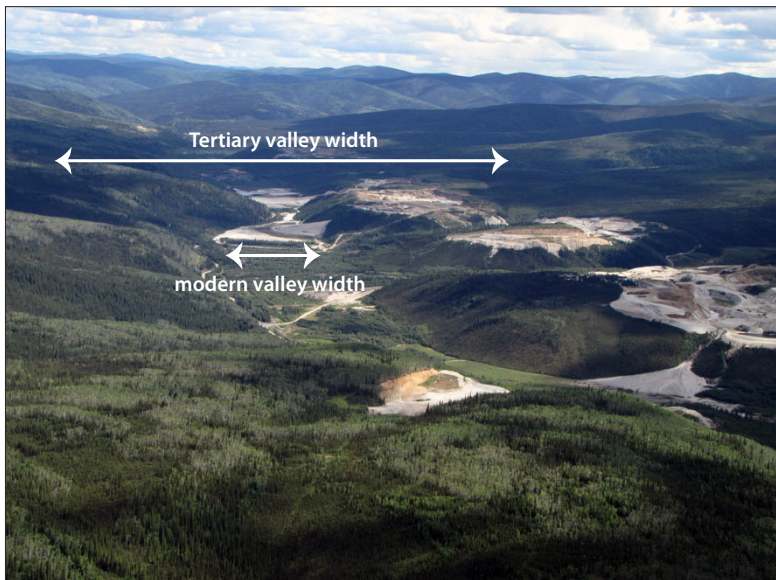
**Figure 19.** Photo looking south toward the headwaters of Hunker Creek showing the broad valley floor of the Tertiary fluvial system (benches currently being mined) and the narrow, inset valley of the modern Hunker Creek drainage. White Channel gravel is a distinctive deposit that makes up benches up to 100 m above modern stream levels.

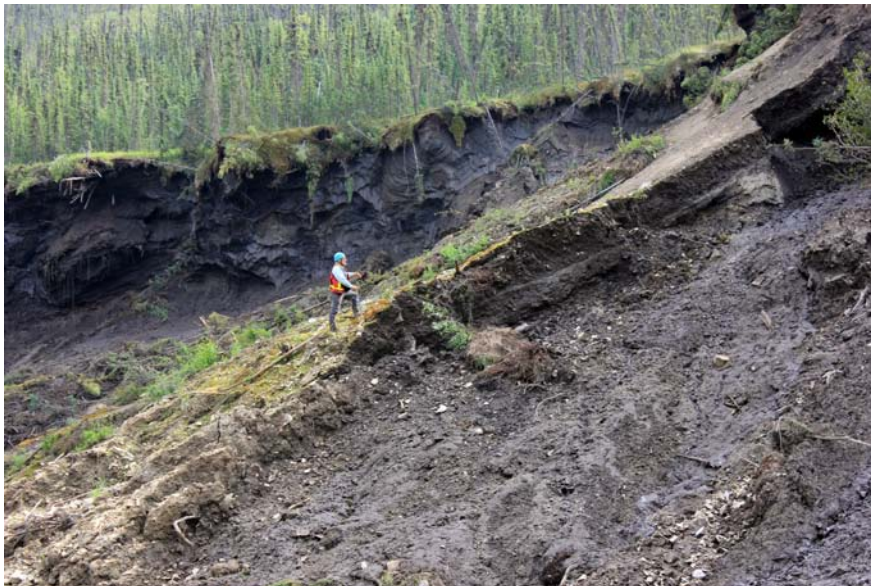
**Figure 21.** Ice-rich ‘muck’ deposits on a north-facing slope in the Hunker Creek valley.

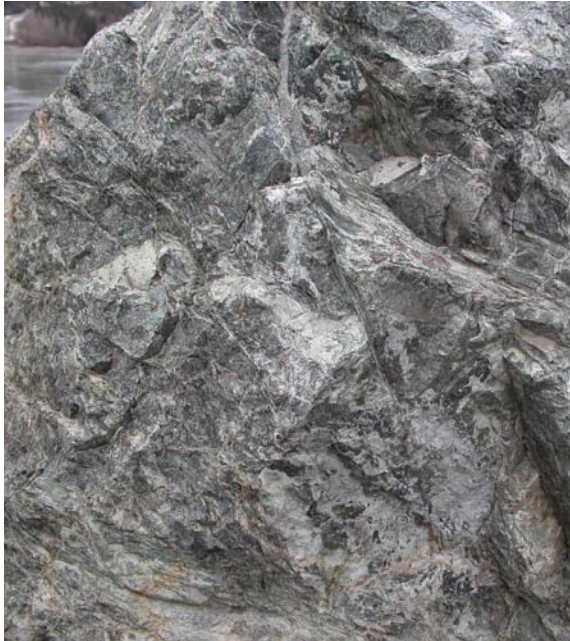
**Figure 22.** Example of Klondike Schist found in the map area.

Bedrock in the map area consists of a widespread suite of schists (commonly referred to as the 'Klondike Schist'; Figure 22); lesser amounts of carbonaceous quartzite (the 'Nasina Formation');

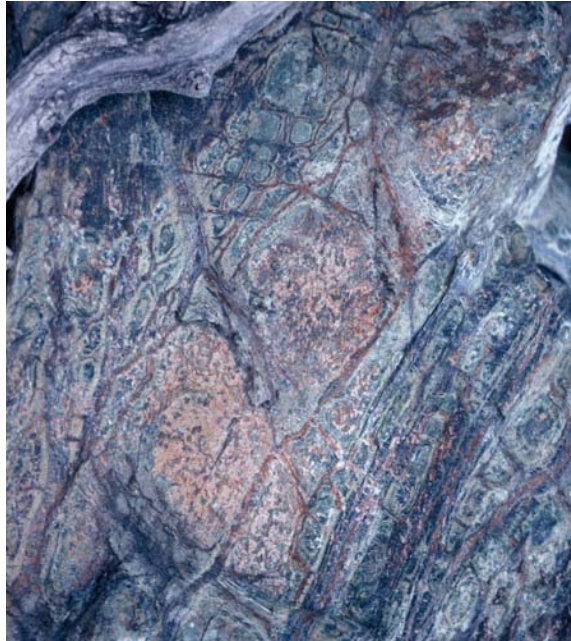
**Figure 23.** Example of serpentinite associated with Slide Mountain terrane rocks in the map area. This example is from the materials comprising the Dawson City landslide (Moosehide Slide).

and uncommon greenstone, serpentinite and harzburgite from the Carboniferous Dawson-Clinton Creek Assemblage (Figure 23). Bedrock (R) is mapped on steep cliffs and slopes along the Klondike and the Yukon river valleys and are exposed by large landslides or glacial or glaciofluvial erosion.

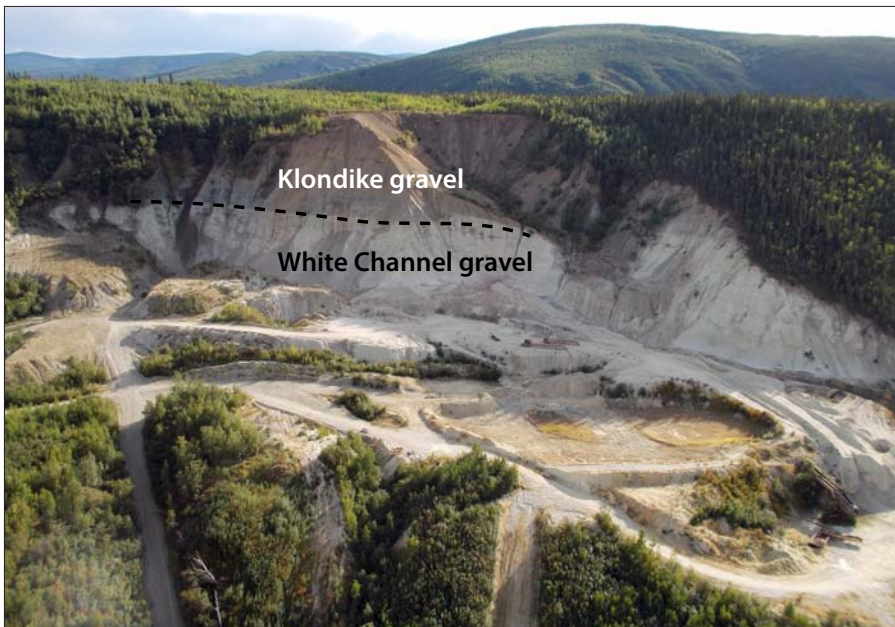
**Figure 25.** Klondike gravel overlies Tertiary, White Channel gravel at Jackson Hill near the mouth of Bonanza Creek.

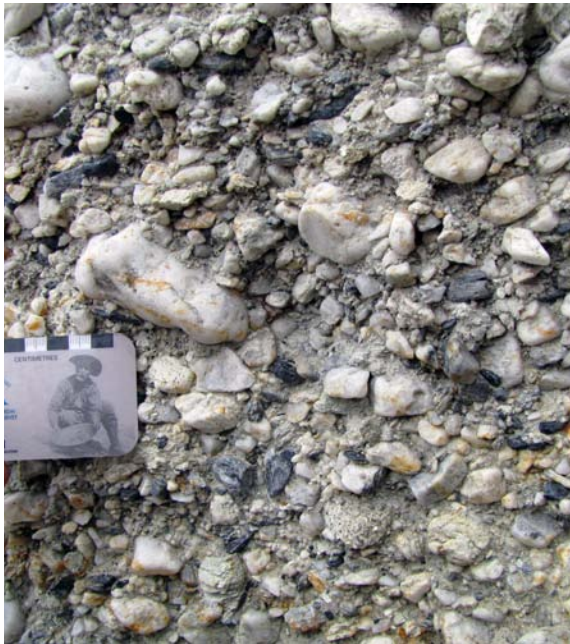
**Figure 27.** Quartz-rich, pebble-cobble gravel of the Tertiary ‘White Channel gravel’ exposed at Australia Hill.

Tertiary fluvial deposits ( $F^T$ ) are characterized by the White Channel gravel which occurs as a light grey to white, quartz-rich pebble-cobble gravel with minor, discontinuous sand and mud interbeds (Figure 27; see also Figure 25). The unit is deposited in thicknesses up to 35 m on irregularly distributed benches bordering the modern valleys, 50 to 100 m above the modern floodplain (Morison and Hein, 1987). The unit has an unconformable lower contact with gently inclined bedrock benches, and both gradational and unconformable upper contacts with overlying glaciofluvial gravel (Froese et al., 2000). The White Channel gravel comprises a lower unit displaying more intense hydrothermal leaching and alteration (Tempelman-Kluit, 1982; Dufresne

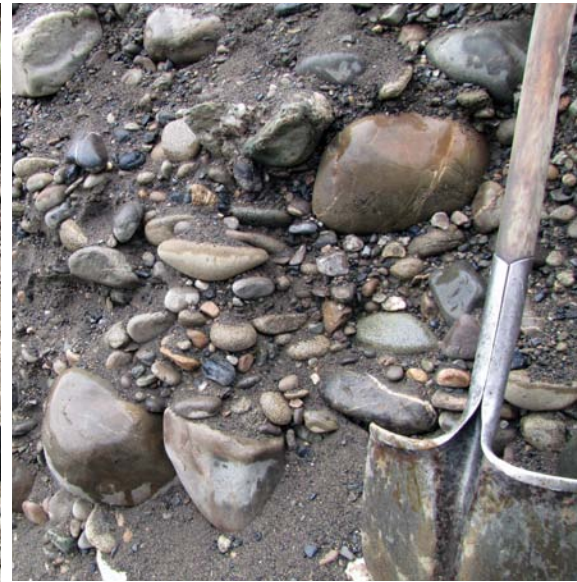
**Figure 30.** Rounded clasts in a sandy matrix is a common texture for coarse, main channel deposits of the modern, active floodplain of the Klondike River.

Active Holocene fluvial deposits ( $F^A$ ) comprise sand and gravel stream materials that are subject to regular flooding. These deposits include both coarse, channel gravel and fine overbank flood deposits (Figure 29). Main channel gravel deposits are moderately to well sorted, and contain rounded clasts in a sandy matrix (Figure 30). Overbank deposits are represented by fine-grained

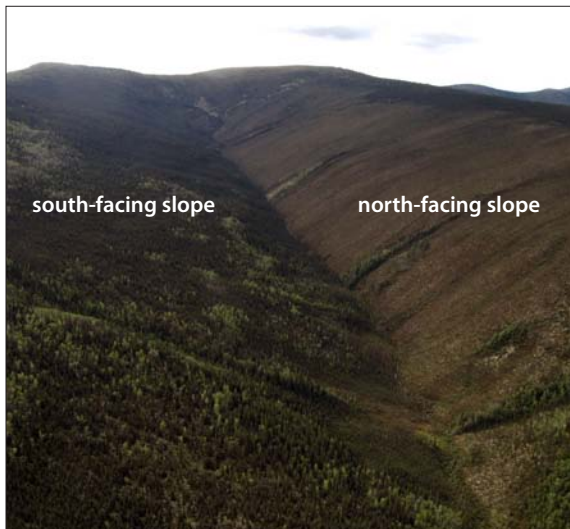
**Figure 34.** Preferential accumulation of organic material on a north-facing slope near the study area.

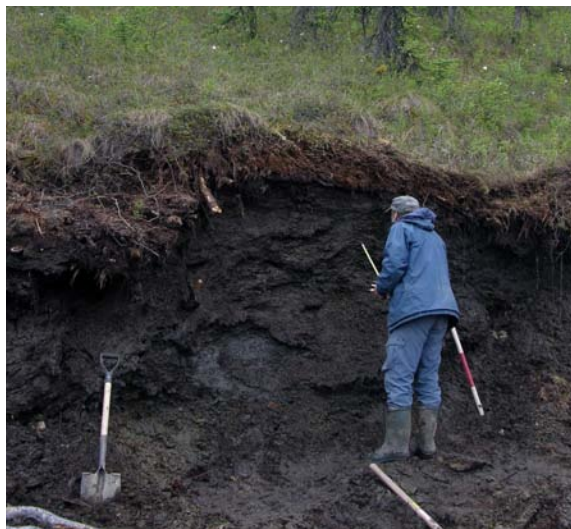
**Figure 35.** Organic blanket (>1 m thick) on a north-facing slope near the map area.

Accumulations of vegetative matter thicker than one metre are mapped as organic blankets and are found on floodplains in old meander scars, pockets on cool north-facing slopes (Figure 35), and on some cool, poorly drained, glaciofluvial terraces. Veneers of organic material (20 cm to 100 cm thick) are widespread in the map area and present on most gently sloped morainal, colluvial, eolian, and fluvial deposits. Organic veneers are not mapped on all surficial units, but are almost always present on poorly drained sites, and cold, north and east-facing slope aspects.

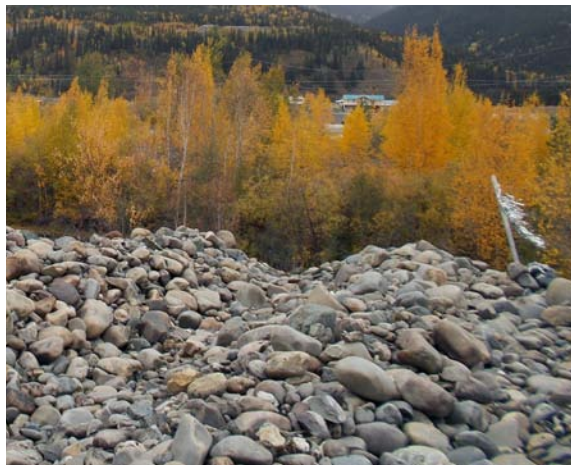
**Figure 37.** Coarse-grained gravel containing cobbles and pebbles compose dredge tailings, making them unusually porous and subject to high rates of groundwater movement.

Most fine sand, silt and clay found in mined fluvial gravel in the Klondike Valley was removed by dredging and the remaining tailings of coarse cobble gravel is unusually porous (Figure 37). Pondered water surrounds the tailings piles, and gravel deposits in the area appear saturated. Much of this water likely represents groundwater flow (Gartner Lee, 2003). In lower reaches of the Klondike River floodplain, dredging has led to a decline in isostatic pressure in response to increased ground permeability (Beasley, 2010), and flooding can occur from below – that is, high river levels produce a corresponding increase in the groundwater table (Inukshuk Planning and Development, 2000).

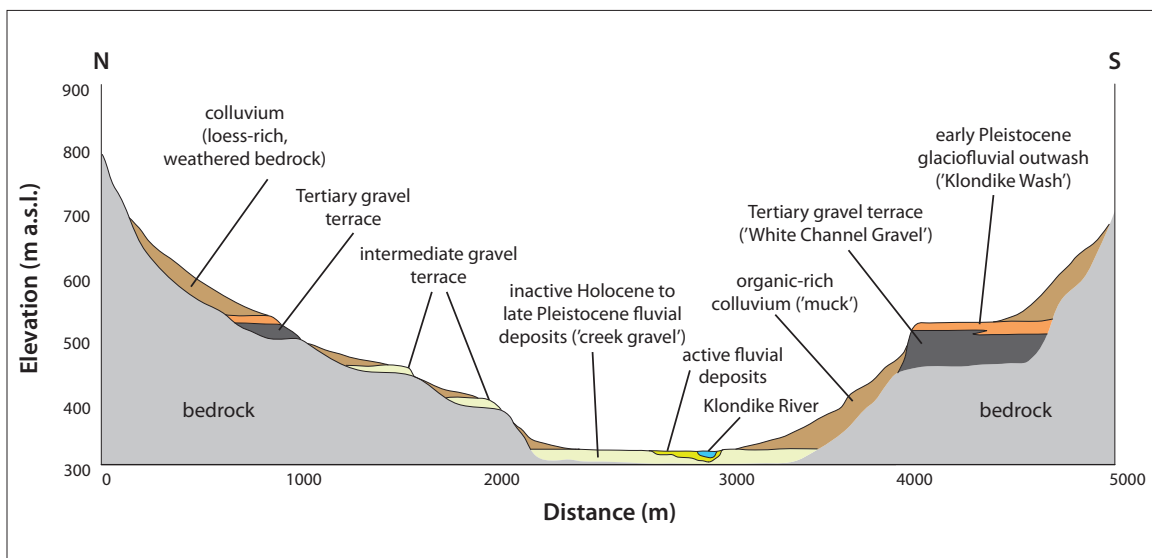
**Figure 38.** An idealized cross-valley profile for the lower Klondike River valley. View is looking up the Klondike River near its confluence with the Yukon River.

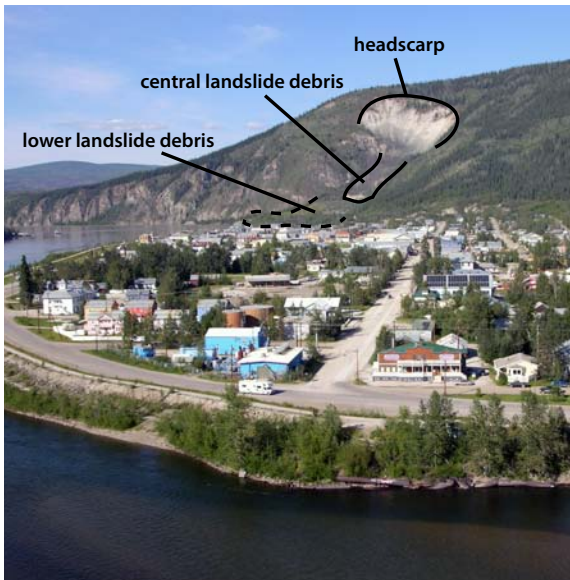
**Figure 41 (above).** The ‘Moosehide Slide’, or Dawson City Landslide, as seen from the Klondike River, showing the headscarp, central landslide debris, and lower landslide debris which has been modified by development.

Landslides generally occur on moderate to steep slopes due to a variety of contributing and triggering factors that include: intense rainfall or snowmelt events, permafrost degradation, forest fires, river erosion, groundwater flow, and/or earthquakes. In many cases, several of these contributing and triggering factors act in combination. Large landslides have been mapped along the lower Klondike River valley, lower Rock Creek valley, and in the townsite of Dawson. Of these, only the landslide in the townsite of Dawson has been studied in detail. The ‘Moosehide Slide’ (also known as the Dawson City landslide) occurs on the western slope of Midnight Dome, with a headscarp immediately above the town, and downslope landslide debris that underlies temporary infrastructure and recreational trails (Figure 41).

Other large, deep-seated rock failures in the map area include complex scarps on the south-facing slope of the Klondike Valley across from Lovett Hill and the municipal airport; a large north-facing failure on upper Bradley Creek in the northernmost part of the map area; east-facing failures on lower Rock Creek; and both east and west-facing landslides above Germaine Creek in the Klondike River valley (see Figure 41 and McKenna and Lipovsky, 2014; map included in back pocket).

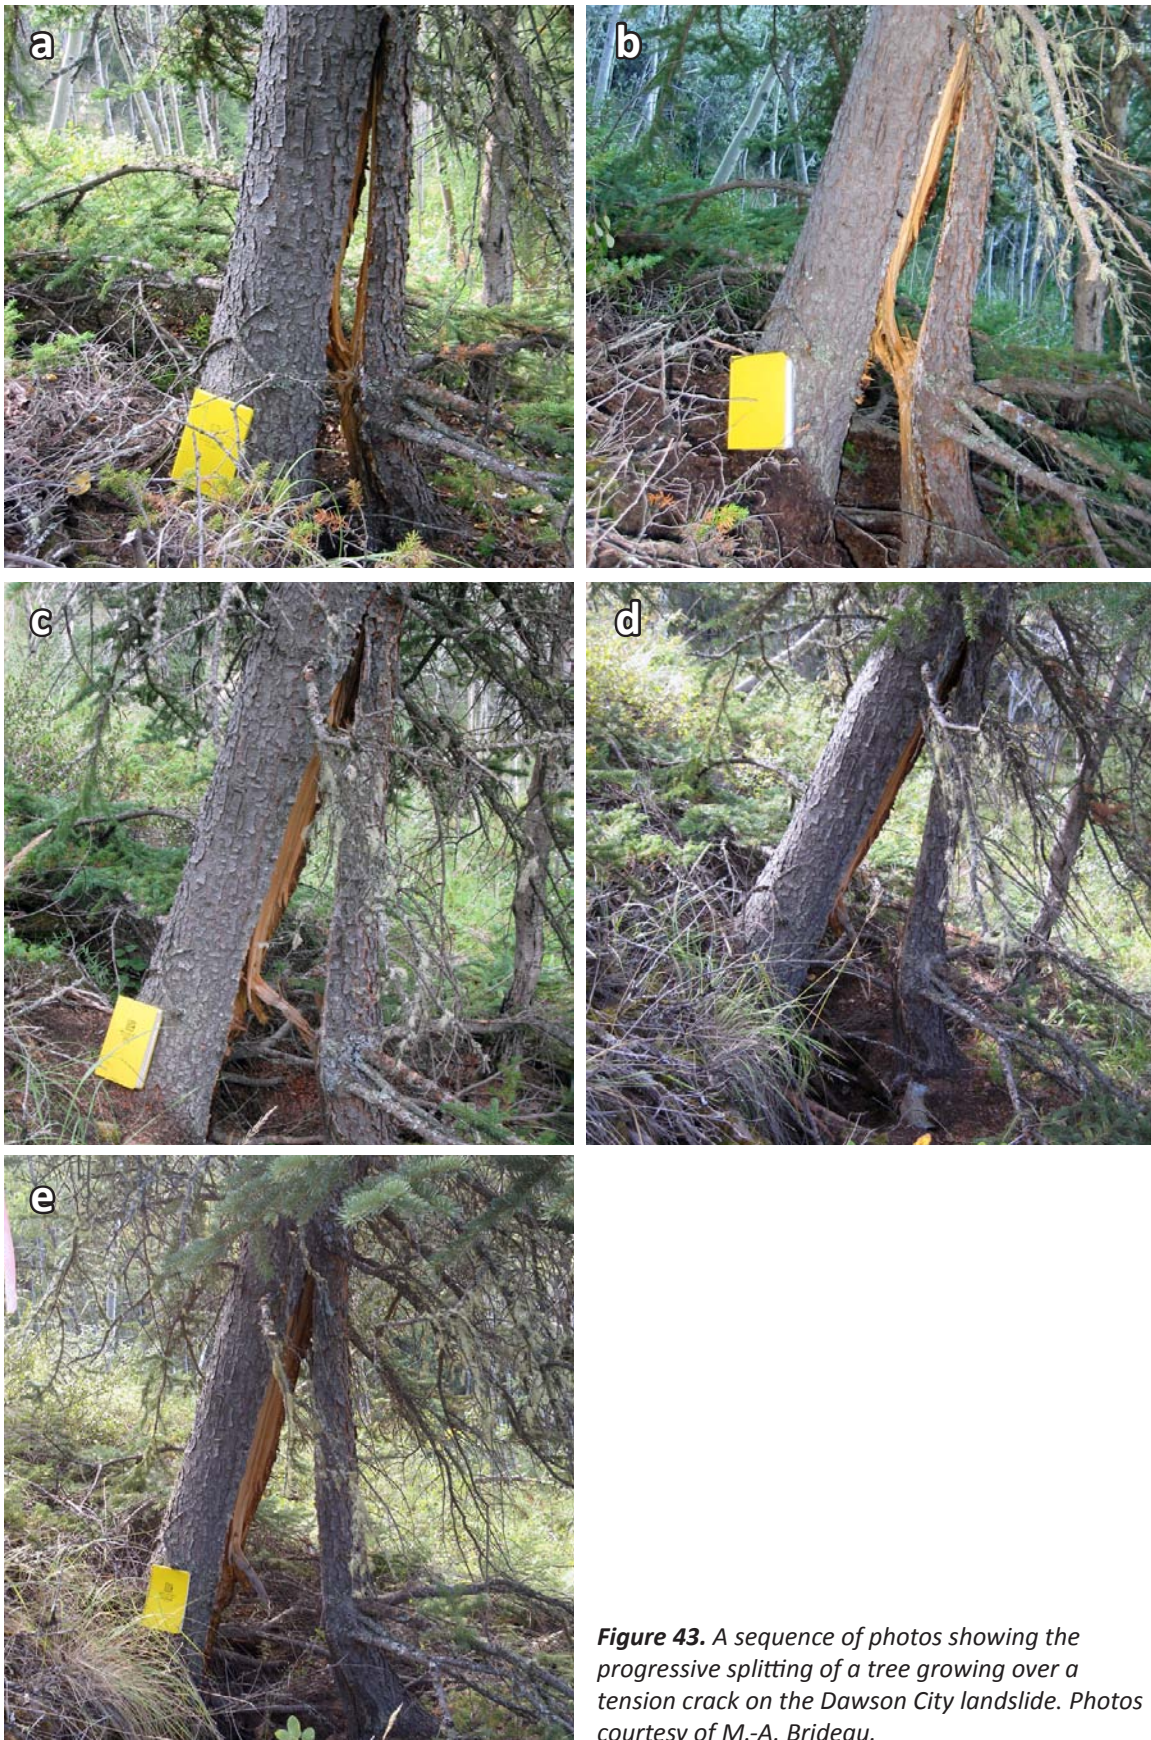
**Figure 43.** A sequence of photos showing the progressive splitting of a tree growing over a tension crack on the Dawson City landslide. Photos courtesy of M.-A. Brideau.

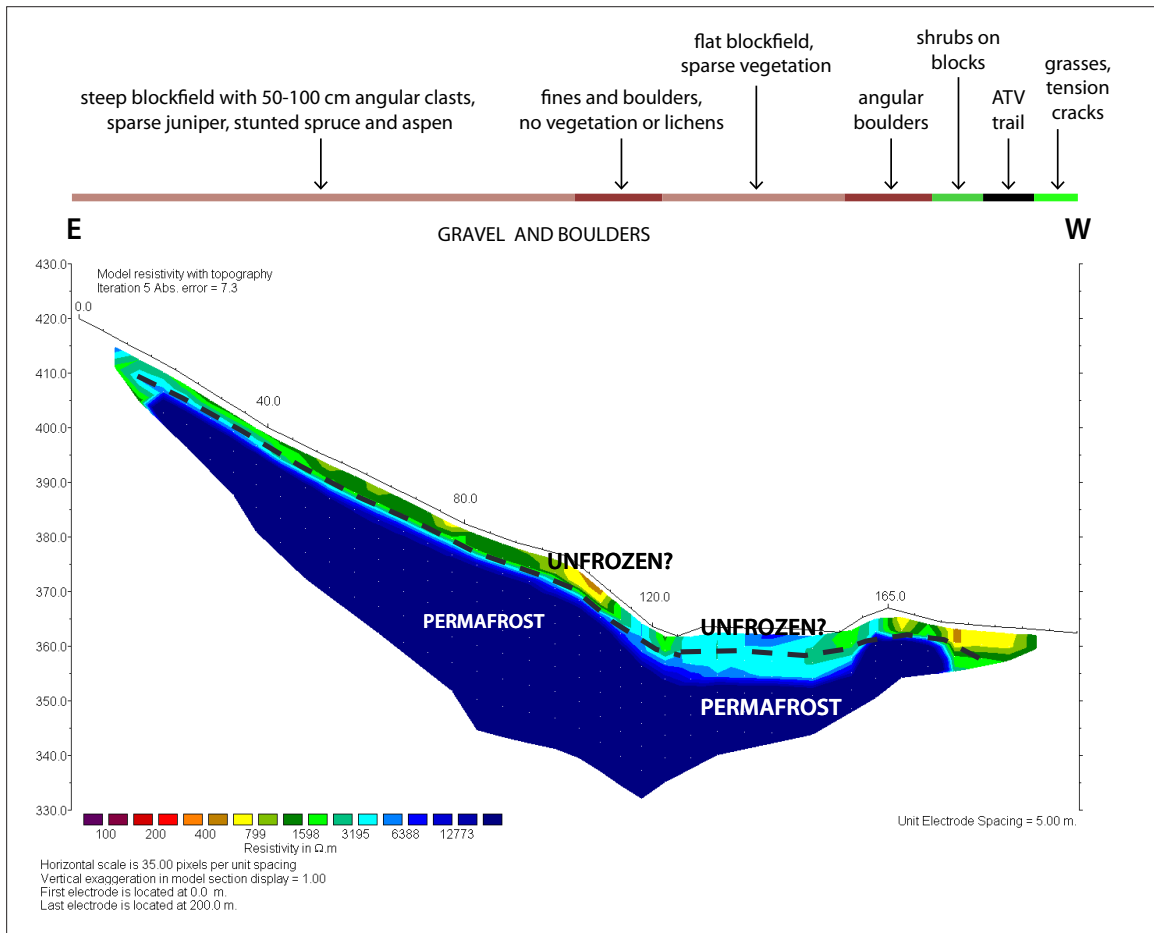
**Figure 44.** ERT profile for the Moosehide Slide (200 m long) was run down the lobate mass at the foot of the steep, unstable headwall of the slide. The profile has a maximum penetration depth of about 30 m. Likely areas of permafrost are outlined by black dashed lines.

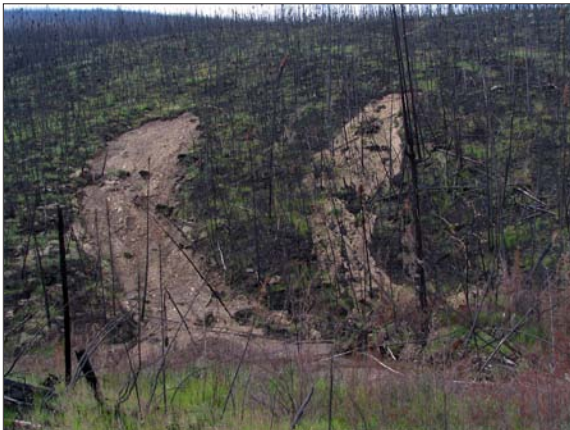
**Figure 46.** Two active layer detachment slides near the map area that were generated after intense forest fire activity in 2004.

Landslides too small to be mapped but pervasive enough to have modified surface materials include active-layer detachments or thaw flow slides (Figure 46), a type of fast periglacial mass

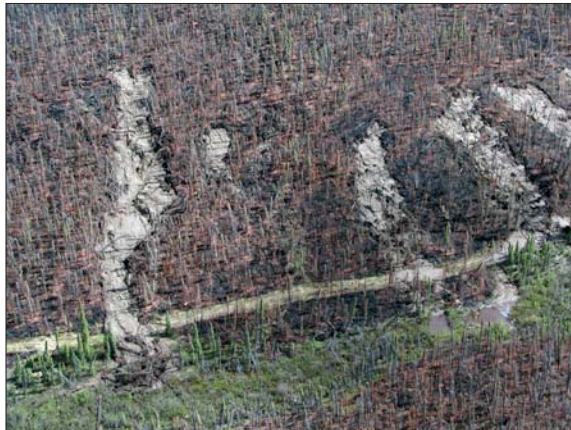
**Figure 47.** A series of active layer detachment slides generated after intense forest fire activity in 2004 blocked roads and access routes.

Active-layer detachments generated after the 2004 fire season were largely in remote locations where there exists little infrastructure or human habitation. Nonetheless, the slides blocked roads, trails, and access routes (Figure 47); impounded waterways; and contributed significant amounts of suspended sediment to nearby streams (impacting both fisheries and placer mining industries). Were landslides of similar size and magnitude to occur within the developed regions of the map area, they could pose a significant risk to both infrastructure and human life.

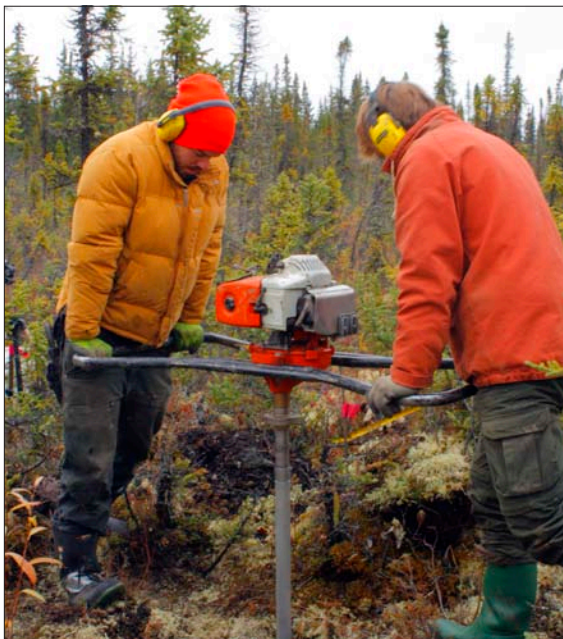
**Figure A1.** Photograph of the GÖLZ™ portable Earth-drill system used for permafrost coring.

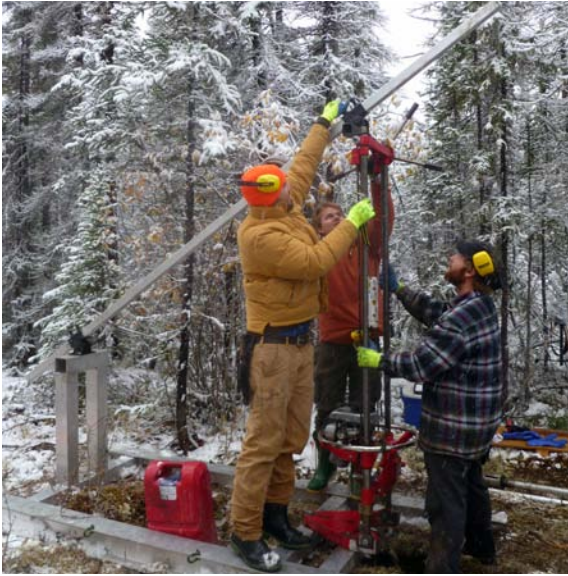
**Figure A2.** Photograph of the Winkie drill, used for permafrost coring.

The Winkie drill is a gas-powered core-drill with a two-speed transmission made for bedrock drilling; this drill has been modified for permafrost drilling in unconsolidated material using a gearbox that lowers the speed to approximately 1200 rpm. Although it is not as mobile as the GÖLZ™ portable core-drill system, it is one of the lightest shift drills on the market (Figure A2) and has the potential to go down to 30 m in ice-rich, fine-grained material. The Winkie core-drill was used with aluminum rods (0.9 and 1.5 m long; Figure A3) and core barrels 10.8 cm in diameter.

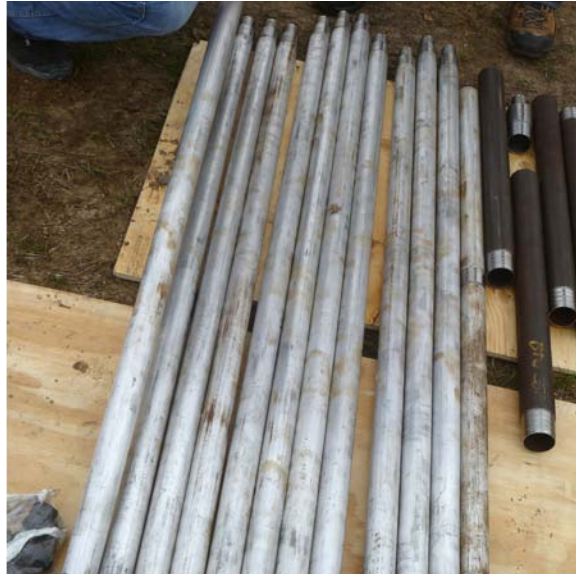
**Figure A3.** Photograph of aluminum rods used for the Winkie drill for permafrost coring.

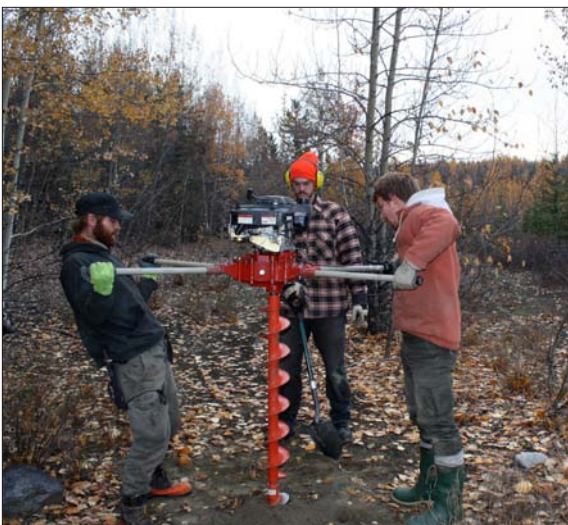
**Figure A4.** Photograph of the Honda drill, used for permafrost coring.

The auger drill is equipped with a Honda GXV160 (144 rpm) motor and flight auger extensions with diameters of 5-46 cm (Figure A4). This drill is destructive and is used to pass through unfrozen sediments of the active layer allowing for bulk ‘grab’ samples. This type of auger is also useful in retrieving deposits of gravel containing clasts that are cobble to boulder sized at the bottom of a borehole.

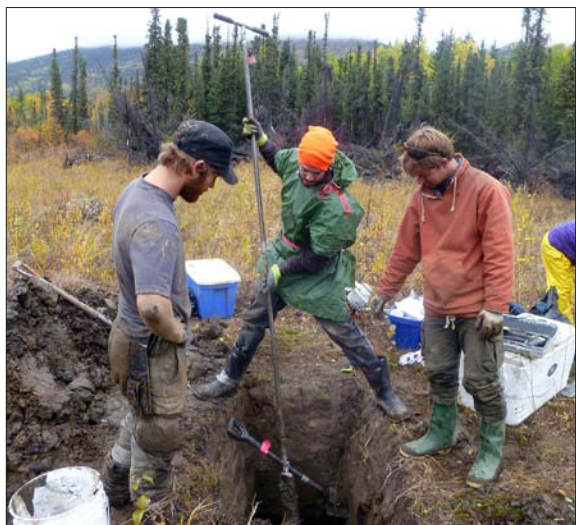
**Figure A5.** Photograph of the hand auger, used for permafrost coring.

The hand auger is used to sample the thawed active layer; it has a 10.2-cm diameter sampling core barrel, and three 1 m-long extension rods (Figure A5). It is ideal for sampling near-surface, fine-grained, unfrozen soil (e.g., clay, silt, sand and fine gravel containing pebbles with a maximum diameter of 25 mm).

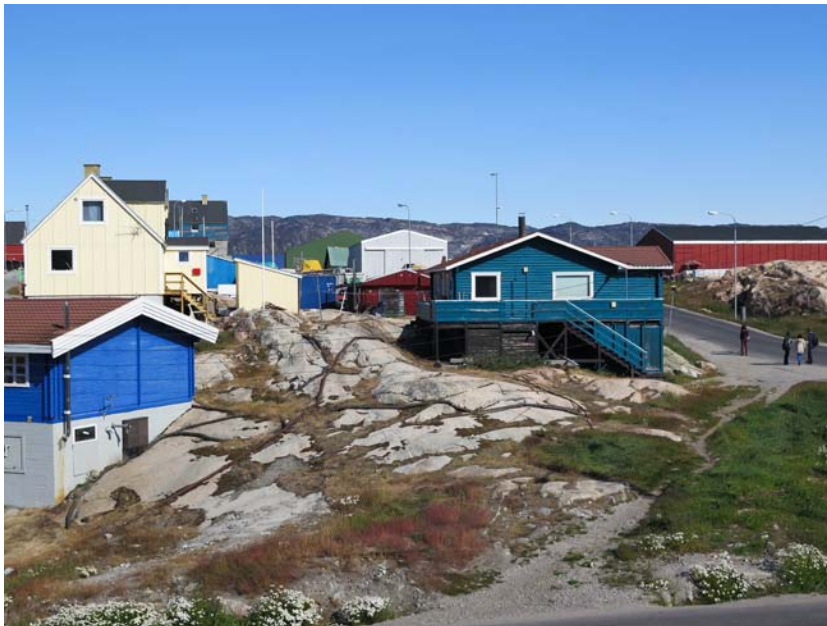
**Figure F1.** Houses in Ilulissat, western Greenland, built directly on bedrock.

The best advice that could be given to an individual or to a contractor is to avoid building on permafrost terrain. If possible, it is always better to find a new site than to face the extra expense and maintenance involved in construction on permafrost. However, in many regions where permafrost is extensive (e.g., in northern Canada, including the Yukon) or where other factors preclude construction on non-permafrost terrain, this advice is sometimes impossible to follow. Building directly on bedrock is a good practice and should be done whenever possible (Figure F1).

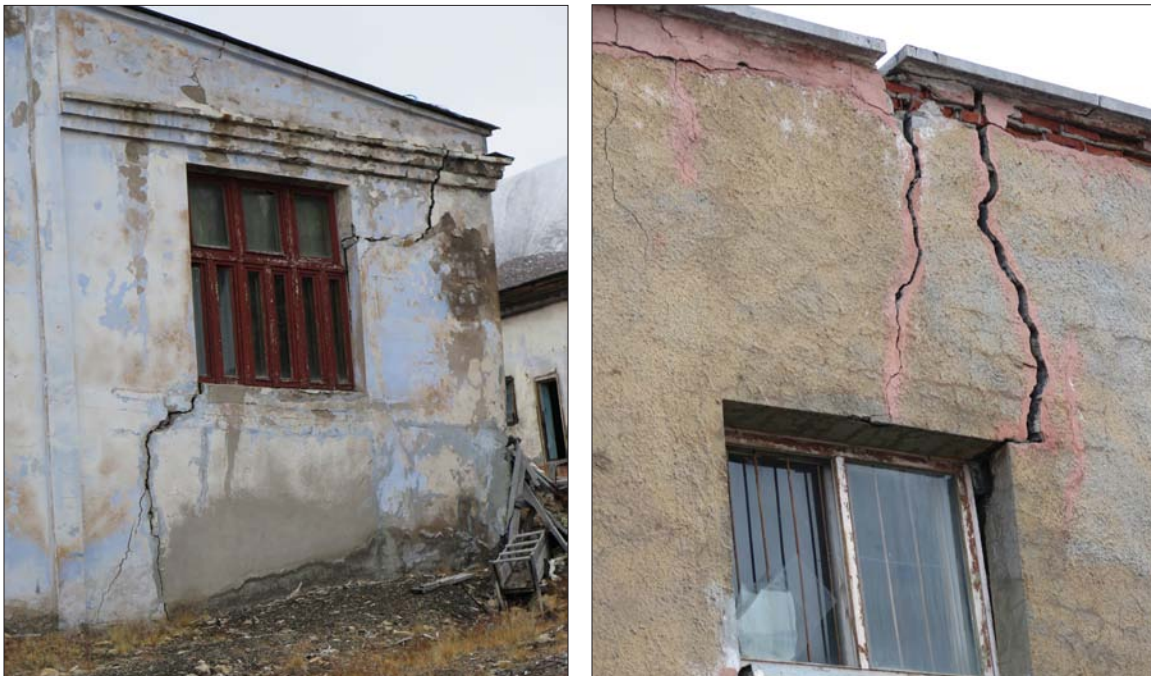
**Figure F3.** Examples of unmaintained buildings in Pyramiden, Svalbard, displaying cracks and uneven settlement in response to permafrost thaw.

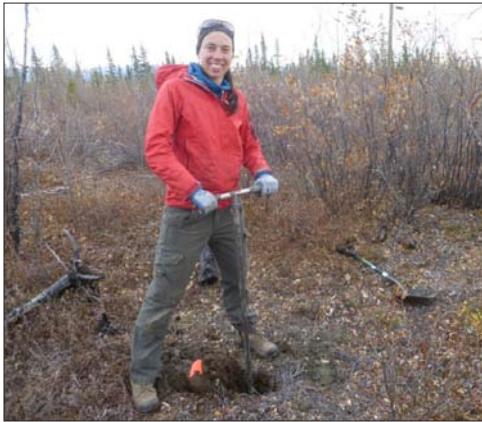
**Figure F5.** Frost-probing to determine depth to permafrost.

When the top of the permafrost is shallow and the active layer is relatively soft, frost probing is an effective method for locating depth to permafrost (Figure F5). This technique uses a steel rod with a handle, which is pushed into the ground manually until the top of the permafrost is reached. With this method, shallow permafrost can easily be detected, and its depth measured. Frost probing is inexpensive, fast and very useful for preliminary site investigations.

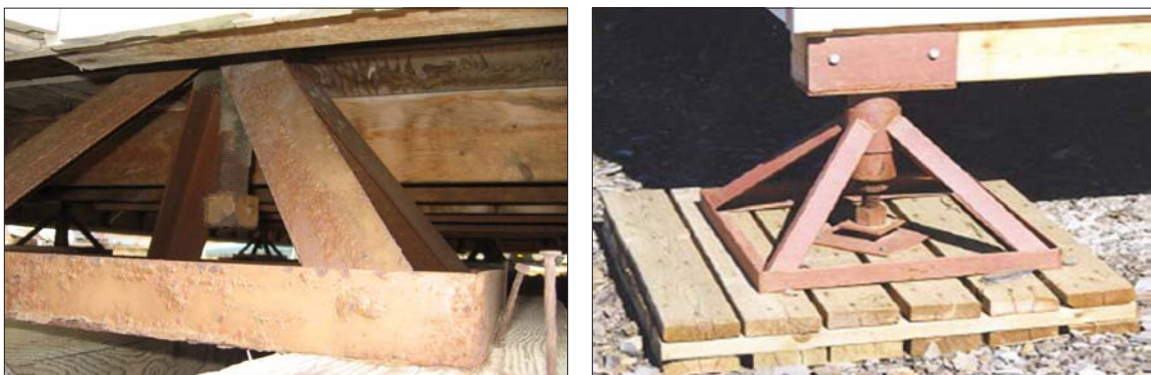
**Figure F11.** Examples of adjustable-jack foundations from Gravel (2012) and CSA (2010).

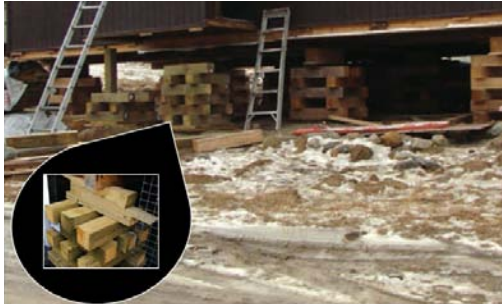
**Figure F12.** Example of a timber-block foundation used in Nunavut (Government of Nunavut, 2013).

Timber-block foundations (Figure F12) work on the same principle as the screw-jack technique. However, screw jacks are not always easily obtainable and it can be more convenient to use timber blocks. Timber blocks are normally screwed together to ensure lateral stability. Timber blocks are commonly sited directly on natural ground (without a gravel pad).

Maintenance operations are almost the same as for screw-jack foundations, described above; however, the operator must use a hydraulic jack to lift the load of the building before shimming the timber blocks. Maintenance for this style of foundation is therefore more labour intensive than for screw-jack foundations.

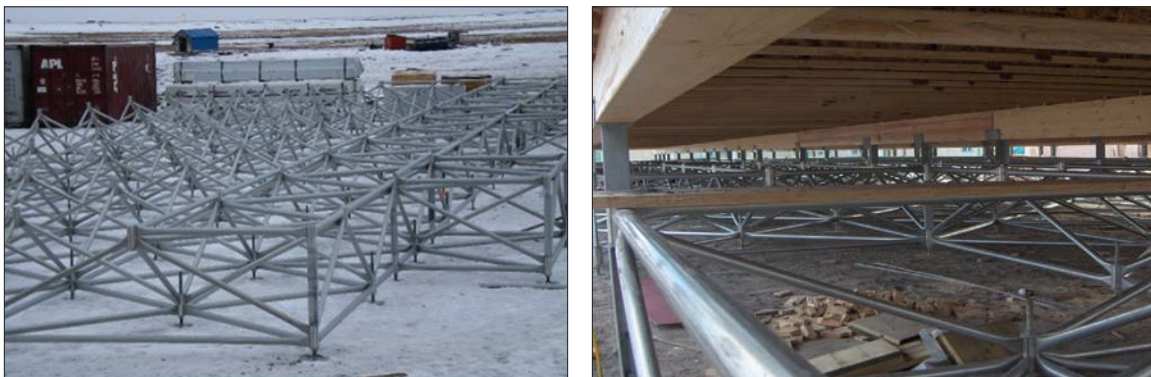
**Figure F13.** Examples of space-frame foundations in Nunavut (Barriault, 2012).

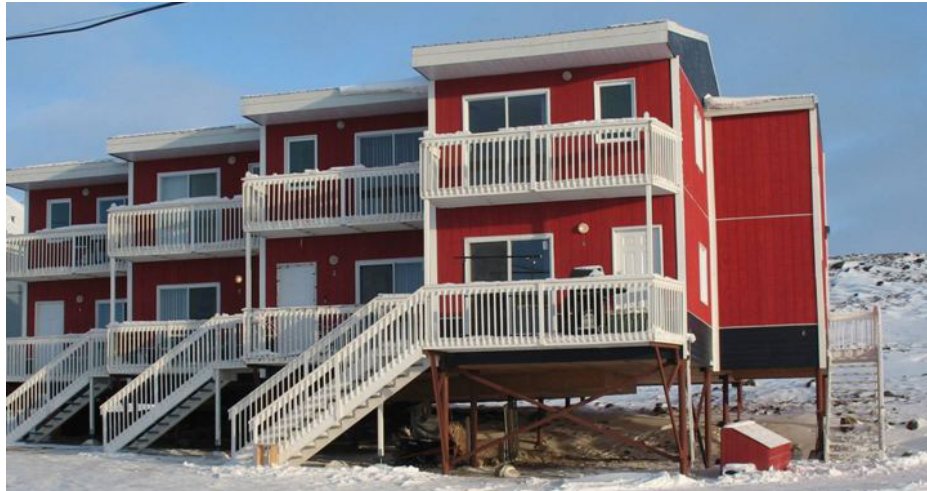
**Figure F14.** Example a steel-pile foundation in Nunavik (Gravel, 2012).

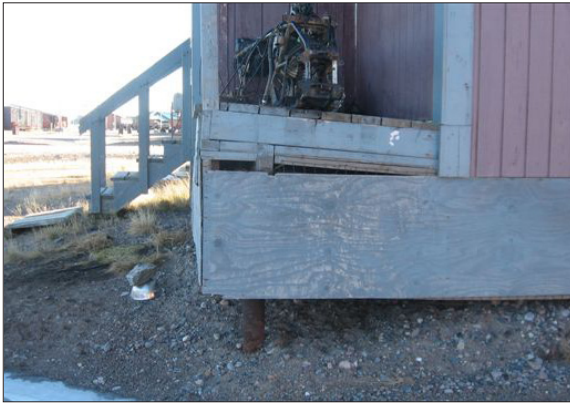
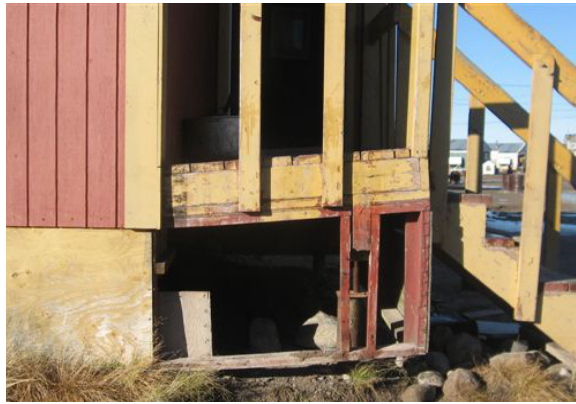
**Figure F15.** Examples of pile jacking in Nunavut (Barriault, 2012).

In response to ground warming, if the active layer deepens, foundation systems that rely on piles may experience increased frost heaving (Figure F15 a,b,c). This frost heaving occurs when a small part of each pile's surface is frozen to the surrounding soil year-round, while a larger part of the pile's surface is exposed to the lifting force exerted through soil expansion when the water in the active layer re-freezes in the autumn and winter (CSA, 2010). If piles are used in a frost-sensitive soil and cannot be placed directly on bedrock, the piles must be equipped with anti-lift shafts to prevent the exertion of a vertical force by seasonal frost, which can distort the building's structure. Various methods can prevent frost heaving when using pile jacking and a competent engineer should be consulted if this method is being considered.

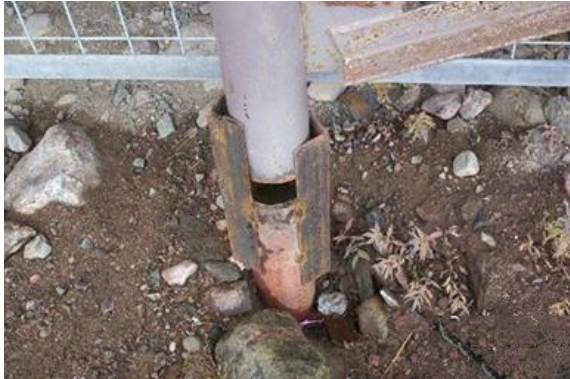
**Figure F16.** Example of thermosyphons, a foundation system that requires a significant amount of expertise to design, install, maintain and monitor (CSA, 2014).

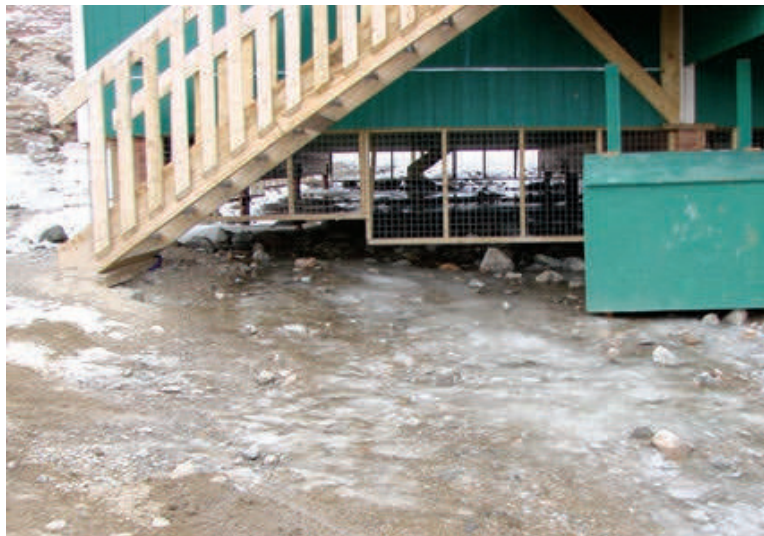
**Figure F18.** Example of water ponding around a foundation built on permafrost (Government of Nunavut, 2013). Water ponding can have a negative impact on permafrost thermal regimes.
